## **INVESTIGATION REPORT**

| <b>Aircraft Make:</b> | Pipistrel | <b>Aircraft registration:</b> | N4JW |
| <b>Aircraft Model:</b> | Virus SW | <b>Aircraft S/N</b> | 877 SWN 100 iS |

| <b>Engine Type:</b> | Rotax 912 iS 3 Sport | <b>Engine TTSN</b> | 54 |

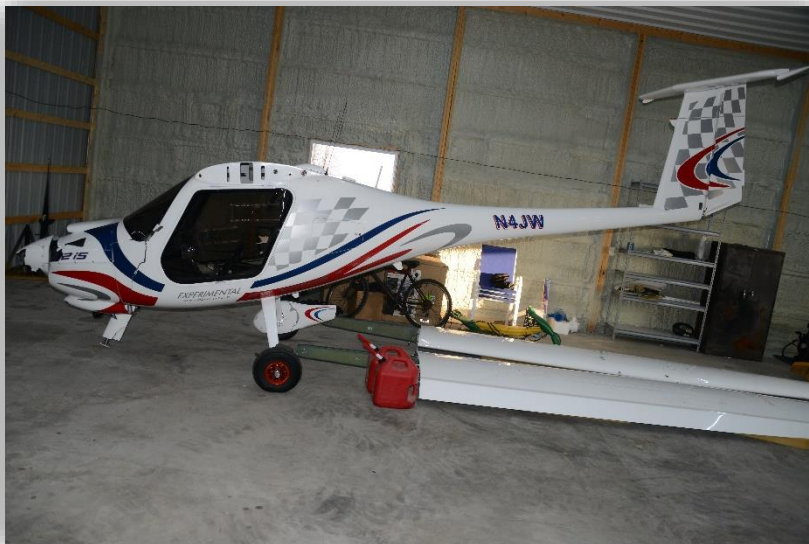
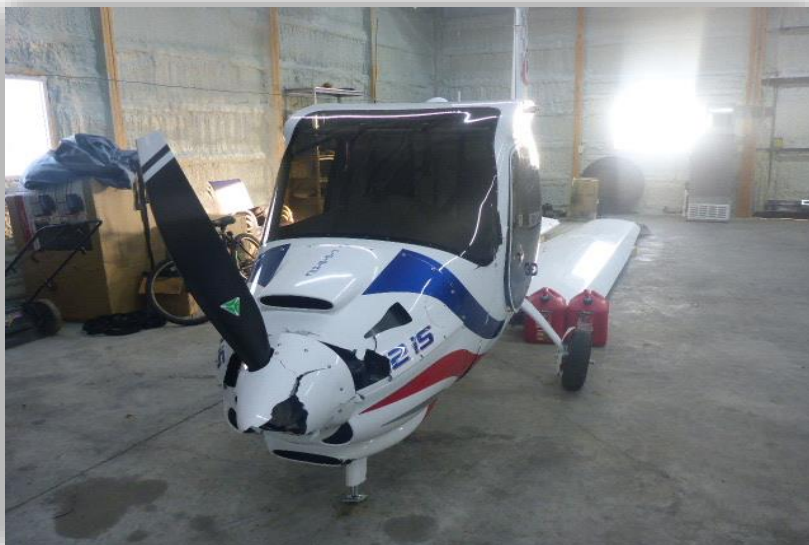
The aircraft sustained frontal impact damage to the engine cowling, propeller spinner, nose landing gear and the left hand wing. One of the two propeller blades was broken off at the hub. Both wings had been removed by the owner and placed on the hanger floor behind the aircraft.

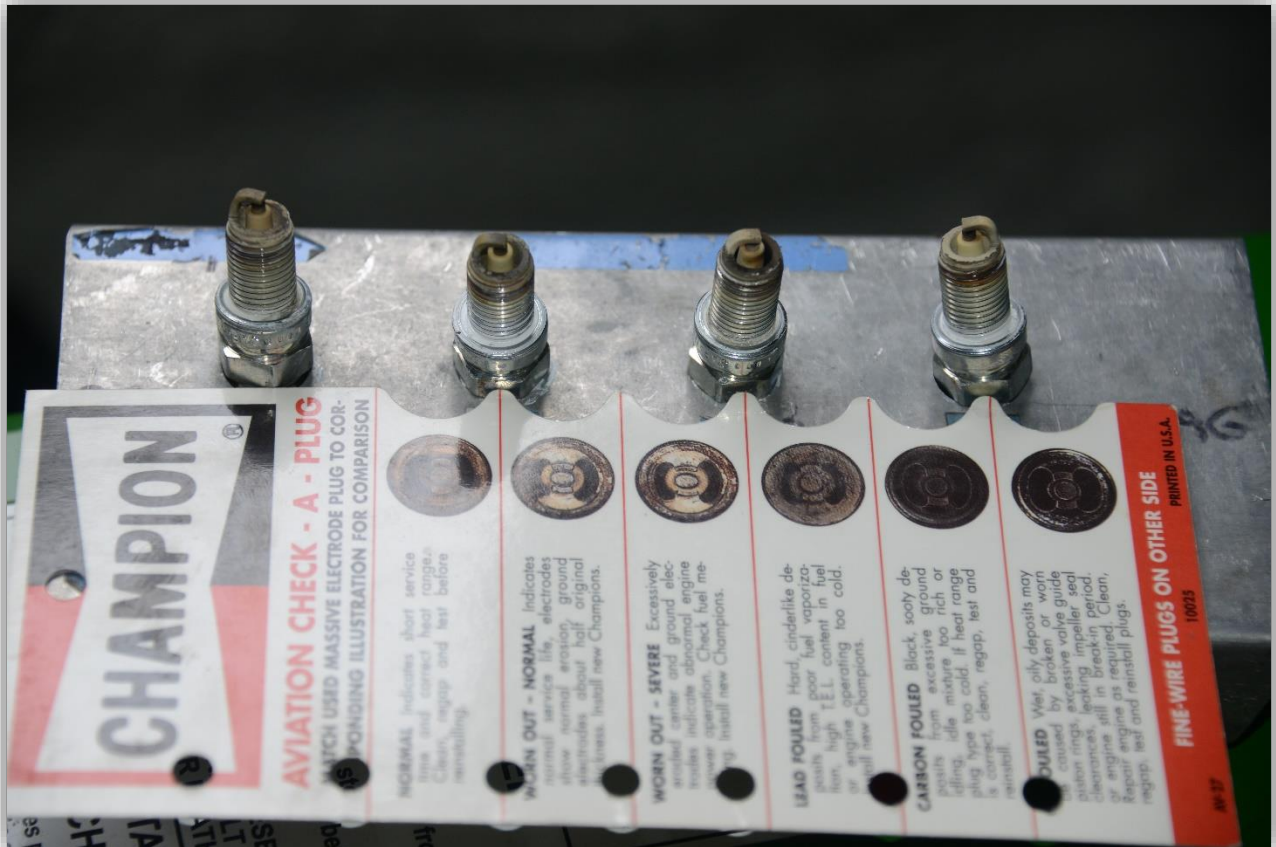
**Spark Plugs:** The top spark plugs were removed from engine and inspected for condition and conformity. The lead build up on the spark plug electrodes indicated the engine had previously operated AV-GAS. No anomalies were found with the top spark plugs of the engine.

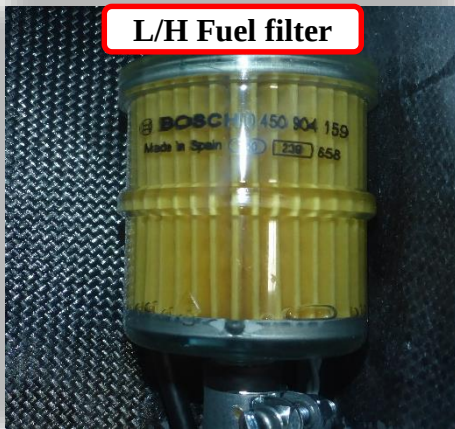
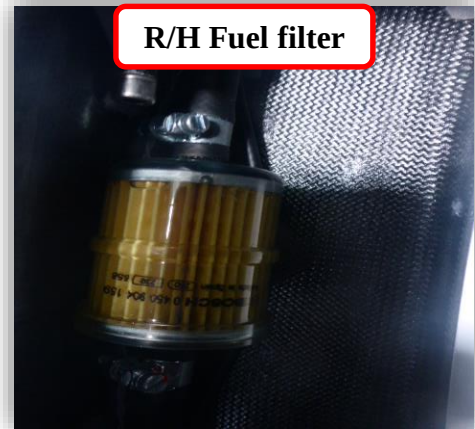
The fuel system was examined for any obstruction by blowing air through the fuel lines. No obstructions were noted. A small fuel sample was collected from each wing and tested for water with the use of water finding paste. No evidence of water was found within the fuel contained in the sample bottles. The gascolator bowl had been previously removed by the FAA inspector. Fuel was still contained within the gascolator bowl and it was tested for water with water finding paste. No evidence of water was found in the fuel that was contained within the gascolator bowl.

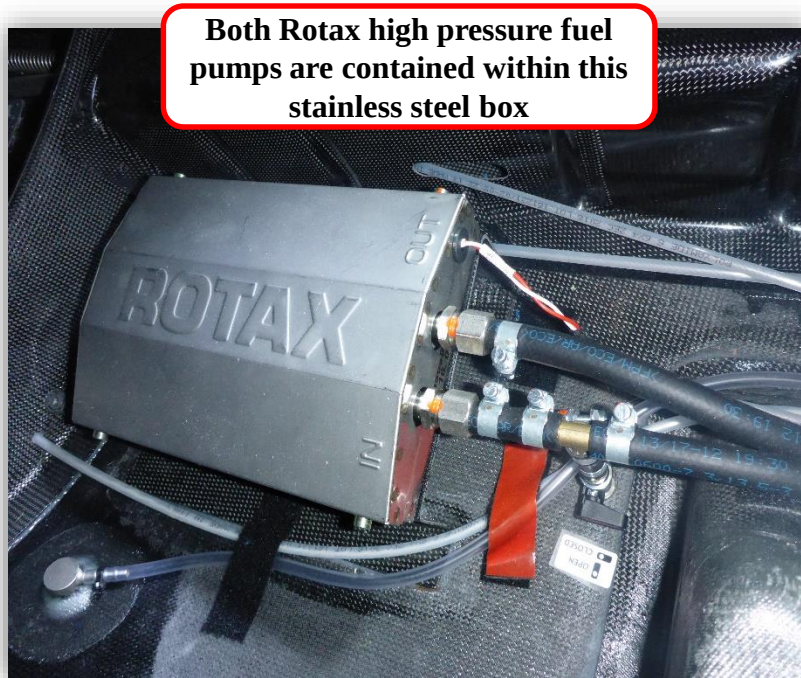
**Fuel system continued:** The Rotax 912iS comes from the Rotax factory with two high constant pressure, electronic fuel pumps that are connected in series with bypass valves. The engine will operate with either one or both pumps running simultaneously. The fuel pressure of the engine is adjusted by a mechanical pressure regulator. The pressure regulator is installed in the fuel line after Cyl. 4. The reference pressure of the fuel system is the airbox pressure. The operating limit of the fuel pressure must be maintained at the inlet of the fuel pressure regulator. The fuel pumps were tested by turning them both on and by pumping fuel through them. Both fuel pumps operated normally and no anomalies were noted.

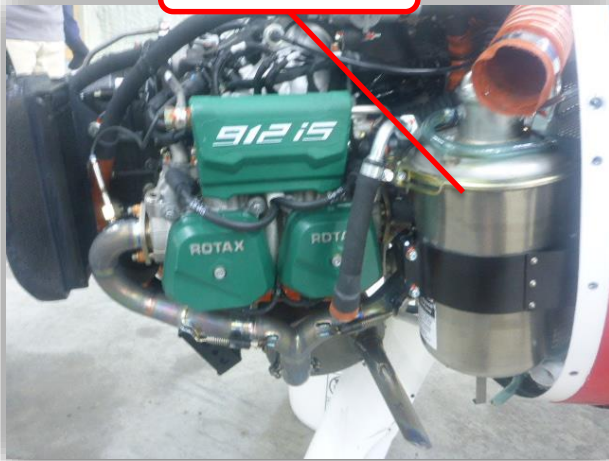
**Rotax Oil tank**

The lubrication system was examined for condition, conformity and modifications. The oil was returned from the engine to the oil tank by rotating the engine by the propeller. The oil level was checked and found to be slightly over filled. The oil system incorporated an aftermarket oil thermostat that is commonly found with aircraft that are operating in colder climates and temperatures. The oil cooler was found to be undamaged and the entire lubrication system was in good condition with no anomalies found.

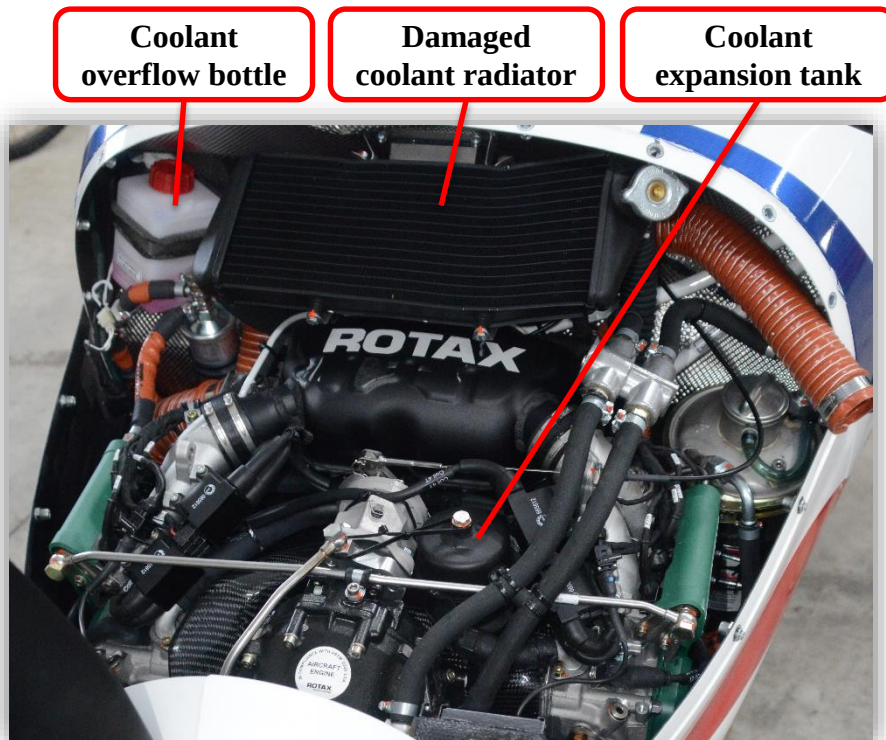
The coolant system was examined for condition, modifications and conformity. The only damage found to the coolant system was on the coolant radiator located on top of the engine. This damage was caused from impact, however the system was not breached and no loss of coolant was noted. No anomalies were found with the coolant system.

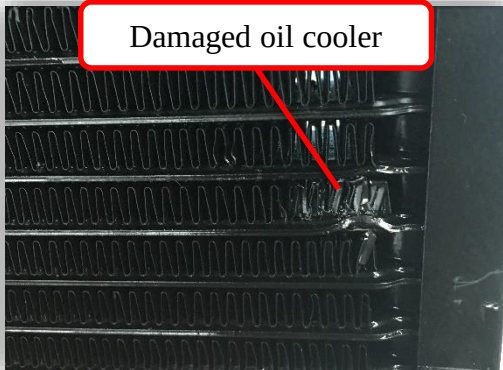
Damaged oil cooler

One of the two oil coolers was damaged from impact and was required to be removed from the engine for test run purposes. The top spark plugs were removed and the engine was rotated by hand to return all the oil contained within the engine case back to the oil tank. The oil and Rotax oil tank was inspected and found to be clean and clear of debris.

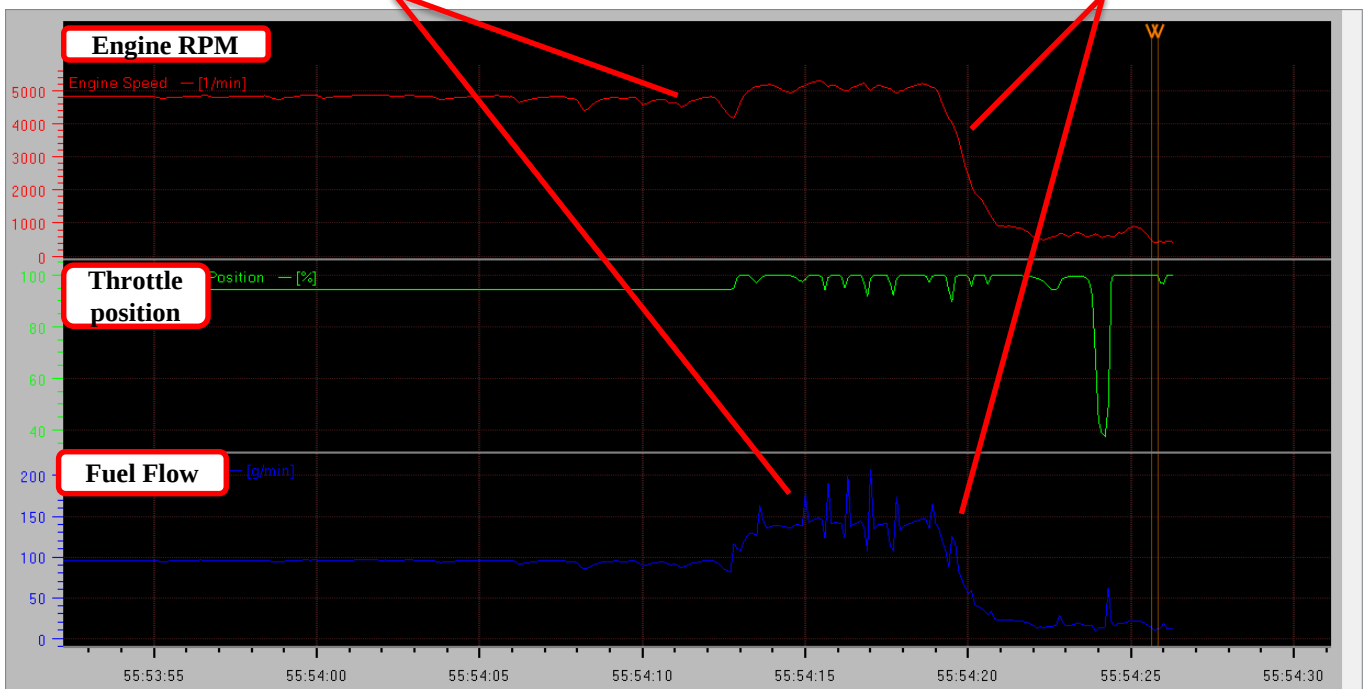
Approximately 10 min and 44 seconds into the second engine test run, the ECU data shows the engine begin to run rough as the RPM and fuel flow begin to fluctuate for approximately 19 seconds until a reduction of RPM and fuel flow is seen. The RPM begins to drop from 5206 RPM to 515 RPM over a 7 second time span. The throttle position remained fairly consistent between 94% and 100% throughout this loss of power sequence, until it was manually manipulated following the drop in RPM. Manipulation of the throttle lever did not make any changes to engine parameters.

**Fluctuation in Engine RPM (Engine begins to run rough) and fluctuations and spikes in fuel flow**

**Drop in RPM and fuel flow**

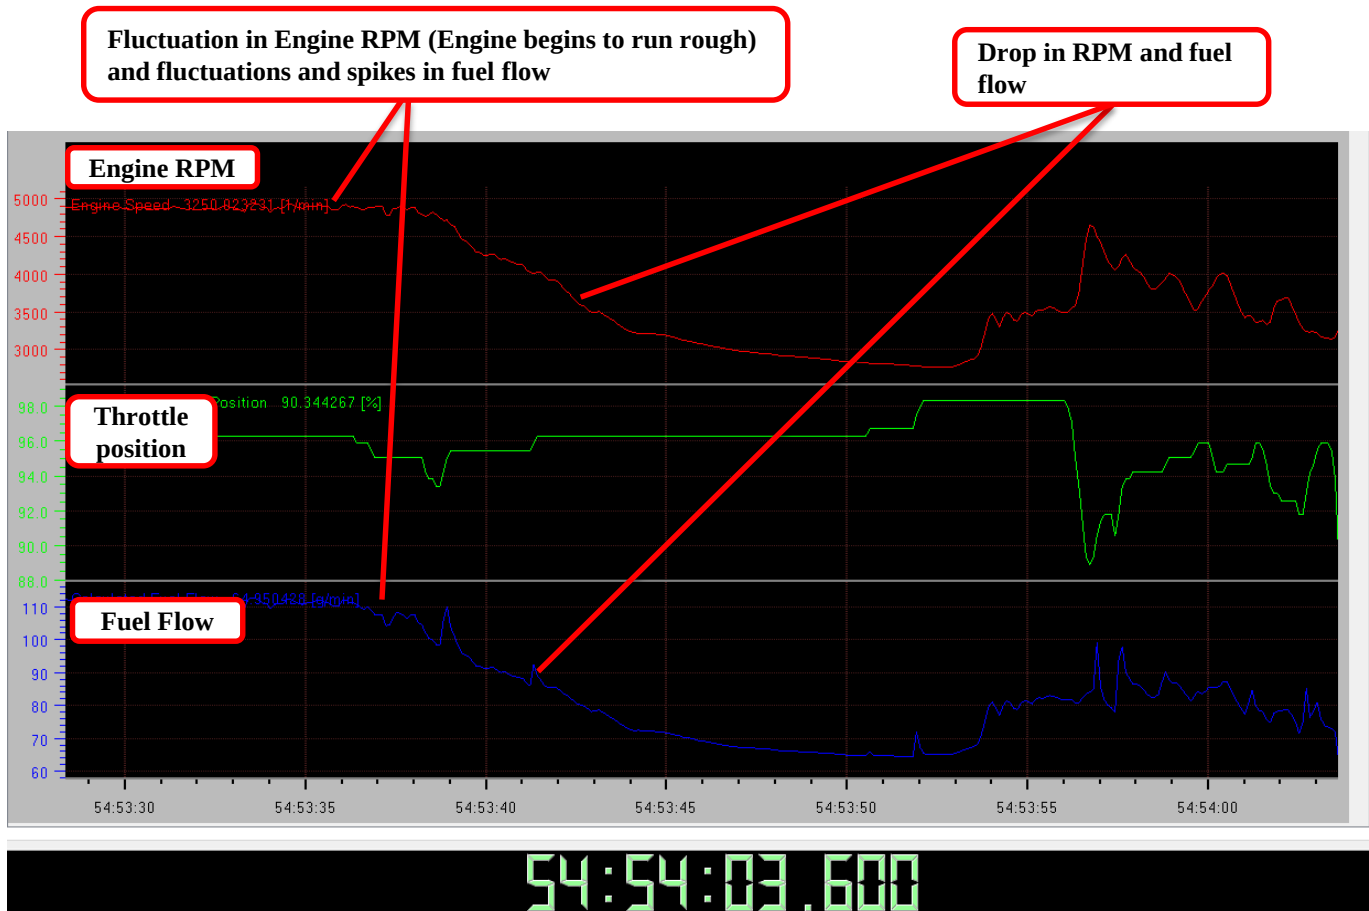
Approximately 21 minutes into the accident flight, the ECU data shows the engine begin to run rough as the RPM and fuel flow begin to fluctuate for approximately 6 seconds until a reduction of RPM is seen. The RPM and fuel flow begin to drop from 4892 RPM to 2766 RPM over a 15 second time span and the throttle position remained fairly consistent between 93% and 96% throughout this loss of power sequence.

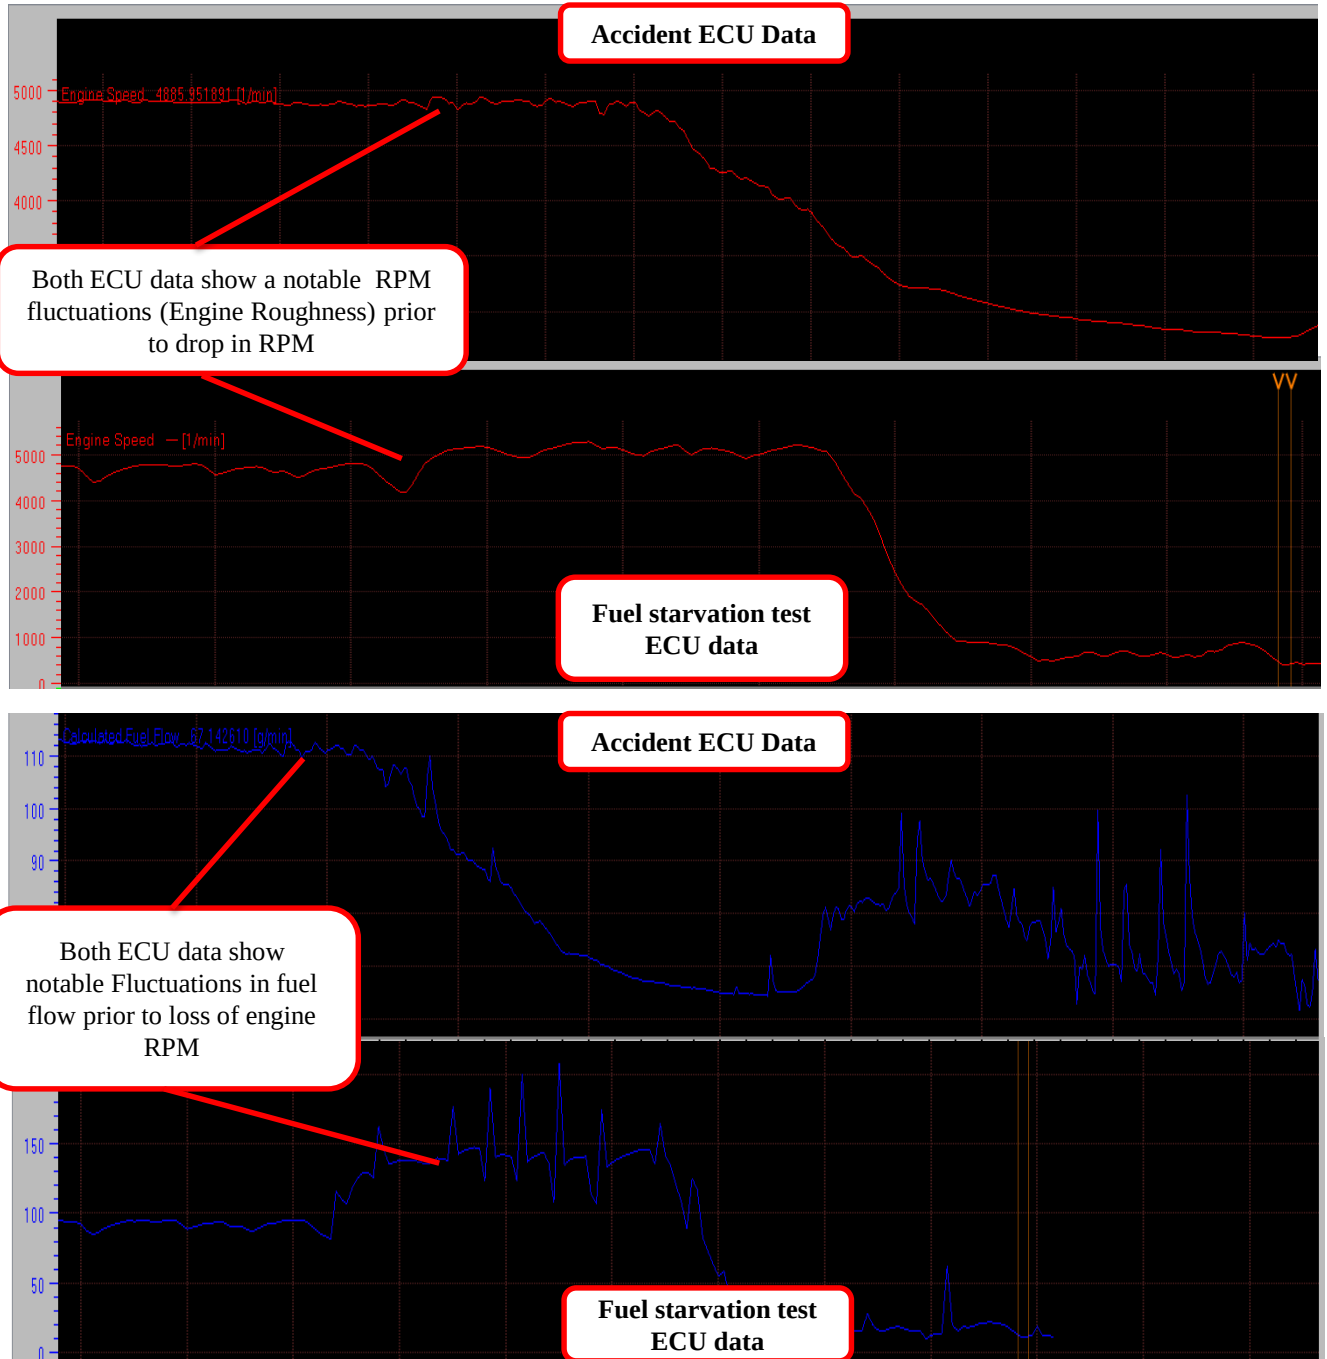
Both the accident ECU data and the fuel starvation test ECU data were compared to each other. Similarities can be seen with the data as RPM show notable fluctuations in engine RPM and fuel flow just prior to drop in RPM.

- Accident engine parameter data (RPM, Fuel Flow, Fuel Pressure) captured from the accident aircraft showed similarities with the fuel starvation test data. These similarities indicate a possible fuel flow interruption or fuel exhaustion to the 912iS accident engine during the L/H climbing turn.

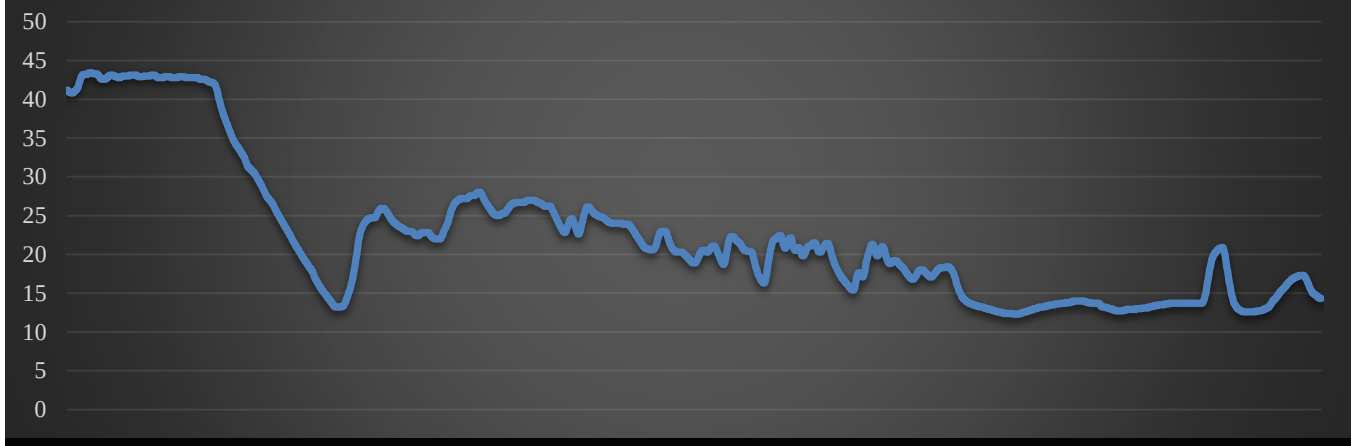
**Accident Aircraft Fuel Pressure**

As shown below, there is a notable drop in fuel pressures on both the accident flight data and the fuel starvation test run data. Both the accident flight data and fuel starvation test run data have similar indications and pressure drop following a rise.

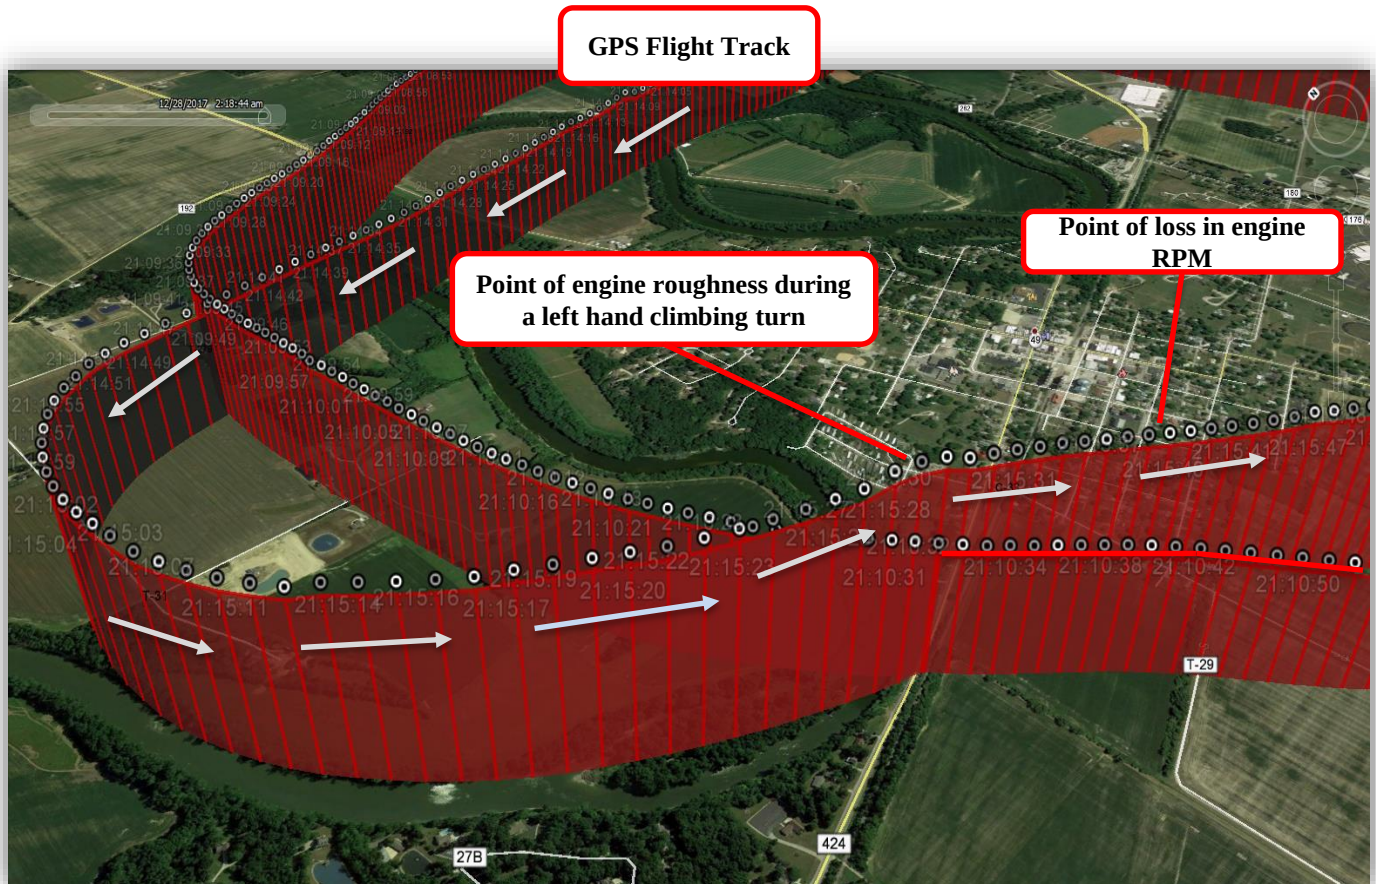
The aircraft was heading South East in a left hand climbing turn when the engine began to loose power following fluctuations in engine RPM (Engine running rough).
