# Continental Motors

## ENGINE EXAMINATION REPORT

| ENGINE MODEL | IO-470-C |
| FILE NUMBER | 17-377 |

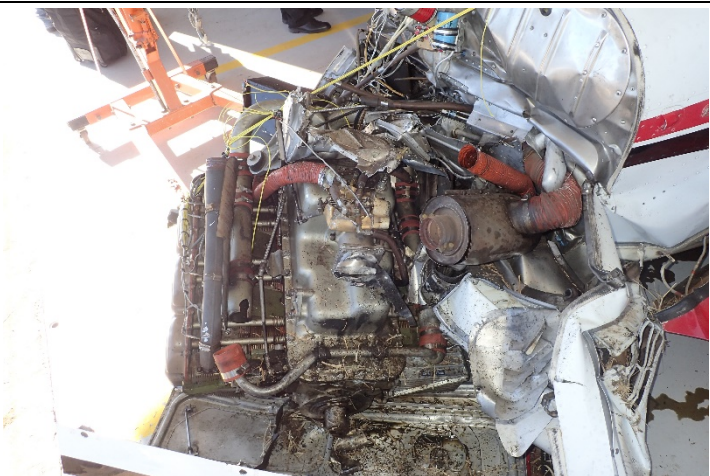
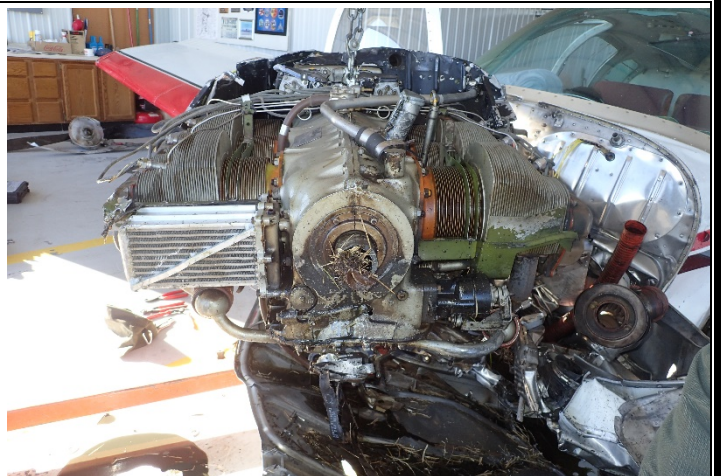
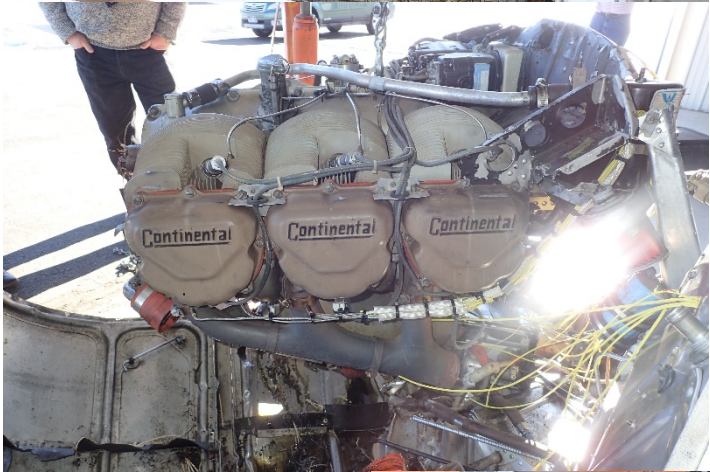
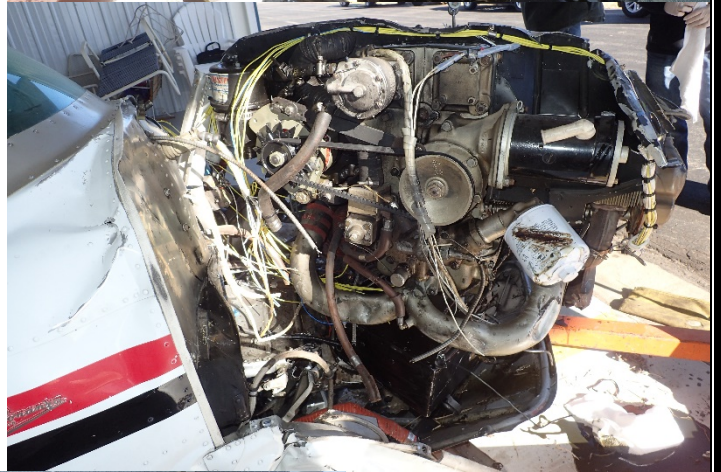
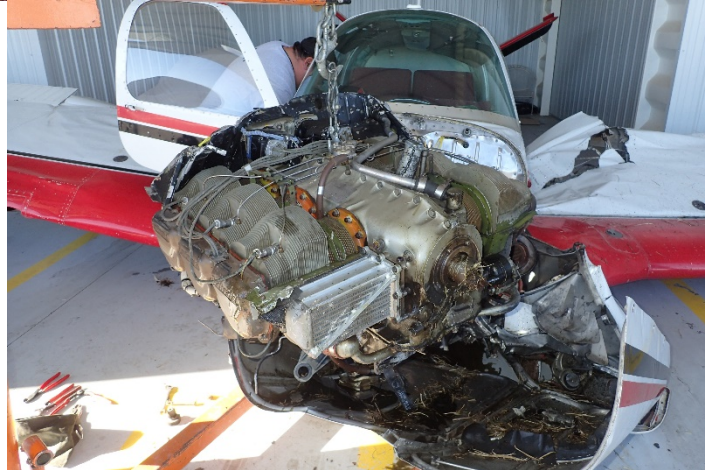
The engine remained partially attached to the airframe though one engine mount, cables, hoses, and wires. The engine was removed from the airframe to facilitate the inspection. The engine sustained impact damage signatures with the most damage occurring to the front of the engine. The propeller flange had broken free from the rest of the crankshaft and the crankcase displayed impact damage to the front bottom portions of the crankcase. The two blade, variable pitch propeller remained attached to the propeller flange; however, the flange had broken free from the rest of the crankshaft. Both propeller blades remained installed in the hub; both propeller blades displayed minor impact damage signatures. All six cylinders remained installed to their cylinder bays and were undamaged.

The fuel pump remained attached to its installation point and displayed impact damage signatures. The fuel inlet line and the vapor return line AN fittings had broken free from the fuel pump. The throttle and metering assembly remained attached to its installation point and displayed impact damage signatures with the most damage occurring to the fuel metering portion of the assembly. The fuel manifold valve remained attached to its installation point and was undamaged. All of the fuel lines were checked and were found to be secure to their attachment fittings.

Both magnetos remained attached to their installation points and were undamaged. The ignition harness remained attached to the magnetos and to the spark plugs; the ignition harness displayed impact damage signatures to several of the ignition leads. Several of the leads were torn and partially severed. All of the spark plugs remained installed in their cylinders and were undamaged.

The induction system displayed impact damage signatures. The induction balance tube and the induction Y-tube displayed the most impact damage signatures. The exhaust risers remained attached to their cylinders and displayed impact damage signatures. There were no signs of exhaust or induction leaks noted.

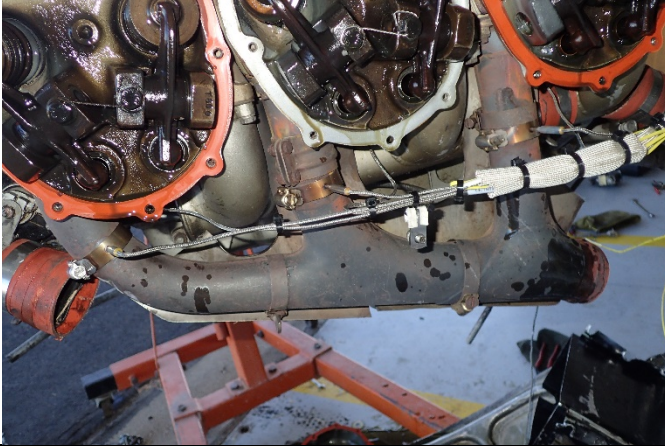
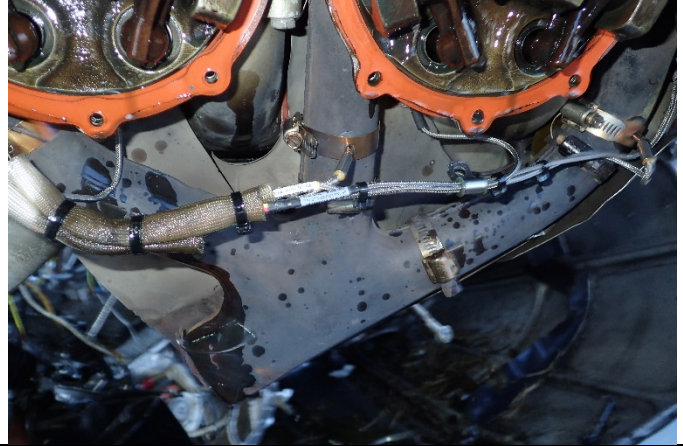
#### EXHAUST SYSTEM

**Condition:** The exhaust system displayed impact damage signatures; both of the exhaust mufflers and tailpipes had broken free from the exhaust risers. There were no signs of exhaust leaks or any other anomalies noted.

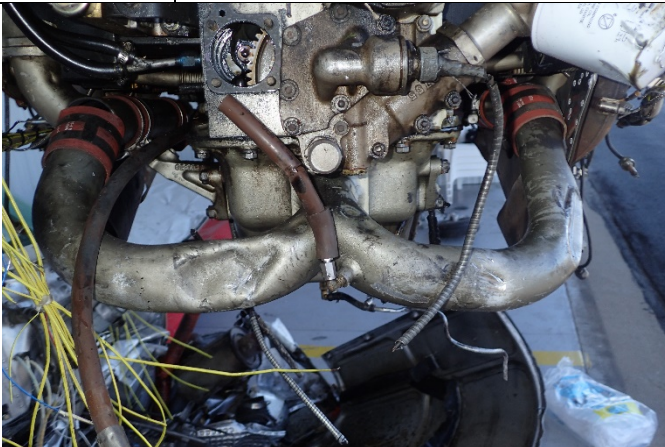
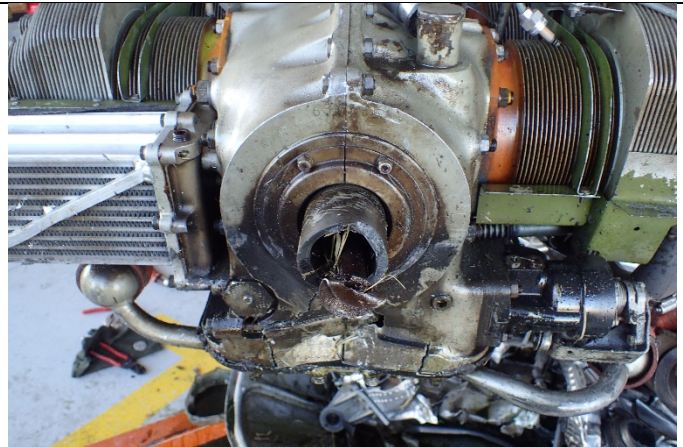
#### INDUCTION SYSTEM

**Condition:** The induction system displayed impact damage signatures to several of the components. The induction balance tube and the Y-tube displayed the most impact damage signatures. There were no signs of induction leaks or any other anomalies noted.

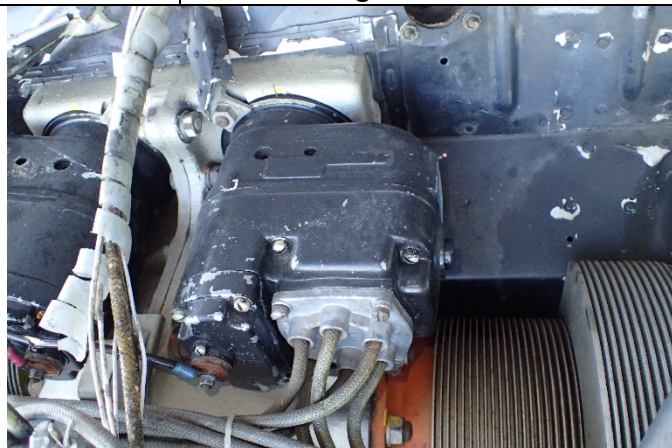
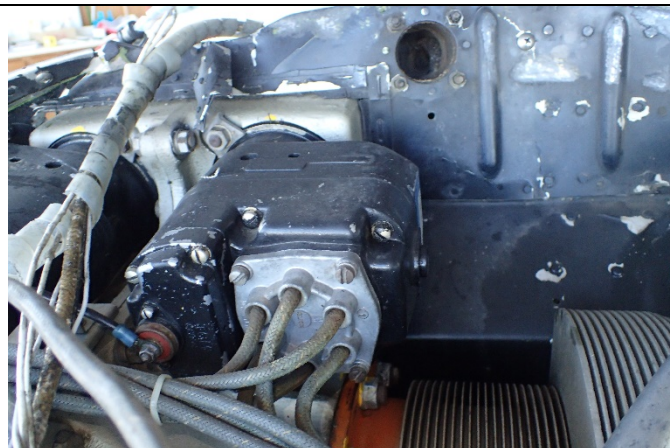
## LEFT MAGNETO

The magneto remained attached to its installation point and was undamaged. The impulse coupling was noted to operate during crankshaft rotation. During impulse coupling operation it was noted that magneto was capable of producing a spark on all six posts in the correct order and was in sync with the right magneto. There were no anomalies noted with the magneto.

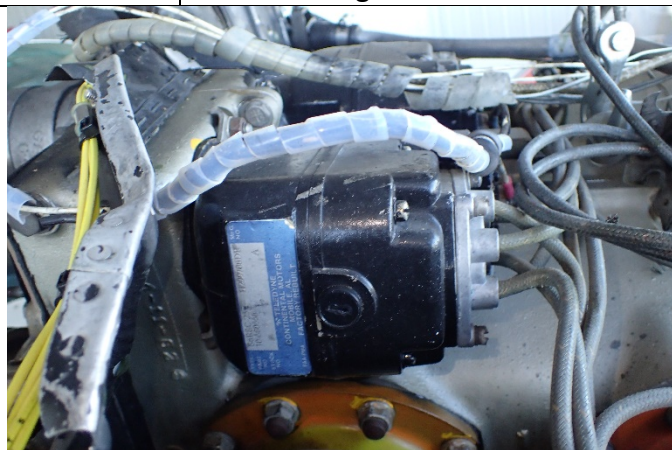
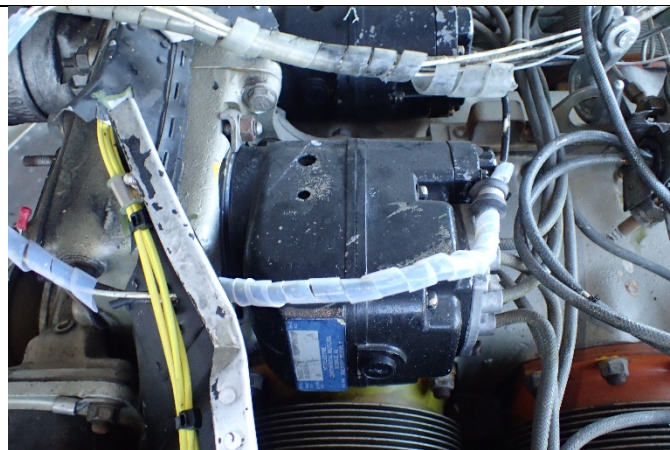
RIGHT  
MAGNETO

The magneto remained attached to its installation point and was undamaged. The impulse coupling was noted to operate during crankshaft rotation. During impulse coupling operation it was noted that magneto was capable of producing a spark on all six posts in the correct order and was in sync with the left magneto. There were no anomalies noted with the magneto.

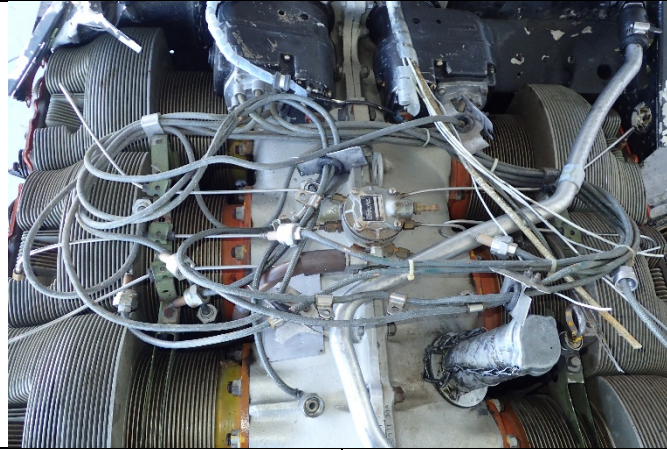
## IGNITION HARNESS

The ignition harness remained attached to the magnetos and to the spark plugs. The harness displayed impact damage signatures; several of the ignition leads were torn and partially severed. During magneto impulse coupling operation, the harness was capable of conducting a spark from the magneto to the ignition lead end or to the first portion of the lead that was partially severed. There were no anomalies noted with the ignition harness.

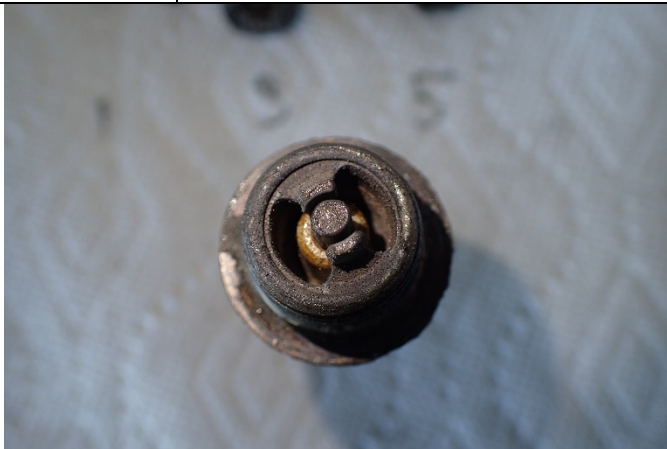
#1 Top Spark Plug

All of the spark plugs remained installed in their cylinders and were undamaged. The top spark plugs were removed from their cylinders and visually inspected. The top spark plugs displayed normal operating and wear signatures when compared with Champion Aviation Service Manual AV6-R. The bottom spark plugs were inspected using a lighted borescope; the #5 bottom spark plug was not examined due to being submersed in engine oil which was consistent with post-accident accumulation. The visible spark plugs displayed normal operating and wear signatures.

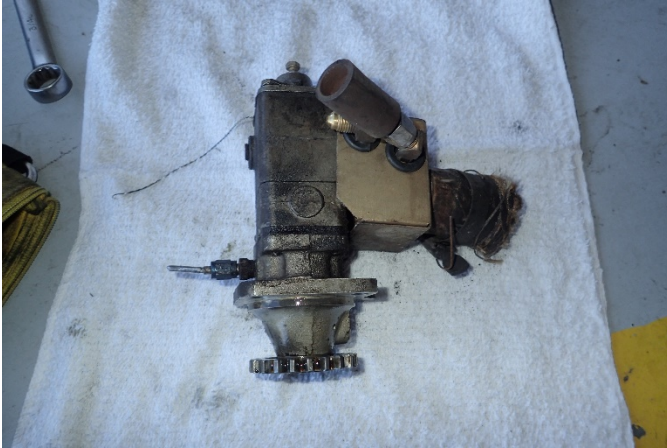
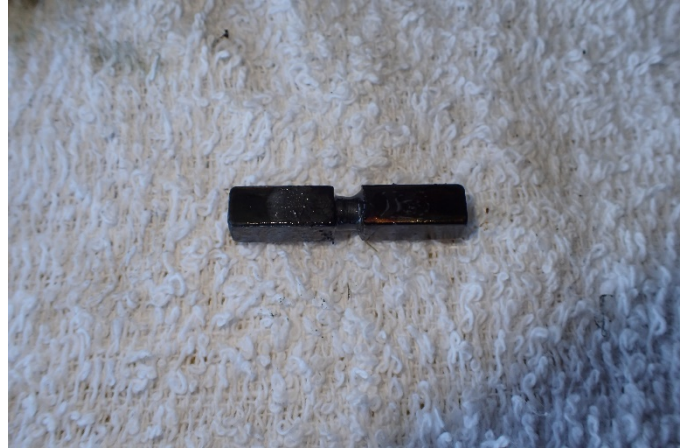
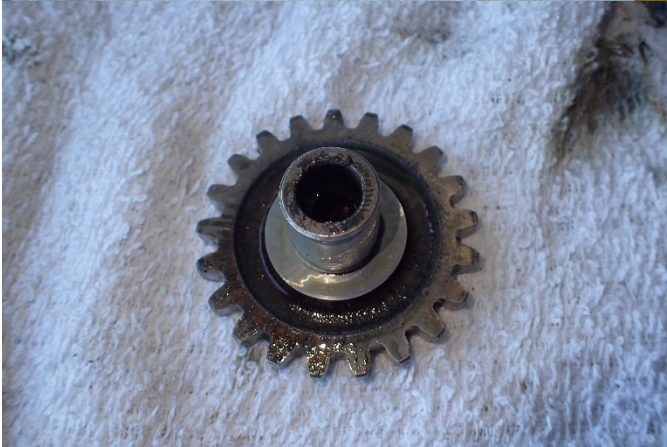
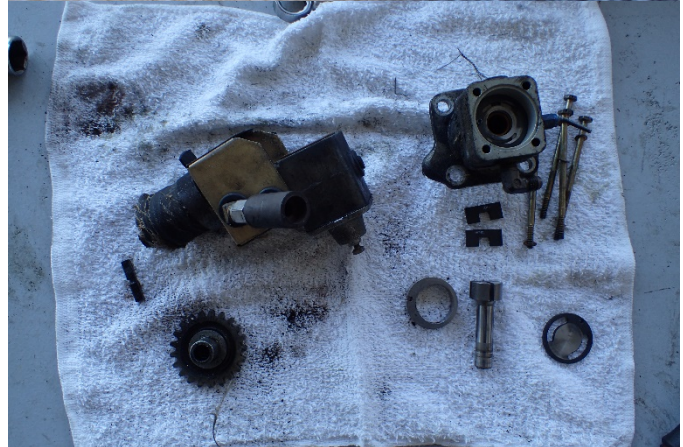
### FUEL PUMP

The fuel pump remained attached to its installation point and displayed impact damage signatures. The fuel inlet and the vapor return AN fitting had broken free from the fuel pump. All of the fuel lines were noted to be secure to their respective AN fittings. The fuel pump was removed and it was noted that the fuel pump drive coupling remained intact. The fuel pump was partially disassembled. There were no anomalies noted with the fuel pump.

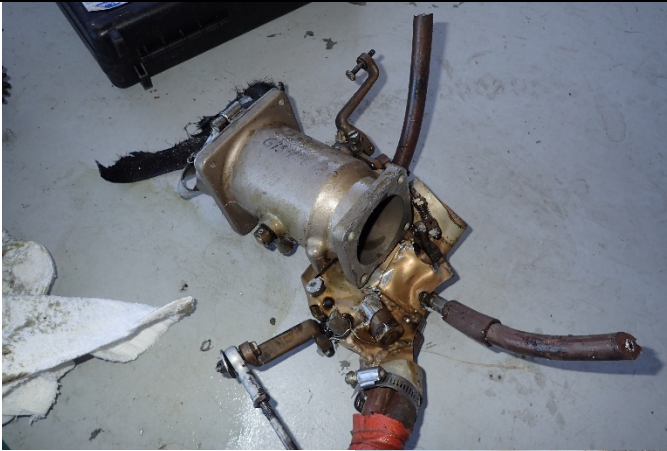
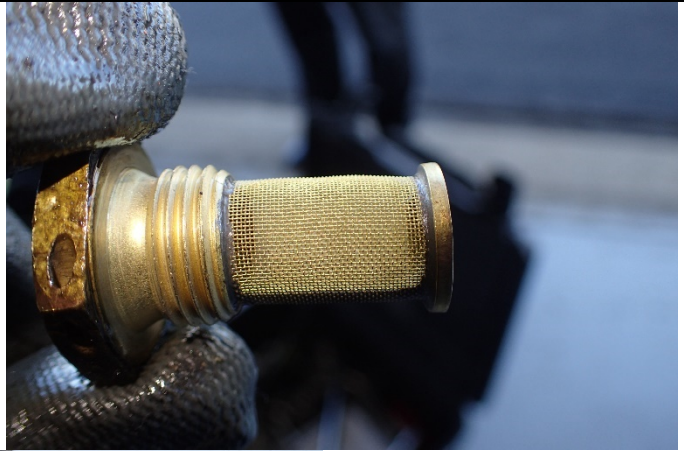
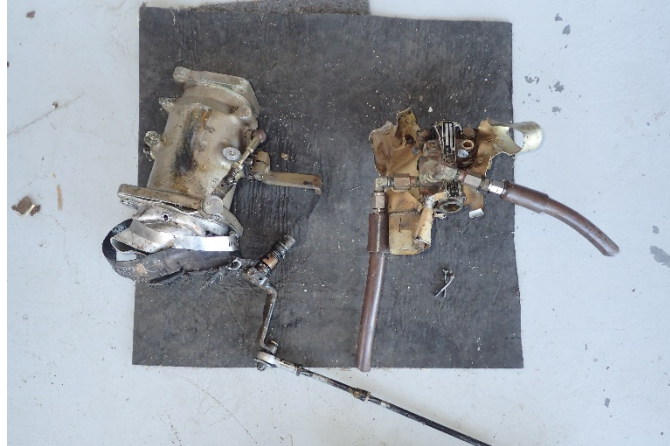
## THROTTLE BODY METERING UNIT

The throttle and metering assembly remained attached to its installation point and displayed impact damage signatures concentrated to the fuel metering portion of the assembly. The throttle and metering assembly was removed and was disassembled. The internal components displayed normal operating signatures and the fuel inlet screen was clear of any contaminants. There were no anomalies noted.

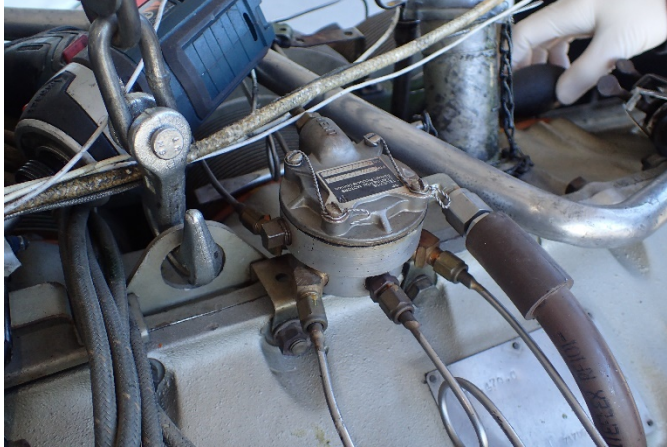
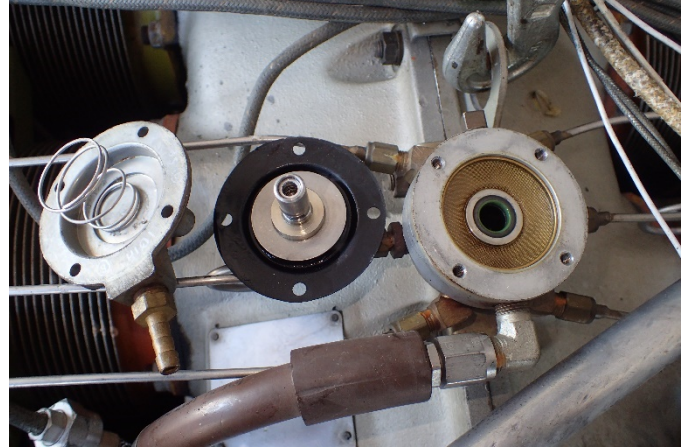
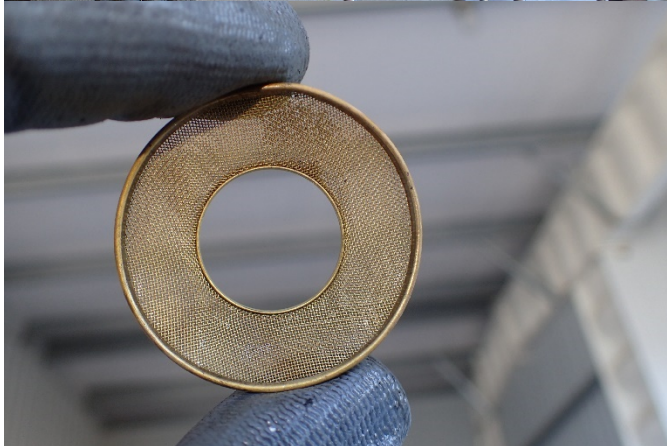
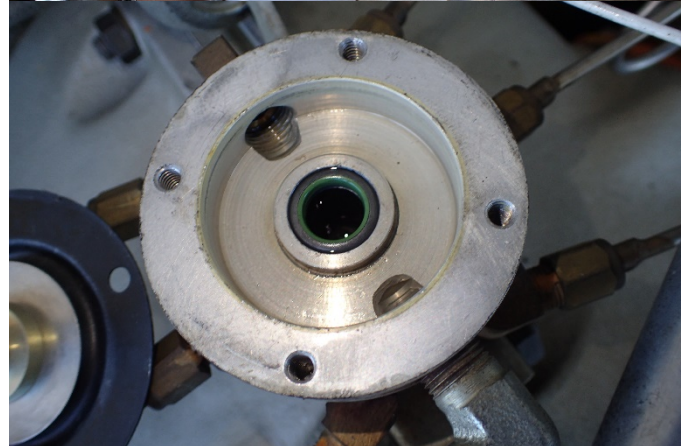
## FUEL MANIFOLD VALVE

The fuel manifold valve remained attached to its installation point and was undamaged. The manifold valve was disassembled and it was noted that the internal components displayed normal operating signatures. There were no anomalies noted with the manifold valve.

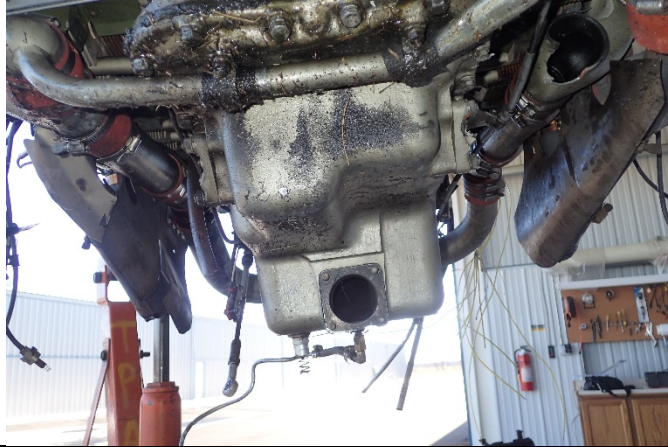
**Condition:** The oil sump remained intact; however, the oil sump quick-drain displayed impact damage and had partially broken off. A significant amount of oil drained from the oil sump; the oil displayed normal color and there were no contaminants noted within the oil.

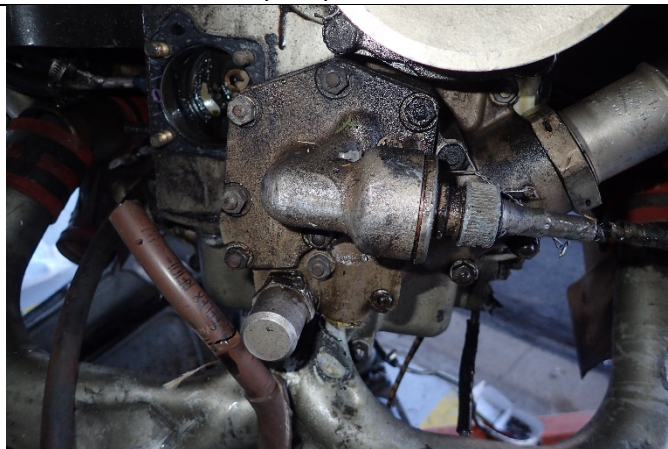
**OIL PUMP**

**Condition:** The oil pump remained attached to its installation point and was undamaged. There were no anomalies noted with the oil pump.

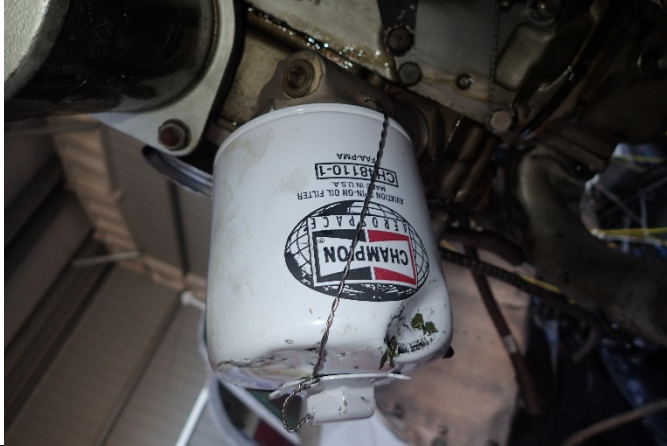
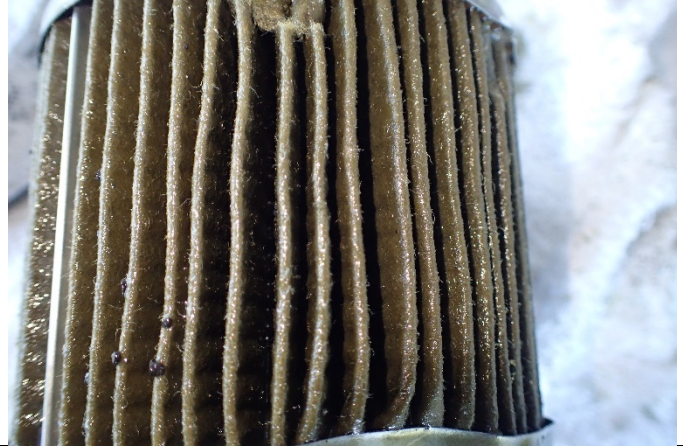
## OIL FILTER

The oil filter remained attached to the oil filter adapter and displayed impact damage signatures. The oil filter was removed and the housing was cut open. The oil filter pleats displayed normal operating signatures and there were no signs of metallic material within the filter pleats.

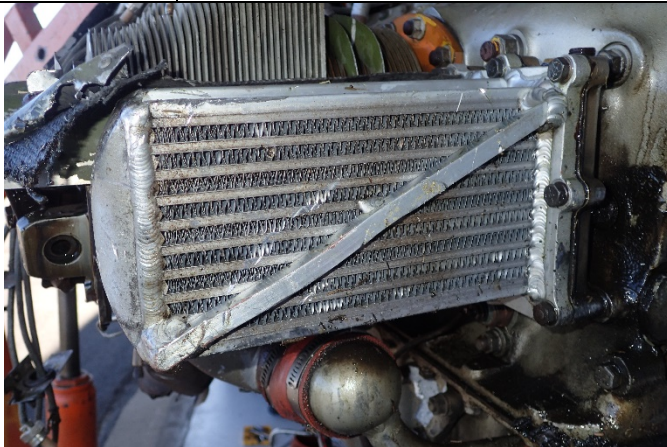
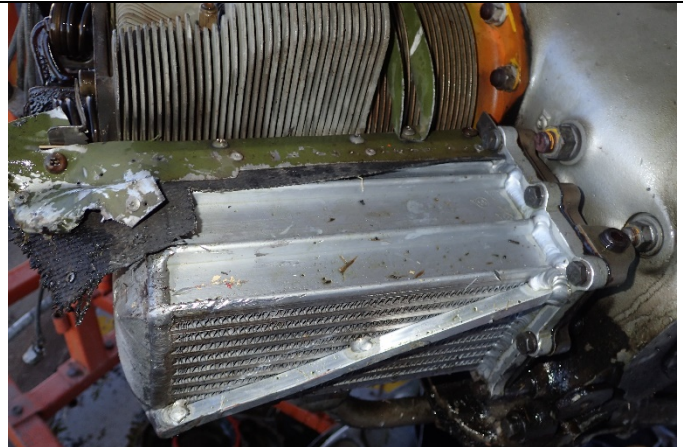
## OIL COOLER

The oil cooler remained attached to its installation point and displayed minor impact damage signatures. There were no anomalies noted with the oil cooler.

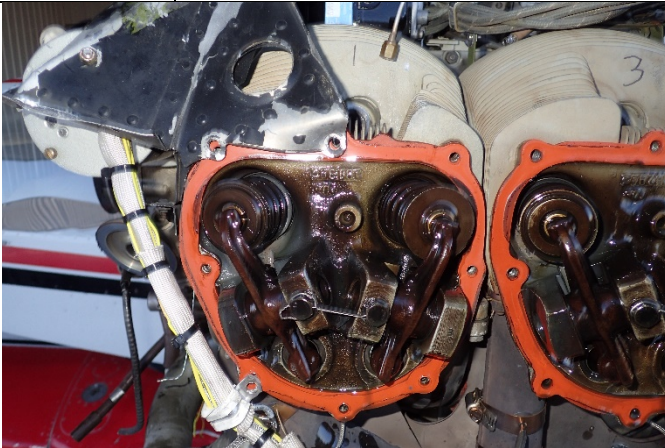
#1 Cylinder

Condition: All of the cylinders remained attached to their cylinder bays and were undamaged. The inside of the cylinders were inspected using a lighted borescope. The piston faces, valve heads, and cylinder bores displayed normal operating and combustion signatures. The crankshaft was rotated using a hand tool and all six cylinders displayed good thumb compression and suction. The overhead components (valves, springs, and rocker arms) displayed normal operating and lubrication signatures. There were no anomalies noted.

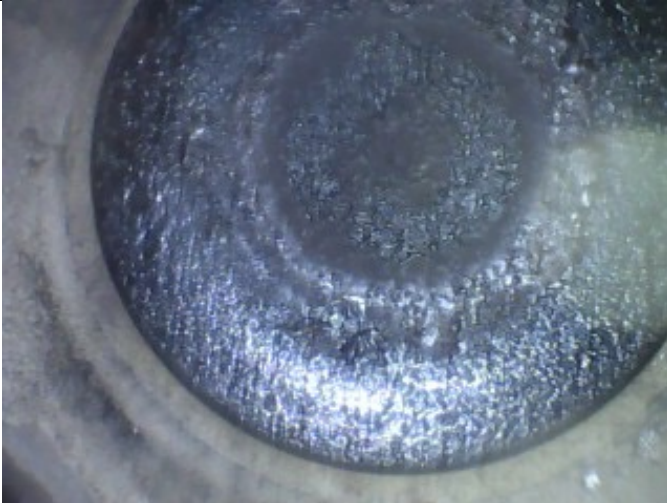
#1 Exhaust Valve

The valve heads were inspected using a lighted borescope; the valve heads displayed normal operating and combustion signatures. During crankshaft rotation all of the valves operated normally. There were no anomalies noted with the valves.

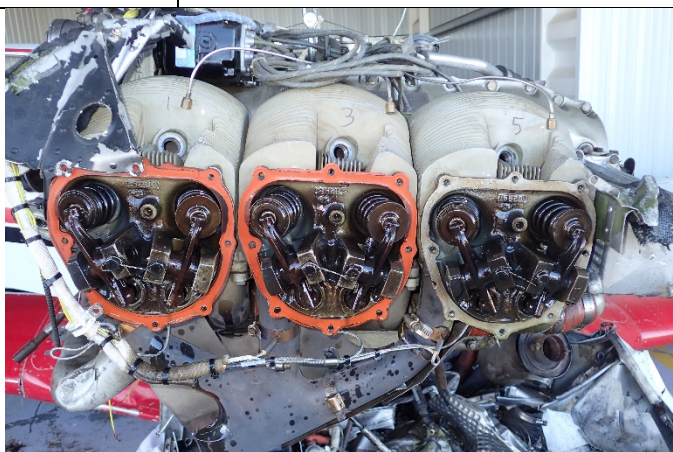
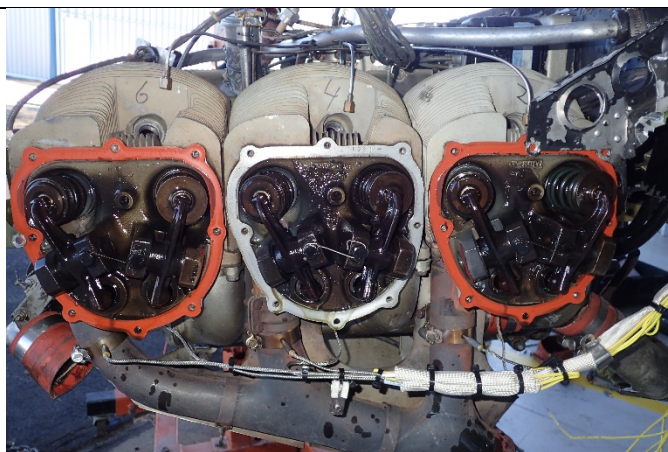
## ROCKER ARMS AND SHAFTS

All of the rocker arms displayed normal operating and lubrication signatures. During crankshaft rotation the rocker arms operated normally. There were no anomalies noted with the rocker arms.

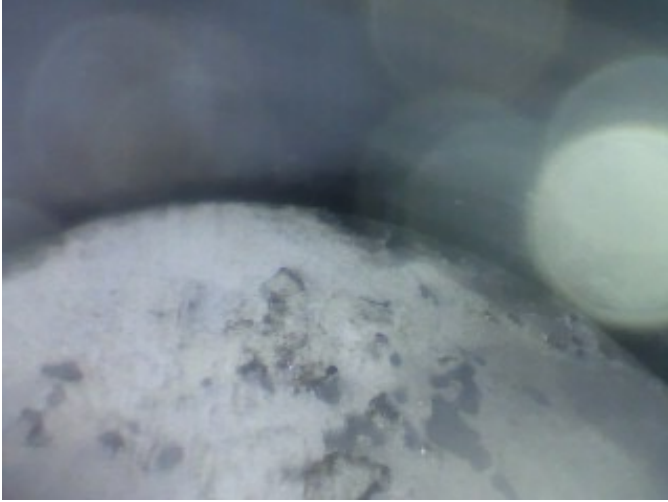
#1 Piston

All of the piston faces were inspected using a lighted borescope. The piston faces displayed normal operating and combustion signatures. During crankshaft rotation all of the pistons operated normally. There were no anomalies noted with the pistons.

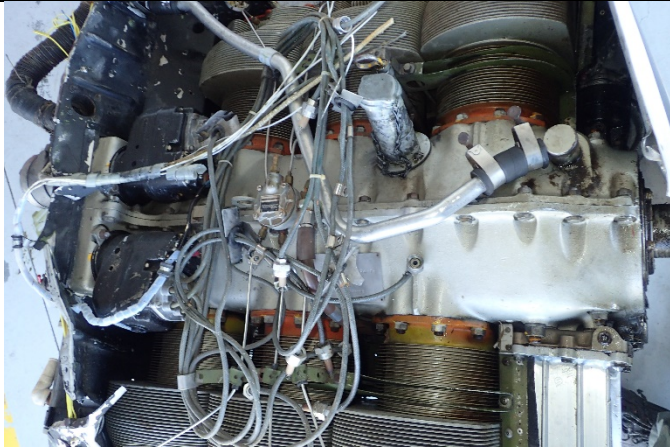
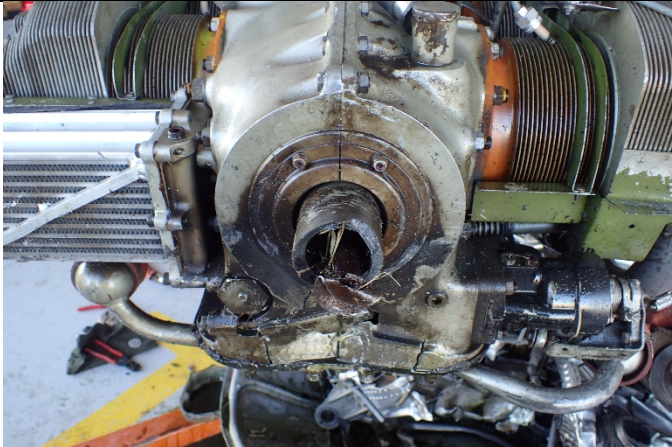
CRANKCASE ASSEMBLY

| Condition: | The crankcase displayed impact damage signatures to the front bottom portion of the crankcase. There were no anomalies noted with the crankcase. | | | |

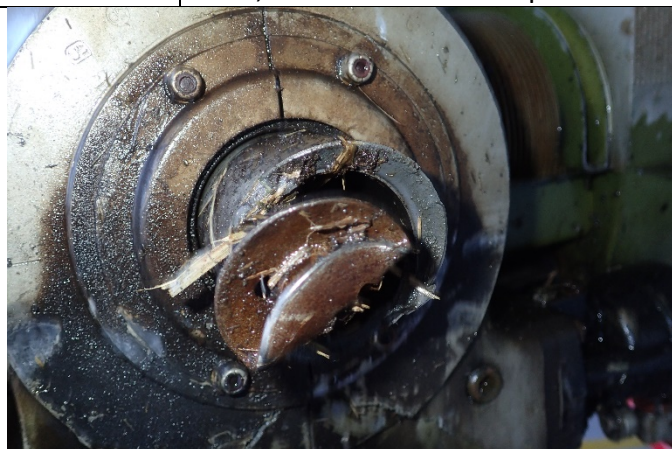
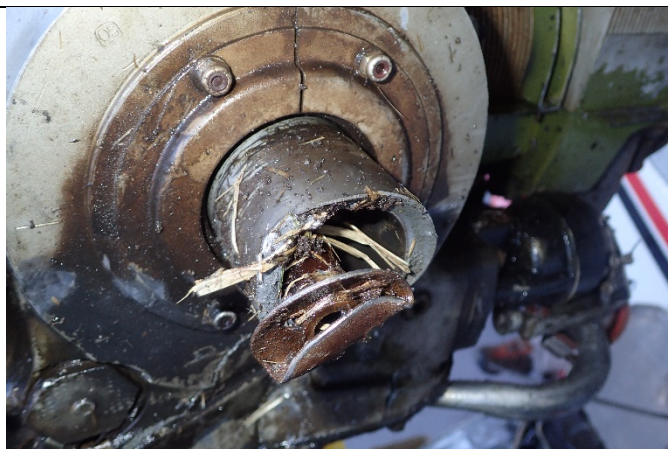
The propeller flange had broken free from the crankshaft and remained attached to the propeller hub. The crankshaft was rotated by inserting a hand tool in one of the accessory drive gears. Continuity was established between the crankshaft, camshaft, connecting rods, and associated components. There were no anomalies noted with the crankshaft.

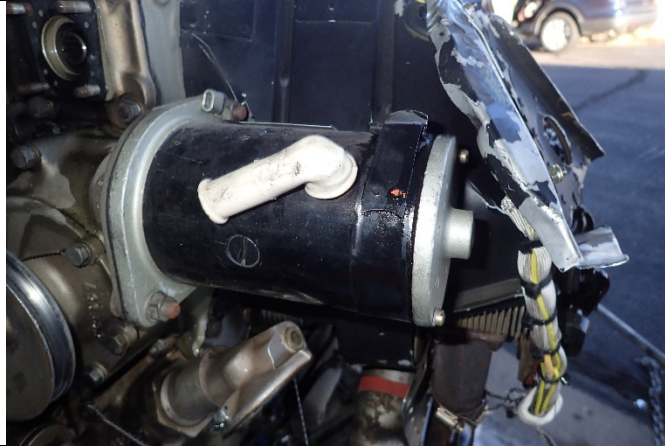
The starter remained attached to its installation point and displayed minor impact damage signatures. There were no anomalies noted.

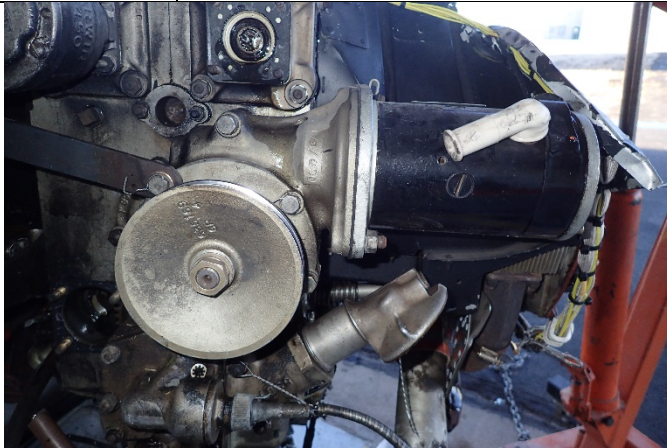
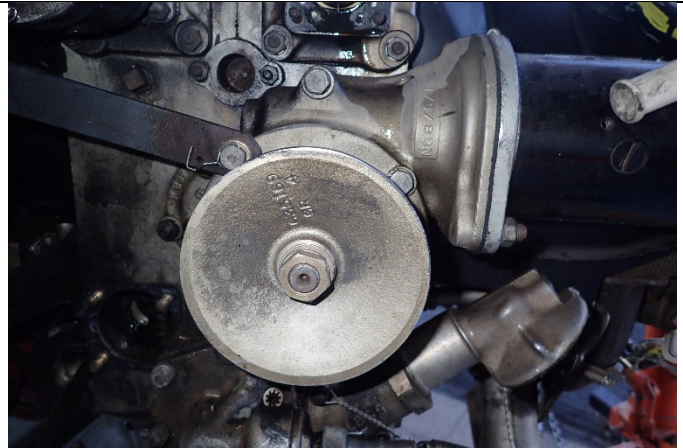
**STARTER ADAPTER**

The starter adapter remained attached to its installation point and was undamaged. There were no anomalies noted with the starter adapter.

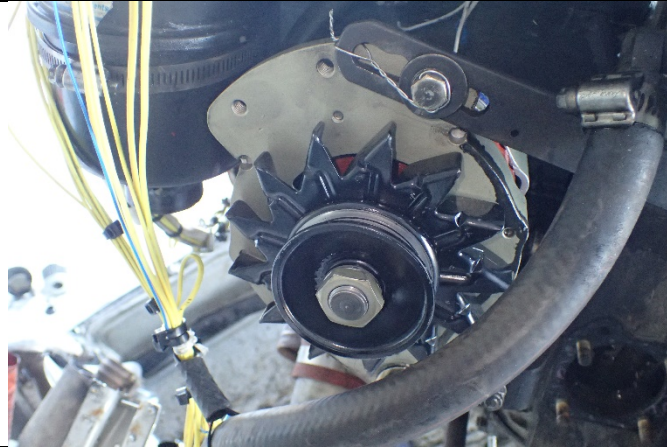
The alternator remained attached to its installation point and was undamaged. There were no anomalies noted with the alternator.

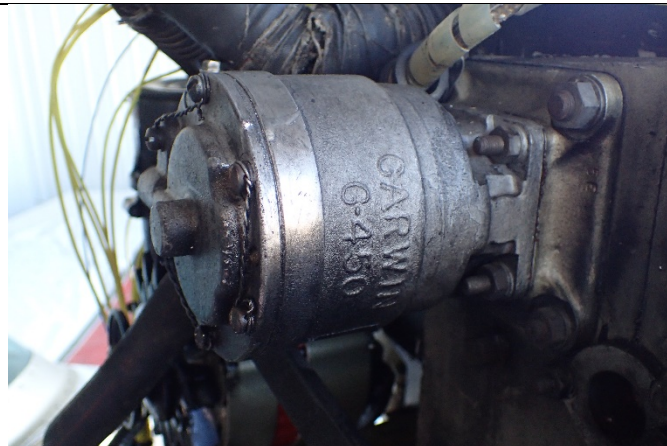
**VACUUM PUMP**

The vacuum pump remained attached to its installation point and was undamaged. There were no anomalies noted with the vacuum pump.

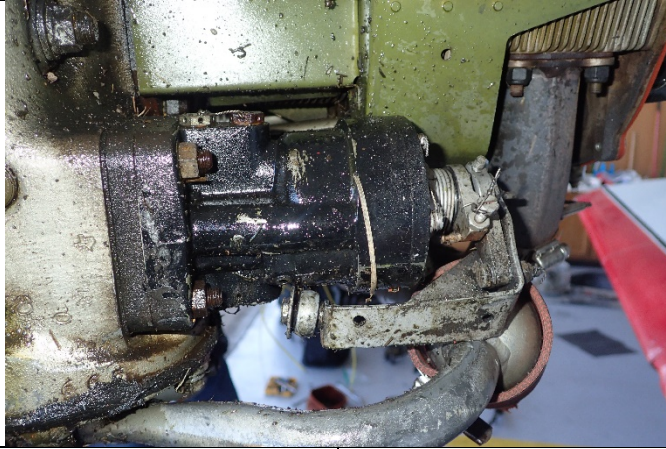
The governor remained attached to its installation point and displayed minor impact damage signatures. There were no anomalies noted with the propeller governor.

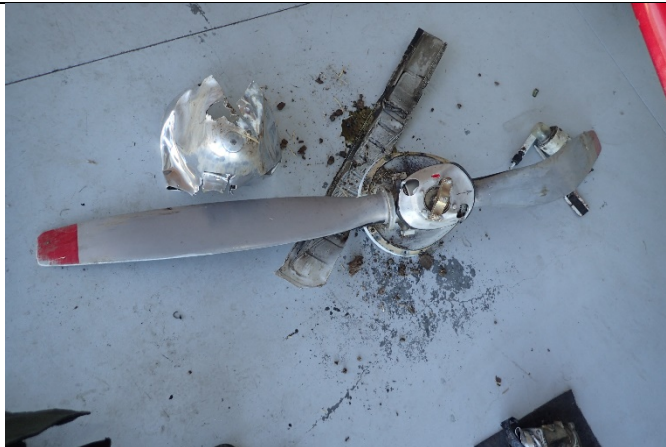
**PROPELLER**

The propeller remained attached to the propeller flange; however, the propeller flange had broken free from the rest of the crankshaft consistent with impact damage. Both of the propeller blades remained within the propeller hub and displayed minor impact damage. One propeller blade was bent slightly aft and displayed minor scratches at the blade tip. The other propeller blade displayed minor scratches at the blade tip. There were no anomalies noted with the propeller.
