# NATIONAL TRANSPORTATION SAFETY BOARD

## MATERIALS LABORATORY FACTUAL REPORT

Report No. 19-013

Place : Longmont, CO  
Date : February 16, 2018  
Vehicle : Thorp T-18, N89ER  
NTSB No. : CEN18LA102  
Investigator : Mike Folkerts (AS-CEN)

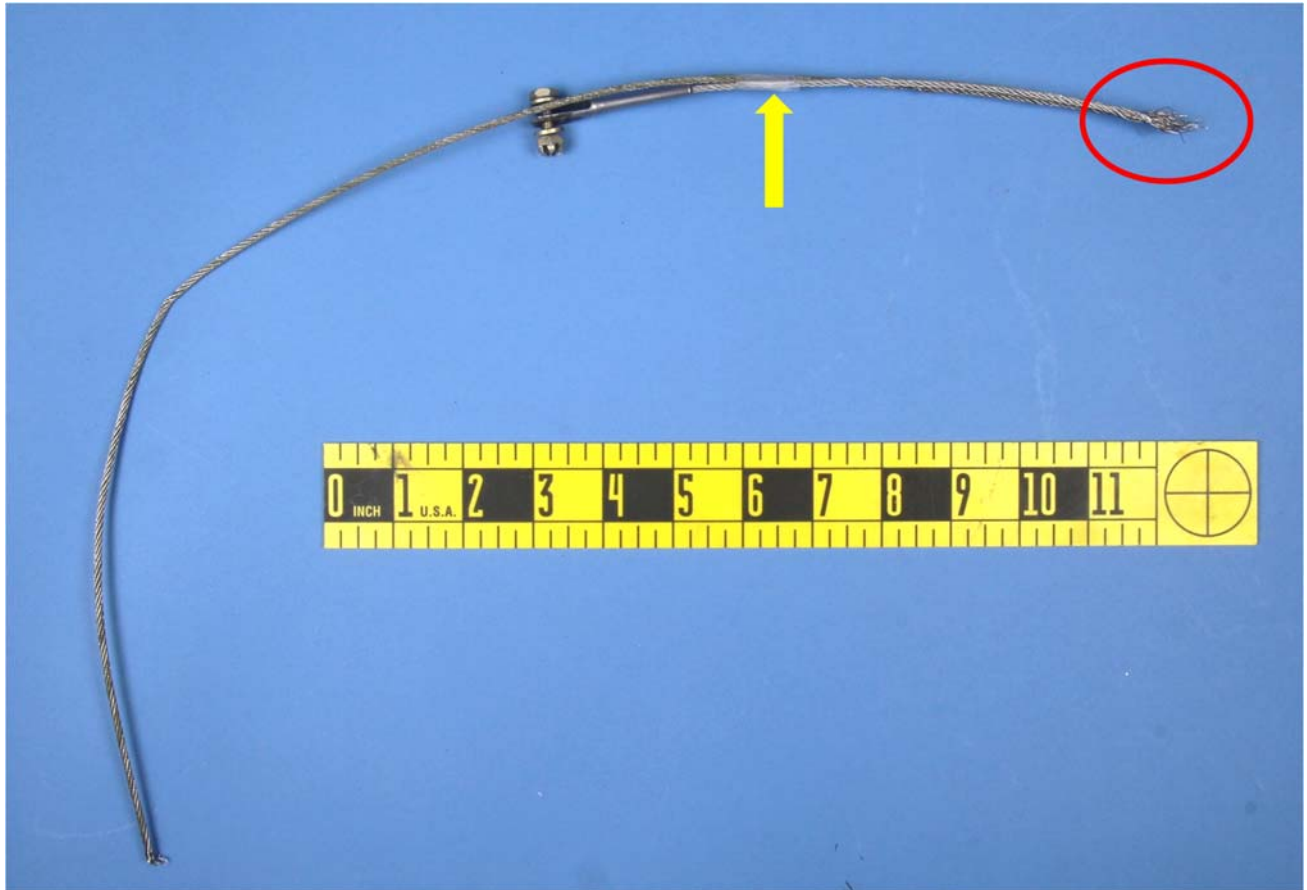
The rudder cable from an experimental Thorp T-18 fractured during landing rollout. The cable was sent to the NTSB Materials Laboratory in two sections taped together so the separated ends were on one side, as shown in Figure 1. Figure 2 shows close-up photos of the two separated ends of the cable. The individual strands of the cable had separated at various lengths and were not concentrated in one axial location.

Figure 1: Overall photo of the two sections of rudder cable sections taped together so the separated ends were on one side. The yellow arrow points to the tape and the red circle indicates the separated ends.

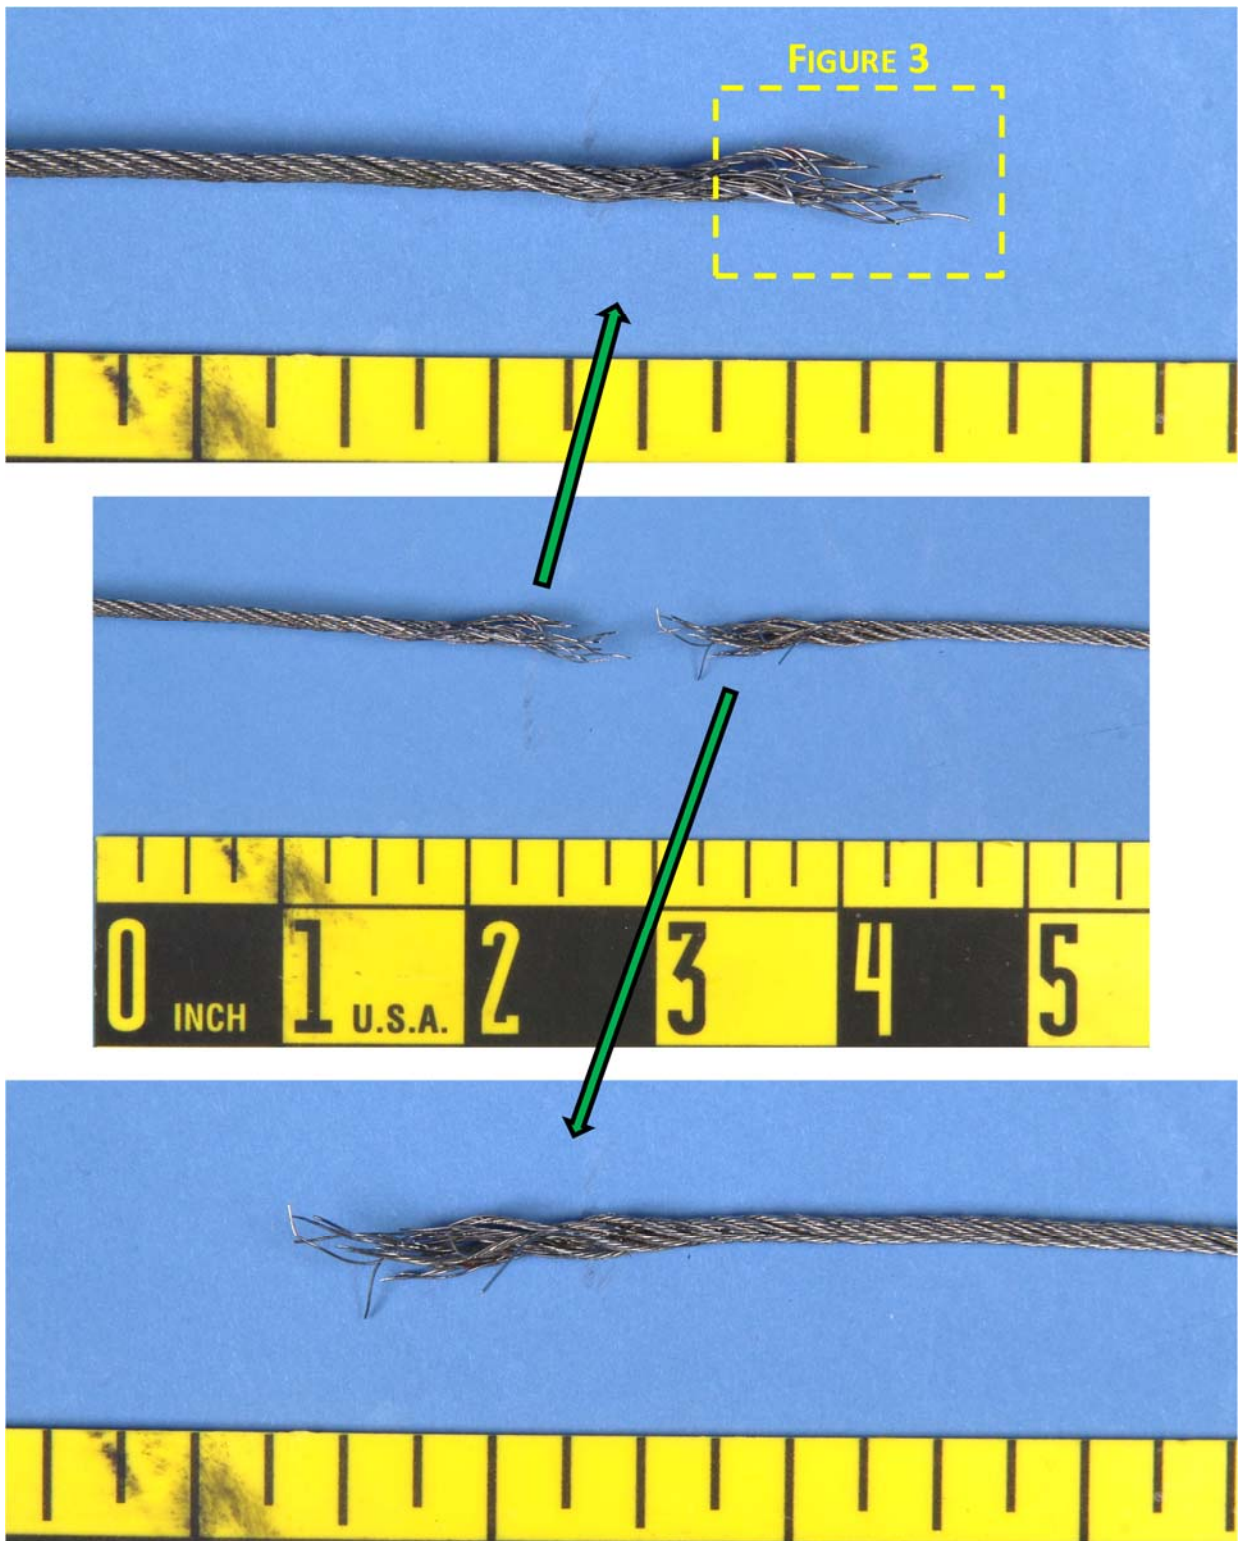
Figure 2: Close-up photos of the two separated ends of the cable. The end in the top photo is shown in more detail in Figure 3.

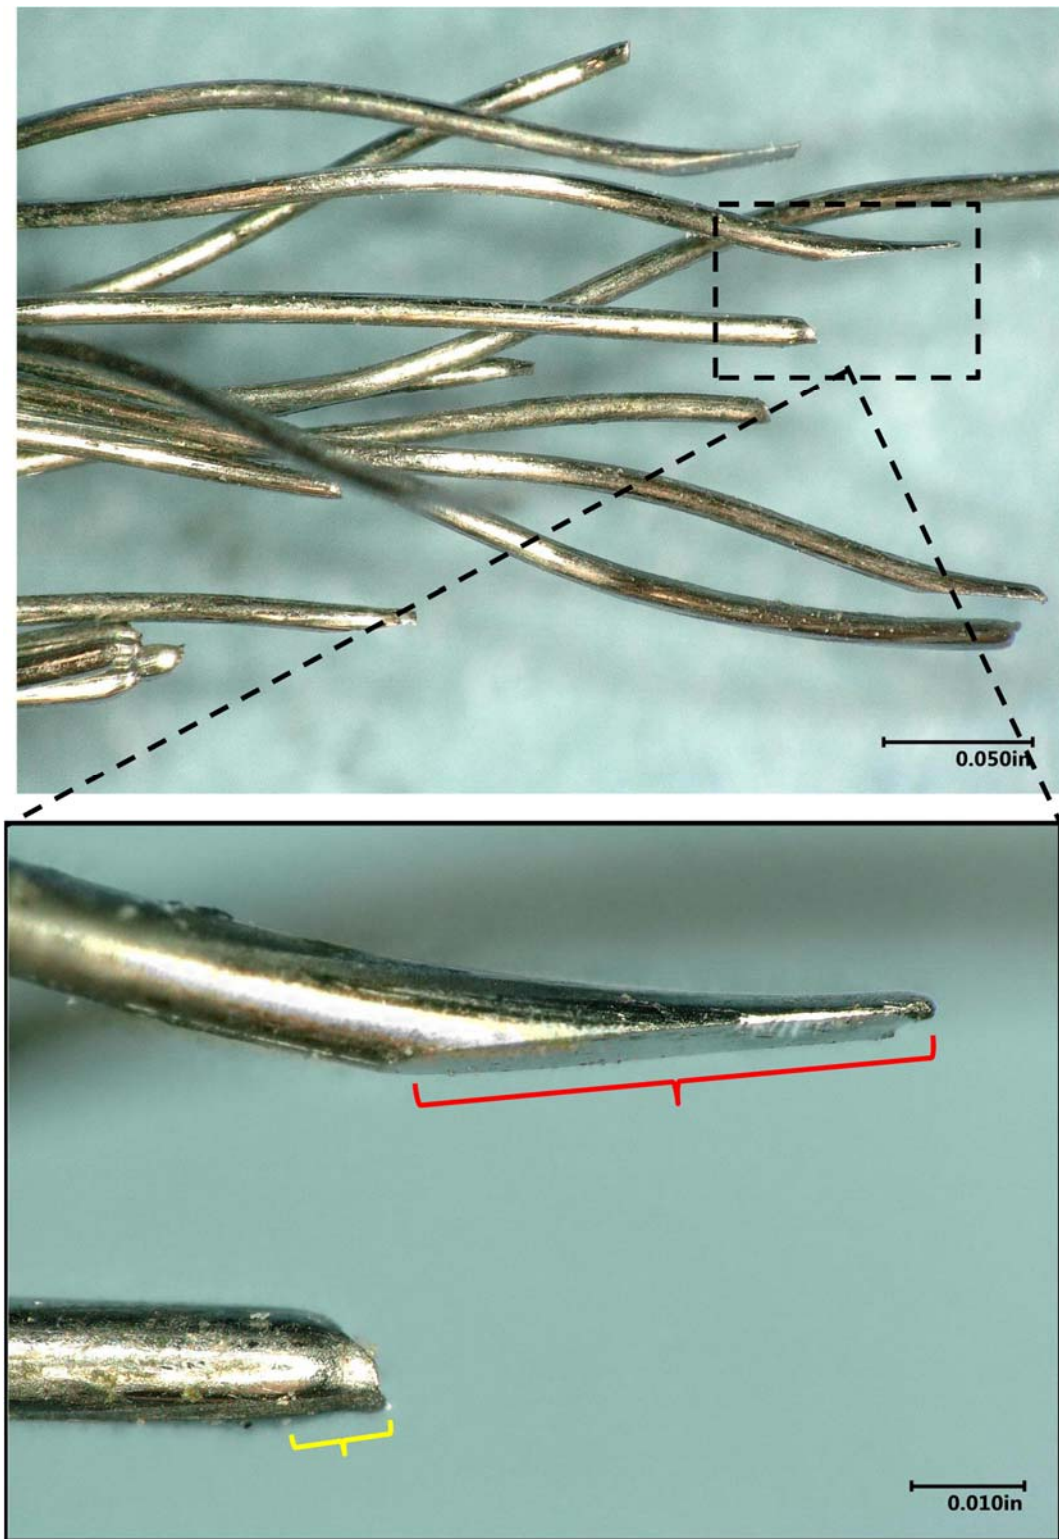
The separated cable ends were examined using a 5x to 50x magnification stereo microscope. There were flat, elongated, angular fracture surfaces on the ends of many of the strands. The angular fracture surfaces had rub marks and the cross-sections of the strands adjacent to the separations had thinned. The orientation and characteristics of the fractured strand ends is consistent with between-strand wear and subsequent overstress separation.

The remaining strands had cup-and-cone like fracture surfaces accompanied by adjacent necking of the strand cross-section, which is consistent with overstress separation.

Digital microscope images of exemplar strand fracture surfaces are shown in Figure 3.

Figure 3: Digital microscope images of exemplar strand fracture surfaces. The red bracket indicates a separated end that had thinned due to wear before overstress separation. The yellow bracket indicates a separated end that had necked prior to overstress separation.
