# Continental Motors

## ENGINE INSPECTION REPORT

| AIRCRAFT MAKE & MODEL | Lancair Legacy |
| FILE NUMBER | 17-448 |

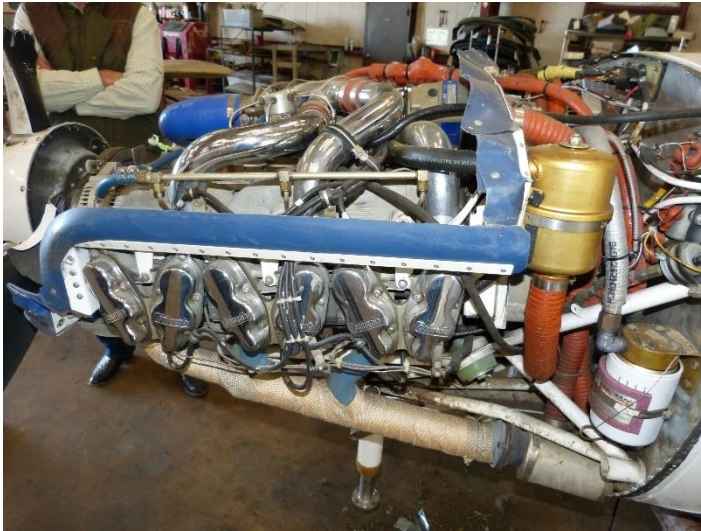
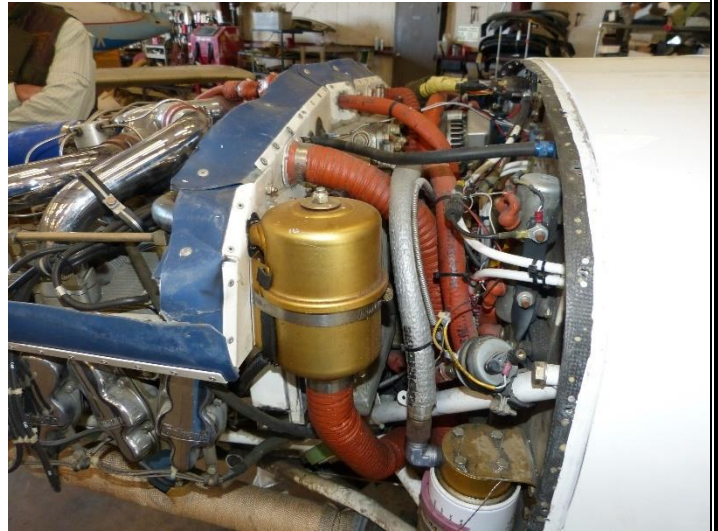
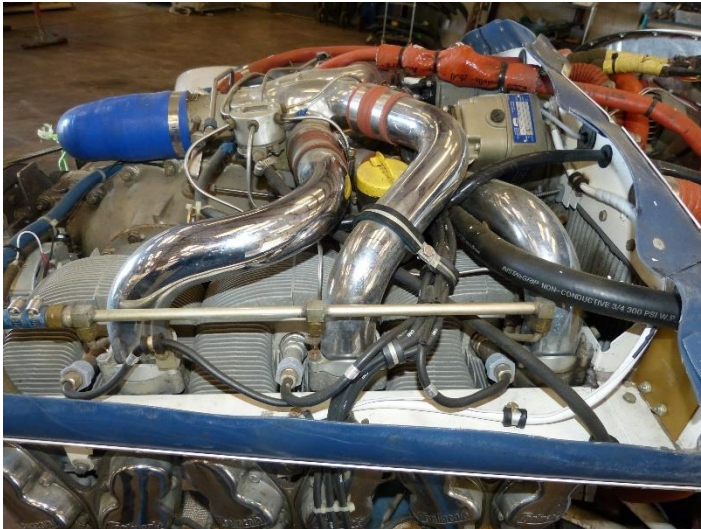
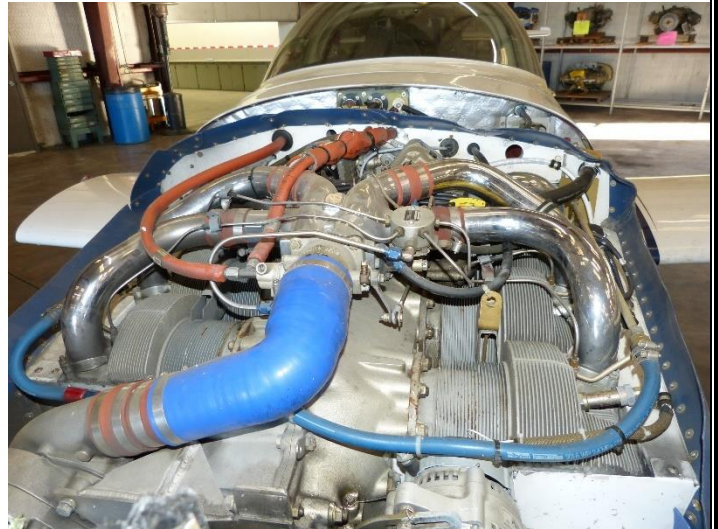
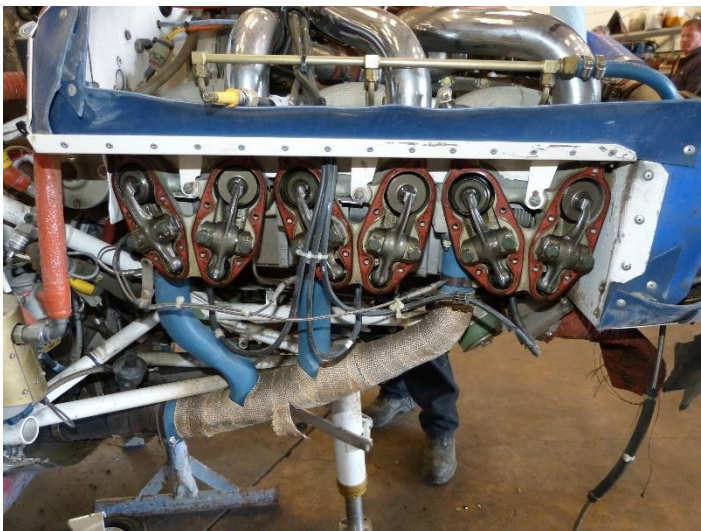
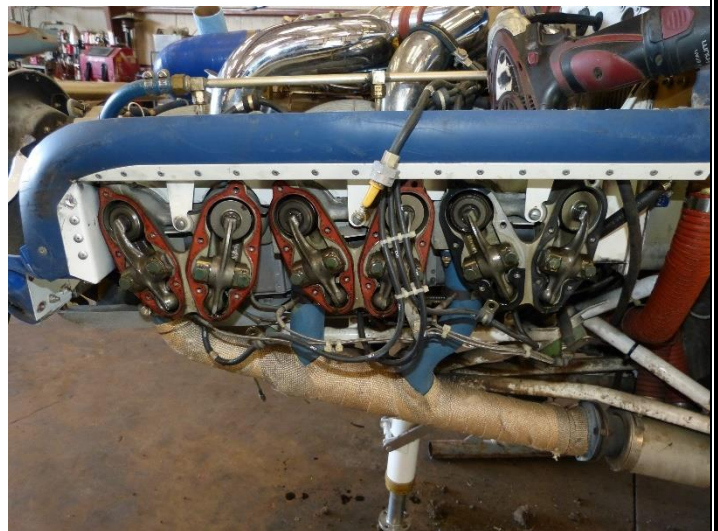
The engine was intact with no damage, and remained in the airframe.

The top spark plugs and rocker covers were removed, and the cylinders were inspected with a lighted boroscope. The cylinder domes and pistons had normal combustion deposits and the valves were in place and not damaged. The crankshaft was rotated using the propeller and continuity was confirmed to all of the cylinders and to the rear of the engine. Good thumb compression was confirmed on all of the cylinders.

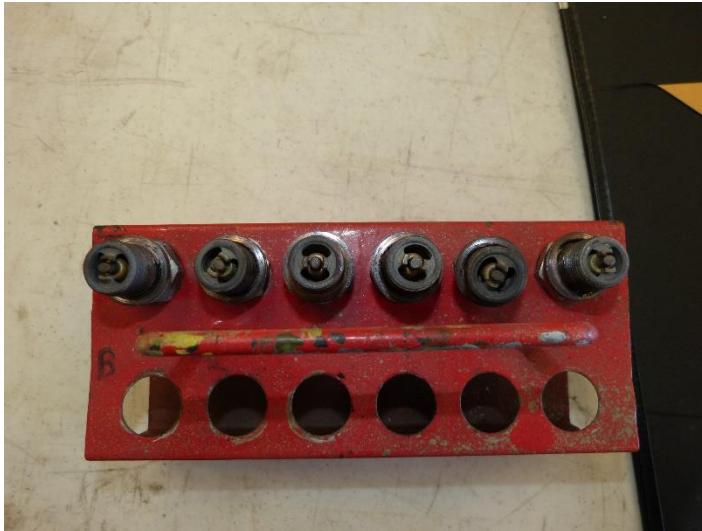
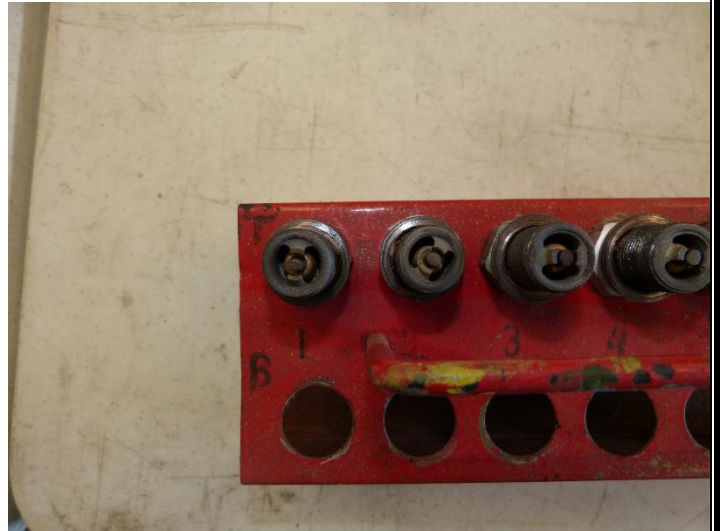
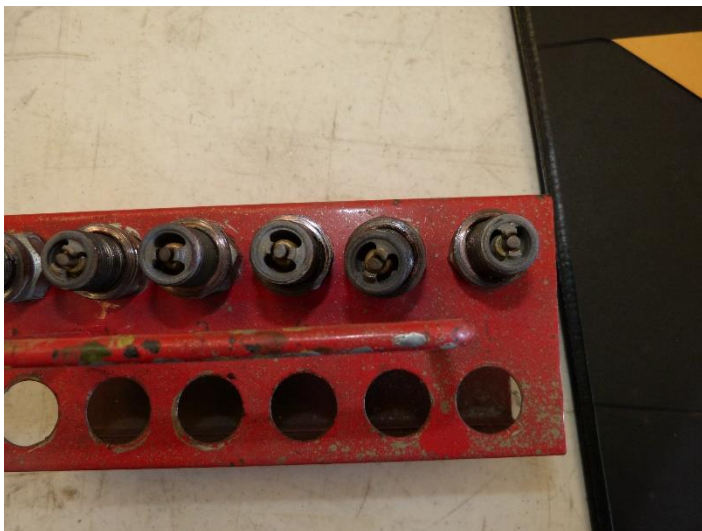
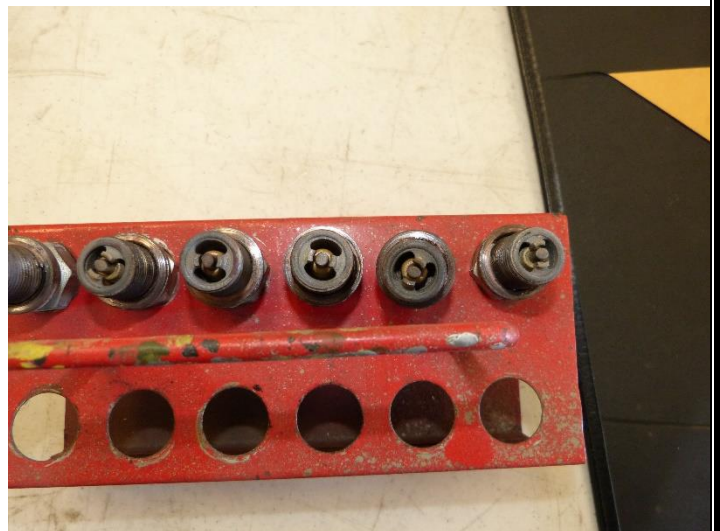
Spark Plugs: Auto Lite UHB-32E

The top spark plugs were removed and examined. They had normal wear and light gray deposits in the electrode areas.

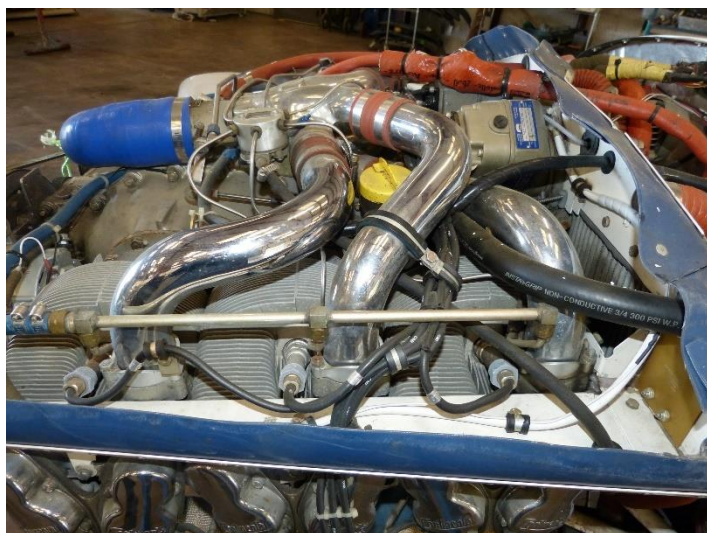
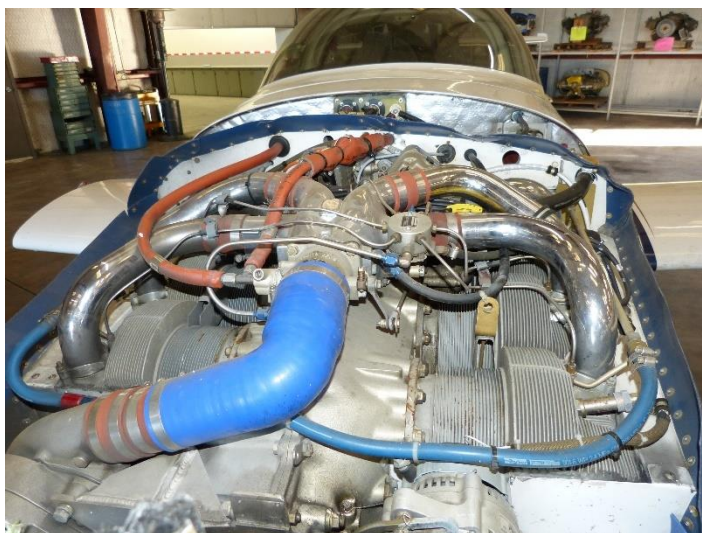
Magnetos: Left, Bendix, PN-10-500556-1, SN-D03GA025

The magneto timing was checked and both magnetos were timed at 23 degrees before top dead center. Both magnetos produced a spark at all spark plug leads when the crankshaft was rotated.

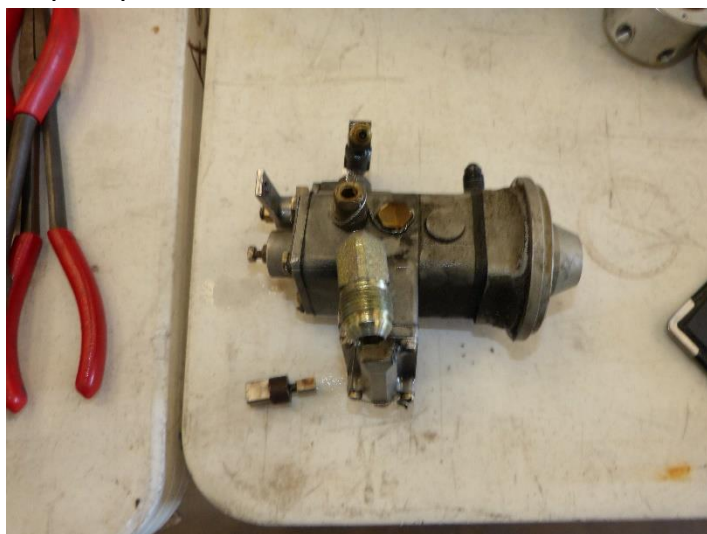
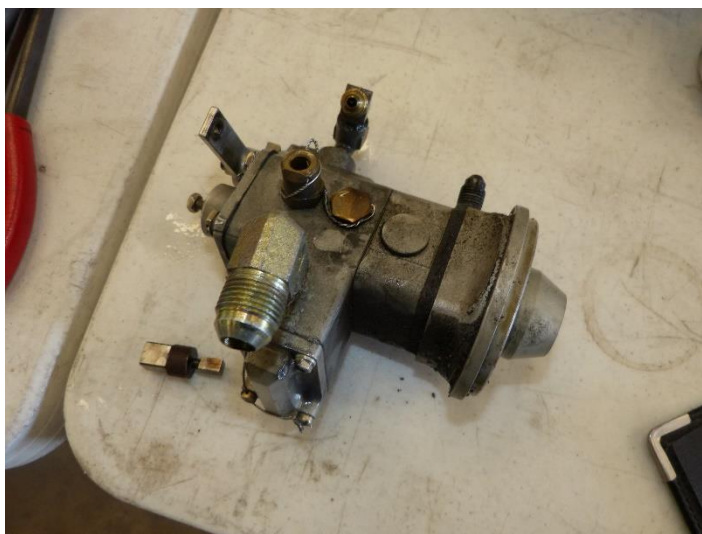
Fuel Pump: PN-6559921-1A1, SN-B05FA079R

The fuel pump was in place and not damaged. The drive coupling was not damaged. The pump was attached to an electric drill and the drive shaft was rotated. Solvent was pumped through the pump when it was rotated.

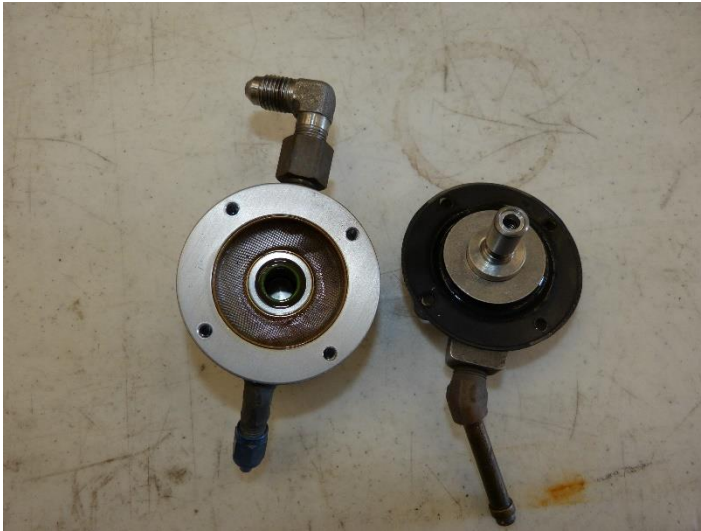
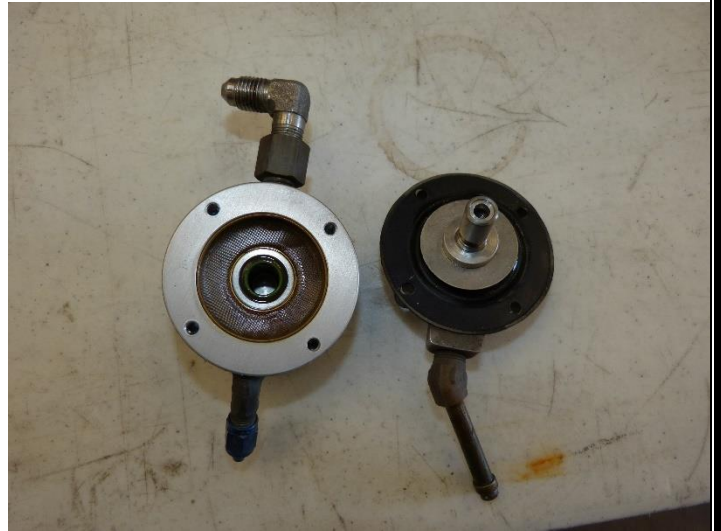
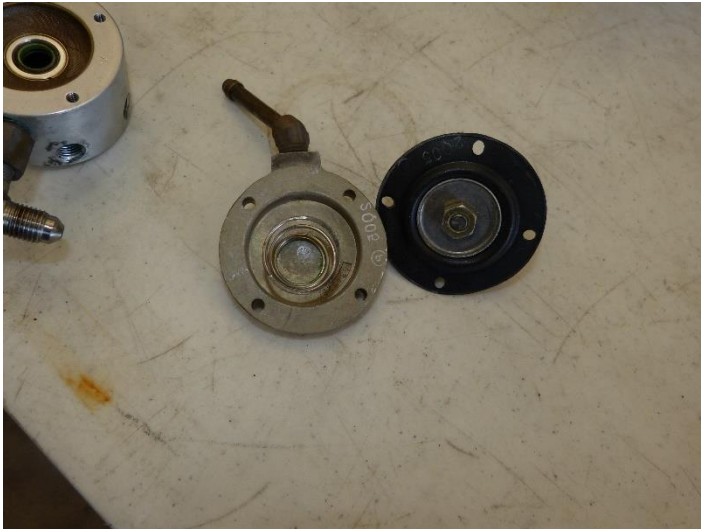
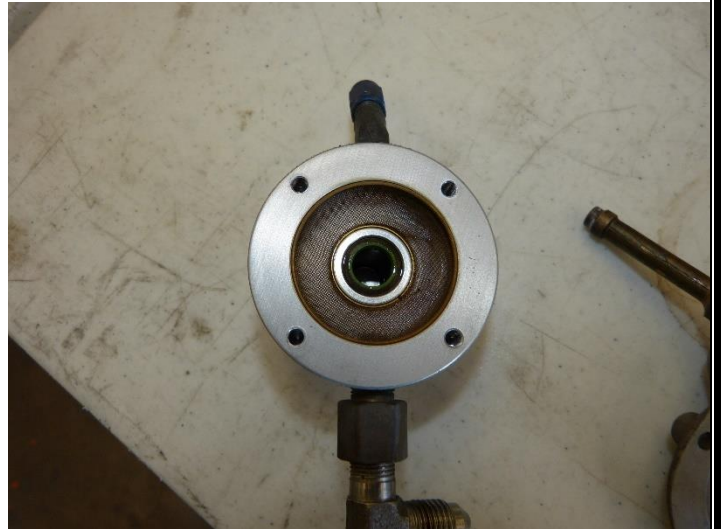
Airframe Fuel Screen: The inline fuel screen was clean and clear, with no contamination.

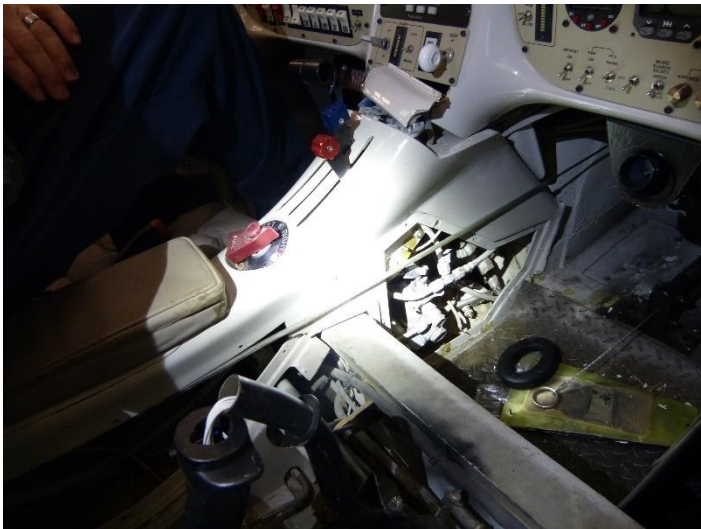
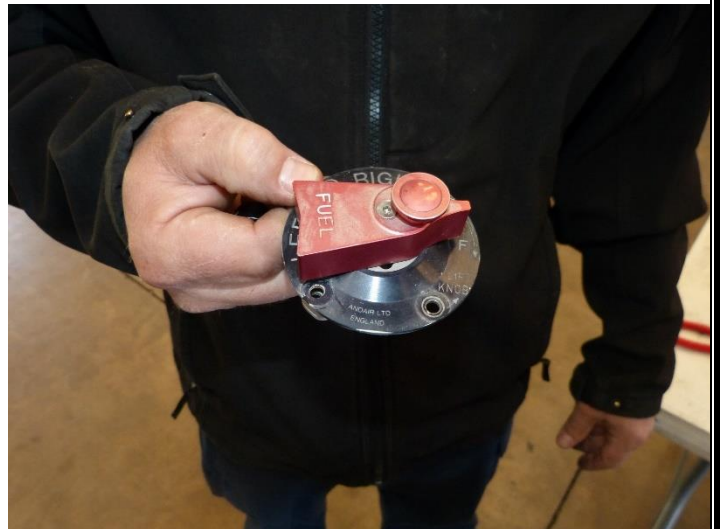
Fuel Selector: The fuel selector handle was separated just below the handle selector. The two "U" joints and the drive shaft were intact. The selector valve was found in the 90 percent closed position.

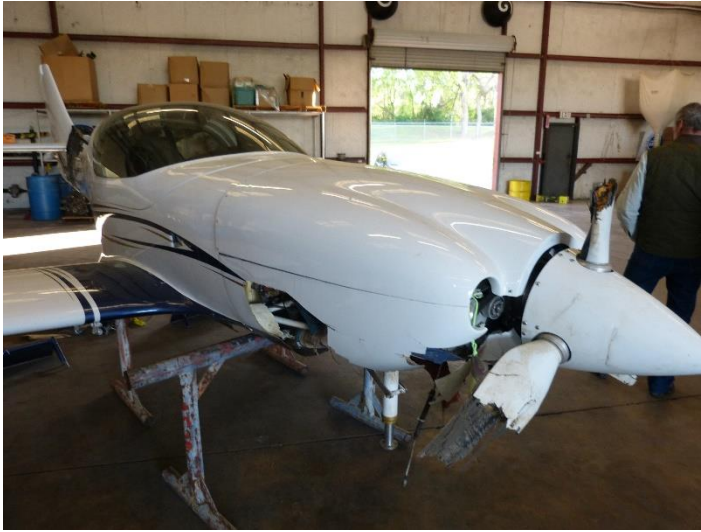
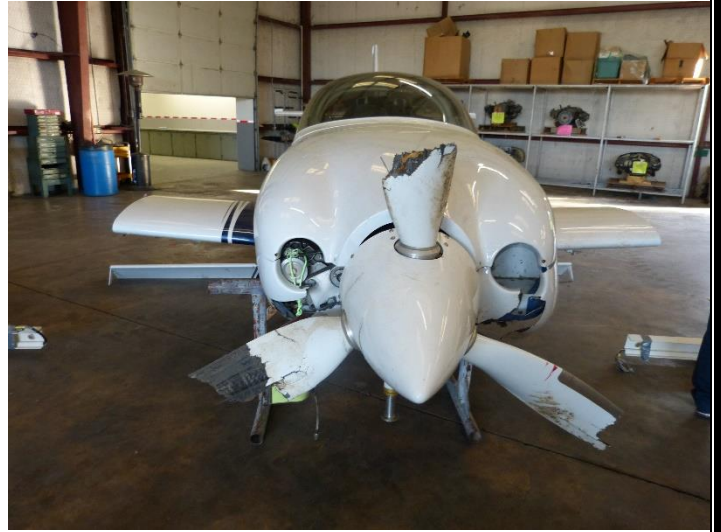
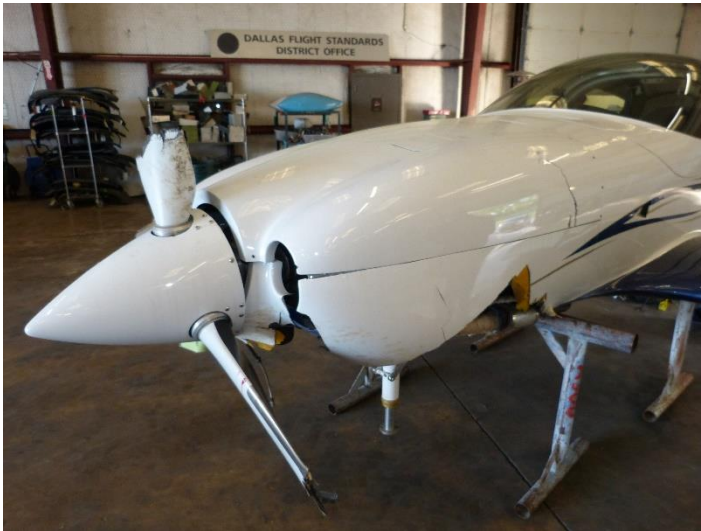
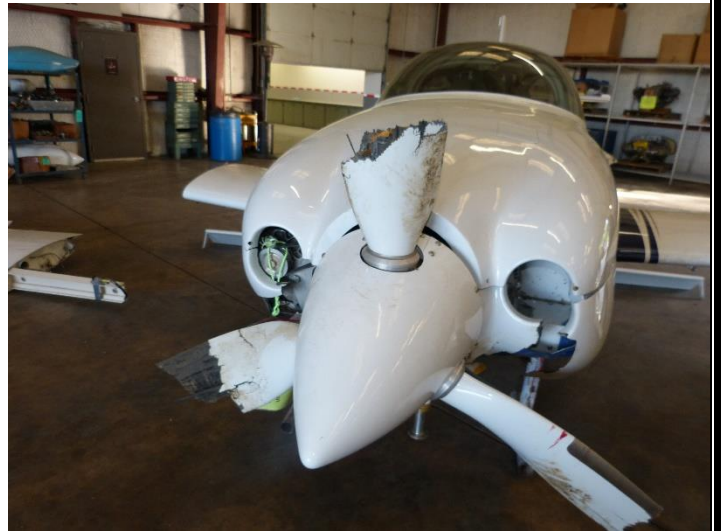
Propeller: The propeller was a composite type propeller and all three blades were sheared off near the hub.
