## **NATIONAL TRANSPORTATION SAFETY BOARD**

# **ENGINE EXAMINATION**

**CEN18LA127**

Location: Tubreaux Aviation (KDTN)  
Date: May 17, 2018  
Aircraft/Case: CEN18LA127  
NTSB IIC: Pam Sullivan

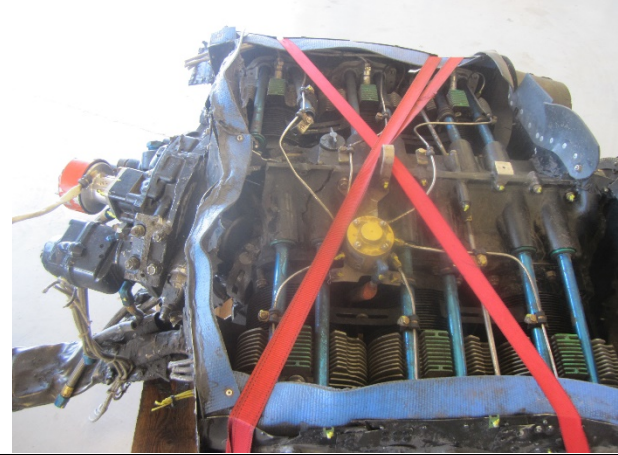
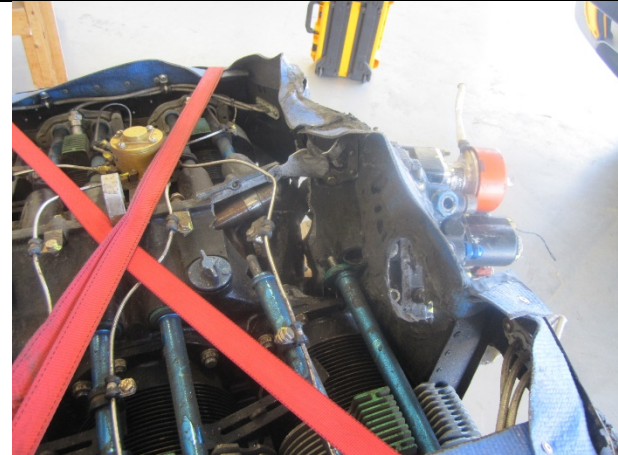
| | <p>Overall condition of the engine.</p> <p>A hole, just above the #5 cylinder is noted. The camshaft is visible thru the hole, and is broken. The crankshaft is also visible, and a broken counterweight is noted.</p> <p>The accessory section is broken and angled to one side. The aft top section of the oil sump is broken and remains with the accessory section. Only residual engine oil remains.</p> |

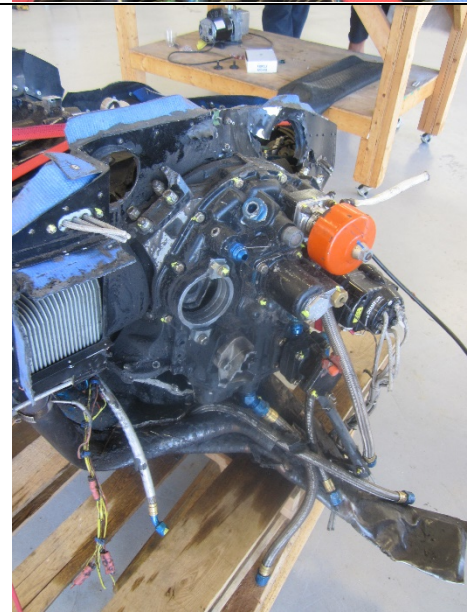
| | <p>Accessory section, the left magneto separated from the engine.</p> <p>The accessories; magnetos, oil pump, etc were free to rotate</p> |

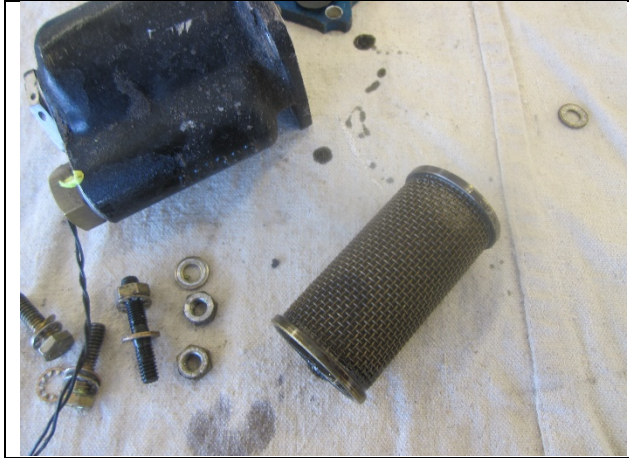
The oil screen was clear of contaminants; the absence of metal particles was noted.

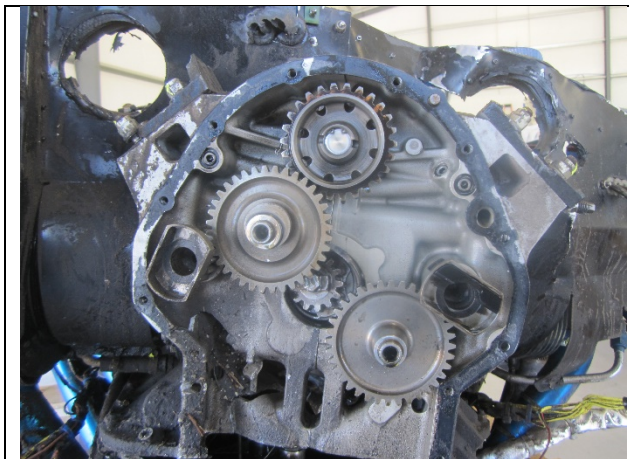
Accessory gears, except crankshaft gear, were in place, and lacked preimpact damage.

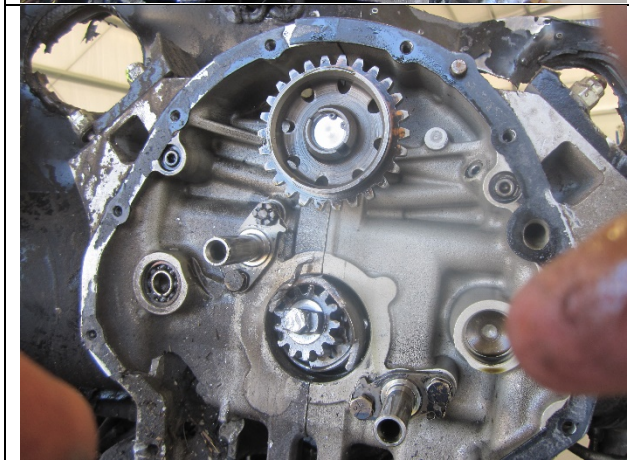
Damage to crankshaft gear and bearing is noted.

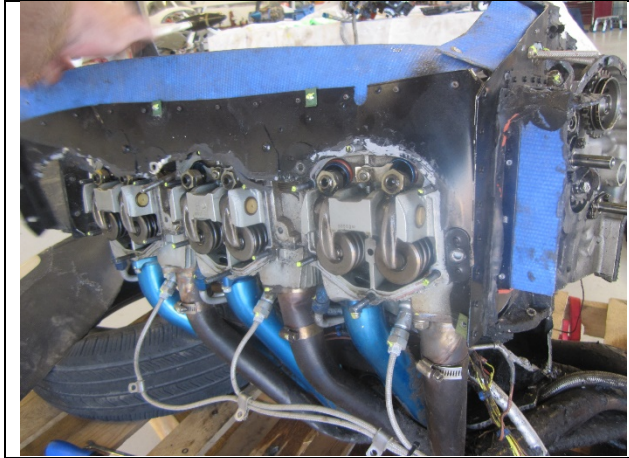
Top cylinder valve train, both left and right sides appeared normal.

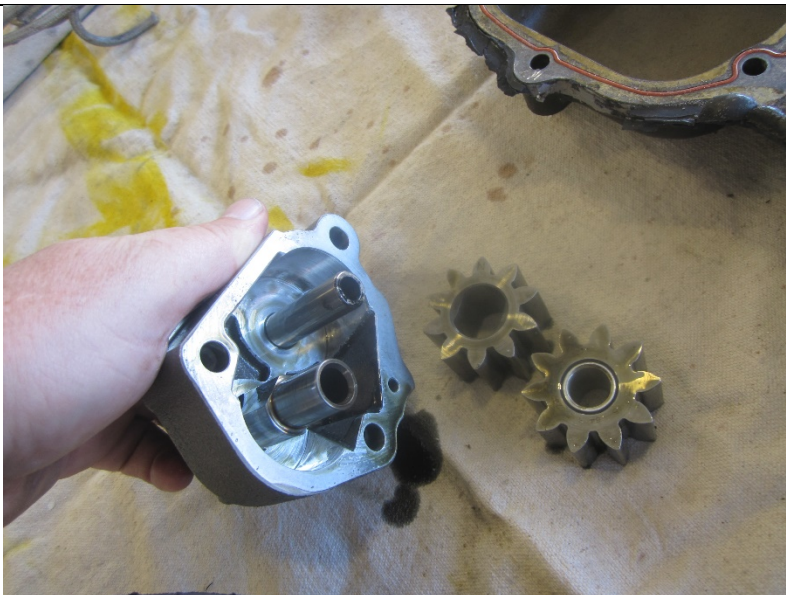
Oil pump was disassembled, and was absent signs of any metal passage.

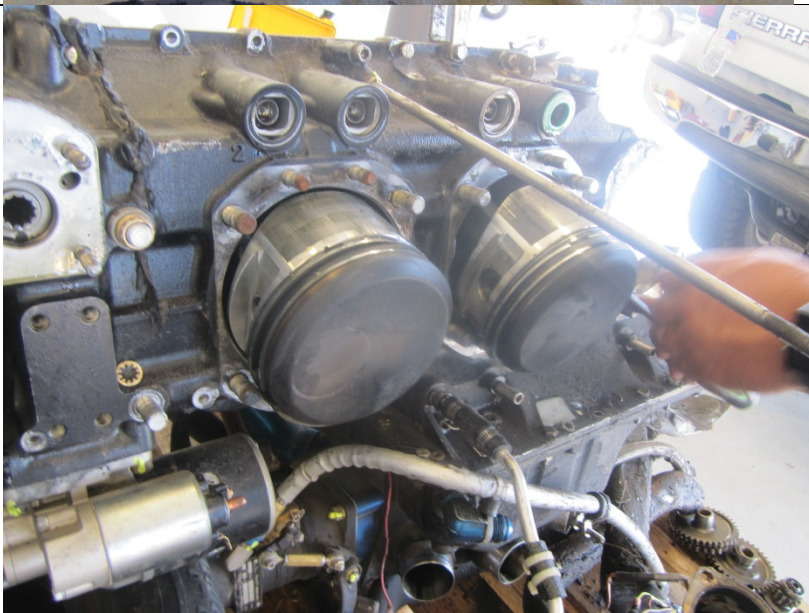
Top of cylinders displayed normal combustion signatures.

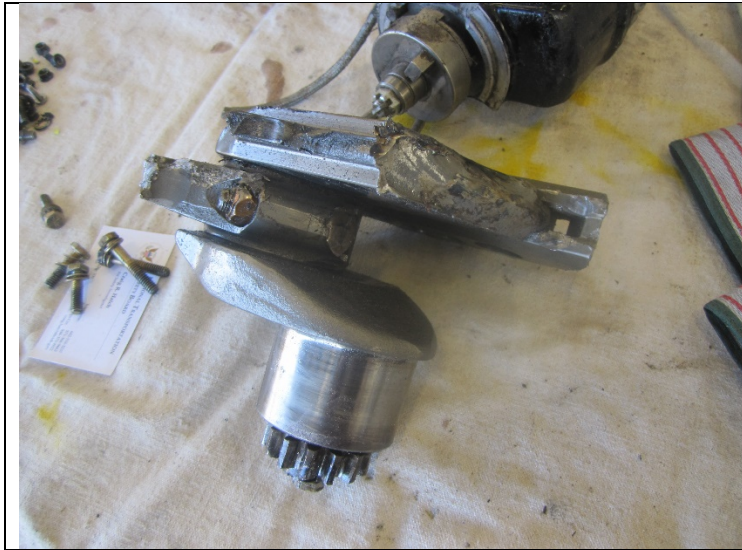
The crankshaft was broken into two pieces. Aft section shown

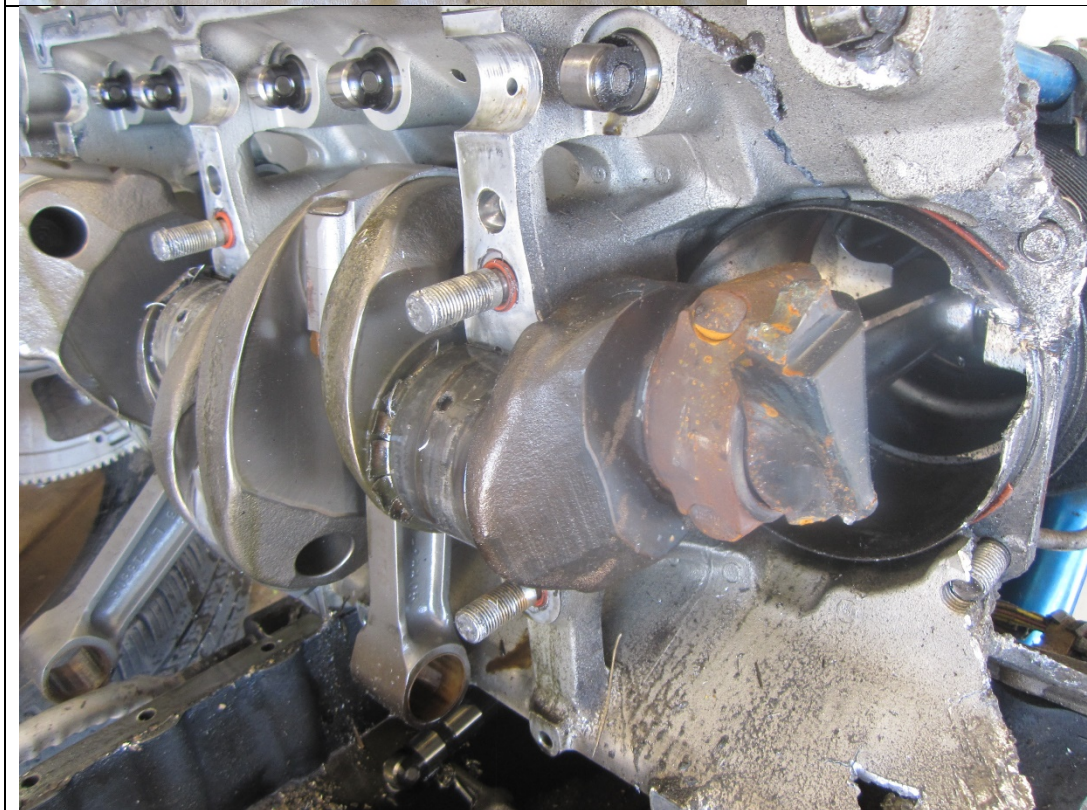
The forward piece of the crankshaft. The crank is broken just aft of the #5 cylinder.

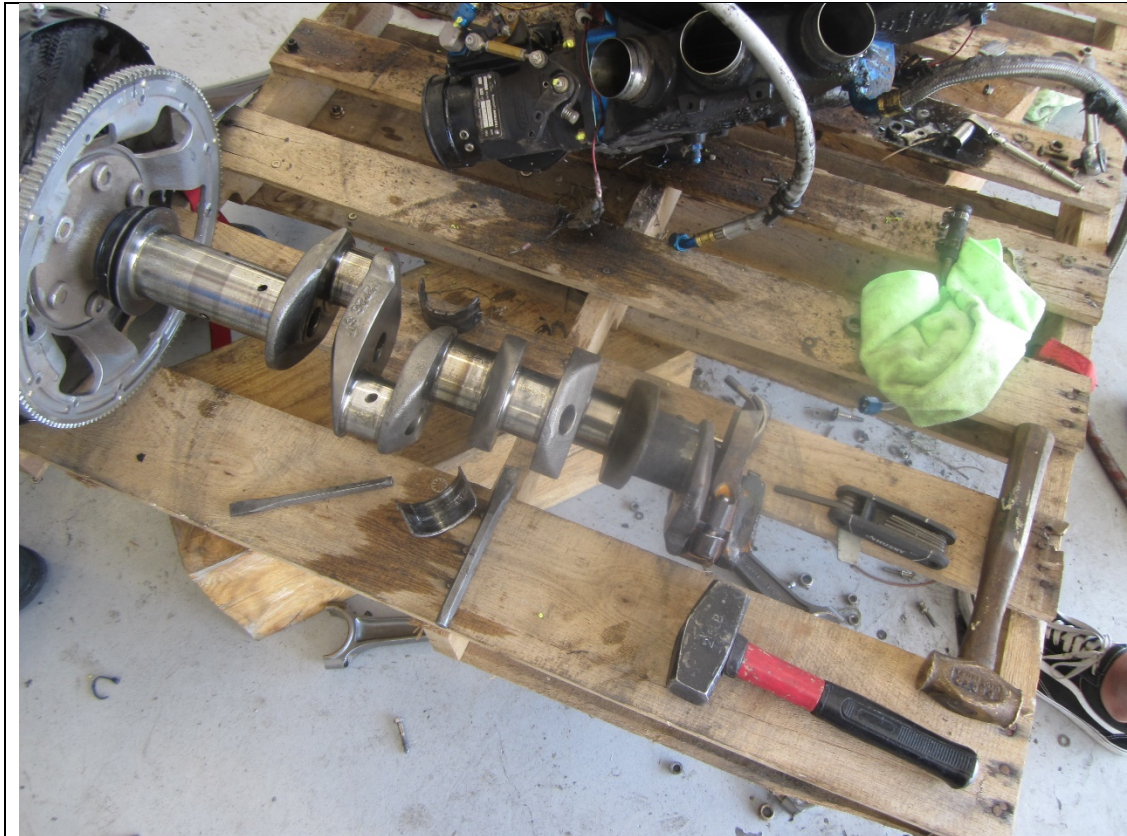
The crankshaft was removed from the case: the #5 connecting rod was cut to facilitate removal from the engine case.

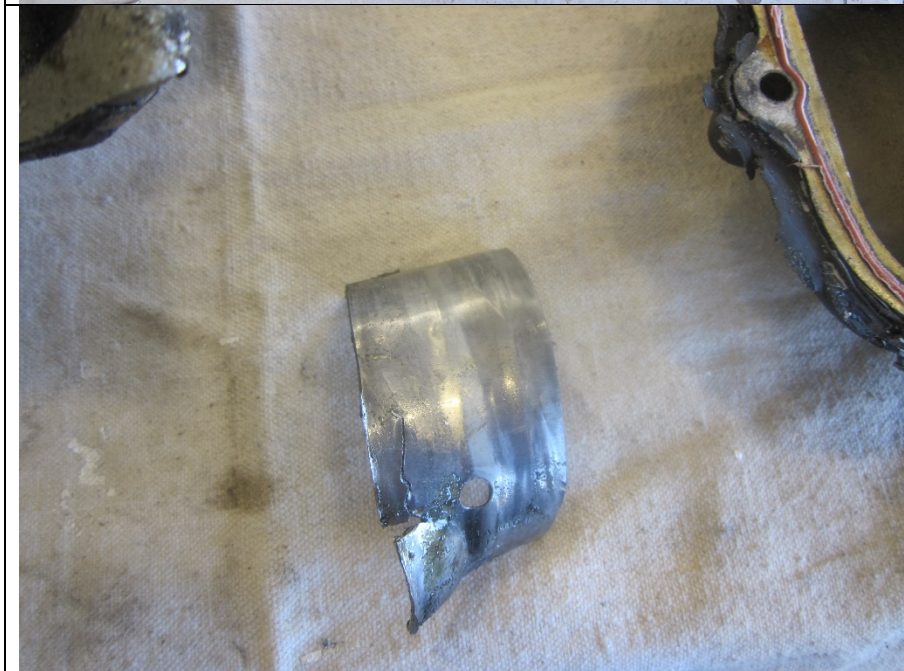
Journal bearing,,,, M10 is stamped on bearing

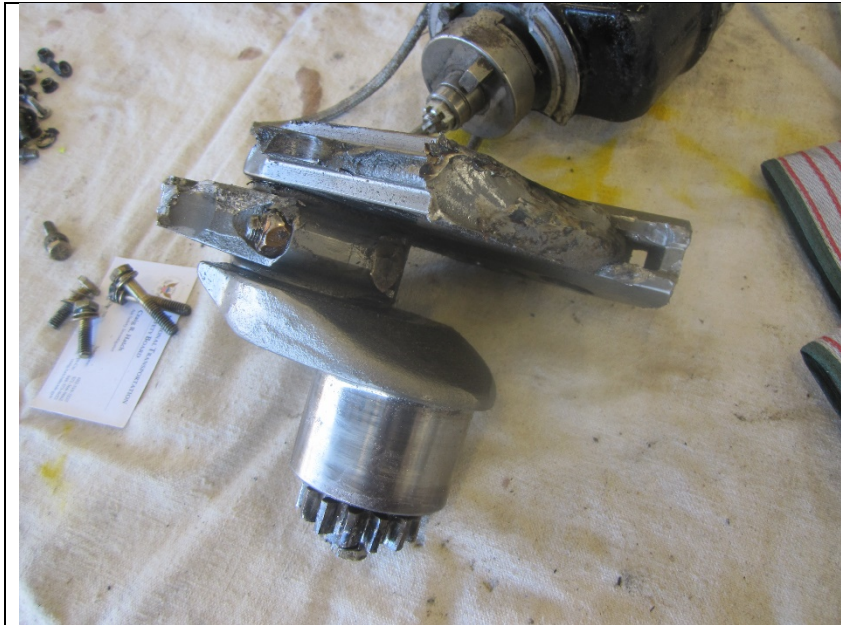
Aft section of crankshaft. One counterweight is missing.

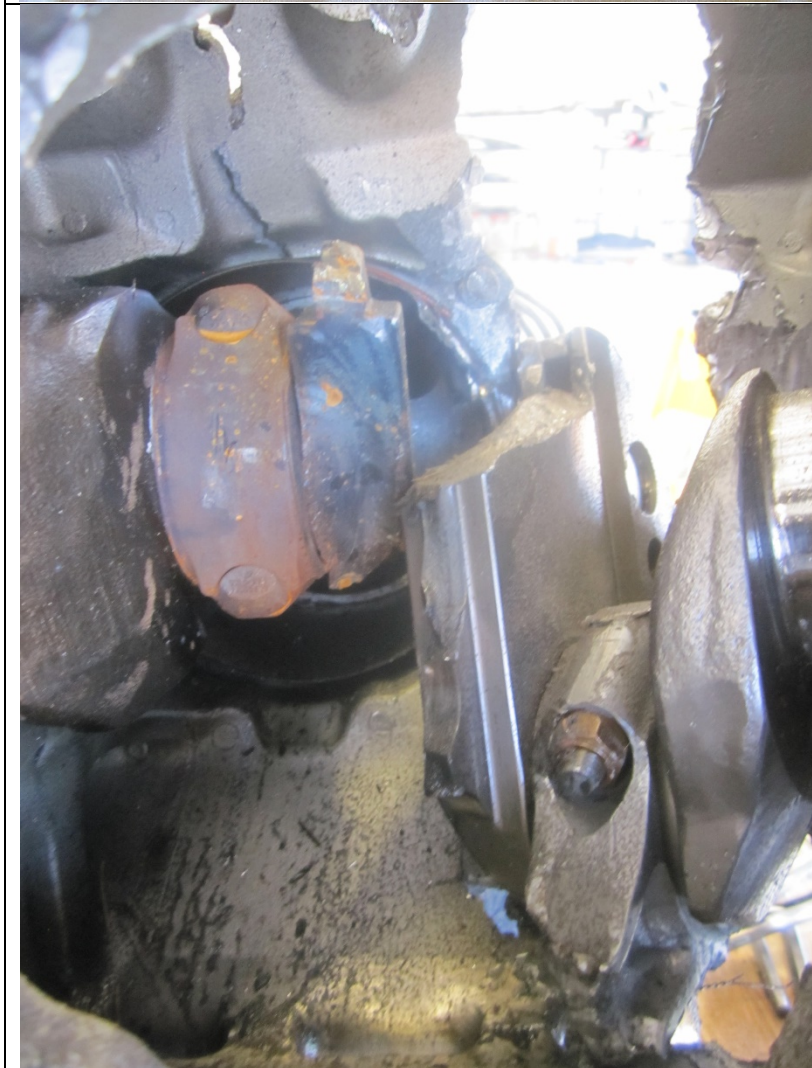
Broken crankshaft

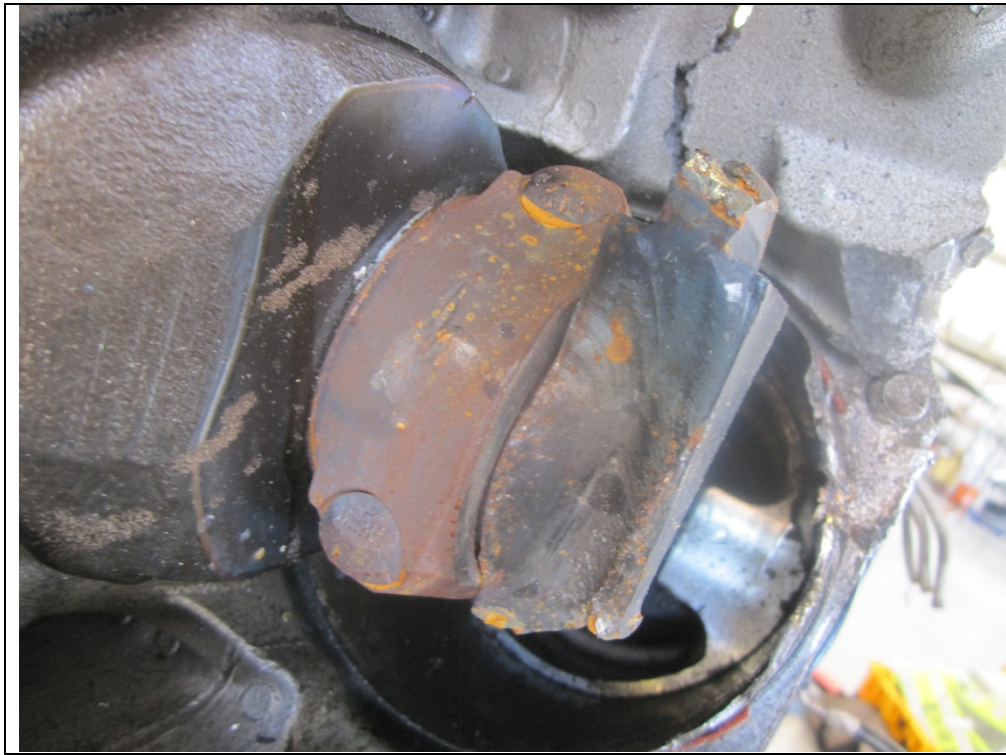
Close up view of crankshaft break. Rings are noted in the fracture surface

The crankshaft was retained for potential material lab analysis.
