# NATIONAL TRANSPORTATION SAFETY BOARD

## MATERIALS LABORATORY FACTUAL REPORT

Report No. 18-046

Place : Fulton, Texas  
Date : March 25, 2018  
Vehicle : MX Aircraft LLC, MXS airplane, N540JH  
NTSB No. : CEN18LA127  
Investigator : Pam Sullivan, AS-CEN

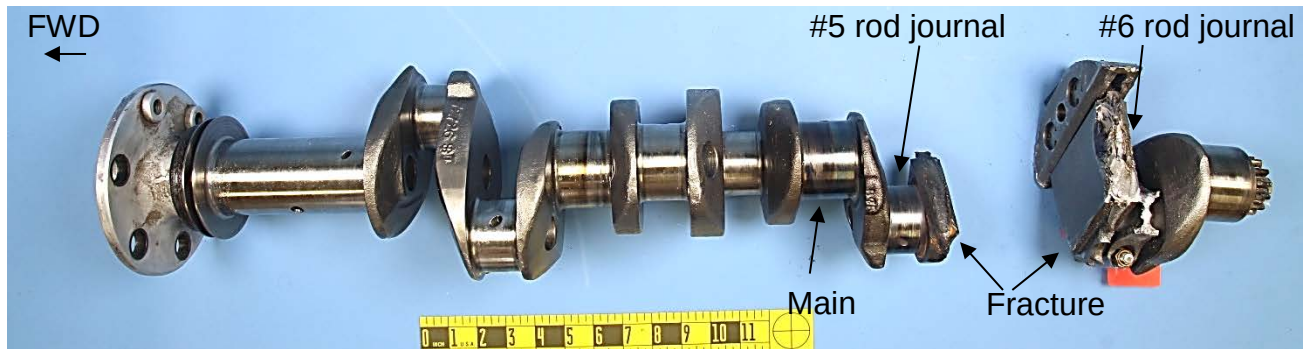
Figure 1 shows a photograph of the as-received crankshaft. The crankshaft fractured at the cheek between the #5 and #6 rod journals. Bench binocular microscope examination of the crankshaft revealed the forward fracture face contained crack arrest marks typical of fatigue cracking that emanated from the aft radius of the #5 rod journal in the area indicated by bracket "O" in figures 2 and 3. The surface of the #5 rod journal and both radii for this rod journal exhibited black-blue heat tint consistent with exposure to heat and contained circumferential gouges. Fatigue crack propagation was through approximately 90% of the cheek cross section. The remaining fracture exhibited rough texture features consistent with overstress separation. The surface of the exposed rod and main journals showed no evidence of circumferential gouges. A soft steel wire was inserted through all the oil lubrication ports. The oil lubrication ports contained no evidence of metal/debris.

Figure 1. As-received crankshaft.

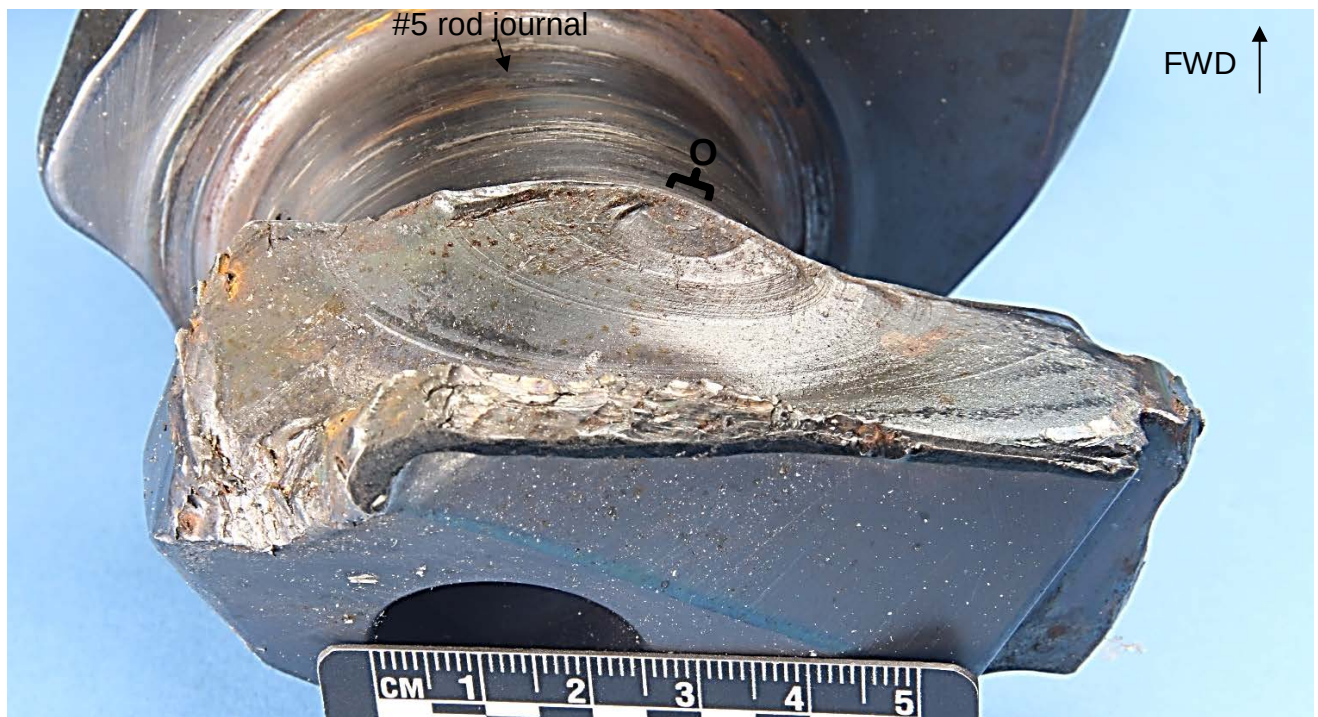
Figure 2. Close-up photograph of the fracture face showing the origin of the fatigue crack indicated by a bracket "O" that emanated from the aft radius of the #5 rod journal.

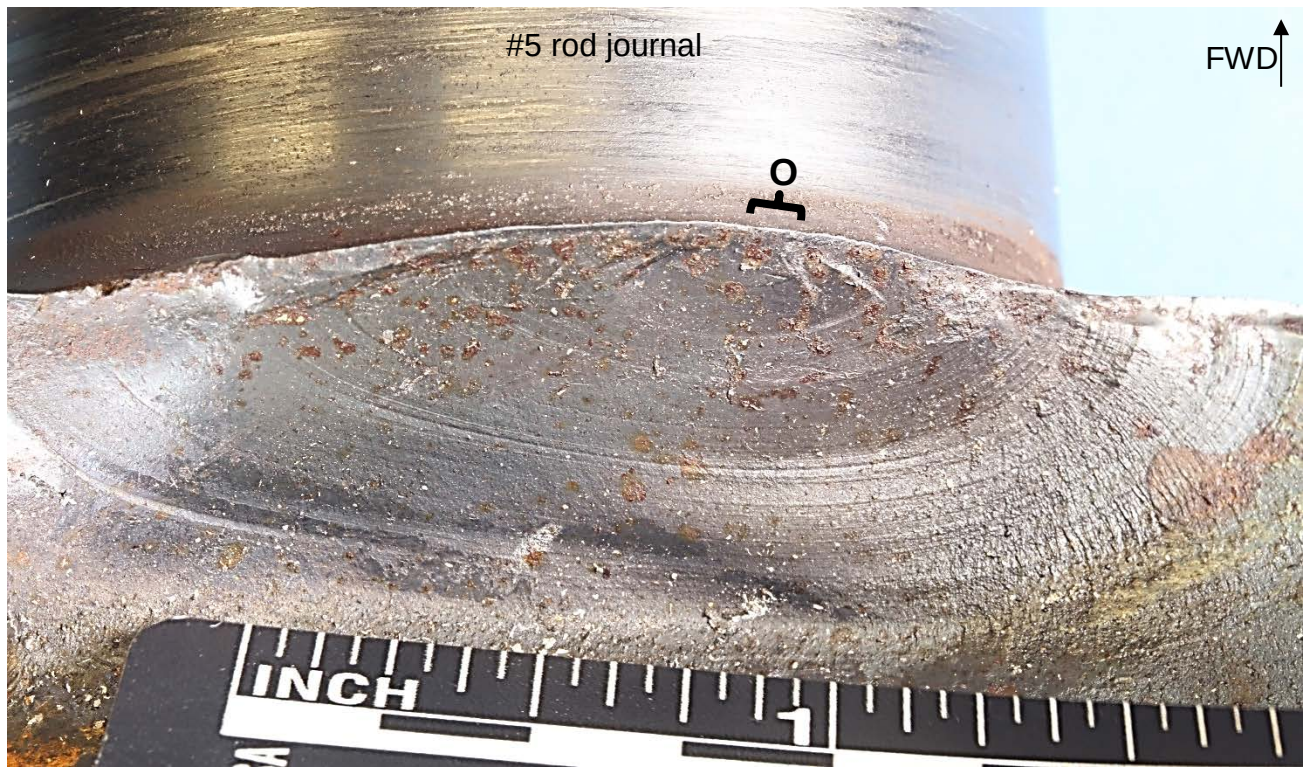
Figure 3. Close-up photograph of the origin of the fatigue crack indicated by a bracket "O".
