# NATIONAL TRANSPORTATION SAFETY BOARD

## MATERIALS LABORATORY FACTUAL REPORT

Report No. 19-014

Place : Kansas City, MO  
Date : March 22, 2018  
Vehicle : Cessna 310R (N372WP)  
NTSB No. : CEN18LA128  
Investigator : Jim Silliman (AS-CEN)

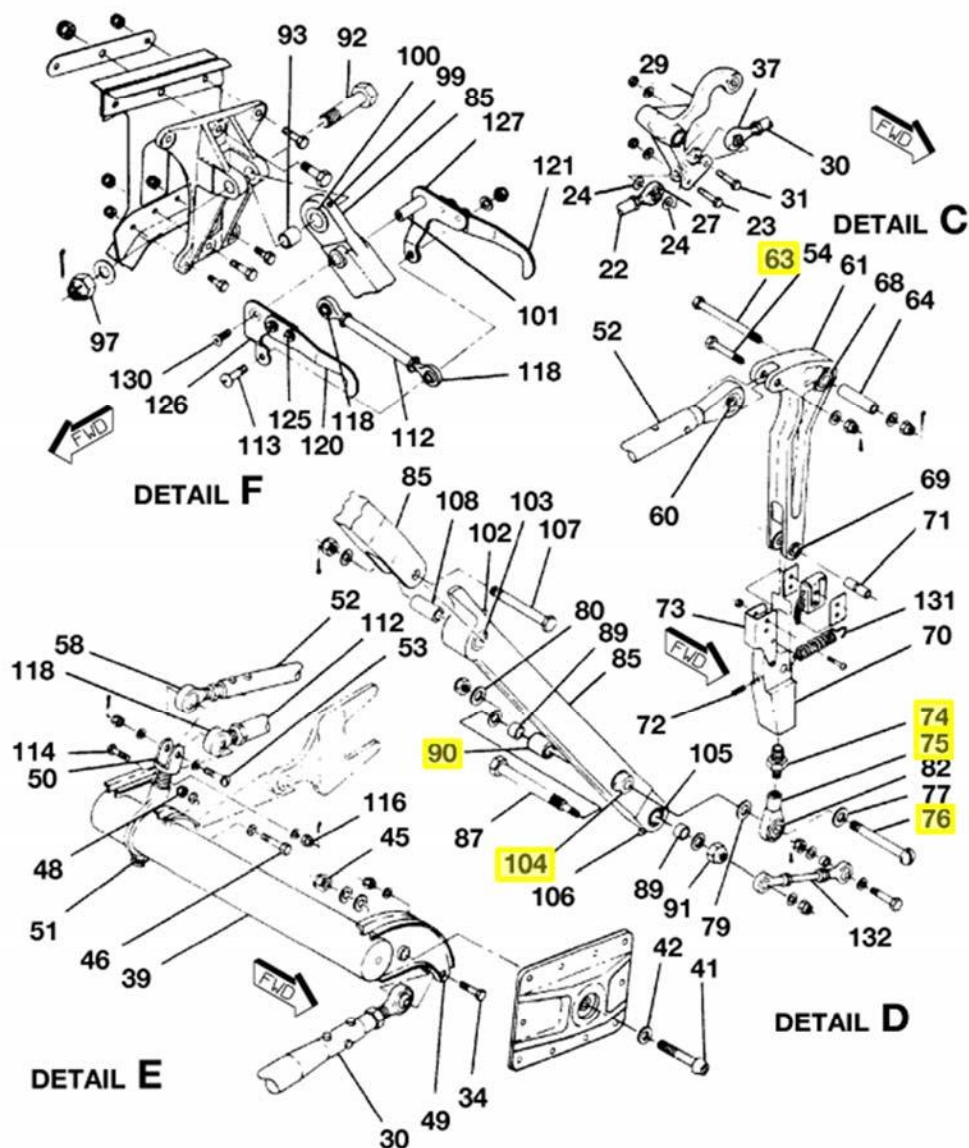
Figure 1: Image of the breakout drawing for the main gear retraction linkage installation from the Cessna Model 310R IPC. The yellow boxes highlight the numbers associated with the submitted parts.

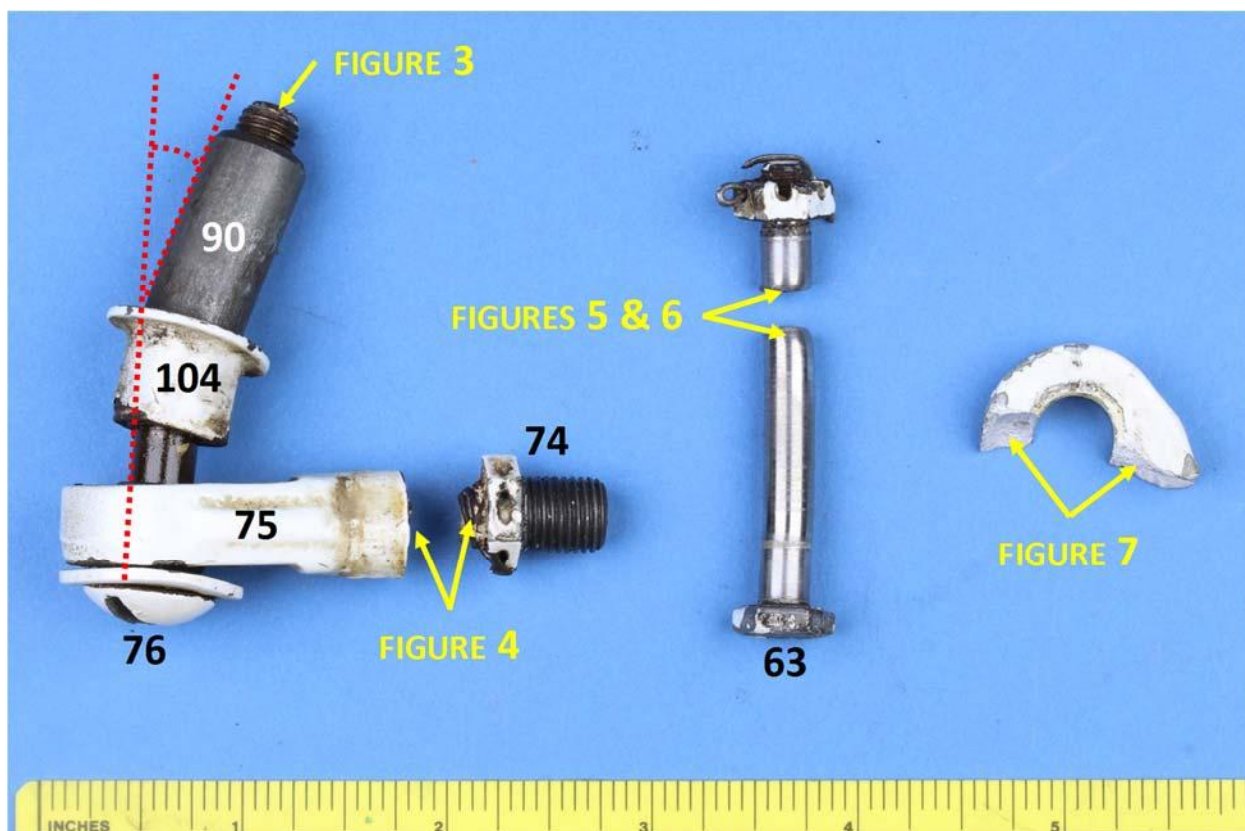
The end fitting bolt had separated through a thread root on the end of the bolt. The bolt was bent, which prevented easy removal of the mating spacer and bushing. The bend in the bolt is illustrated by the red dotted lines in Figure 2. Figure 3 shows the fracture surface on the bolt. The fracture surface was approximately flat, but significant smearing and secondary damage obscured the finer features. Two crescent-shaped marks on the fracture surface (blue arrows) aligned with mounded material on the sides (red arrows), which was consistent with impact damage. The exact cause of the end fitting bolt separation could not be determined.

Figure 2: Overall photo of the submitted hardware. The red dotted lines indicate the bend in the end fitting bolt. The fracture surfaces of the pieces are shown in the figures indicated.

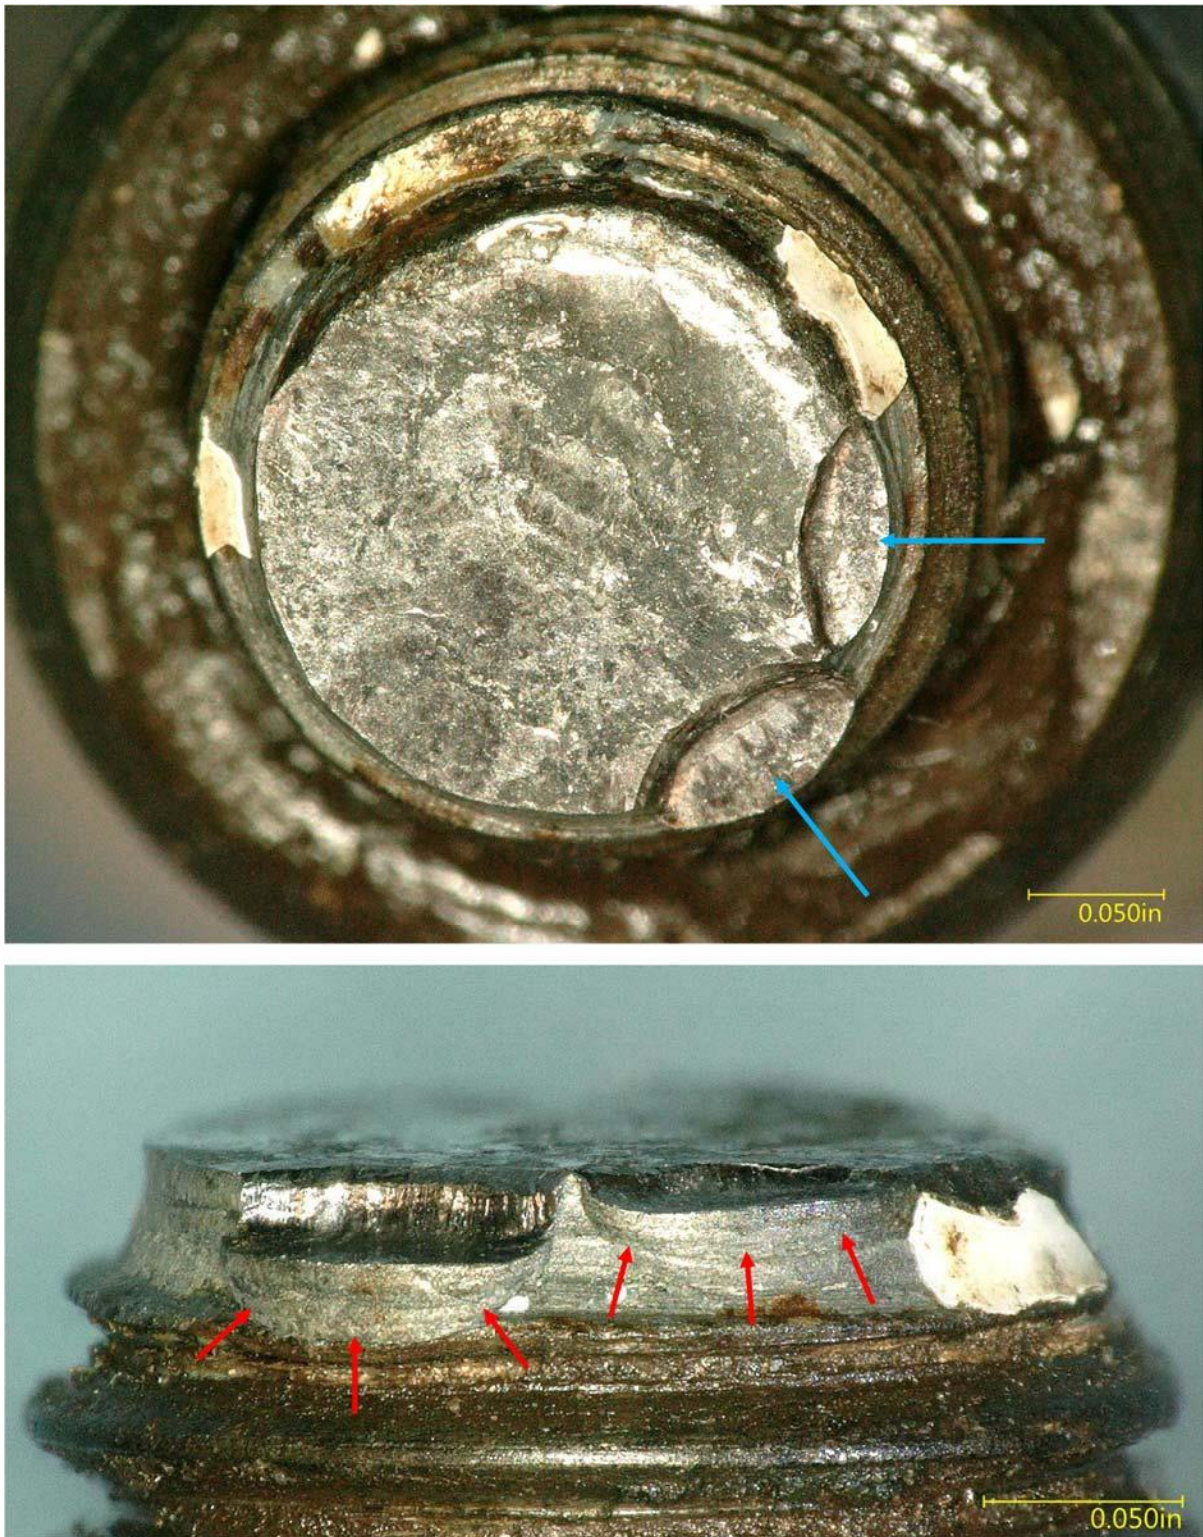
Figure 3: Digital microscope images of the end fitting bolt fracture surface (top) and profile (bottom). The blue arrows point to two crescent-shaped marks on the fracture surface. The red arrows point to mounded material adjacent to the crescent-shaped marks.

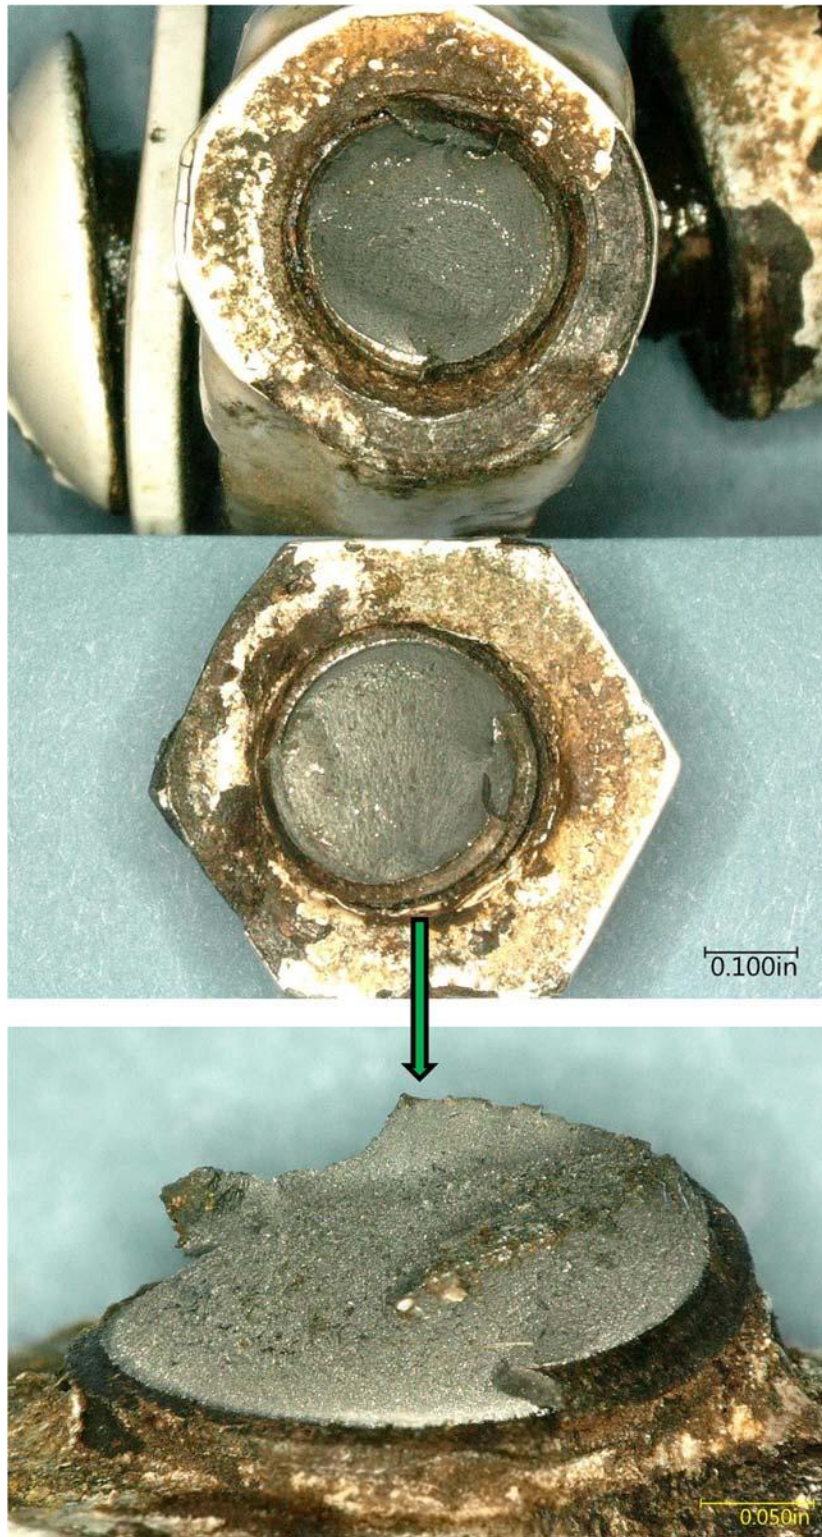
The end fitting adjustment screw, shown in Figure 4, had separated across a few threads and had a slight cup and cone configuration to the fracture surfaces. The fracture

surface features were rough and consistent with overstress. The orientation and shape of the fracture surfaces was consistent with torsional overstress.

Figure 4: Digital microscope images of the fracture surfaces on the mating halves of the separated end fitting adjustment screw.

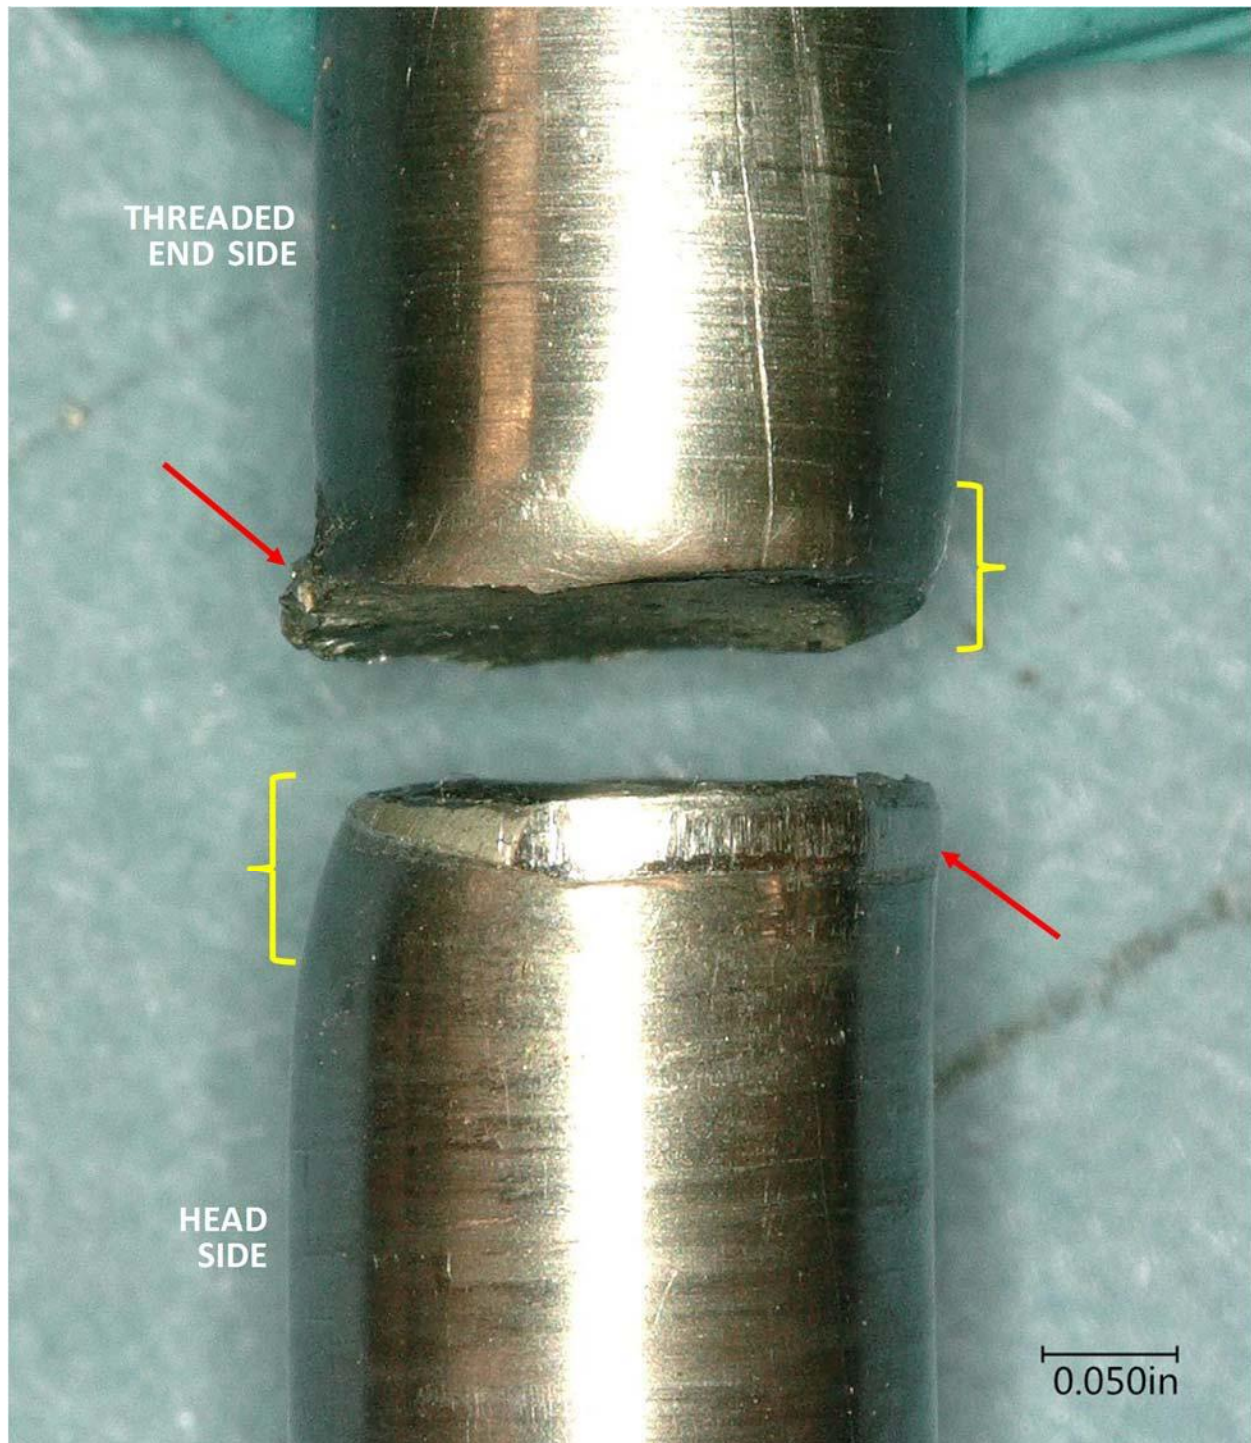
The bellcrank assembly bolt pieces are shown in profile in Figure 5. The fracture surfaces had evidence of necking (red arrows) on one side and slight mushrooming (yellow brackets) on the other side. The fracture surfaces matched such that the necking on one piece mated to the mushrooming on the other piece (i.e. the necking on the head side of the bolt mated to the mushrooming on the threaded end side of the bolt). These features were consistent with shear deformation. The fracture surfaces on the bolt pieces are shown in Figure 6. The fracture surface features were consistent with overstress. Smearing damage on the fracture surfaces was consistent with a shearing motion.

Figure 5: Digital microscope image of the mating bellcrank assembly bolt pieces as viewed in profile. The red arrows point to necking and the yellow brackets indicate slight mushrooming adjacent to each fracture surface.

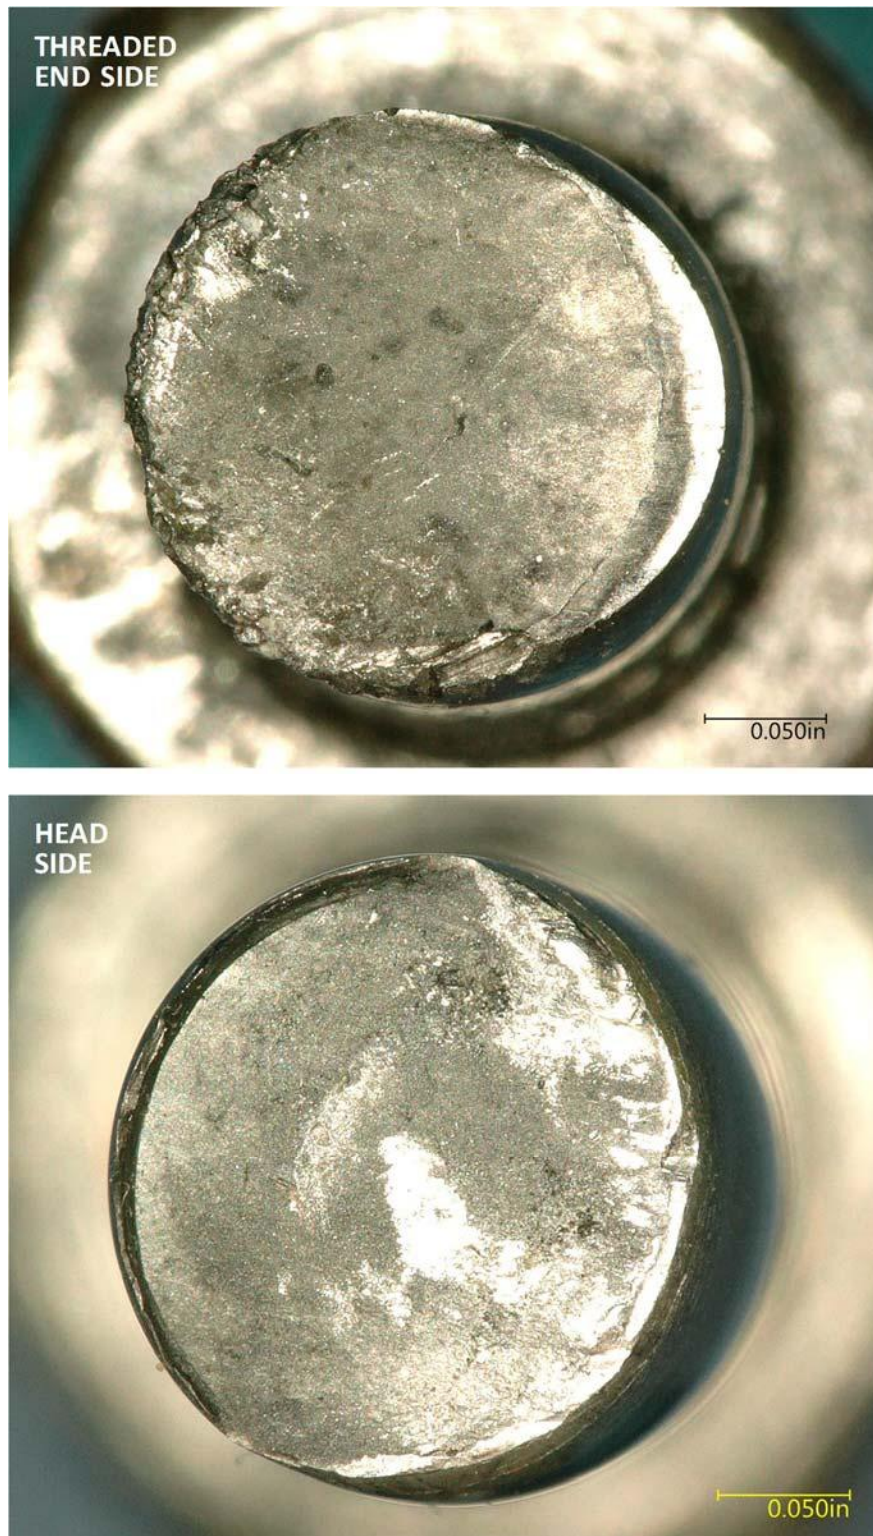
Figure 6: Digital microscope images of the fracture surfaces on the bellcrank assembly bolt pieces.

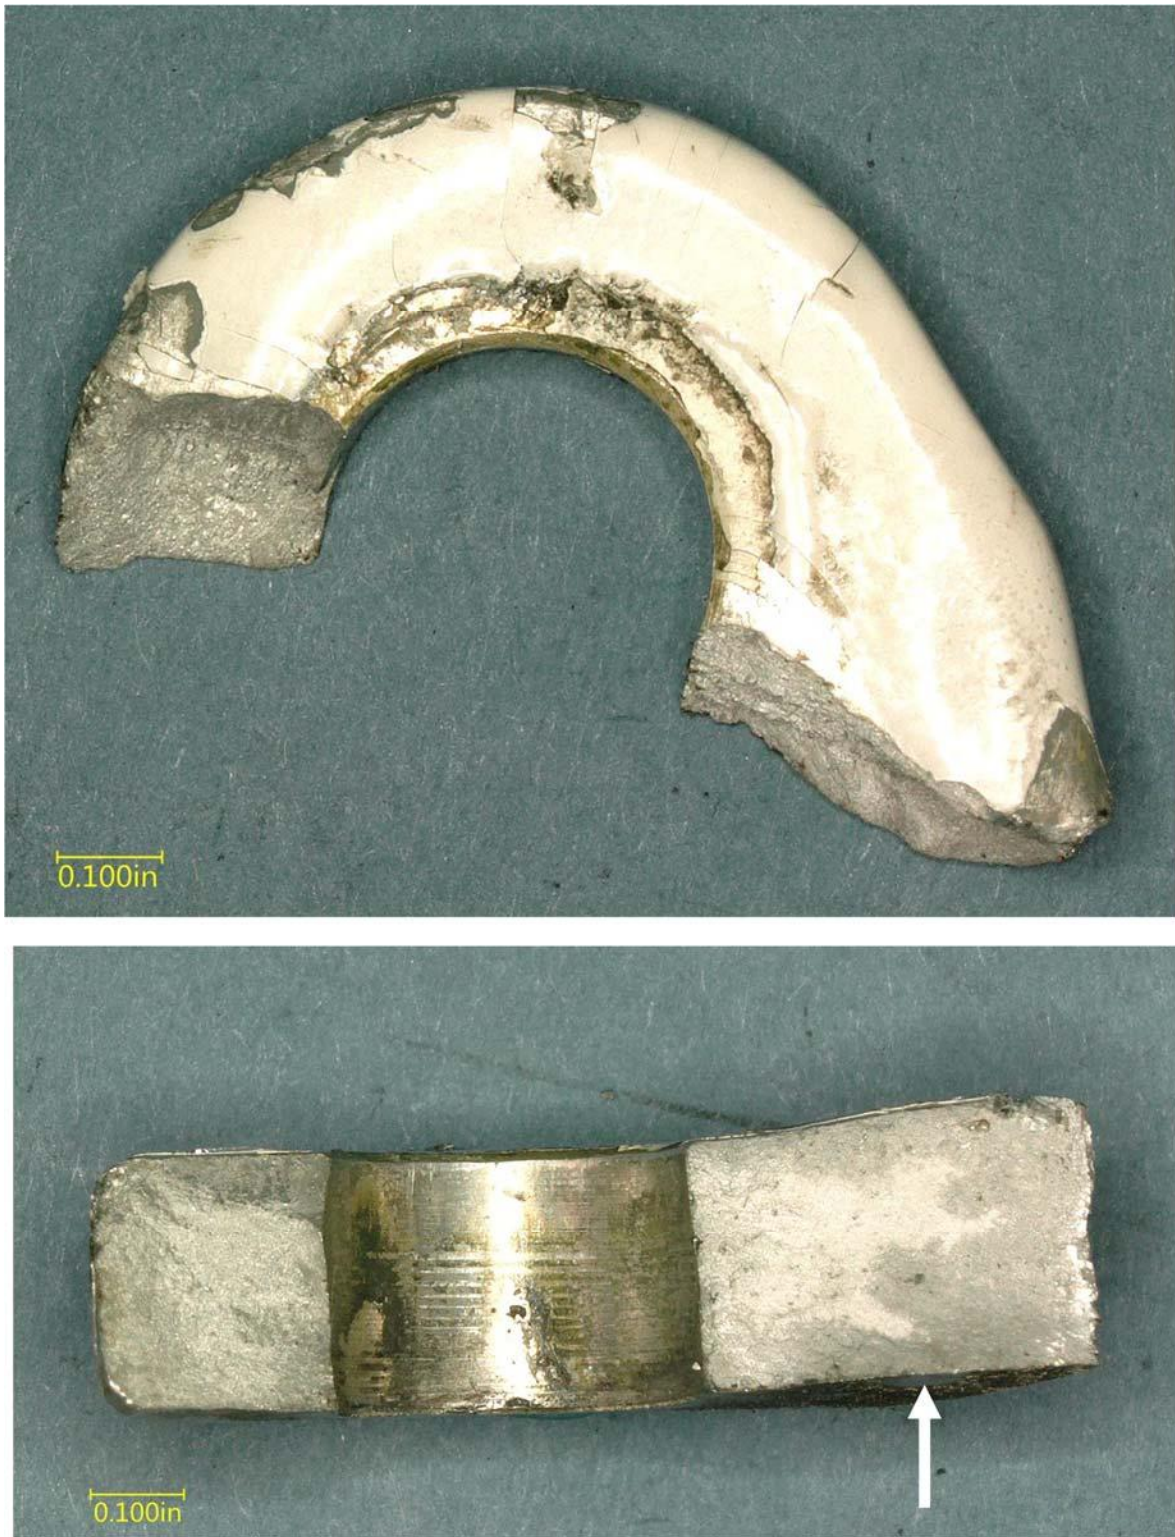
The flange piece separated through the hole, as shown in Figure 7, but the two fracture surfaces were not circumferentially aligned (one side was through a thicker portion of the flange than the other). One half of the piece was deformed out of plane, as indicated by the white arrow. The fracture surfaces had shear lips and features consistent with fast fracture overstress. The deformation and overstress were consistent with separation due to impact.

Figure 7: Digital microscope images of the flange piece. The white arrow indicates the out of plane deformation of one half of the piece.
