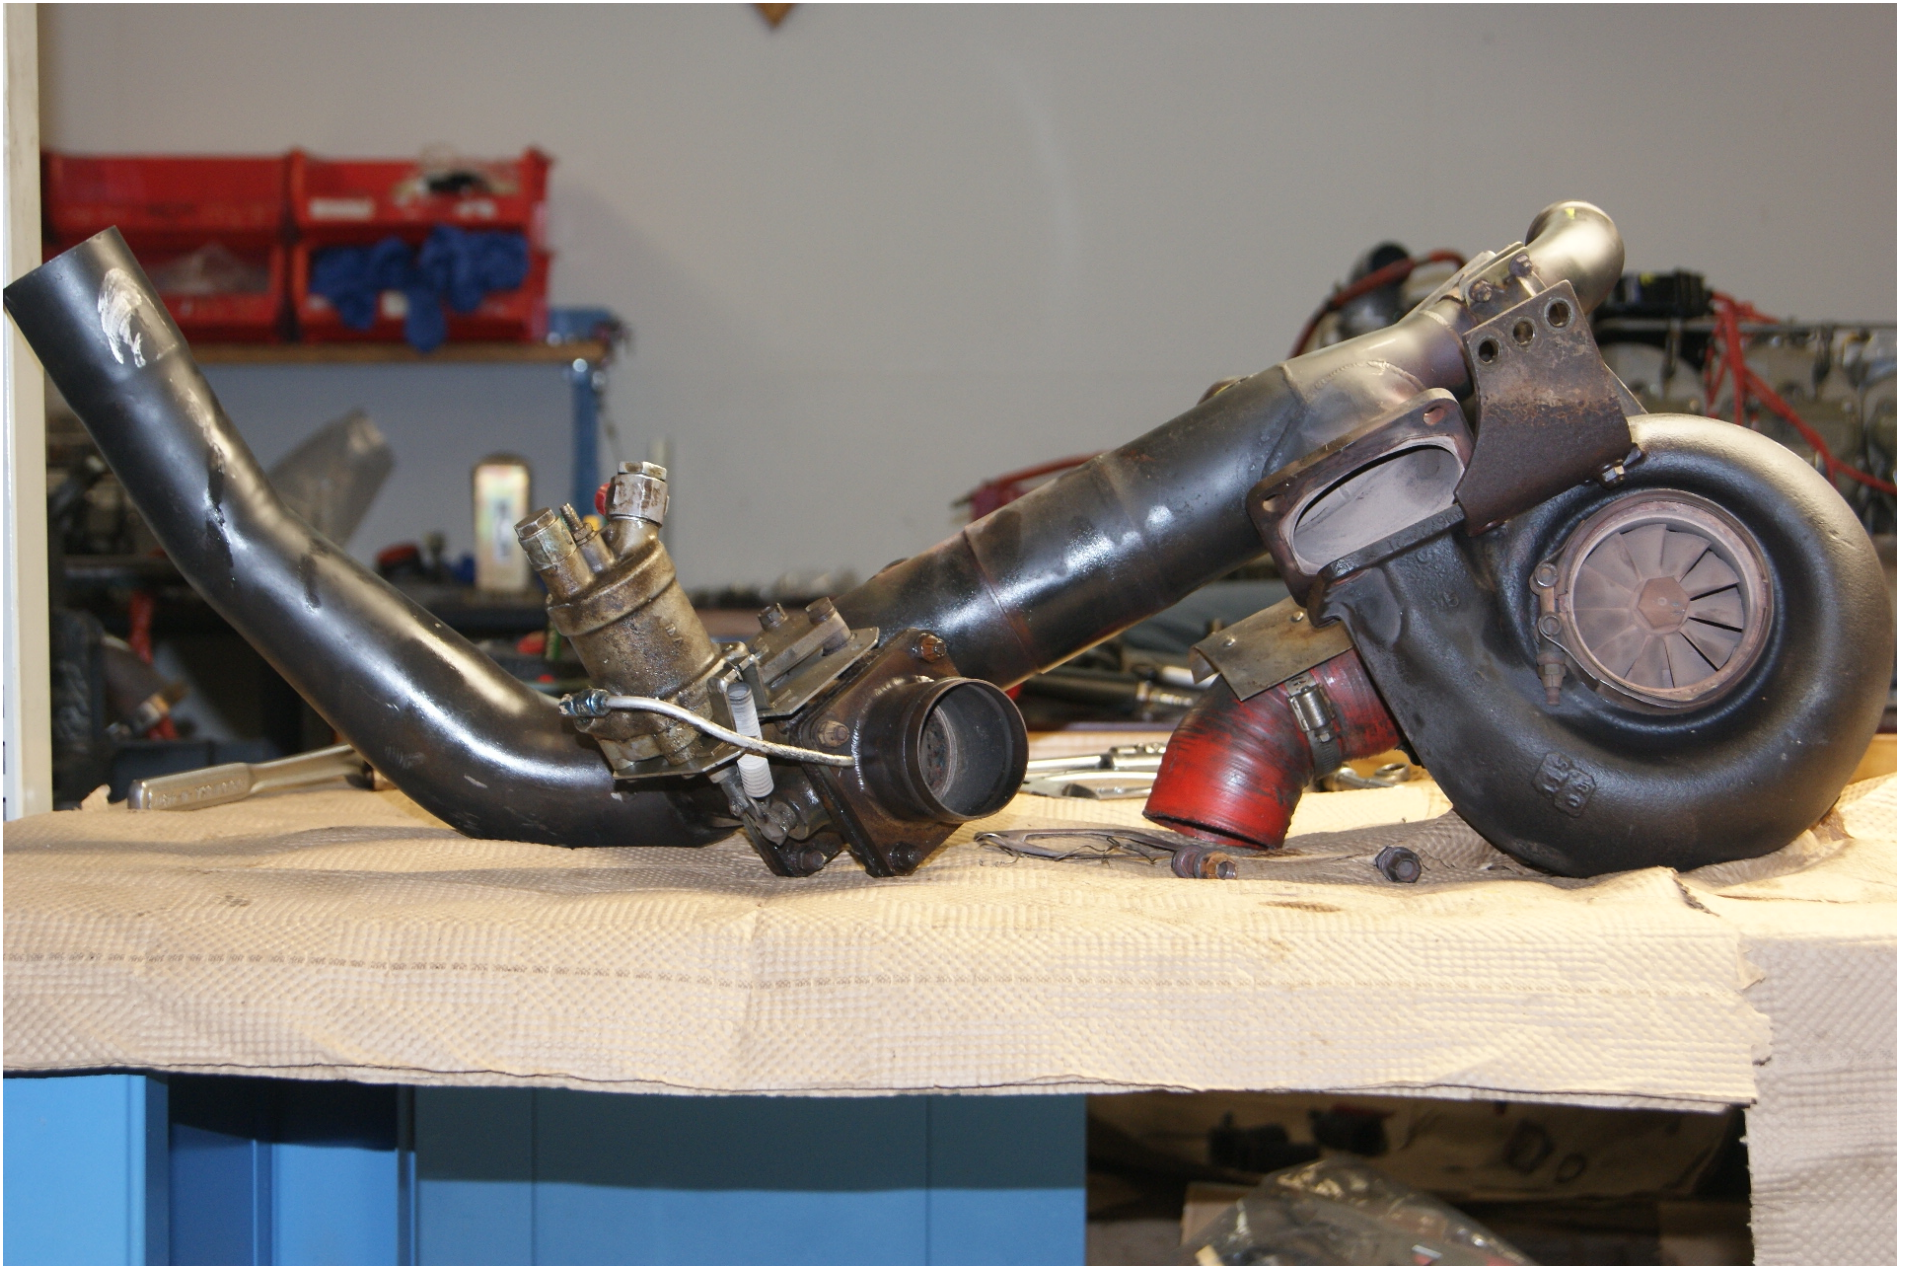
**Photo 1 – The turbocharger after being separated from the engine.**

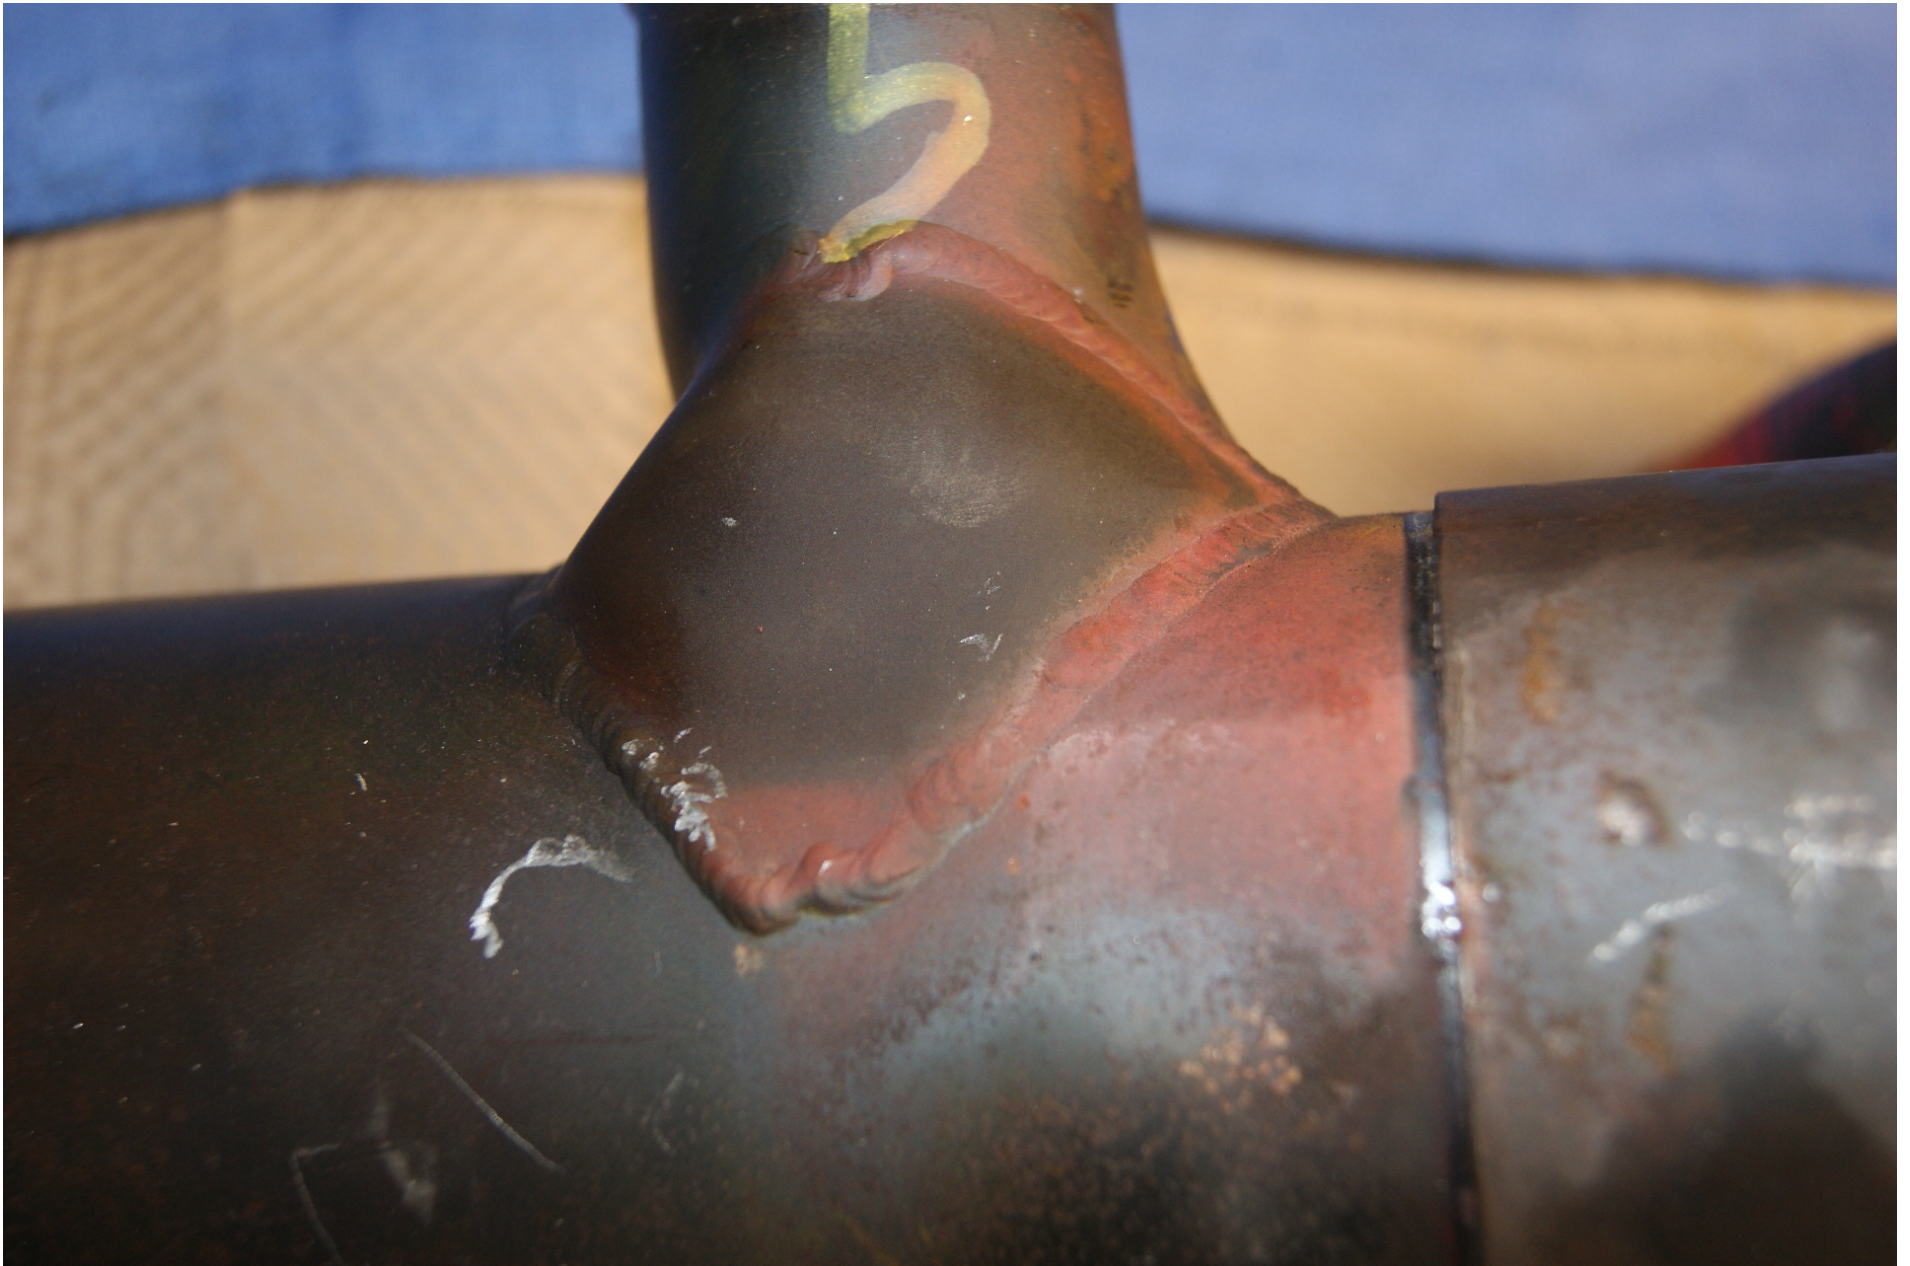
**Photo 2 – Turbocharger manifold bore evidence of hot gas seepage.**

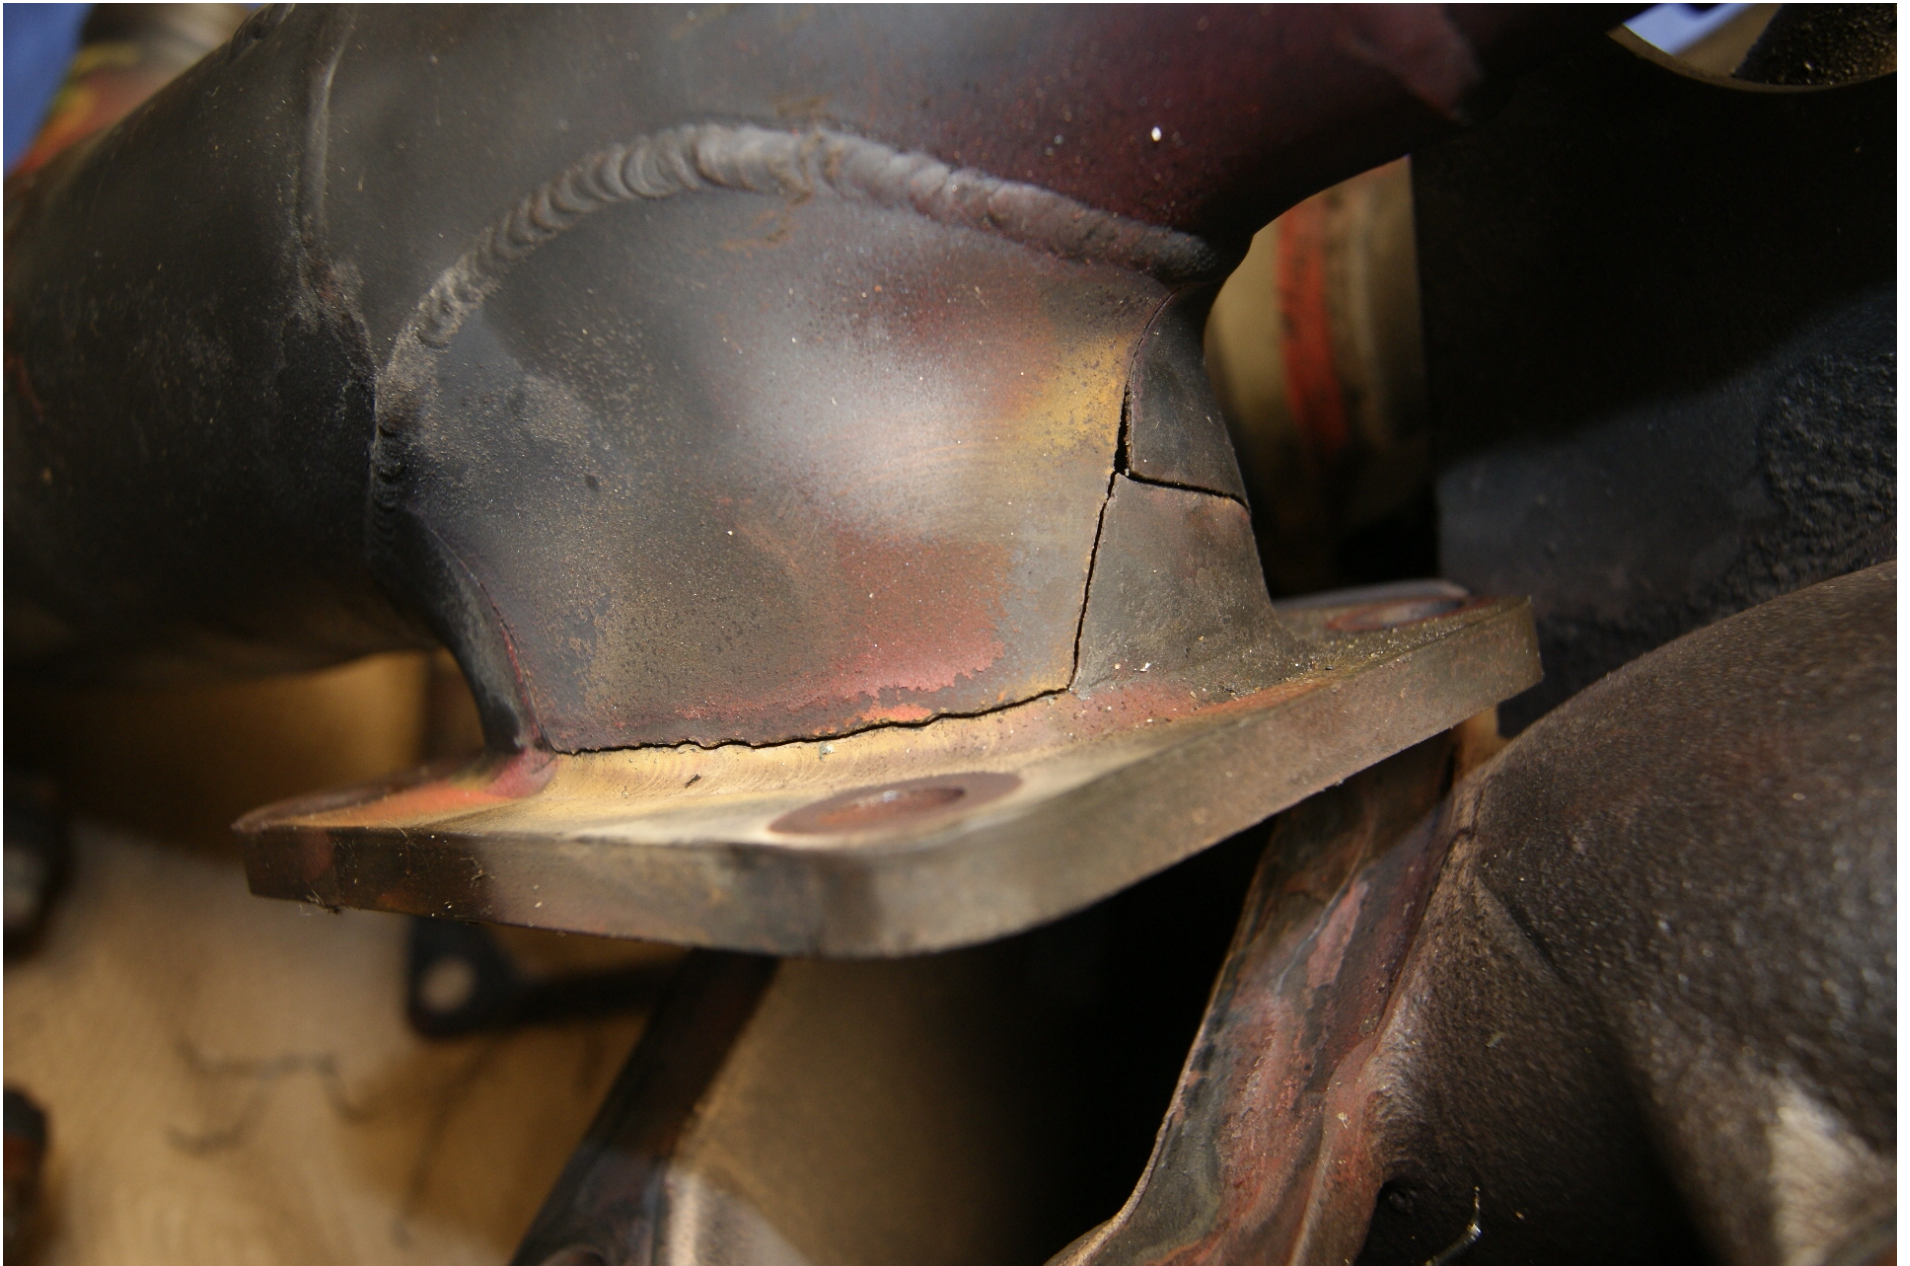
**Photo 3 – Crack at the base of the manifold.**

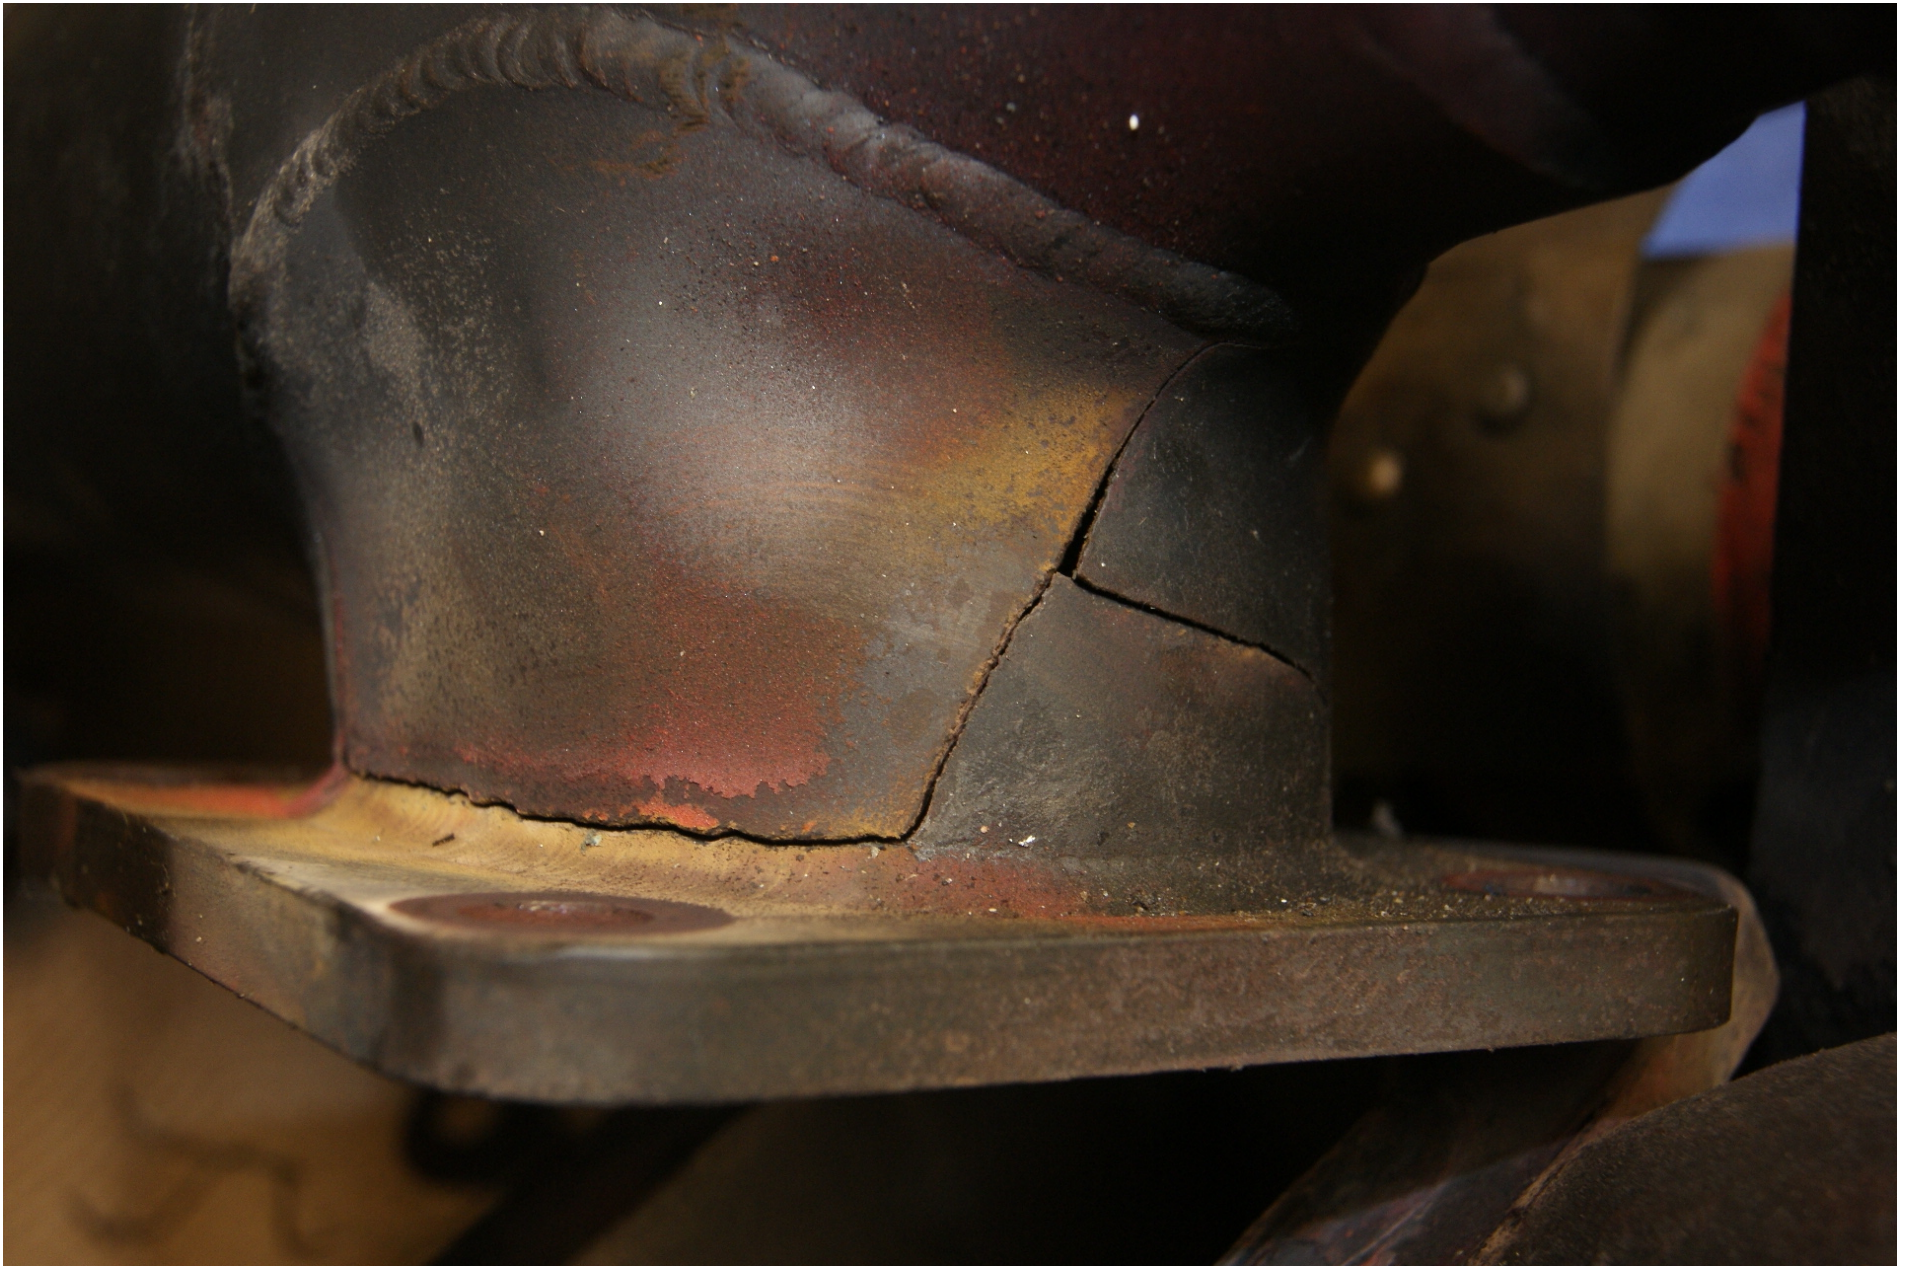
**Photo 4 – Another view of the manifold crack.**

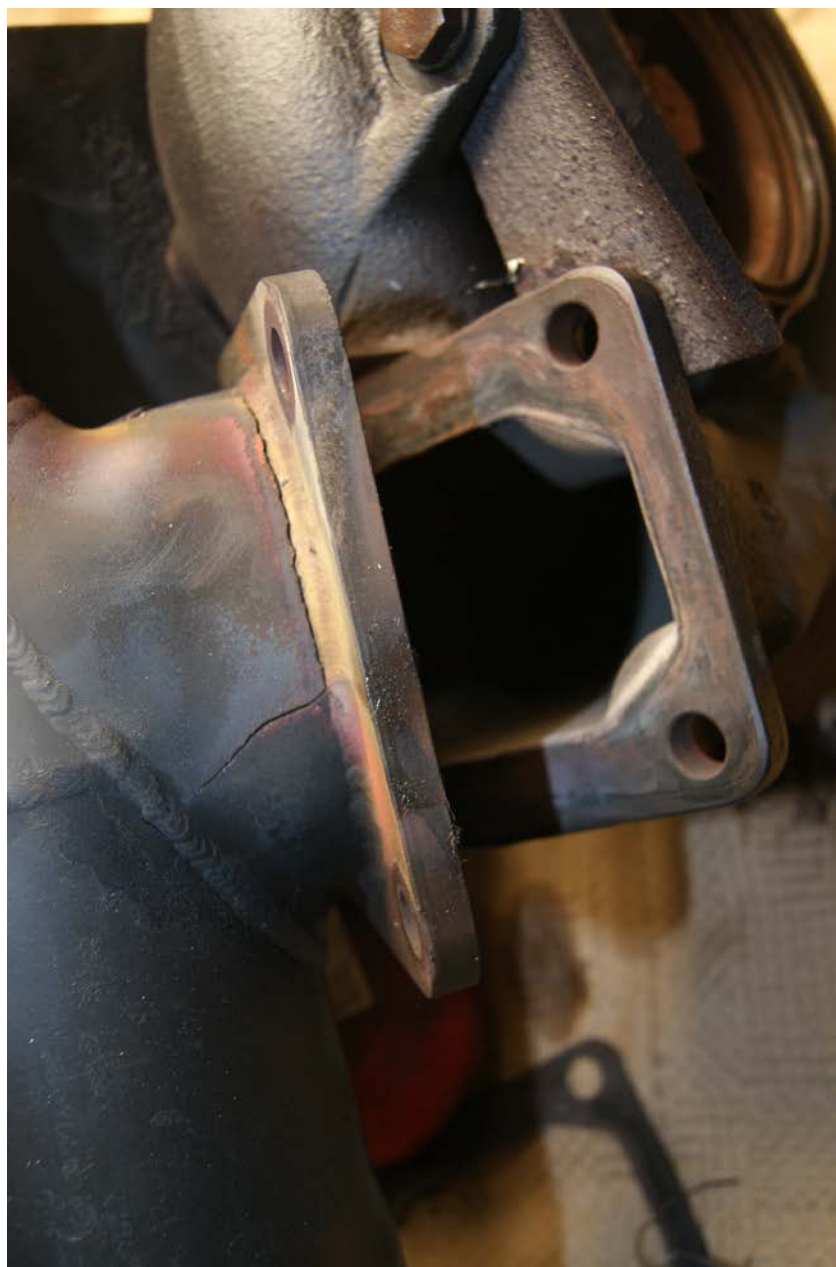
**Photo 5 – Separated manifold flanges.**

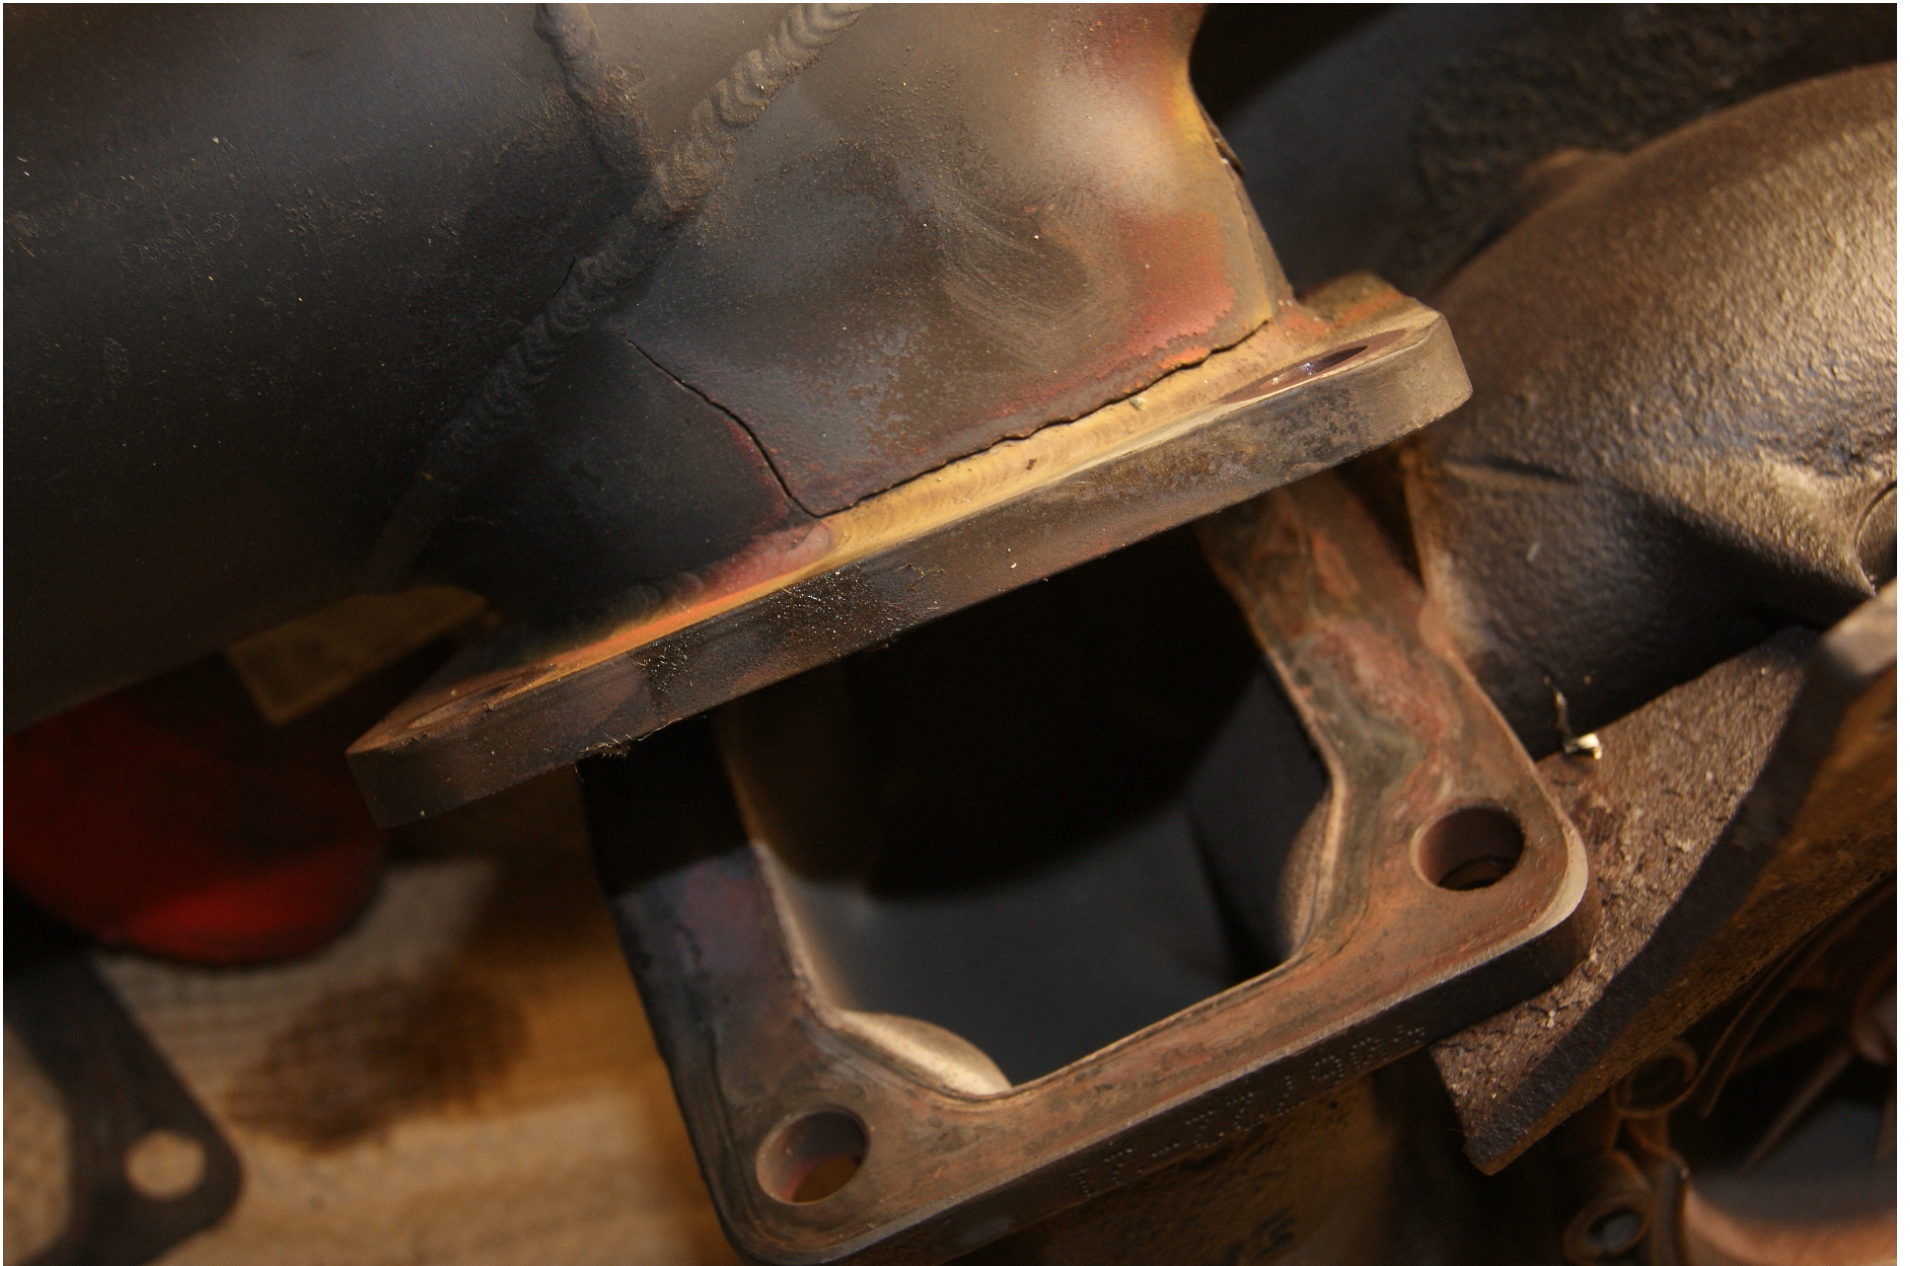
**Photo 6 – Another view of the separated manifold flanges. Note crack has propagated around the base of the manifold.**

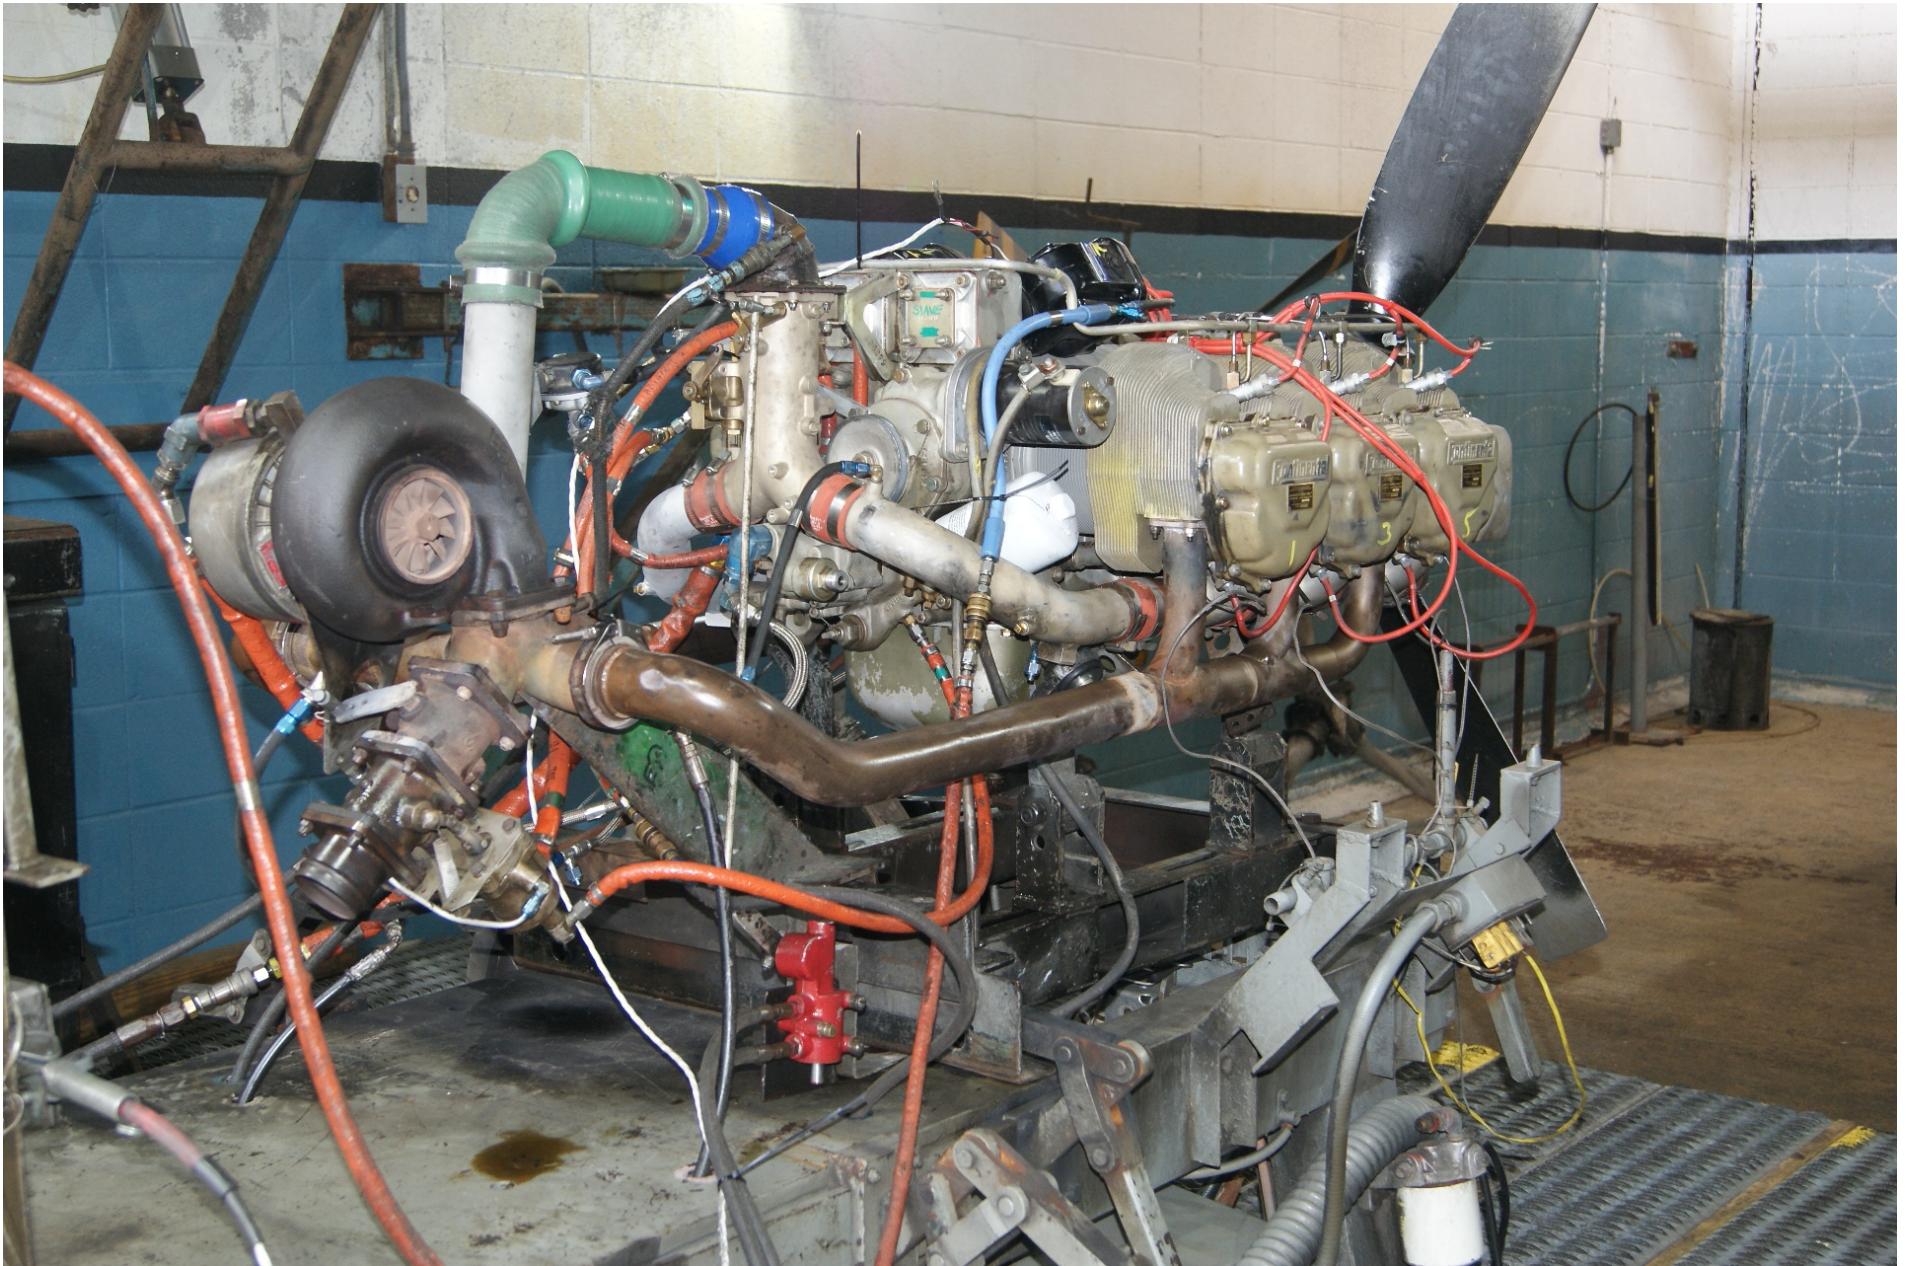
**Photo 7 – Preparing the engine for test run with turbocharger and new manifold installed.**

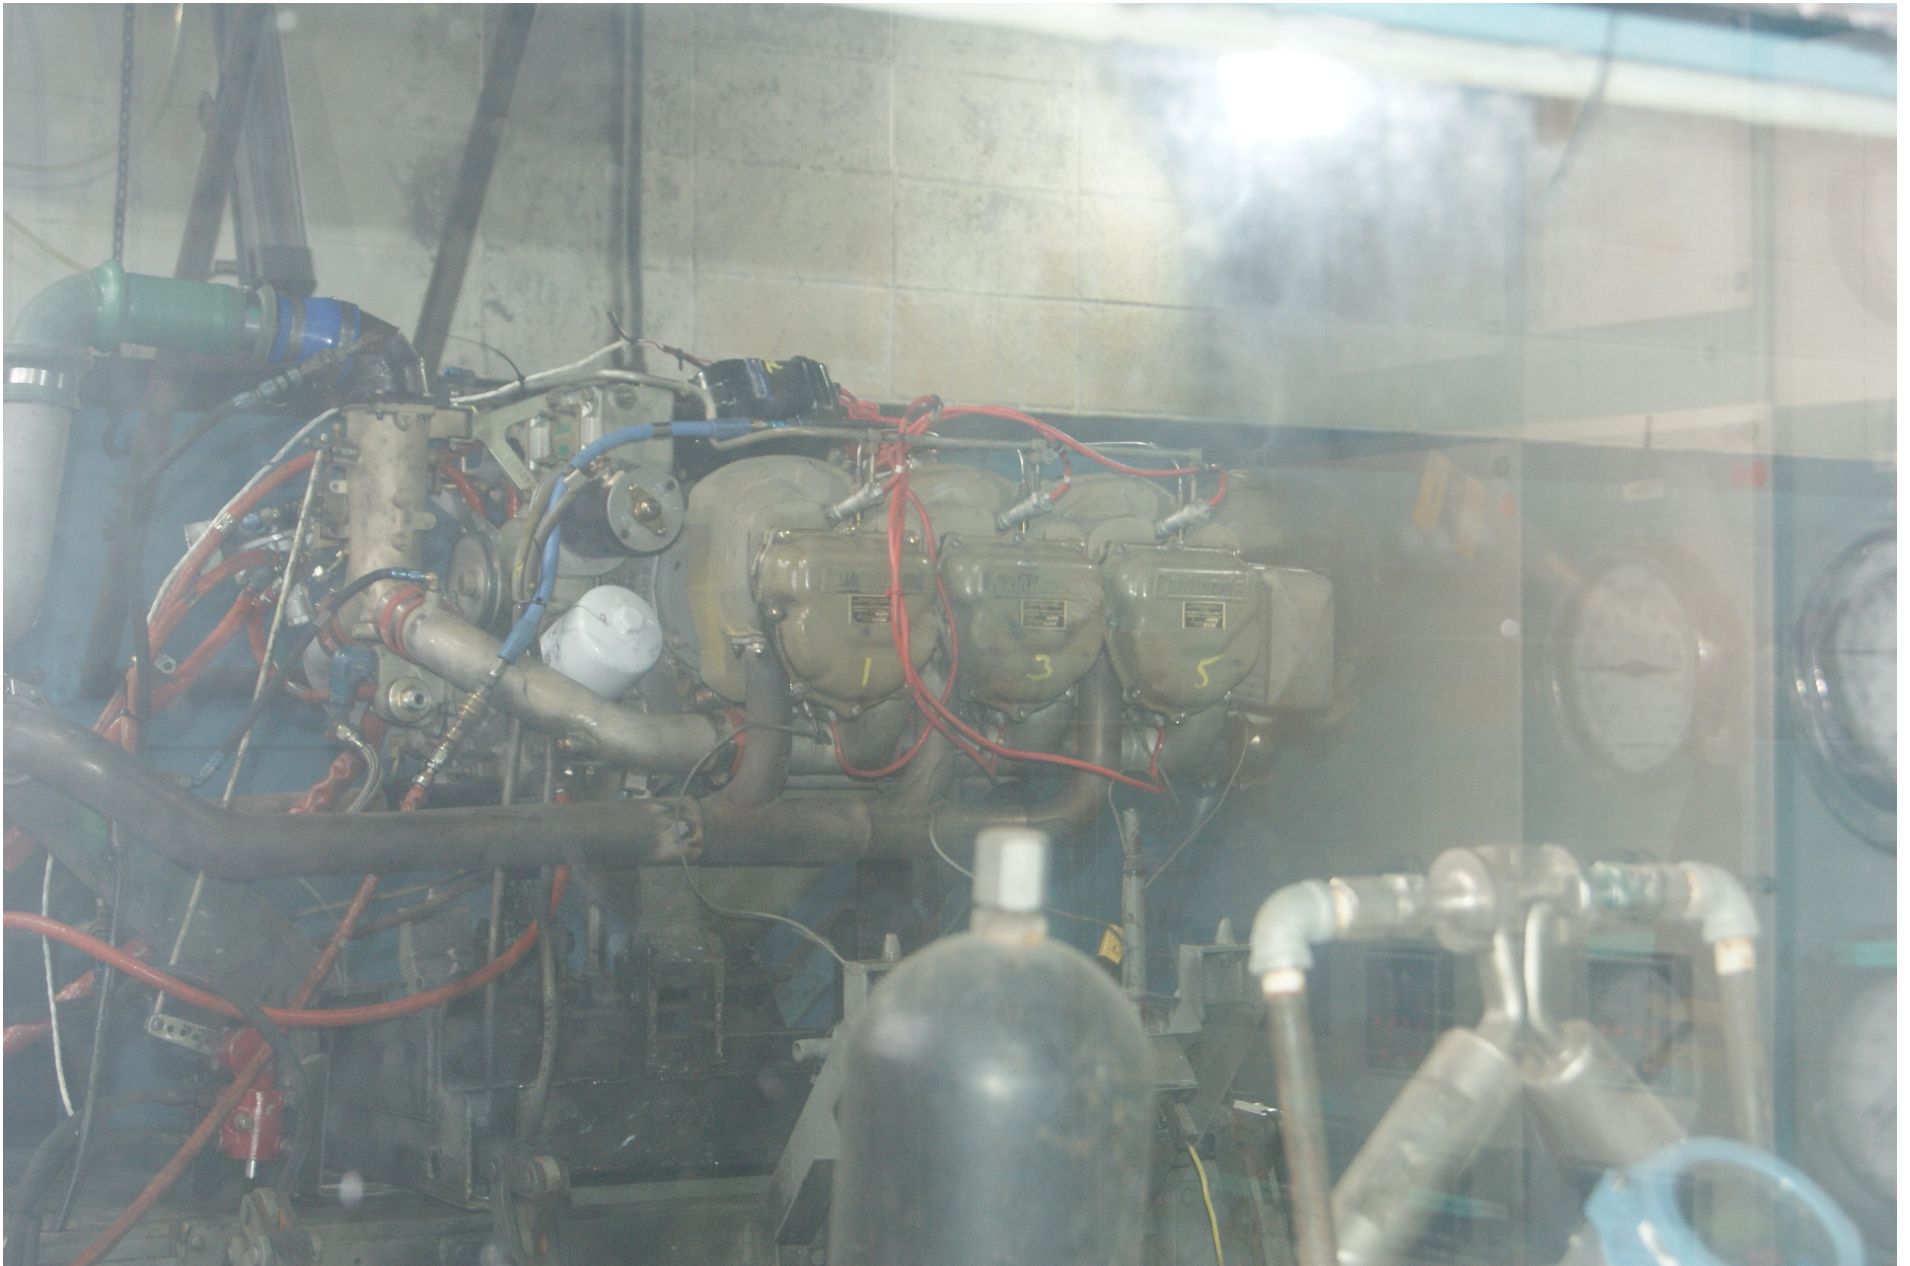
**Photo 8 – Engine running in test cell.**
