## **NATIONAL TRANSPORTATION SAFETY BOARD**

# **ENGINE EXAMINATION**

**CEN18LA159**

The airplane was in cruise flight at 7,000 ft msl, when the pilot heard an unusual noise from the engine. Shortly afterward, the engine lost power. He subsequently executed a forced landing to an open field. A visual inspection of the engine noted a small hole in the engine case, just above the number one cylinder.

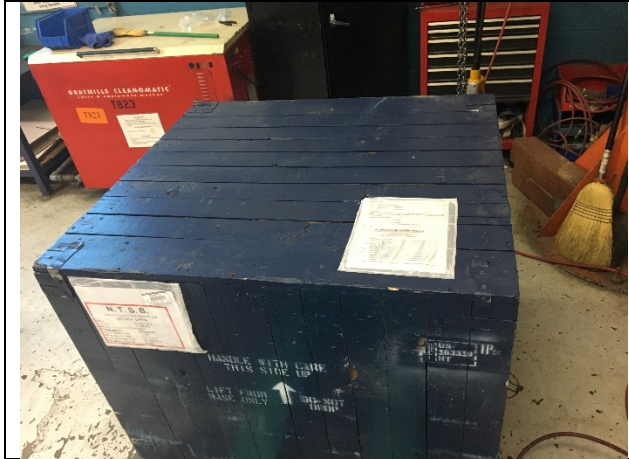
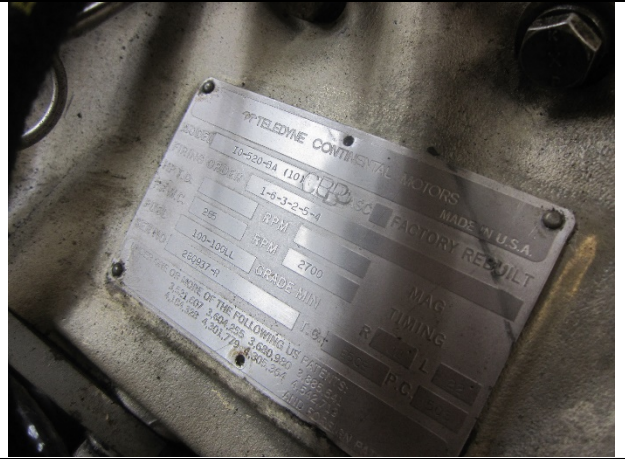
The engine crate as shipped to CMI. The engine datatag was changed from IO-520-BA (10) to IO-520-BB (10).

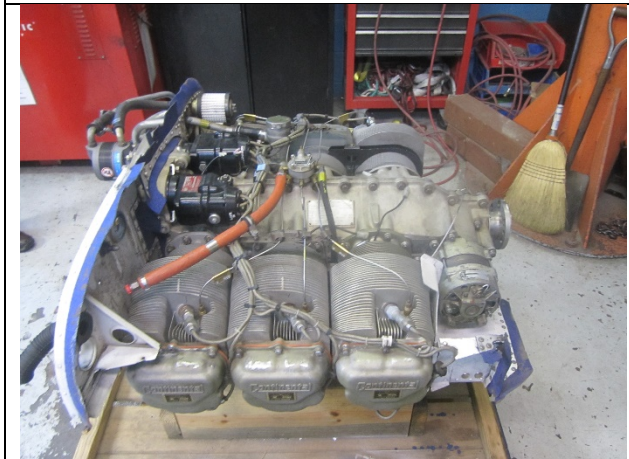
The engine prior to disassembly

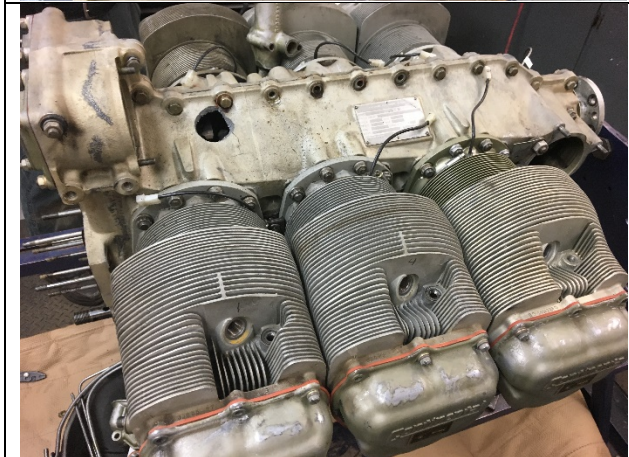
The engine was stripped of components, so the engine could be disassembled.

A hole, above the number one cylinder is clearly visible.

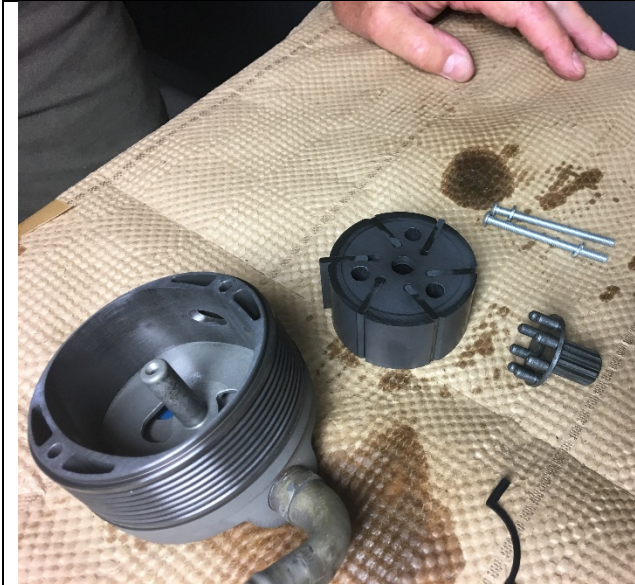
The various engine components were examined.

The vacuum pump disassembled, no abnormalities were noted.

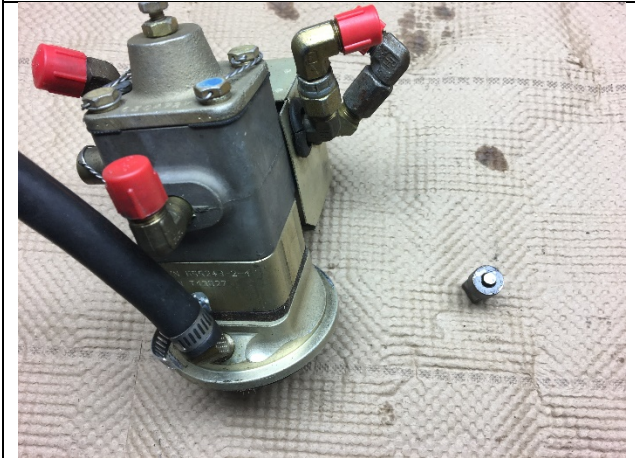
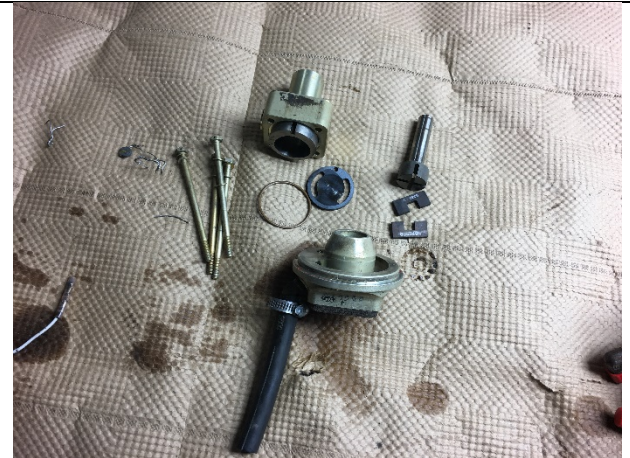
The fuel pump was separated from the engine, the drive shaft had sheared; the end of the shaft was smeared. No other anomalies were observed.

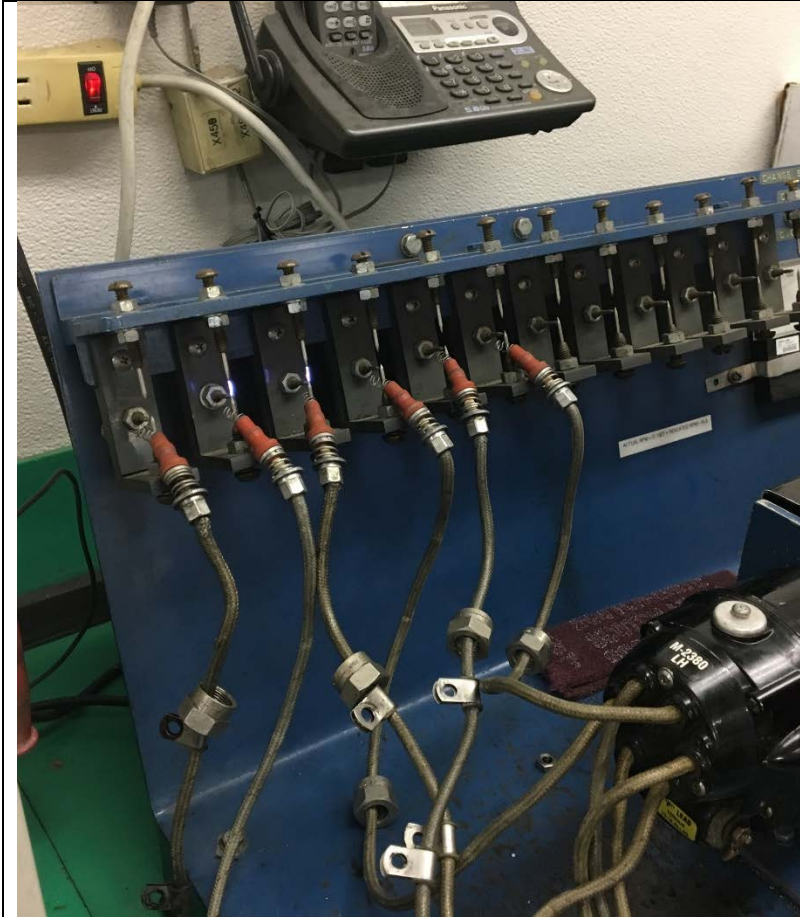
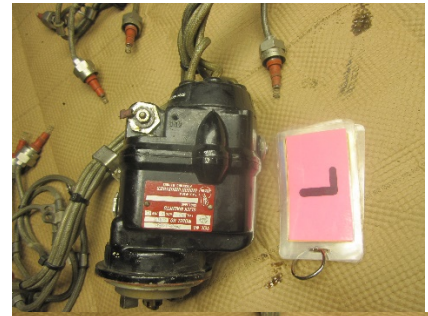
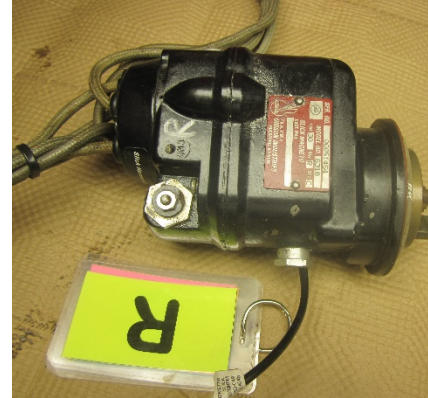
Both left and right magnetos, were bench tested; no abnormalities were noted

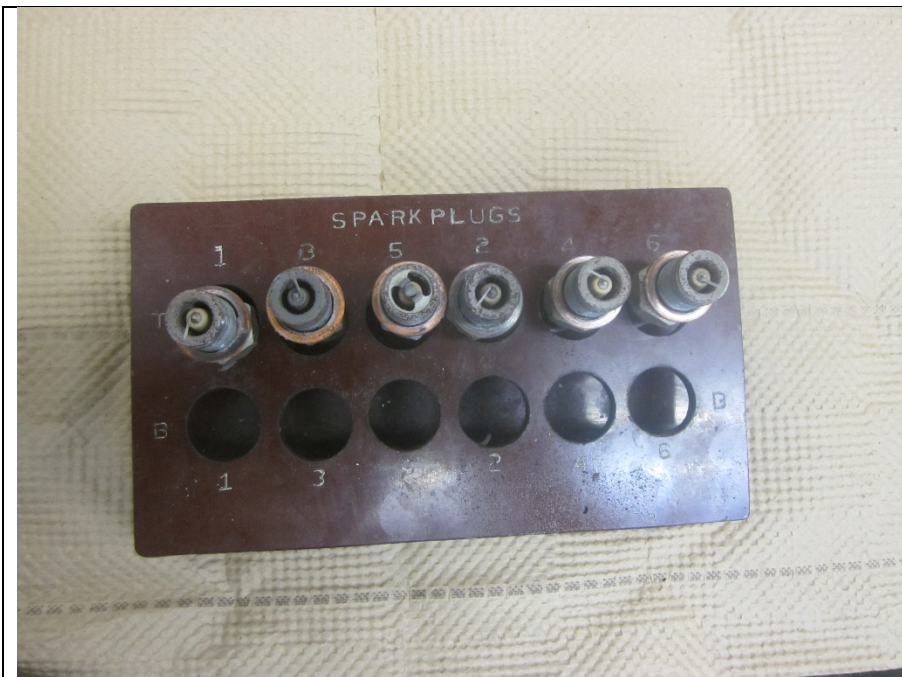
The top set of sparkplugs were removed from the engine. The number five cylinder sparkplug, had massive electrodes as opposed to the fine wire sparkplugs on the other cylinders.

The plugs exhibited normal combustion signatures.

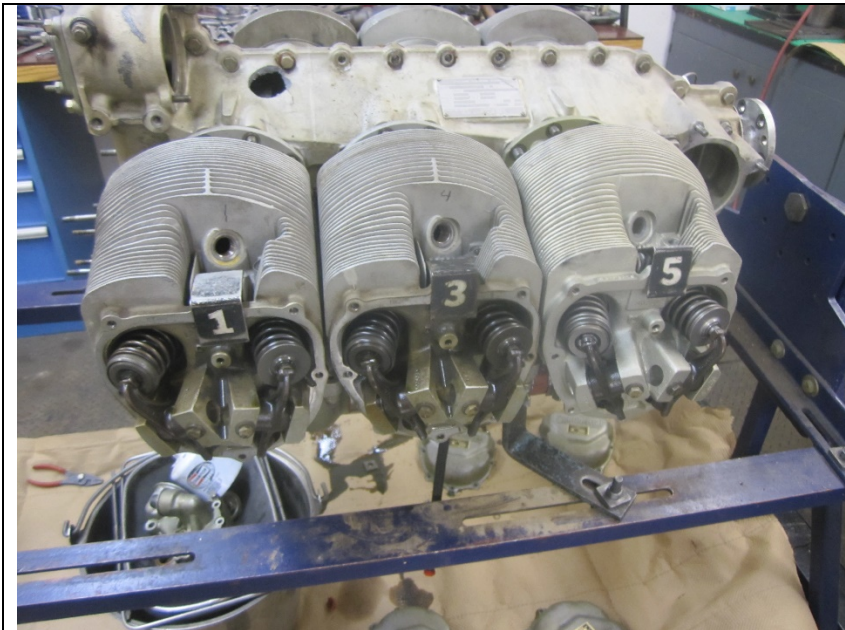
Prior to cylinder removal, the cylinder bolts and case through bolts were checked for torque values.  
(see attached sheet for torque values)

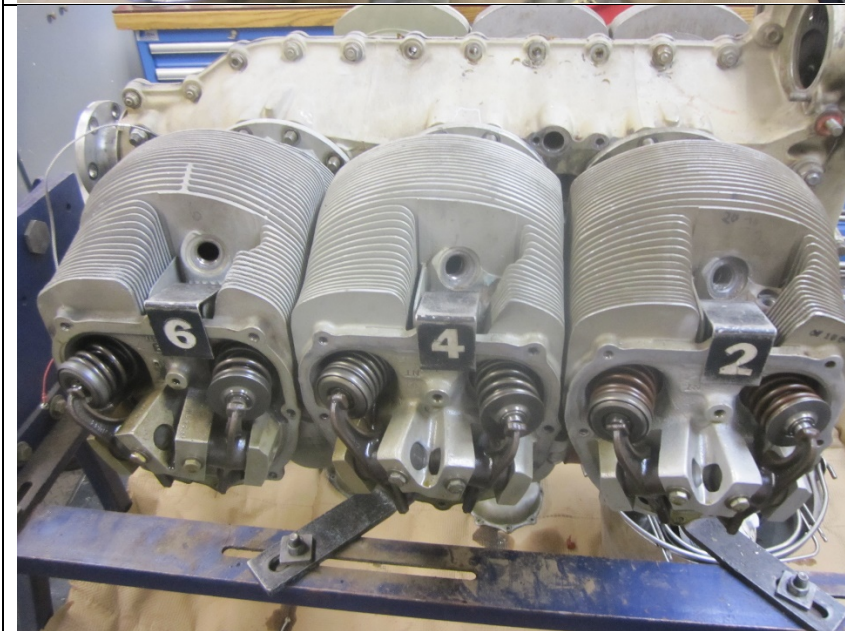
No anomalies were noted with the cylinder valve train.

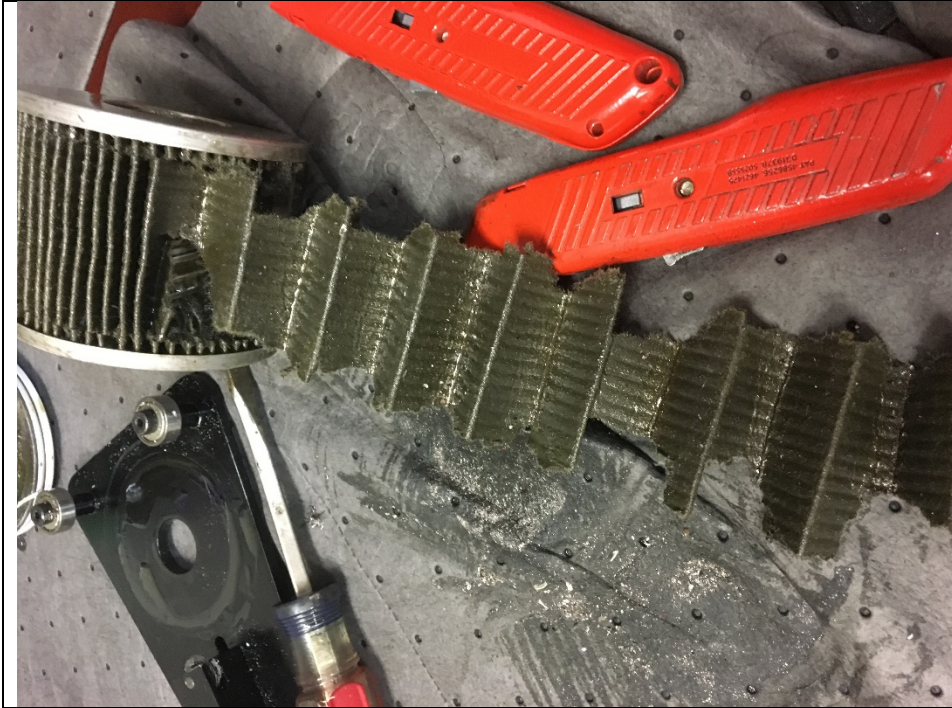
The oil filter was cut open: metal was present in the filter element

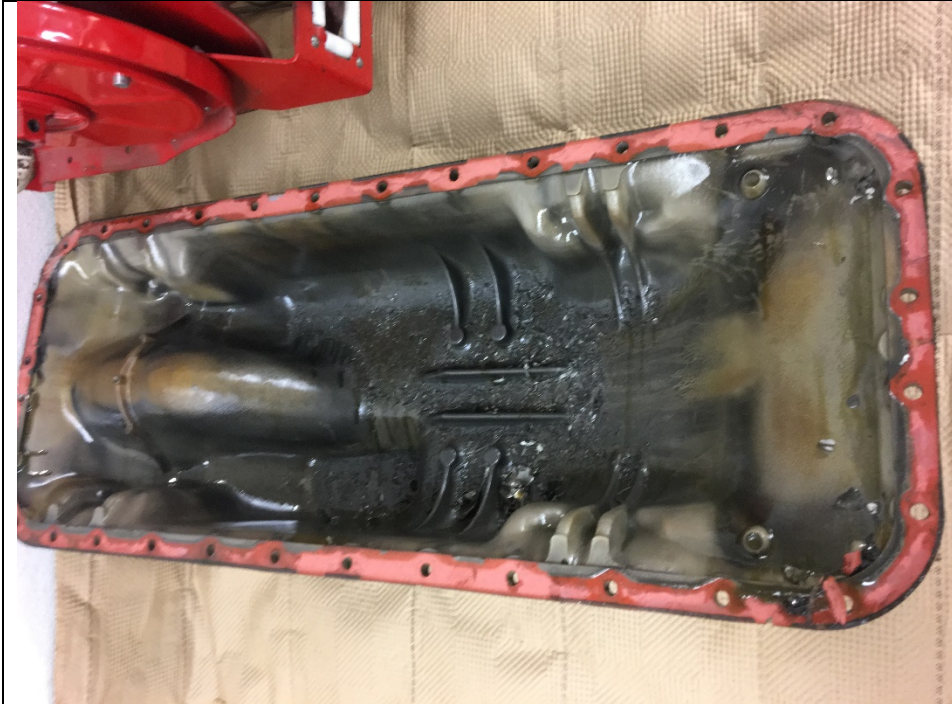
The engine oil sump also contained metal pieces.

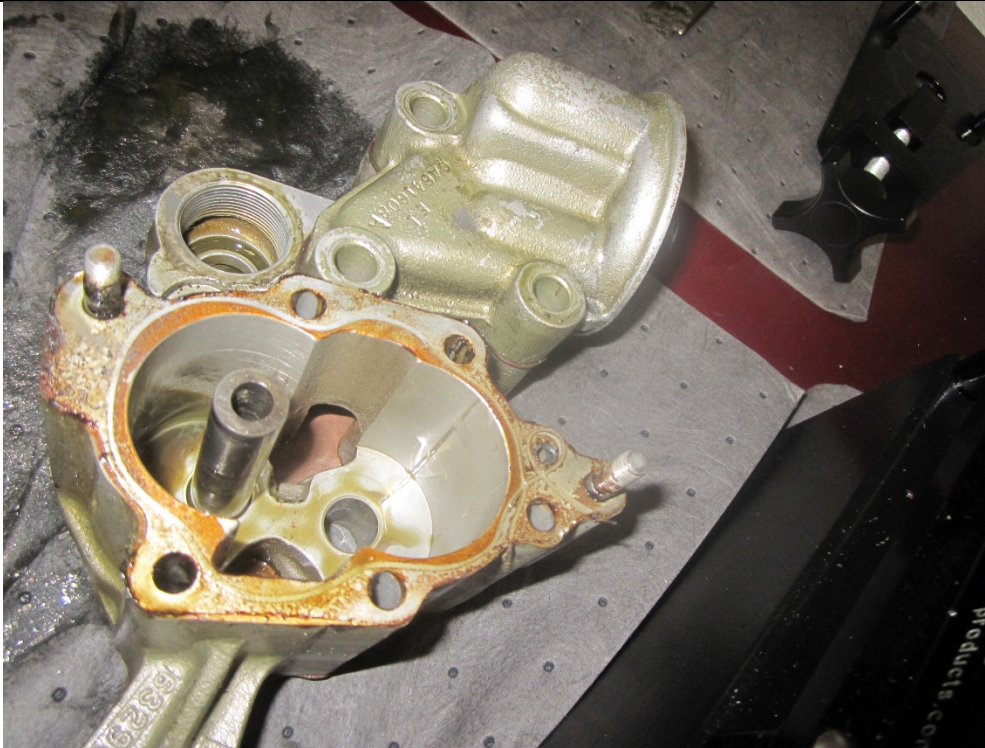
The oil pump had indication of hard object passage.

Otherwise no anomalies were noted with the oil pump, camshaft, or accessory section.

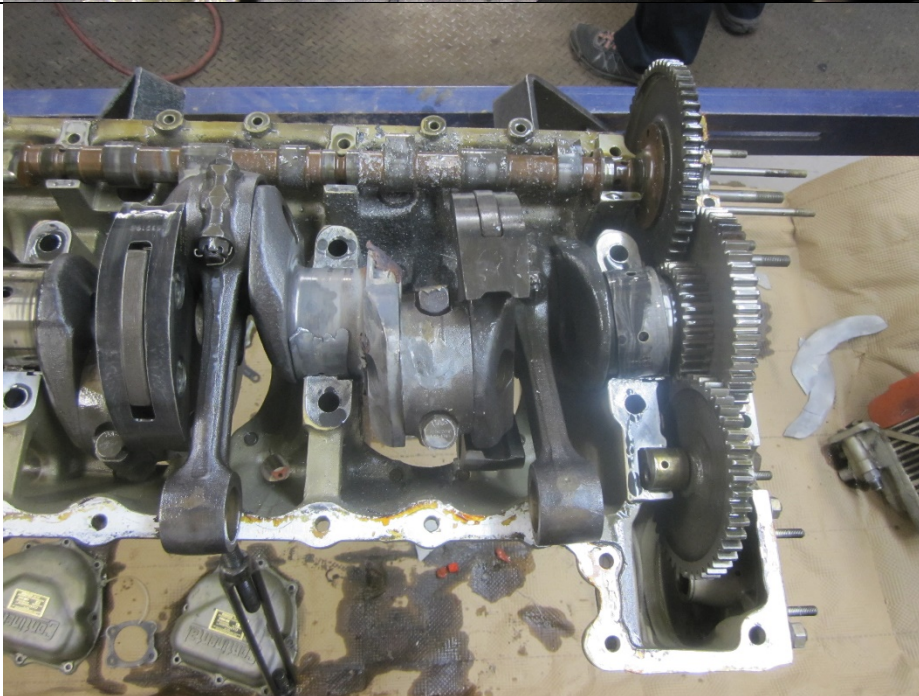
The case halves were separated

The crankshaft was broken into two pieces.

The crankshaft displayed signatures consistent with the lack of lubrication.

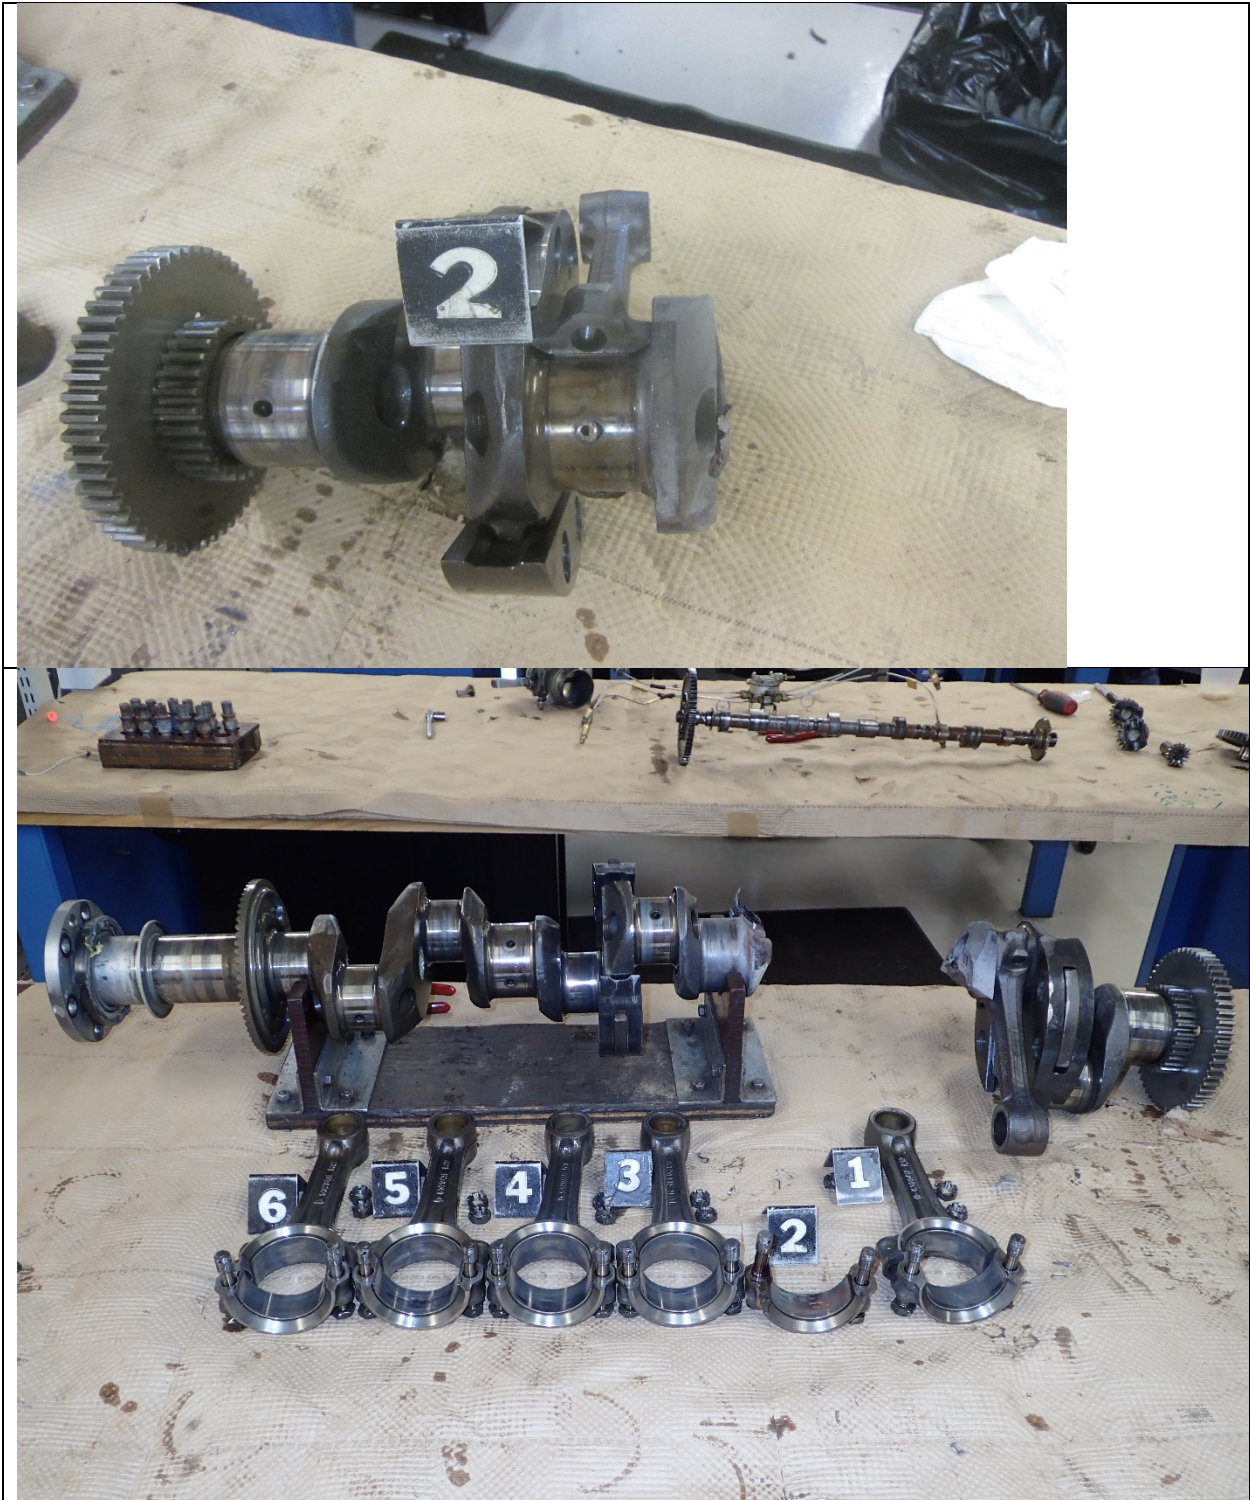
The number two connecting rod remained seized to the crankshaft.

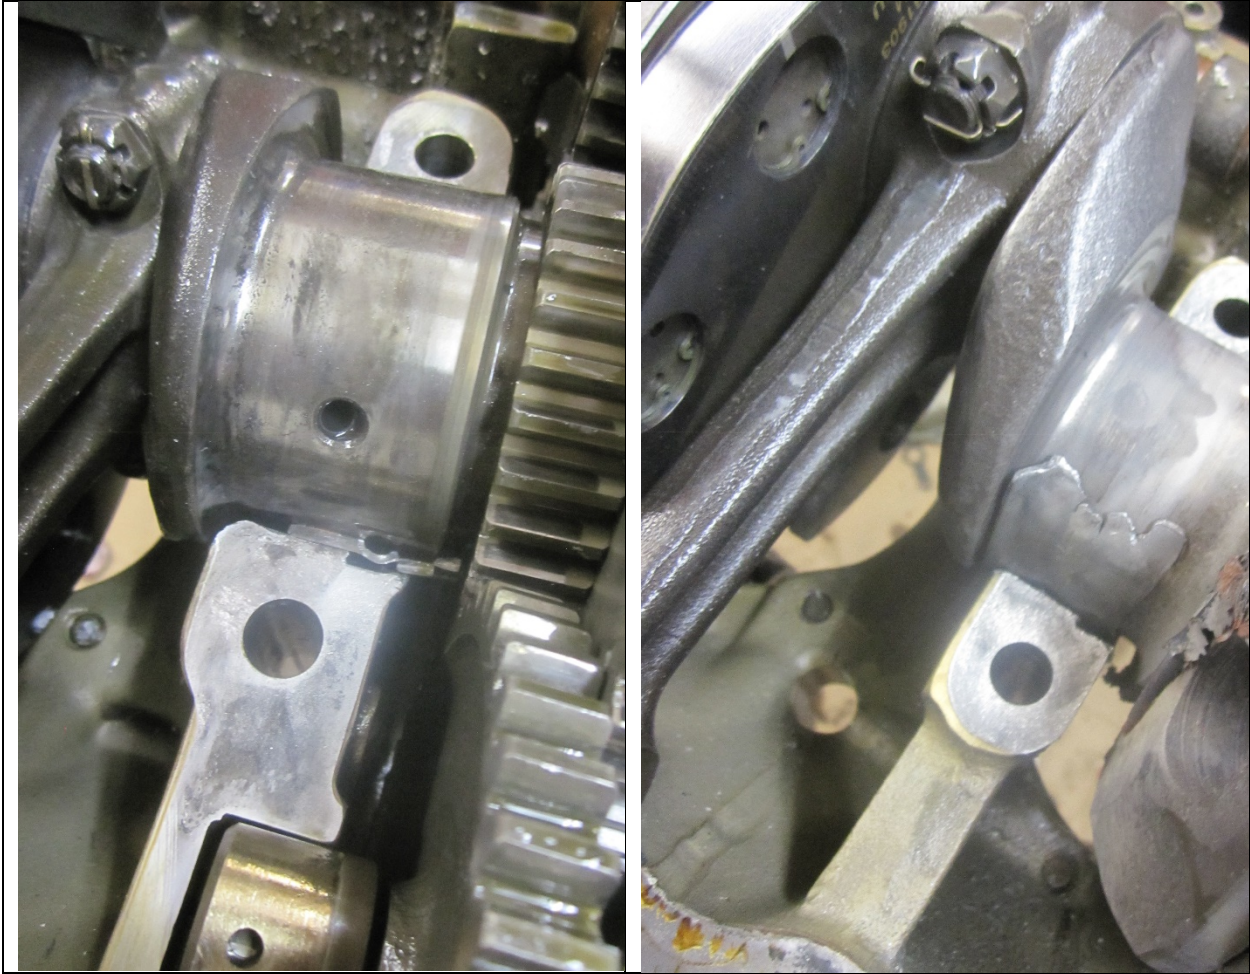
Main journal bearings, movement and damage

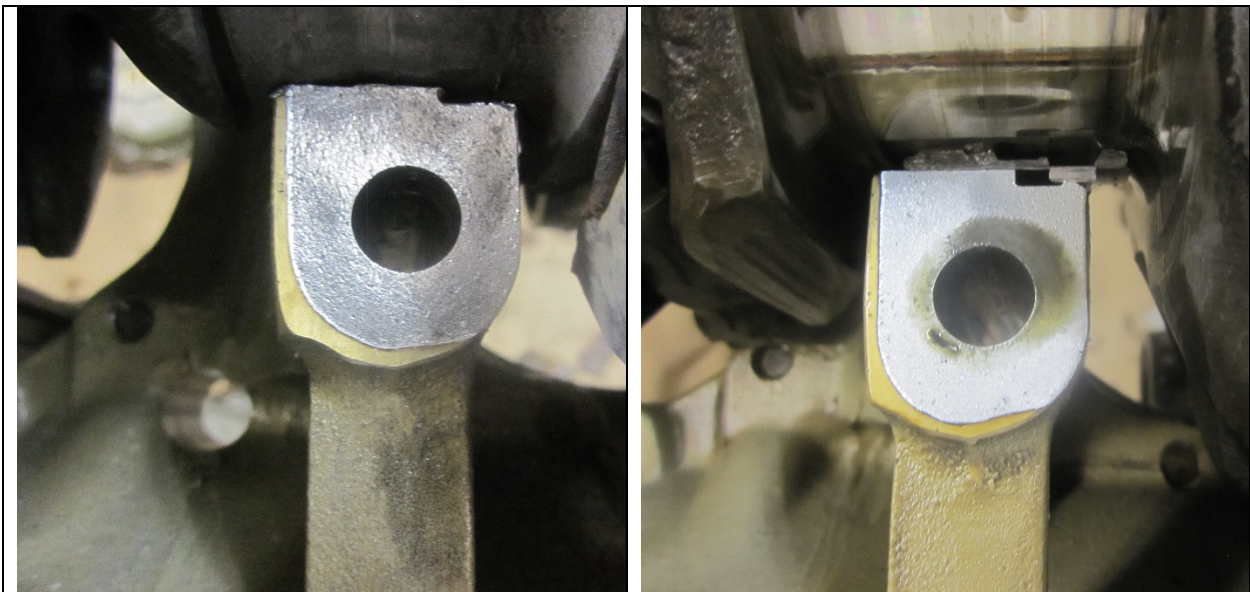
Evidence of case fretting
