**NTSB**

# ***SAFETY ALERT***

## **Take Time to Torque**

***Apply proper torque to prevent accidents***

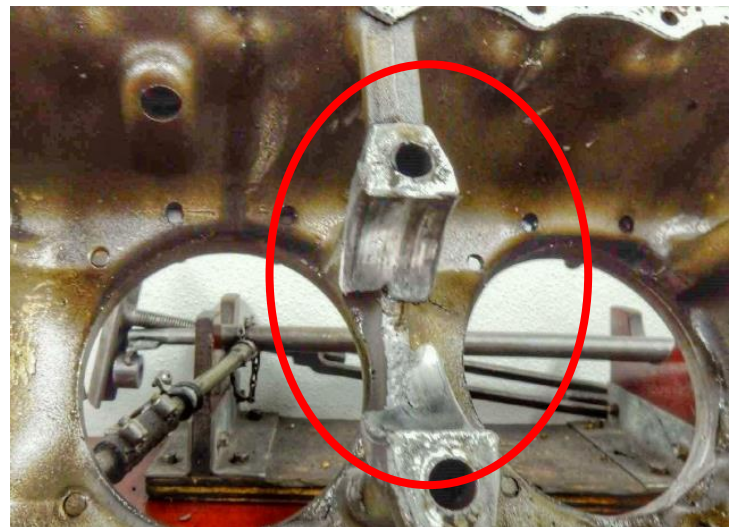
**Figure 2.** Internal damage to another engine resulting from the application of improper torque.

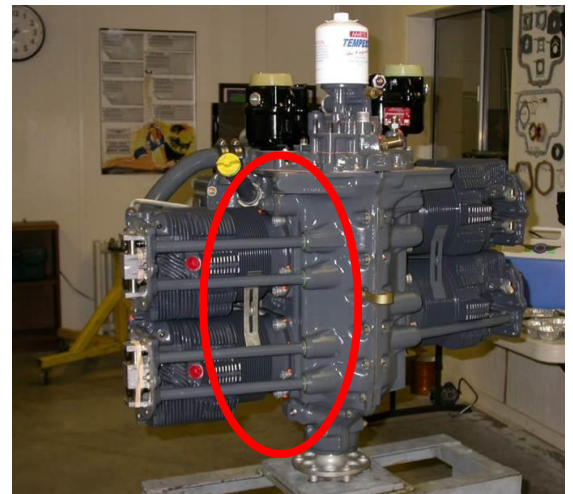
**Figure 4.** Engine on stand showing torque seal on fasteners.

- Also use torque seal to verify that the applied torque has not changed and to visually confirm which fasteners have been torqued (see figure 4).
- Beware of leaving hardware that has been only finger tightened. Once you start the process, make sure you complete it. Set a reminder if you need to step away before completing the torqueing process.
