# NATIONAL TRANSPORTATION SAFETY BOARD

## MATERIALS LABORATORY FACTUAL REPORT

Report No. 18-079

Place : Broomfield, Colorado  
Date : May 7, 2018  
Vehicle : Cessna 182E, N3292Y  
NTSB No. : CEN18LA162  
Investigator : Andrew Todd Fox, ASI-CEN

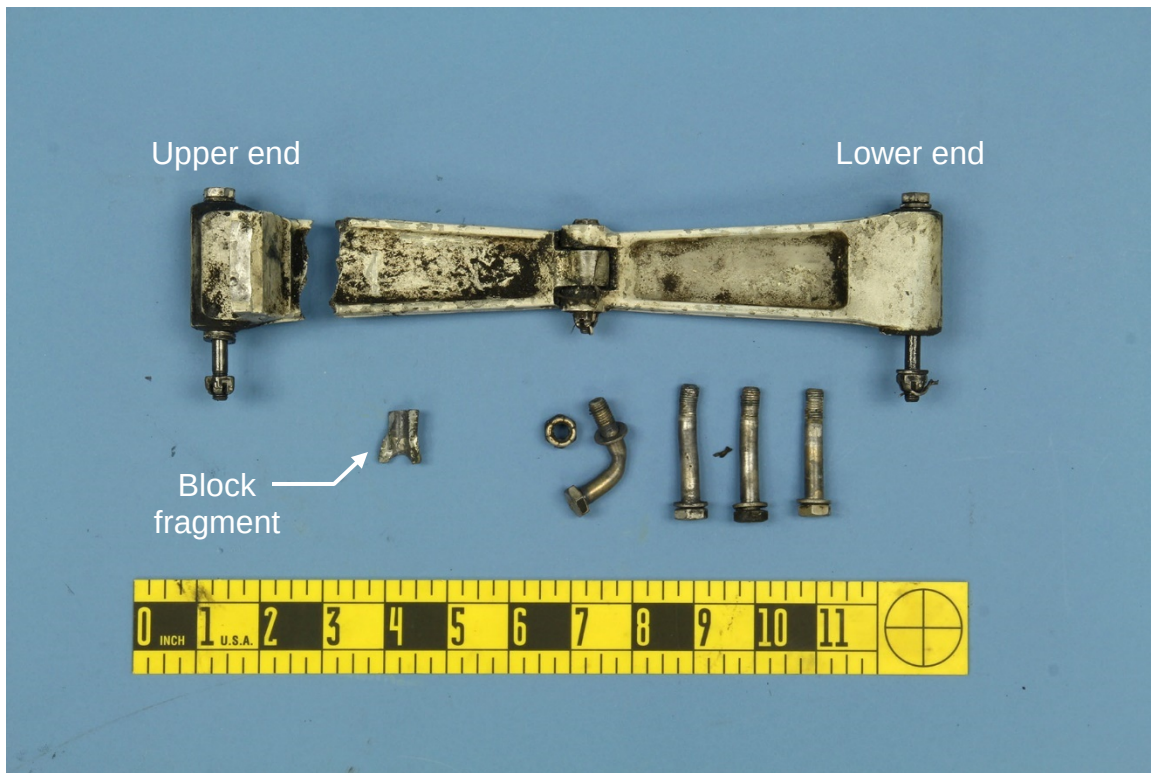
Pieces of a nose landing gear torque link assembly from a Cessna 182E, N3292Y, were submitted to the NTSB Materials Laboratory for examination. The torque link assembly, as it was received by the lab, is shown in figure 1 along with four attachment bolts and a fragment of the nose wheel yoke attachment block. The upper torque link arm was fractured near its upper end. One of the attachment bolts was bent and the block fragment exhibited features consistent with bending overstress.

**Figure 1:** Image of the fractured torque link assembly, nose wheel yoke attachment bolts, and attachment block fragment.

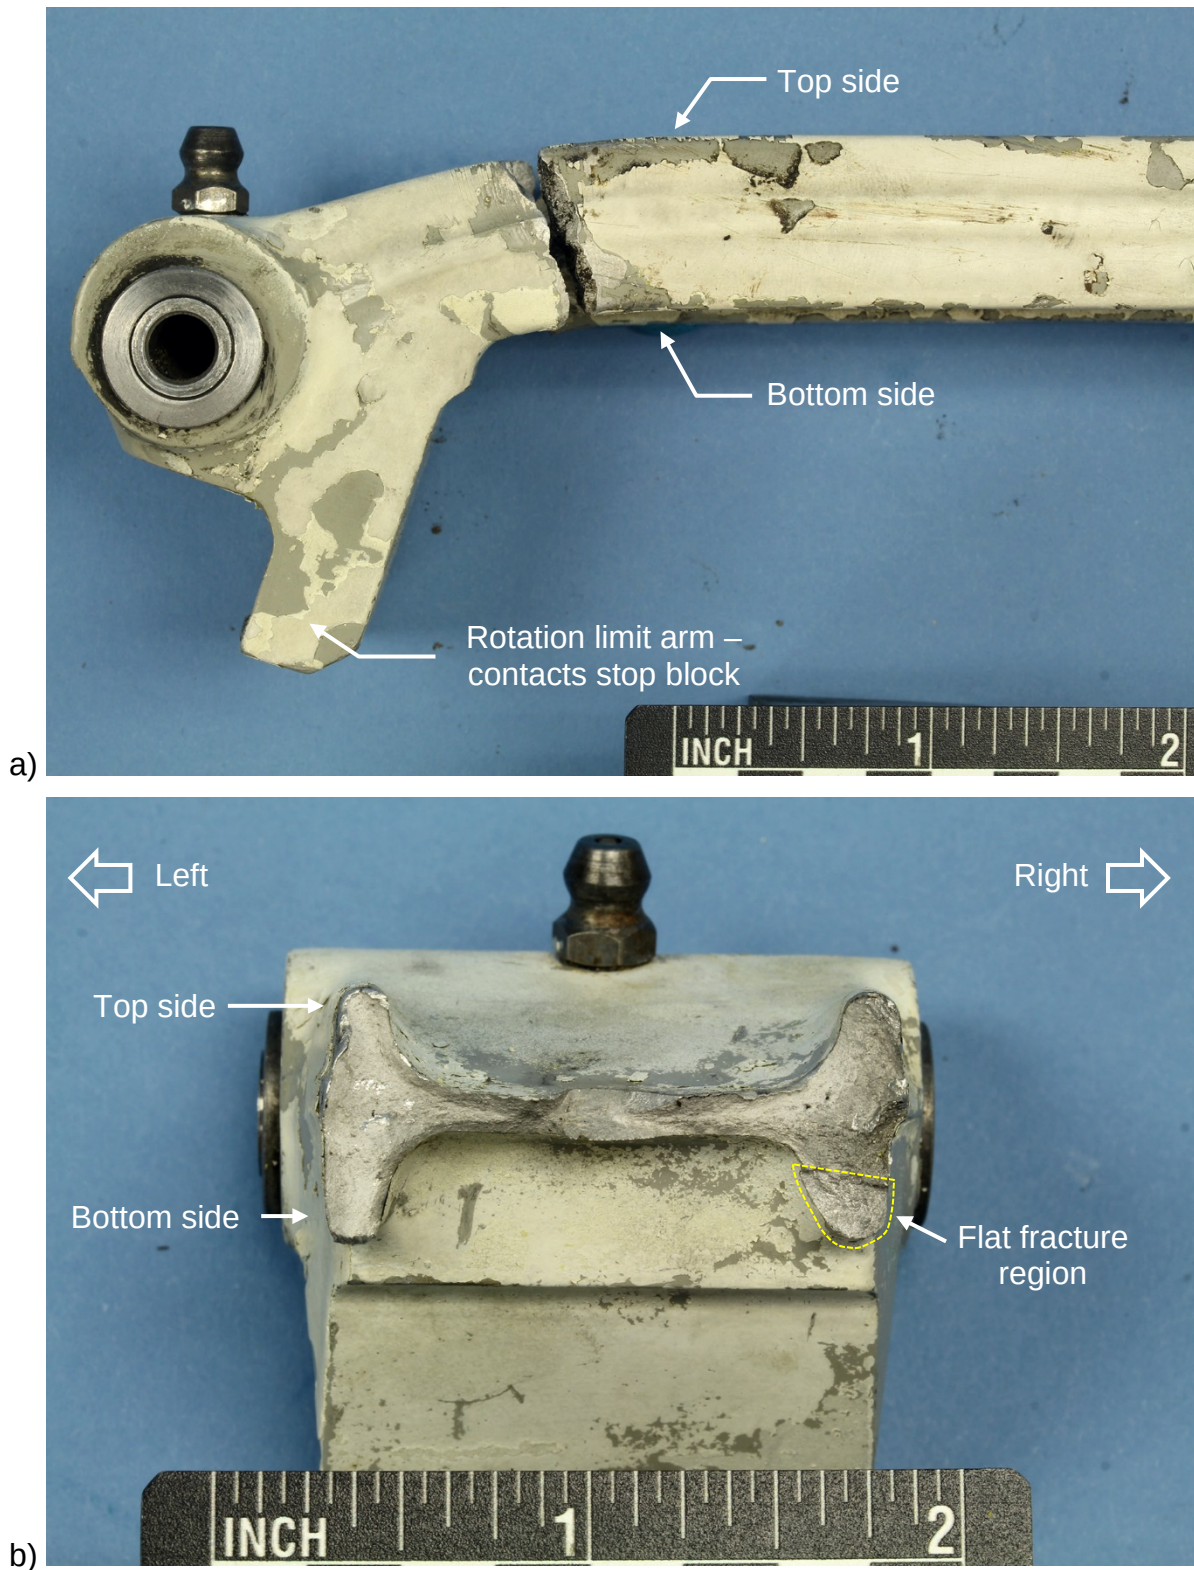
The fracture in the upper arm is shown, viewed from its left side, in figure 2a and the upper face of the fracture is shown in figure 2b. For convenience, the sides of the arm were labelled "top" and "bottom" as indicated in figure 2a, as if the link were installed and the gear retracted. As the gear is extended, the link rotates about a bushing at the upper end until an arm (rotation limit arm) near the pivot point hits a stop block. The link was fractured adjacent to the rotation limit arm and, when viewed from the side, exhibited a downward bend. The top side of the link exhibited cracks in the paint along the web and the left and right flanges as shown in figure 2c, consistent with tensile deformation. By contrast, the web and flanges on the bottom side of the link did not exhibit any paint cracks, as indicated in figure 2d.

**Figure 2:** a) Left side view of the torque link assembly showing a downward bend; b) image of the fracture surface;

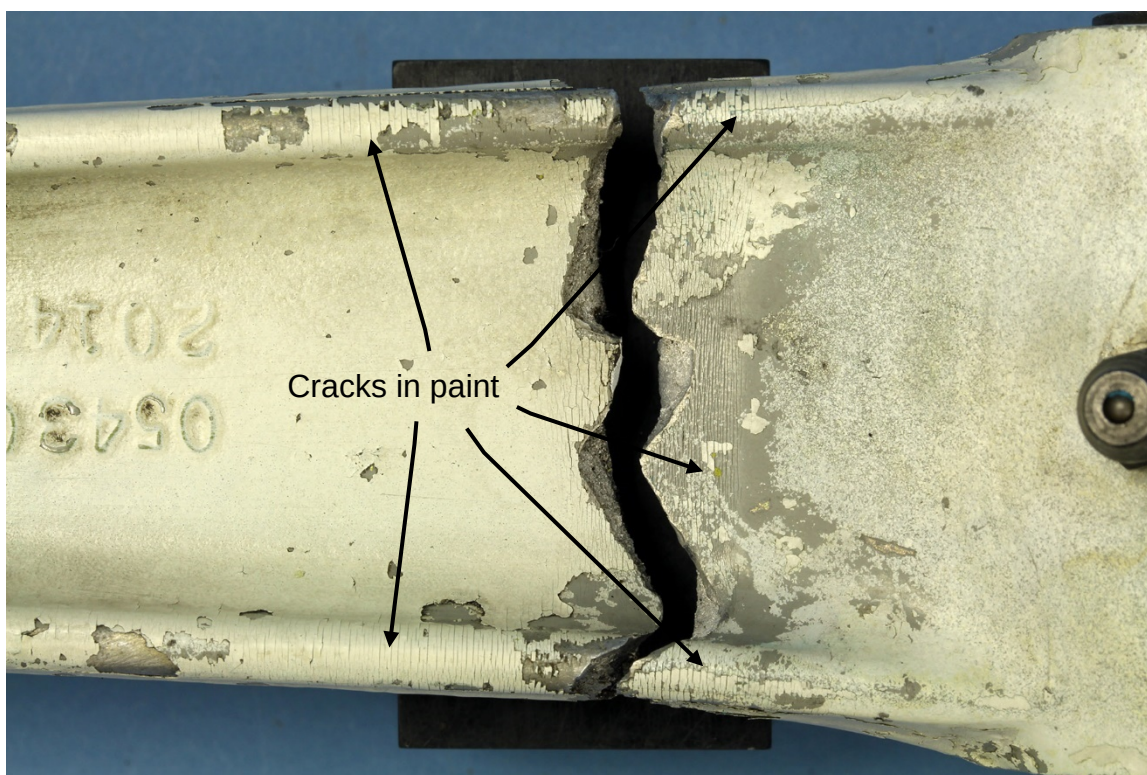
**Figure 2 (cont.):** c) image of the torque link assembly top side in the vicinity of the fracture showing cracks in the paint; and d) image of the bottom side in the vicinity of the fracture where no cracks were observed in the paint.

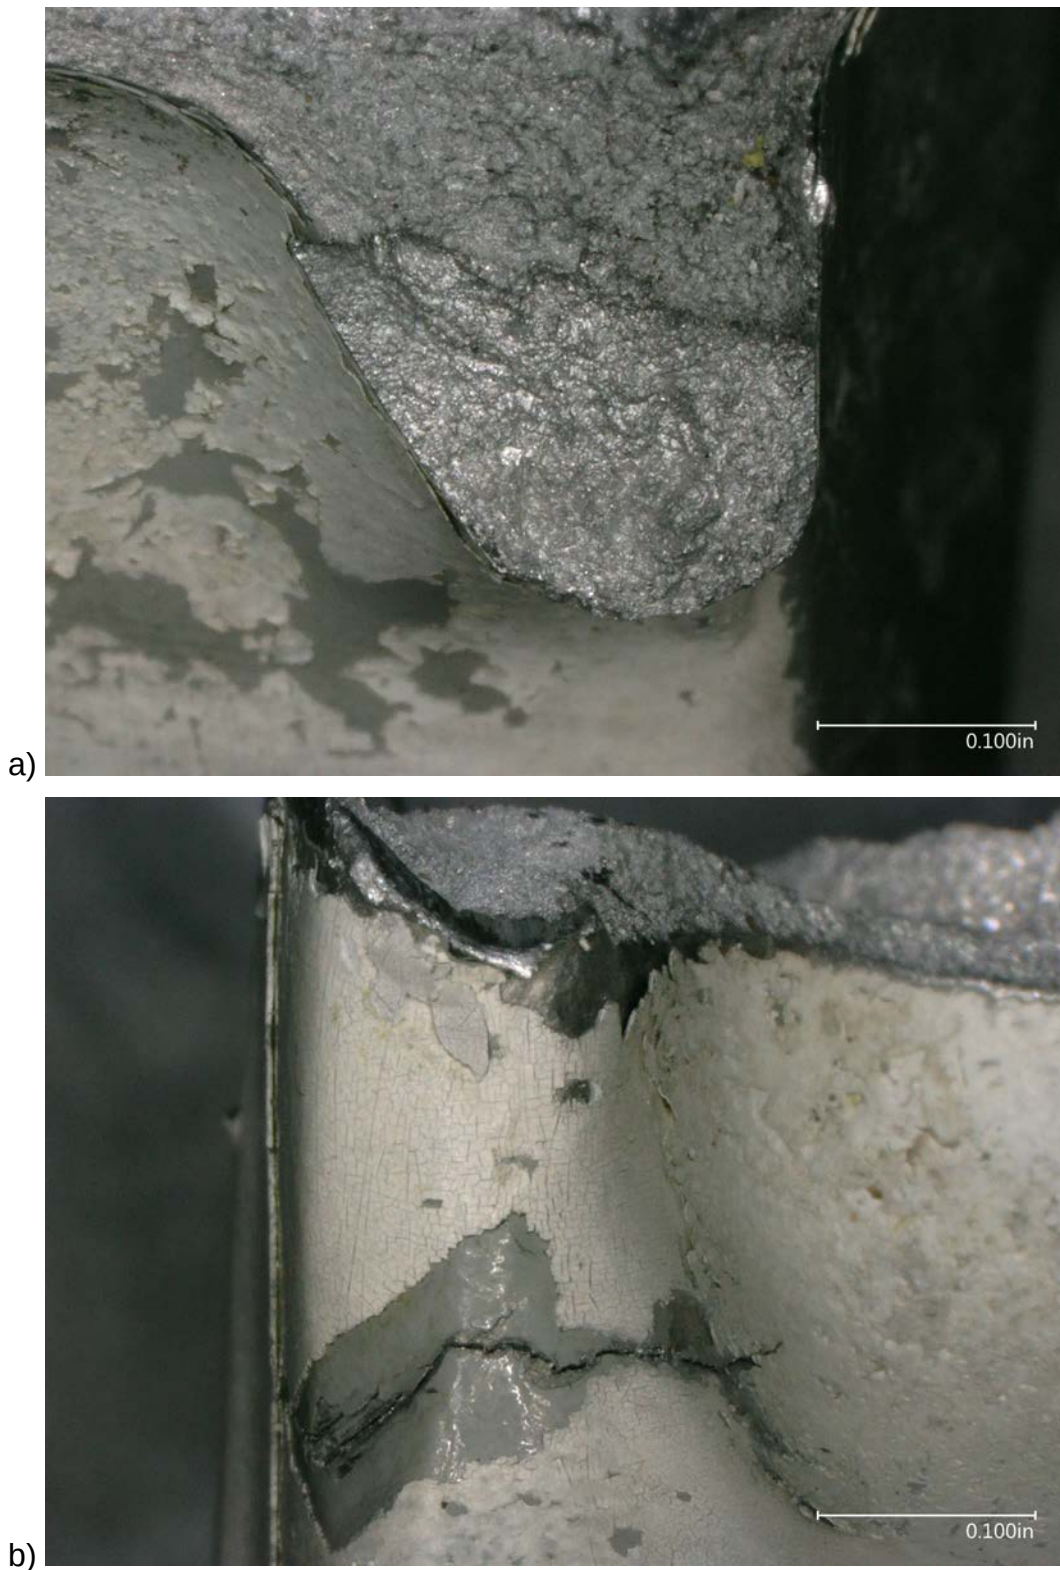
As otherwise noted, the fracture surface exhibited a rough appearance with 45° shear lips near the outer surfaces, consistent with tensile overload. However, there was a fracture region on the bottom side of the right flange that exhibited a comparatively flat appearance, indicated by the yellow dashed region in figure 2b. That region is shown in greater detail in figure 3a. Examination of the left flange revealed a crack in the bottom

side of the flange in approximately the same longitudinal position as the flat fracture region on the right side. The crack was closed (as opposed to open due to tensile deformation).

**Figure 3:** a) Image of the flat fracture region on the right side of the upper link fracture surface and b) side view image of a crack on the left side of the upper link in approximately the same longitudinal location as the fracture on the right side.

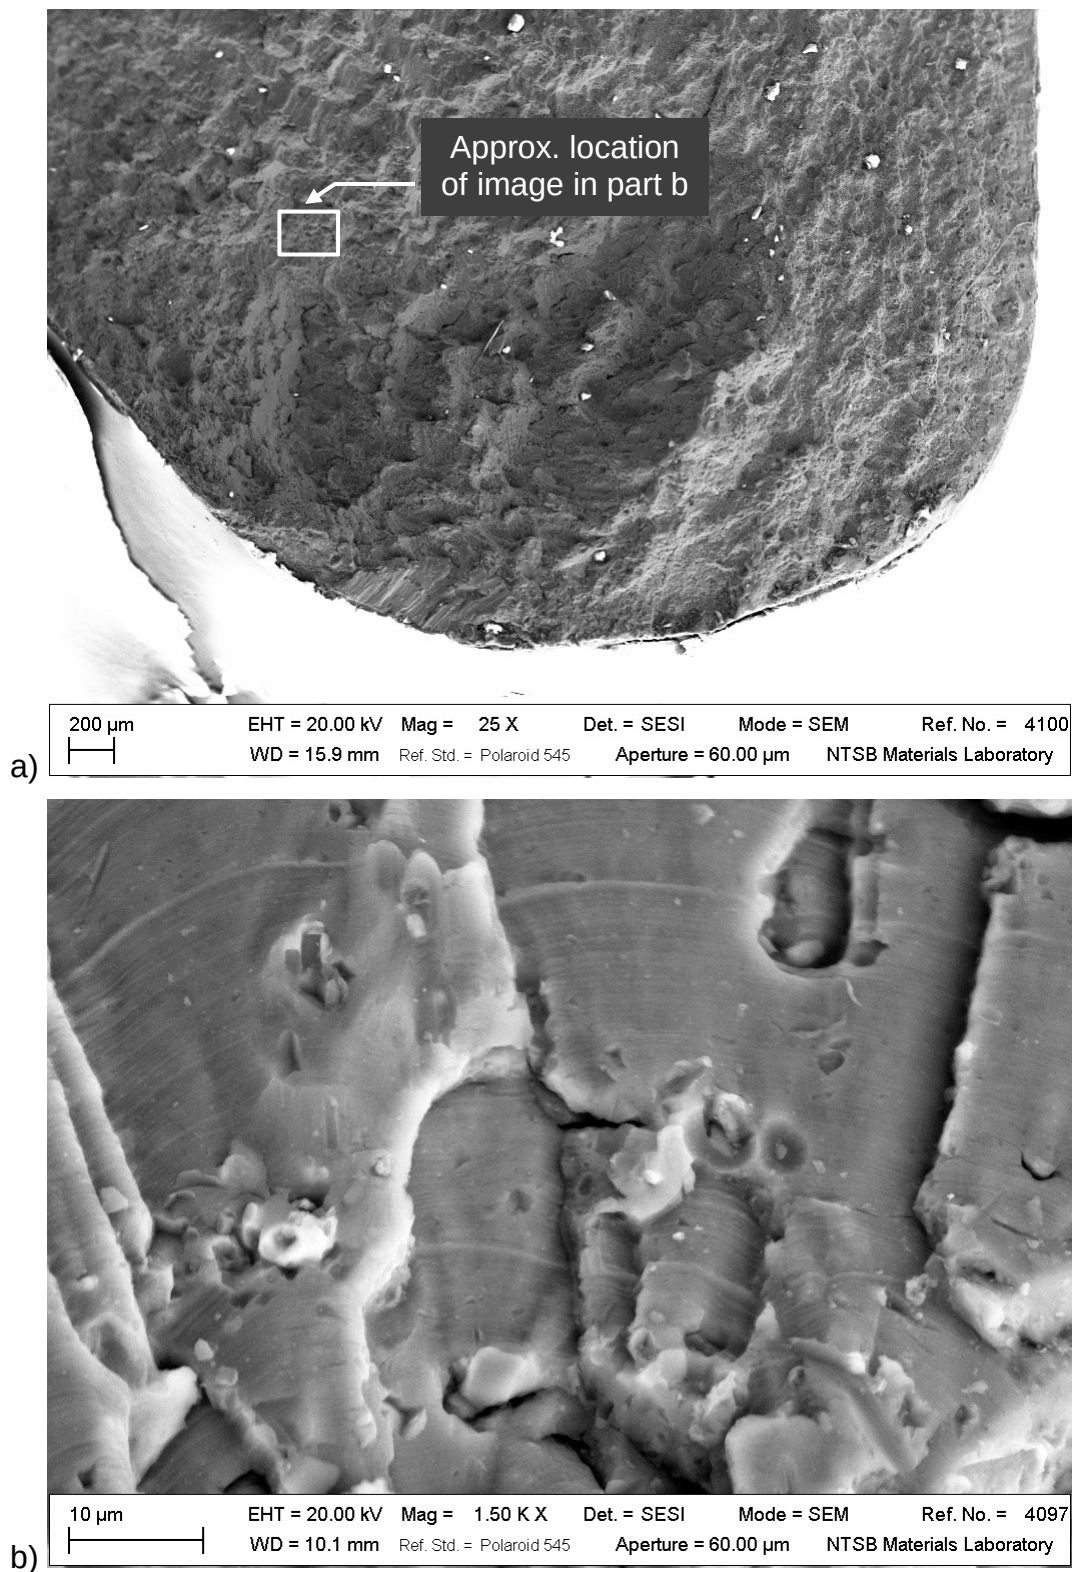
The piece of the link assembly with the upper fracture face was cleaned in accordance with standard laboratory protocols and the flat fracture region on the bottom part of the right flange was examined using a scanning electron microscope (SEM). A low magnification image of the flat fracture region is shown in figure 4a. Much of the fracture exhibited features consistent with impact or smearing damage but in some areas, striations consistent with fatigue were observed such as at the location indicated in figure 4a, which is shown in figure 4b. Another area close to the overstress region is shown in figure 4c which also exhibited discernable fatigue striations.

Taken as a whole, the observations were consistent with a downward bending overstress fracture in the upper torque link with preexisting fatigue cracks present on the compressive side of the bending load.

**Figure 4:** a) Low magnification scanning electron microscope image of the flat fracture region on the right side of the fracture and b) higher magnification image approximately at the location indicated in part a showing fatigue striations.

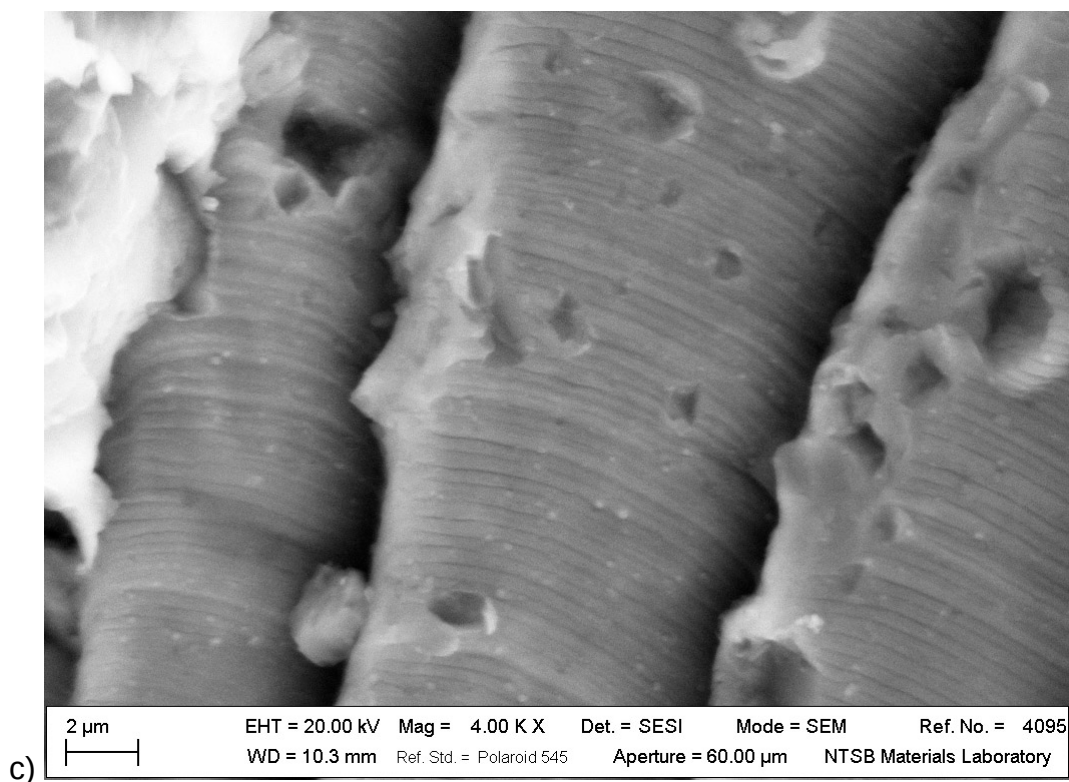
**Figure 4 (cont.):** c) another region close to the overstress region that also exhibited fatigue striations.
