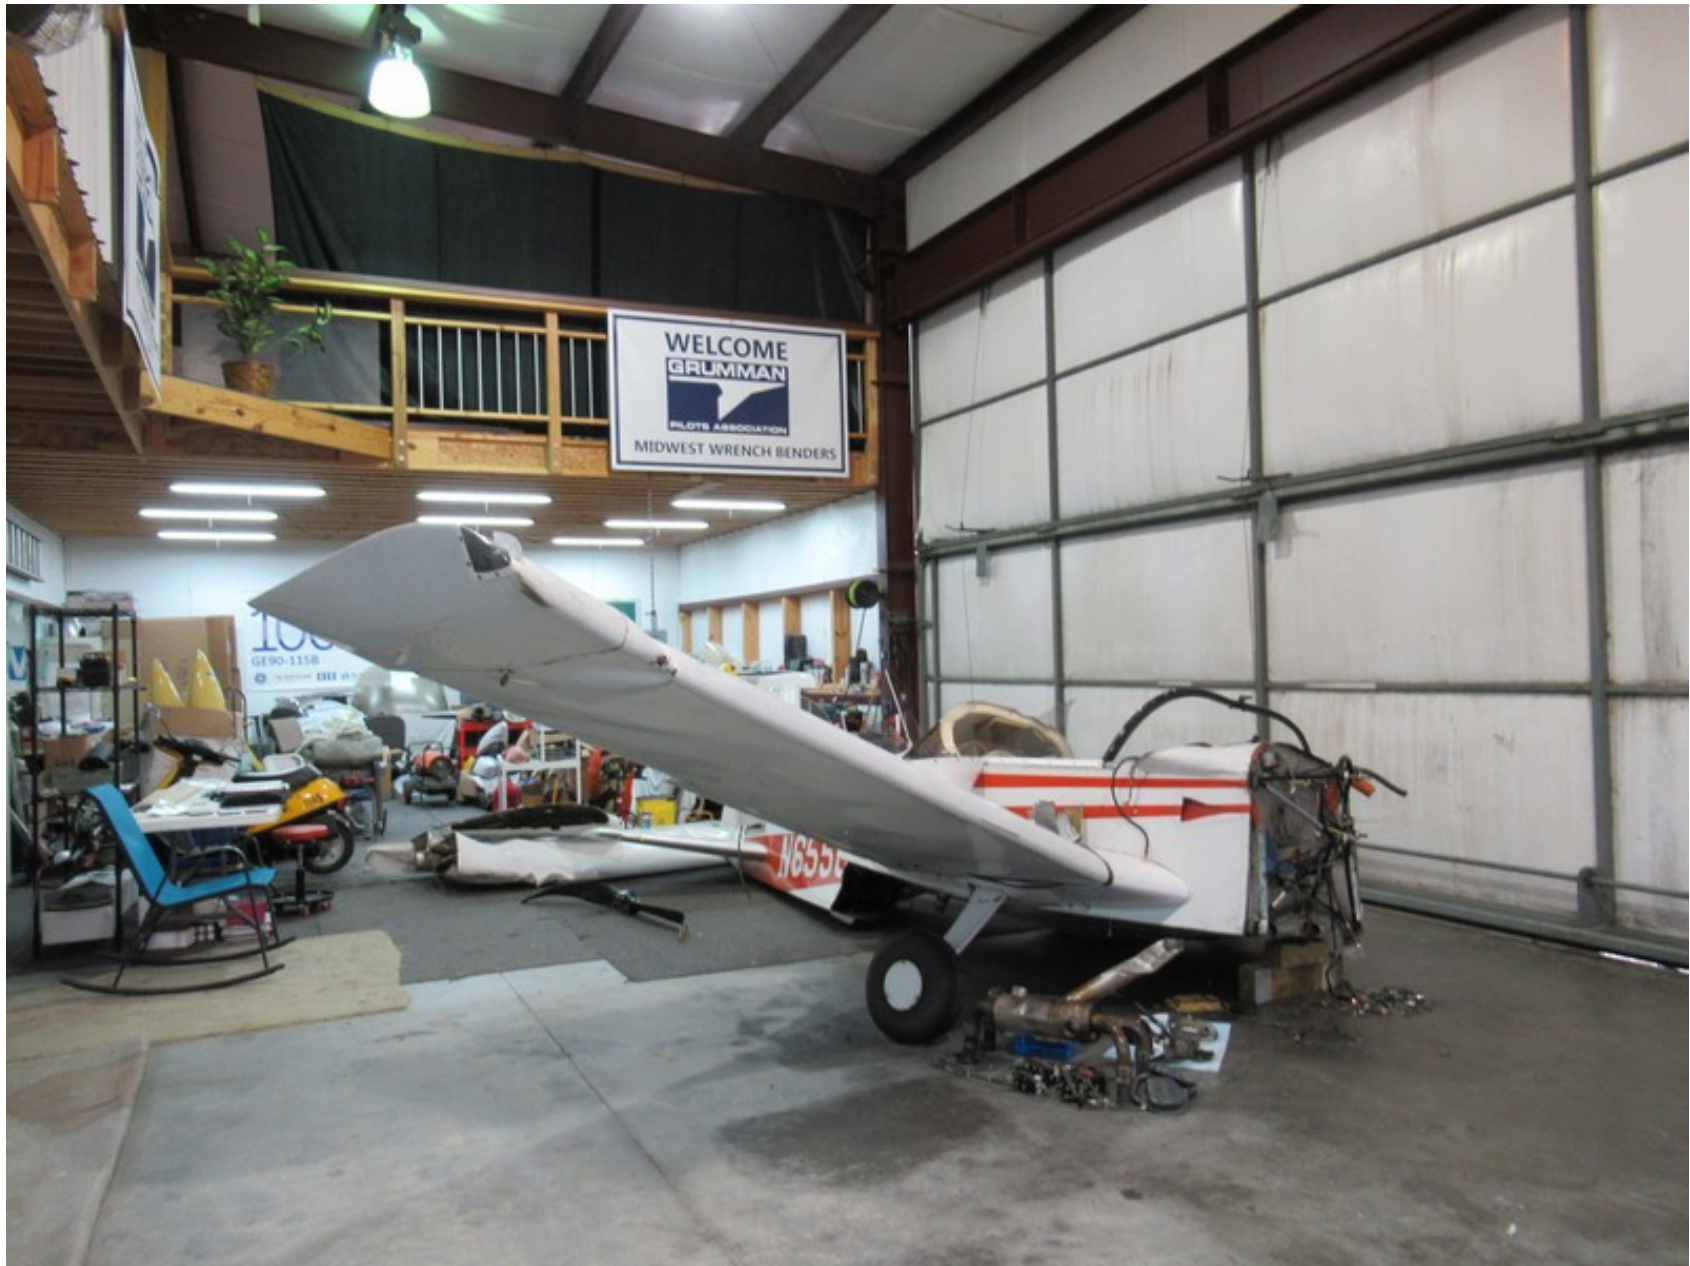
**Photo 1 – Front quartering view of the right wing and fuselage.**

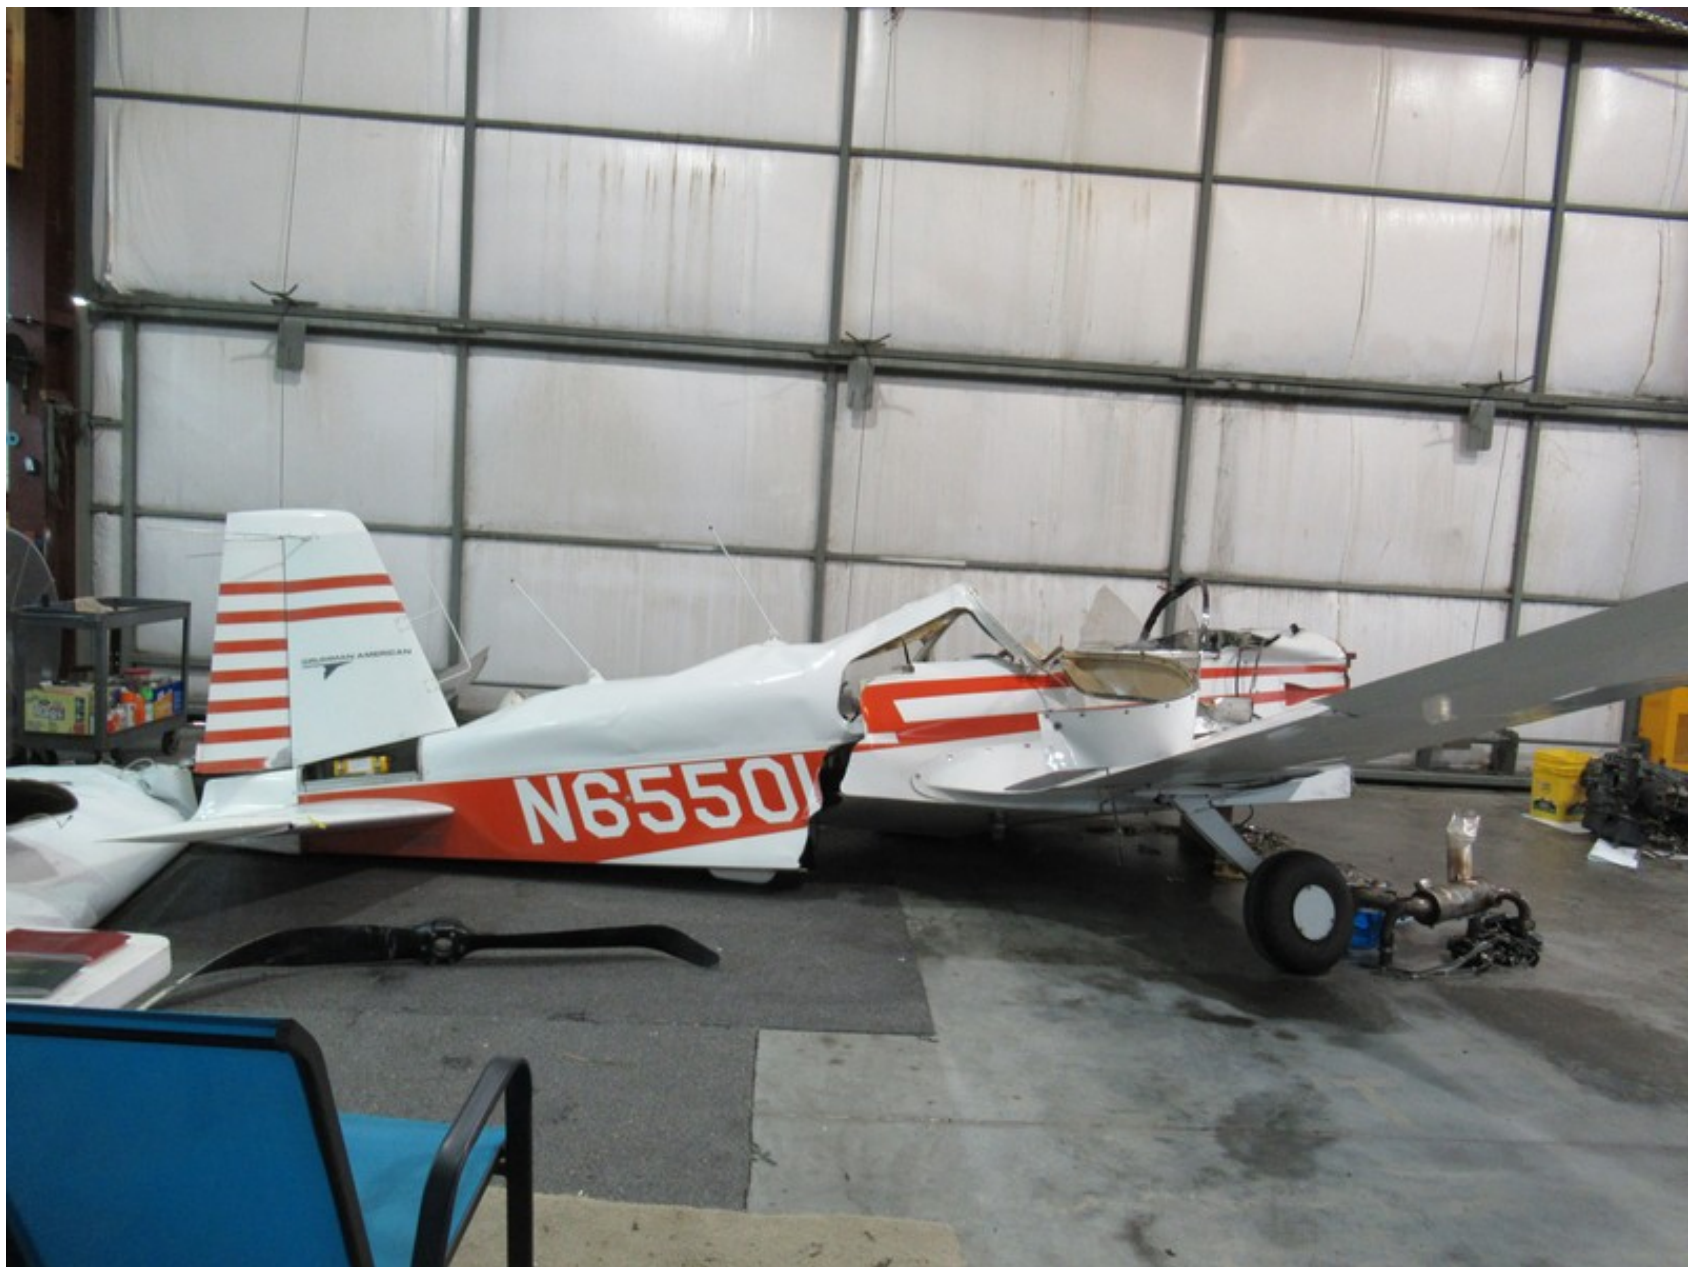
**Photo 2 - Rear quartering view of the right wing, empennage, and fuselage.**

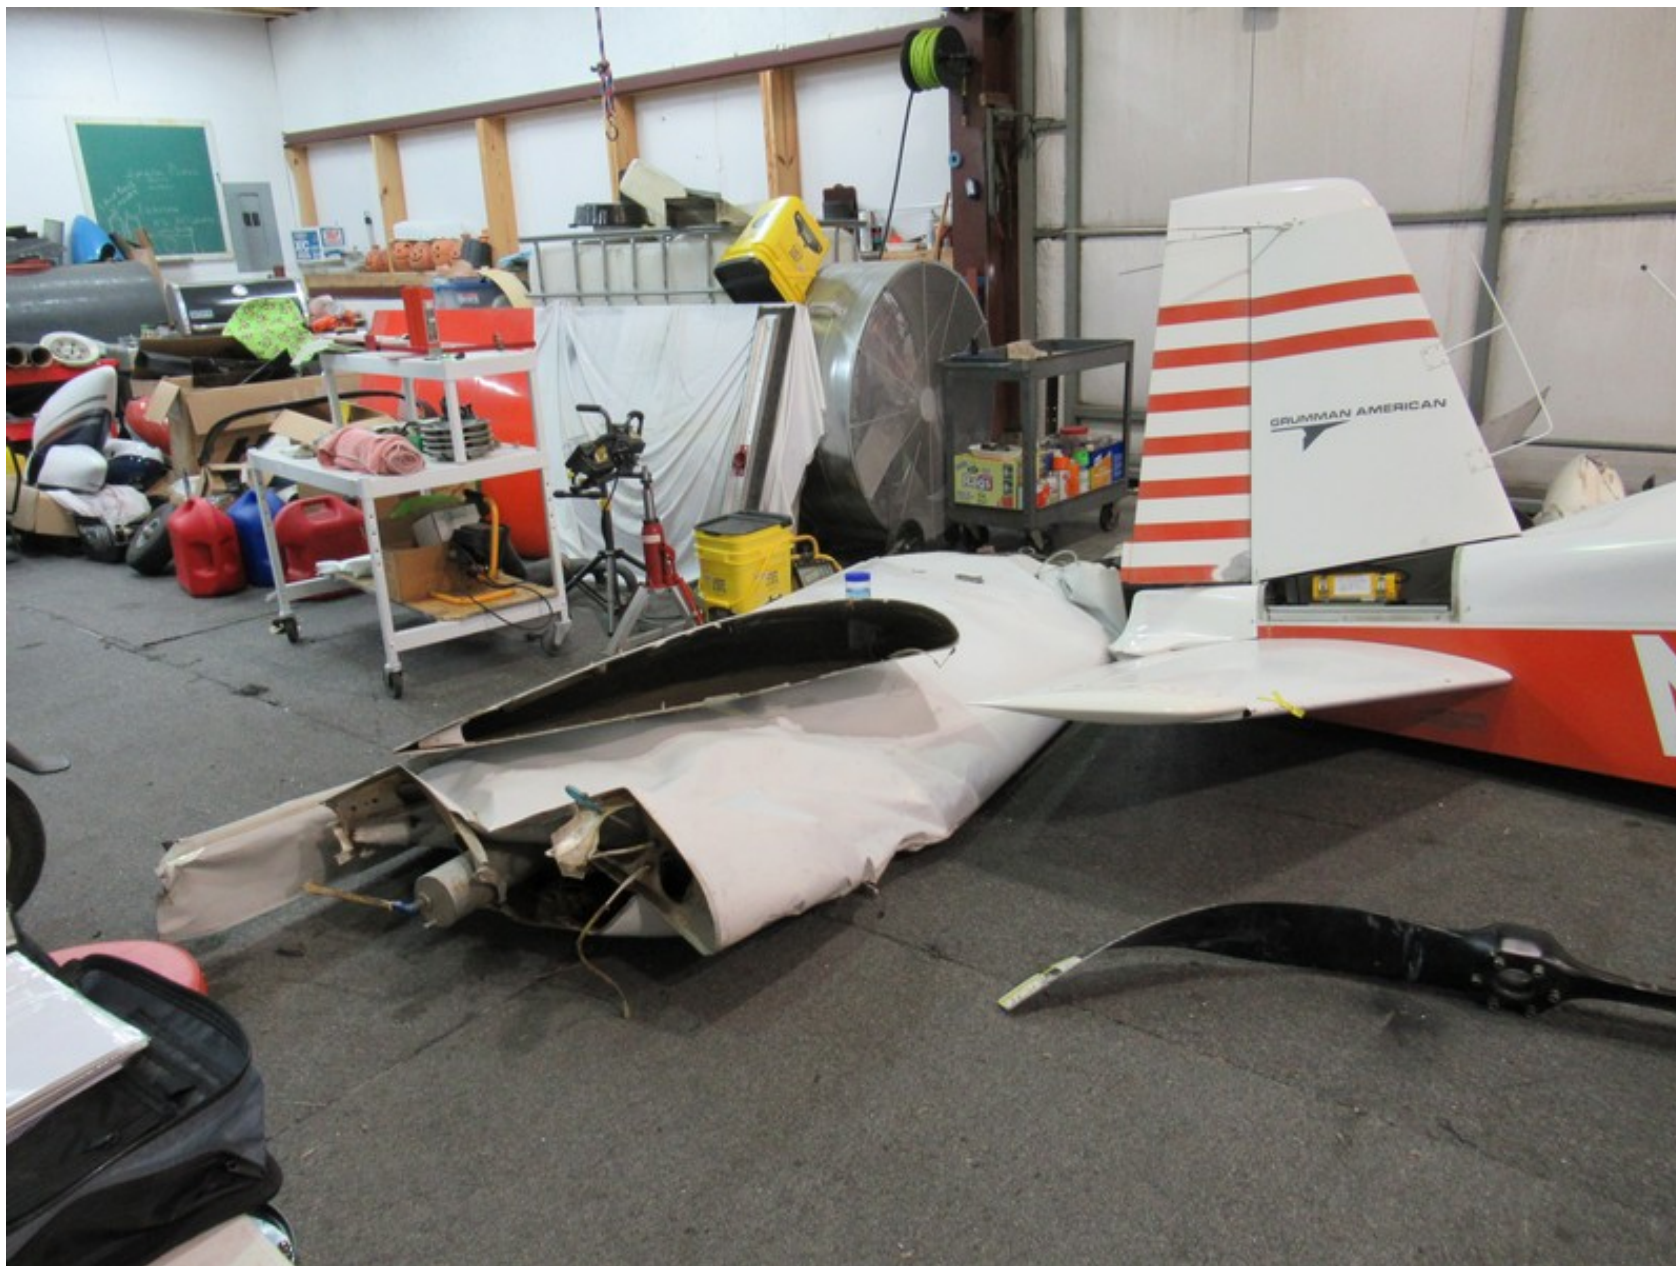
**Photo 3 - View of the separated left wing and empennage.**

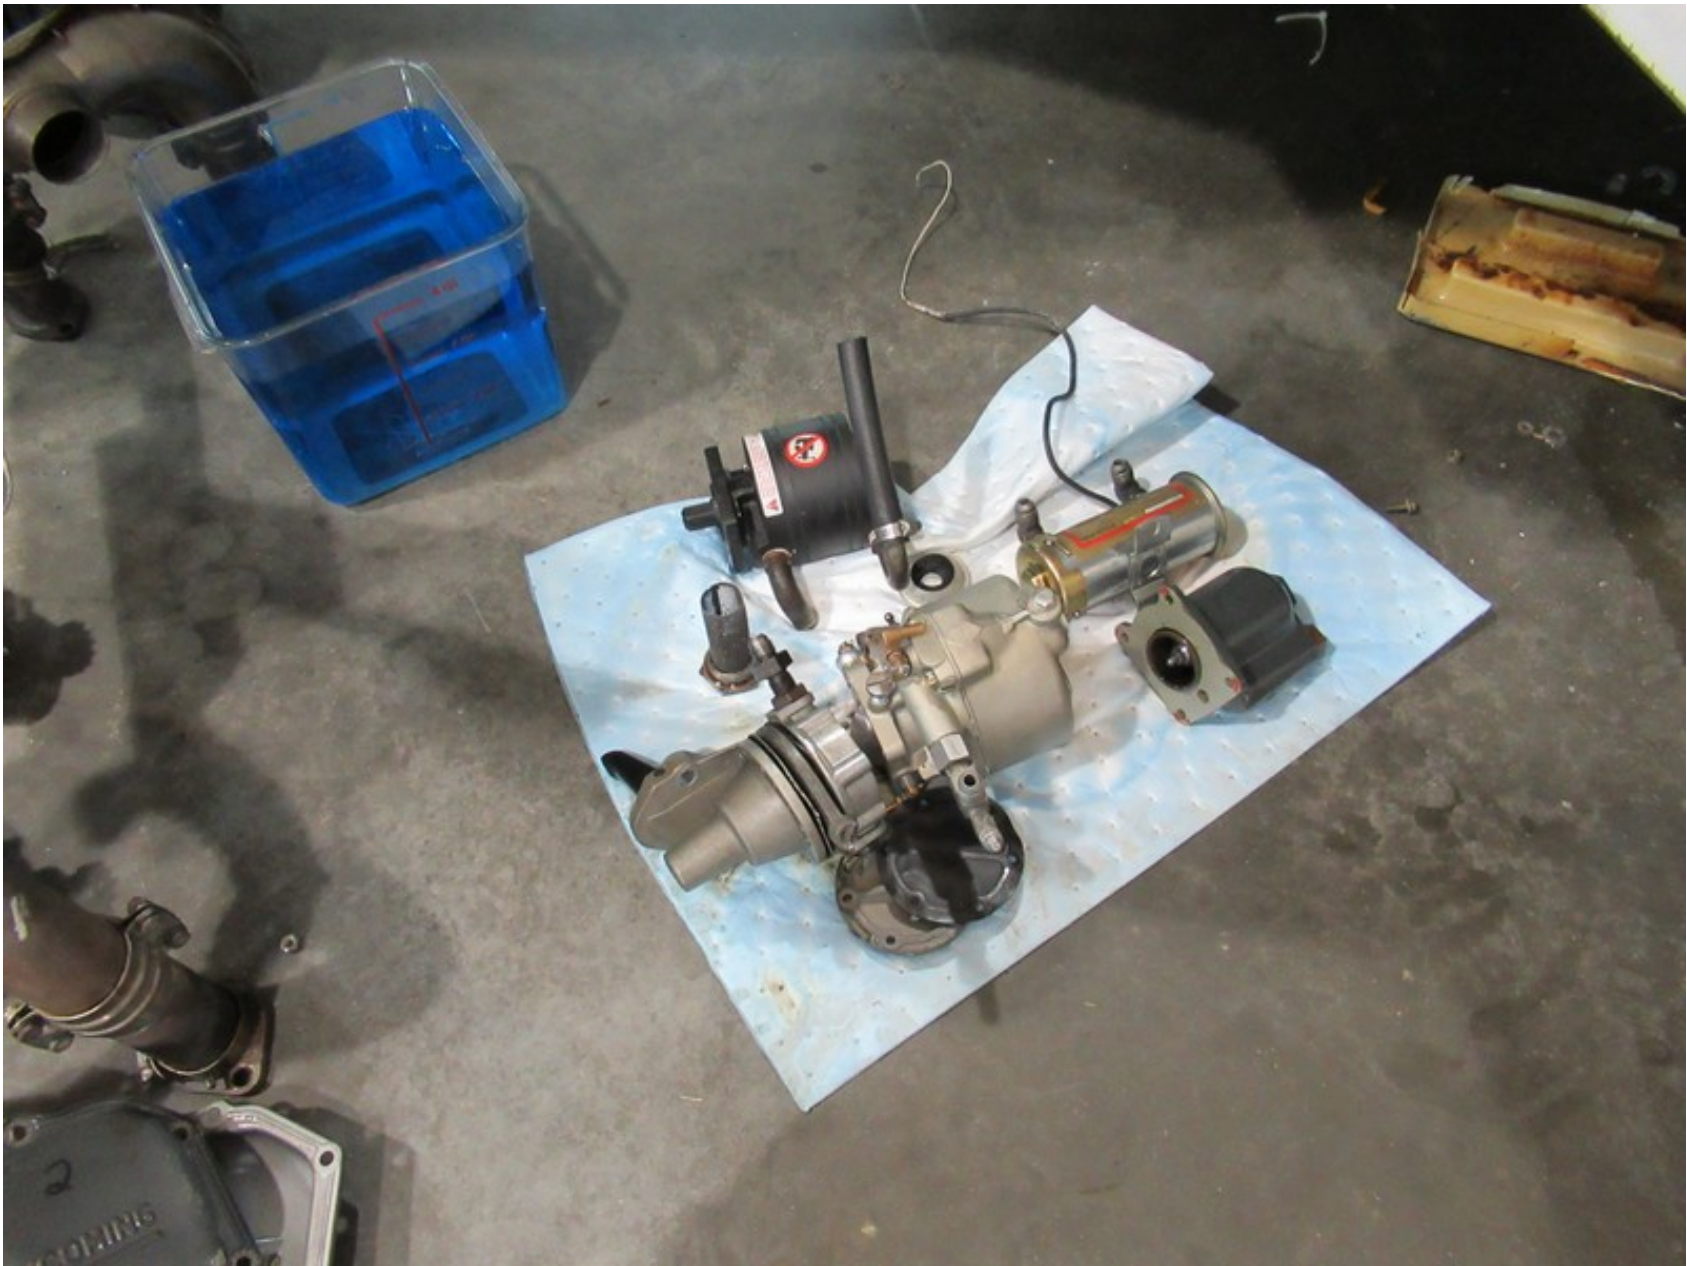
**Photo 4 – Close-up view of removed engine accessories and recovered fuel.**

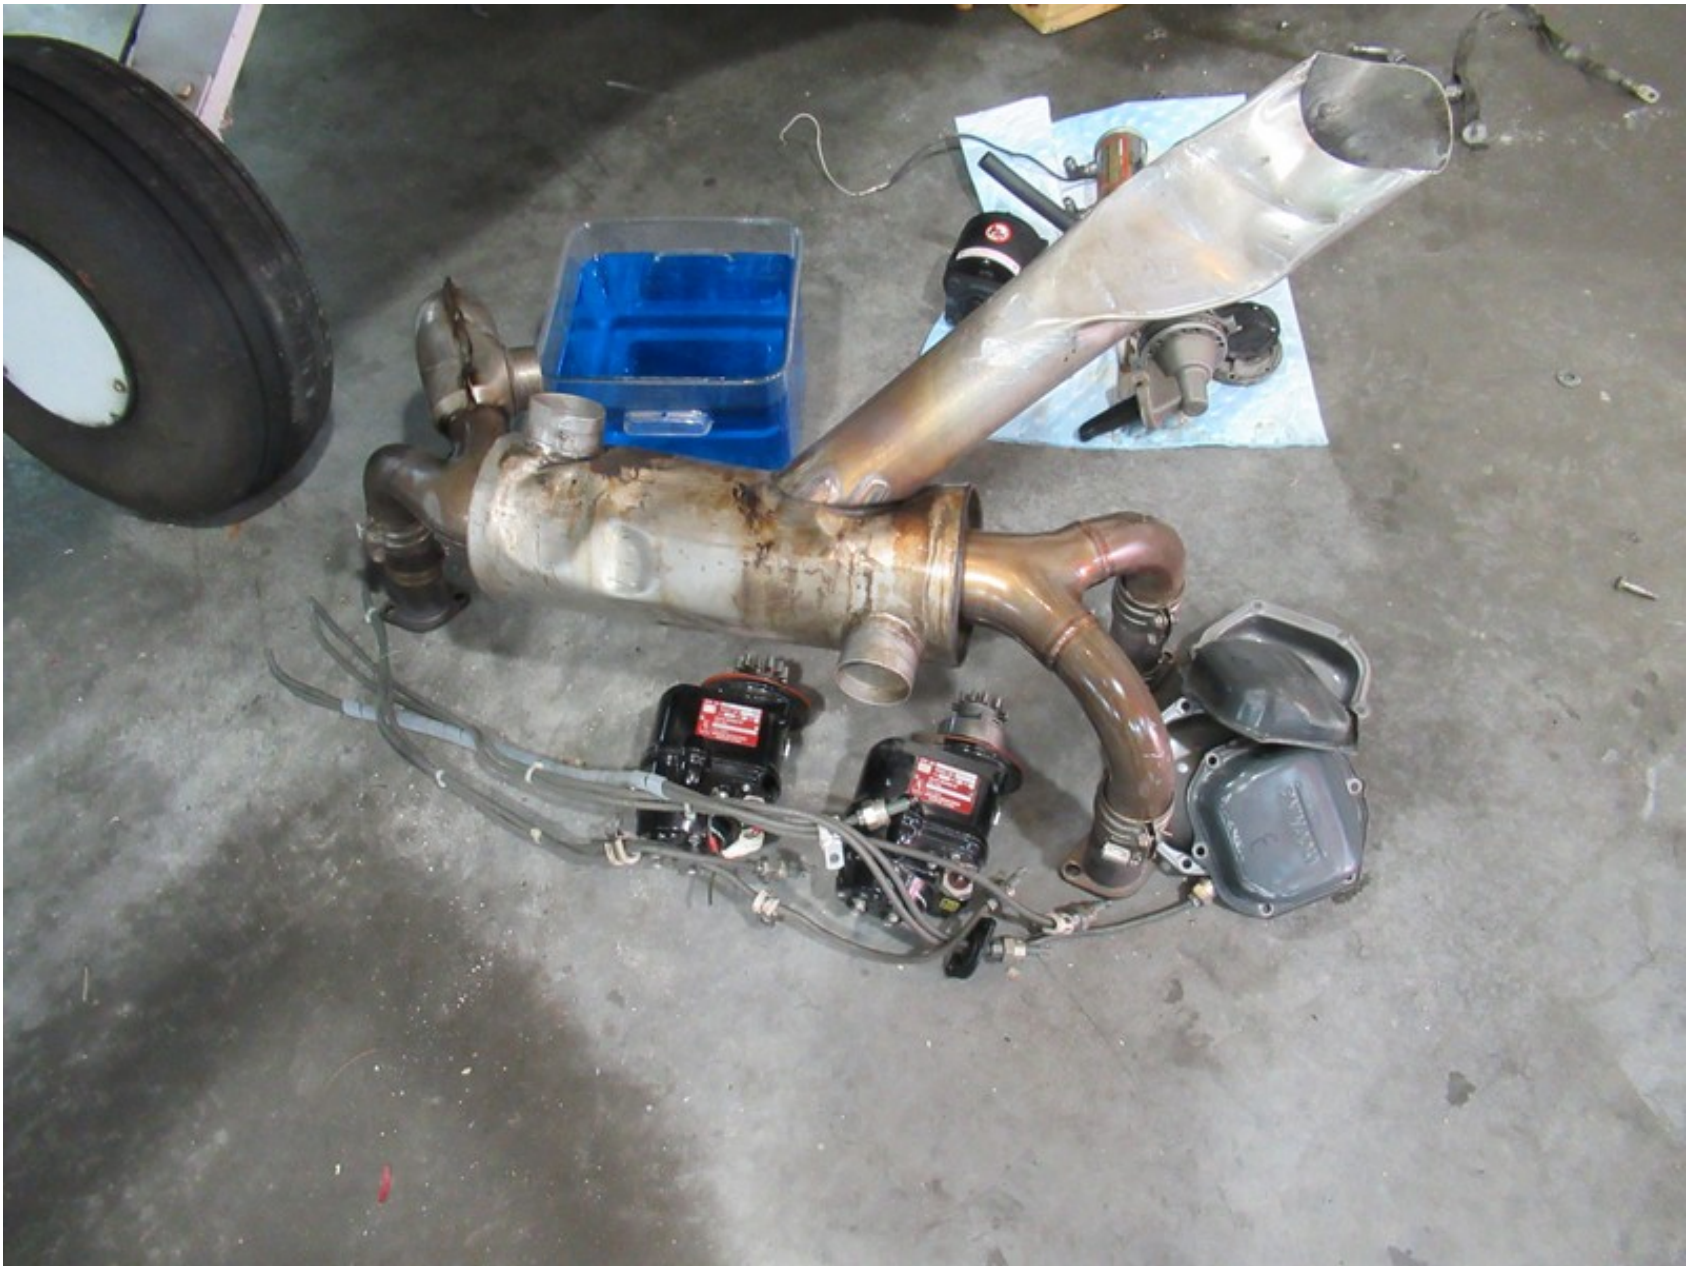
**Photo 5 - View of removed engine accessories and recovered fuel.**

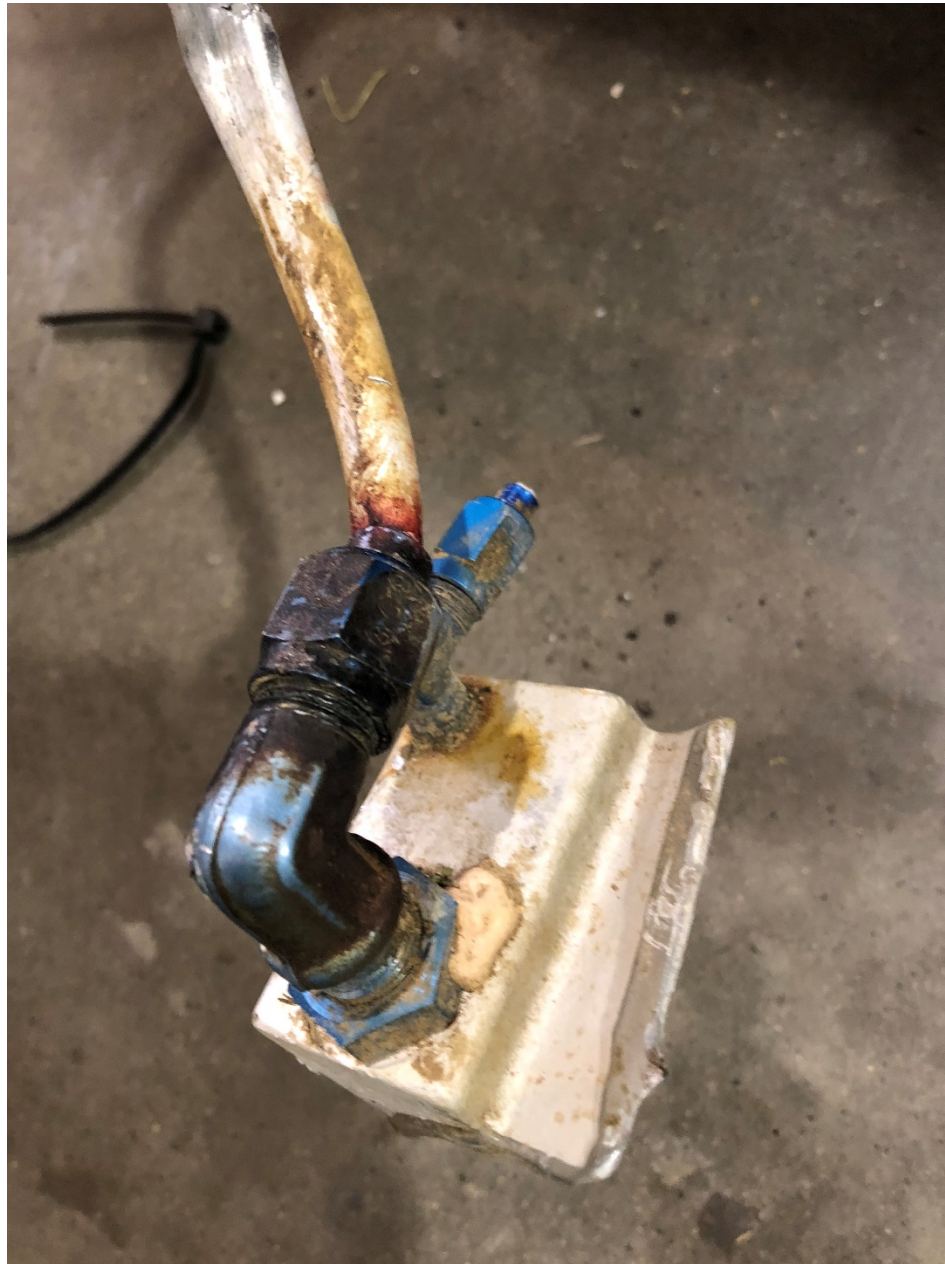
**Photo 6 - View of fittings from the left fuel tank that exhibits staining.**
