# NATIONAL TRANSPORTATION SAFETY BOARD

MATERIALS LABORATORY FACTUAL REPORT

Report No. 18-104

Place : Fort Wayne, IN  
Date : May 15, 2018  
Vehicle : Cessna 177F, N9058F  
NTSB No. : CEN18LA174  
Investigator : Pam Sullivan

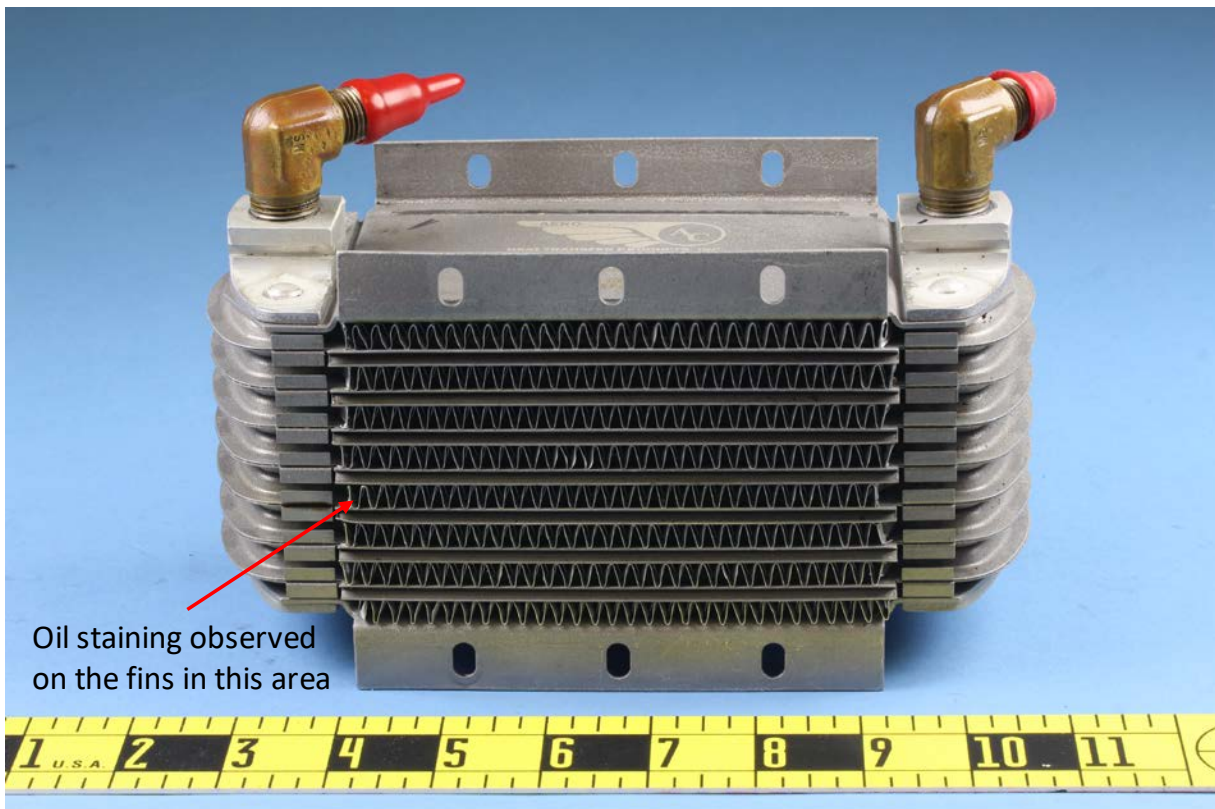
The oil cooler appeared to be in relatively new condition. There was no damage visible to the cooling fins and no debris fouling the air passages. Some oil staining was observed in the area of the third oil circuit up from the bottom on the left side (figure 1). This staining was evident on both the forward and aft sides at this location. Shop air was used to pressurize the oil cooler and observe the leak (figures 2, 3). Under pressure, oil leaked from between the plates forming the third oil circuit from the bottom (figure 4). The locations of the leaks did not exhibit any evidence of mechanical damage by an external source. The locations of the leaks did not exhibit any evidence of bulging or other distortions. The likely cause of the leak is due to a defect in the brazed joint between the plates forming the oil circuit.

Figure 1: Oil cooler as received.

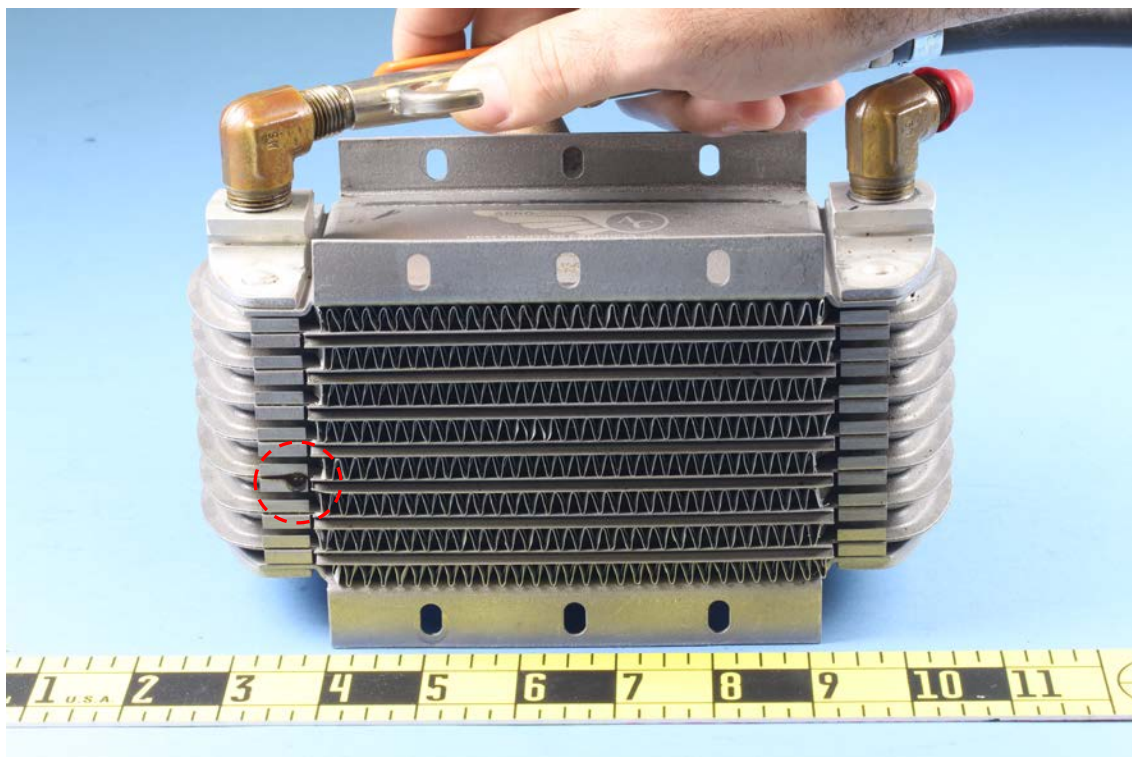
Figure 2: Forward side of oil cooler exhibiting leak while under pressure. The oil leak location is circled in red.

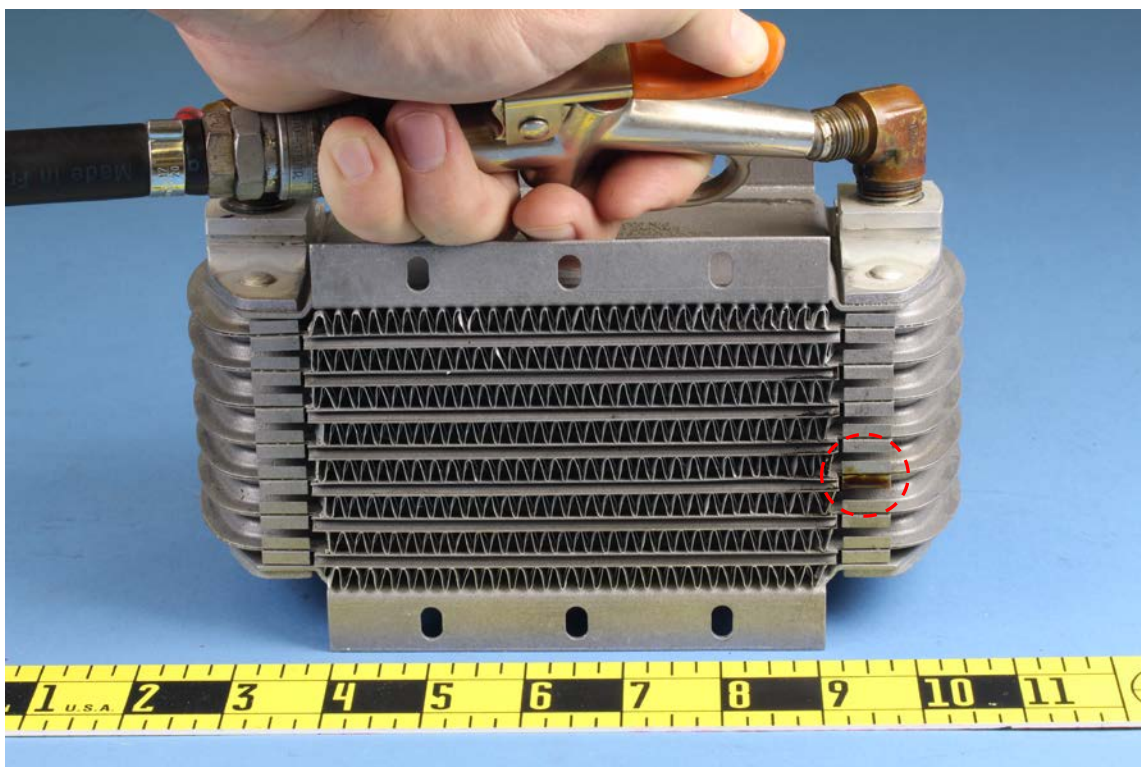
Figure 3: Aft side of oil cooler exhibiting leak while under pressure. The oil leak location is circled in red.

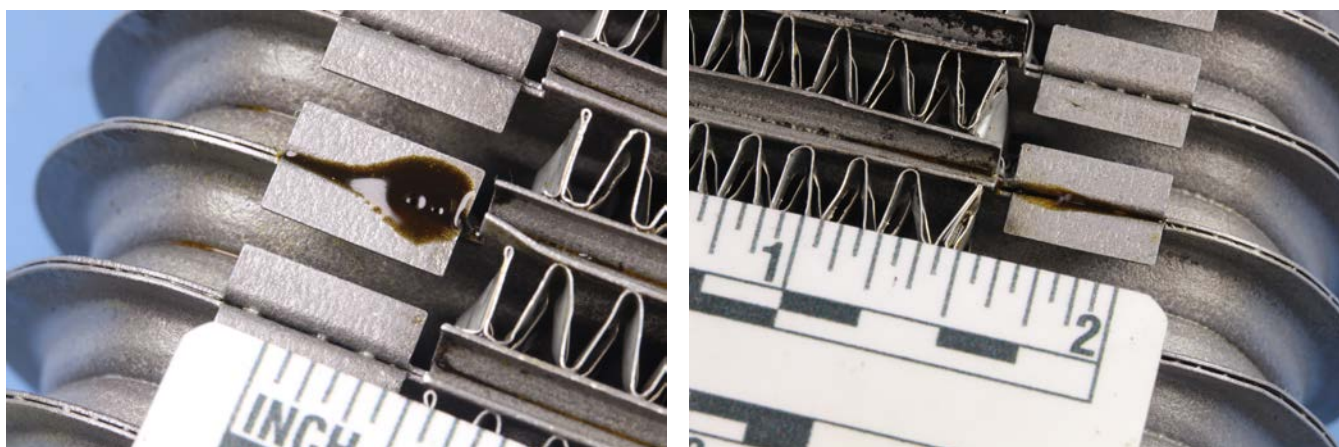
Figure 4: Close up of the leaks between the plates forming the third oil circuit from the bottom of the oil cooler.
