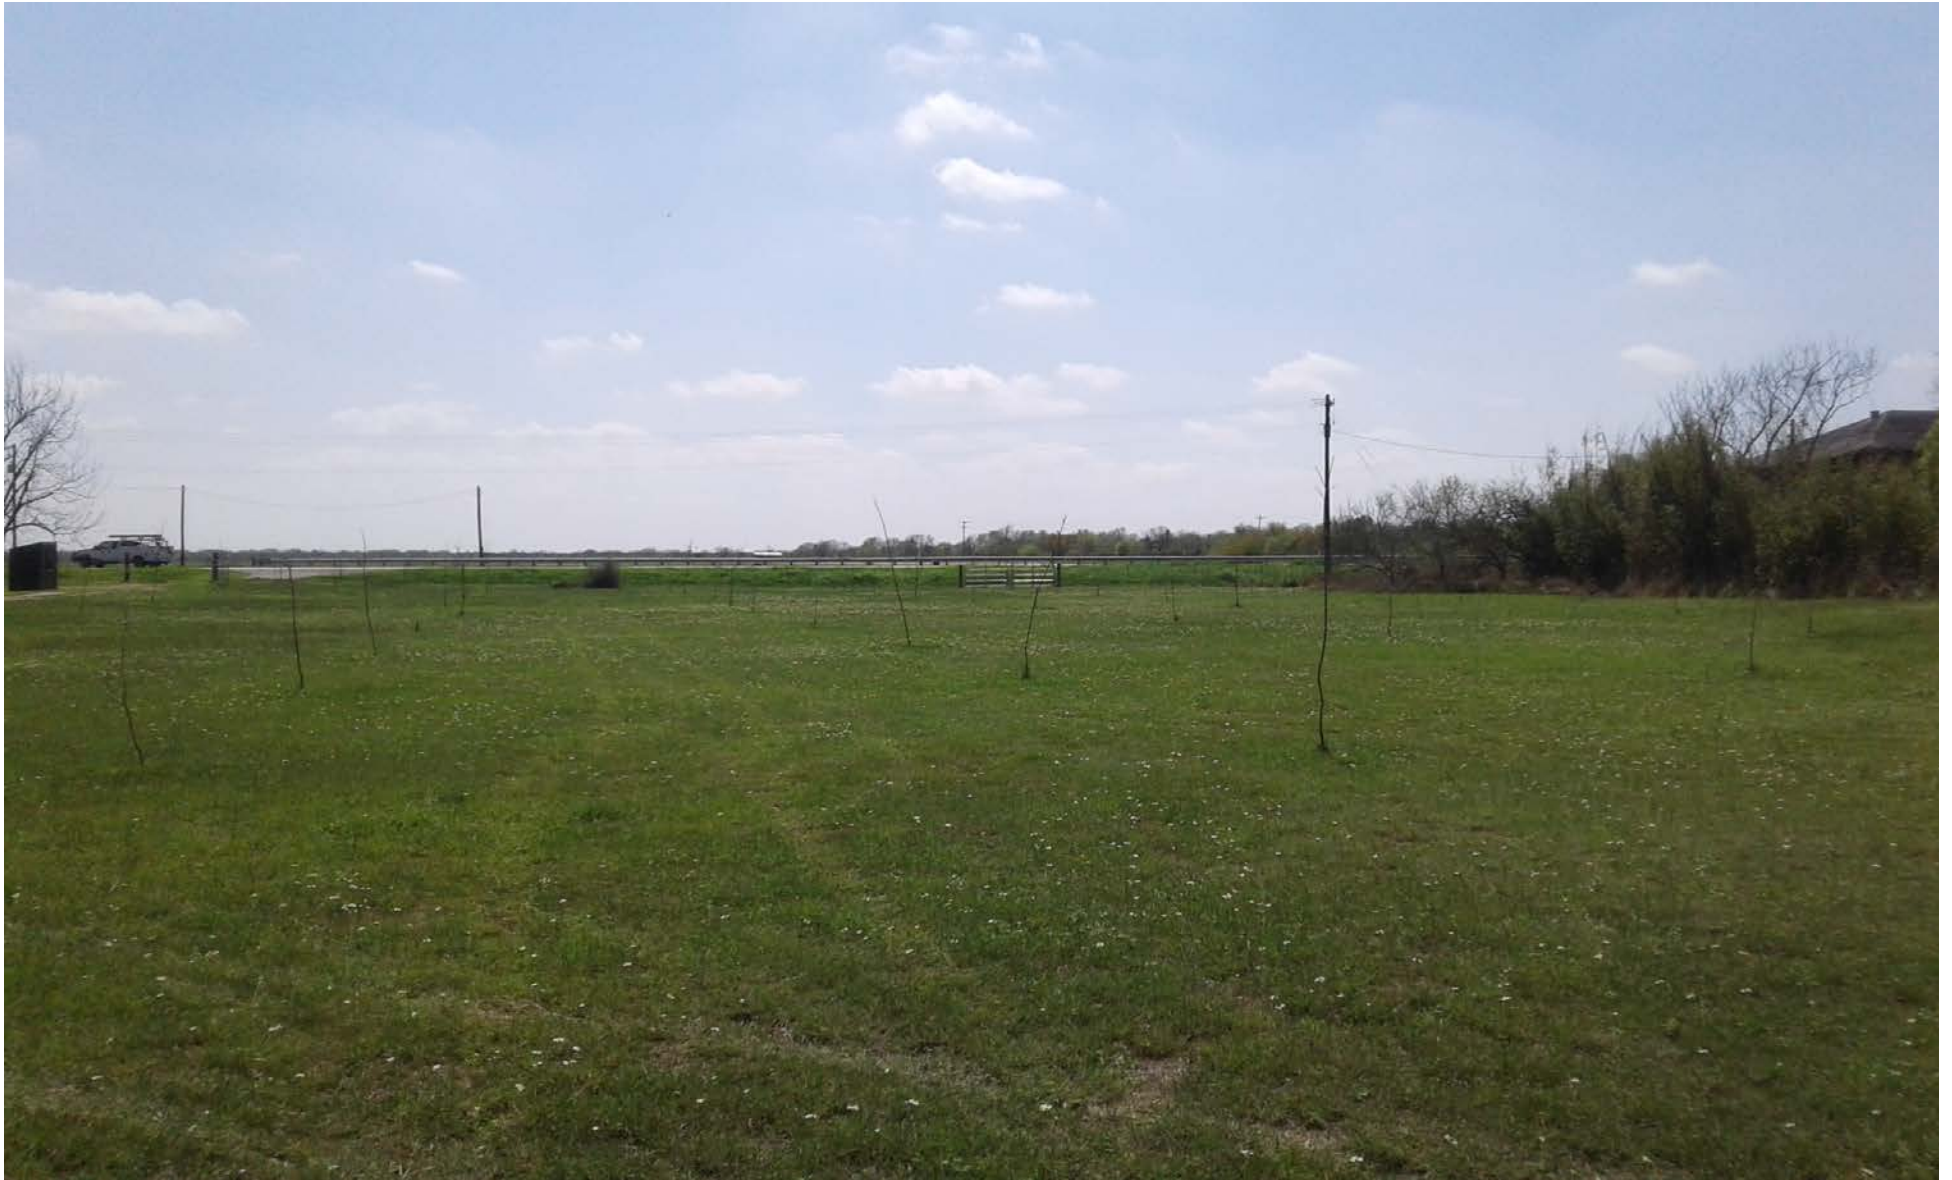
**Photo 1 – Open field where the airplane landed (Pilot photo)**

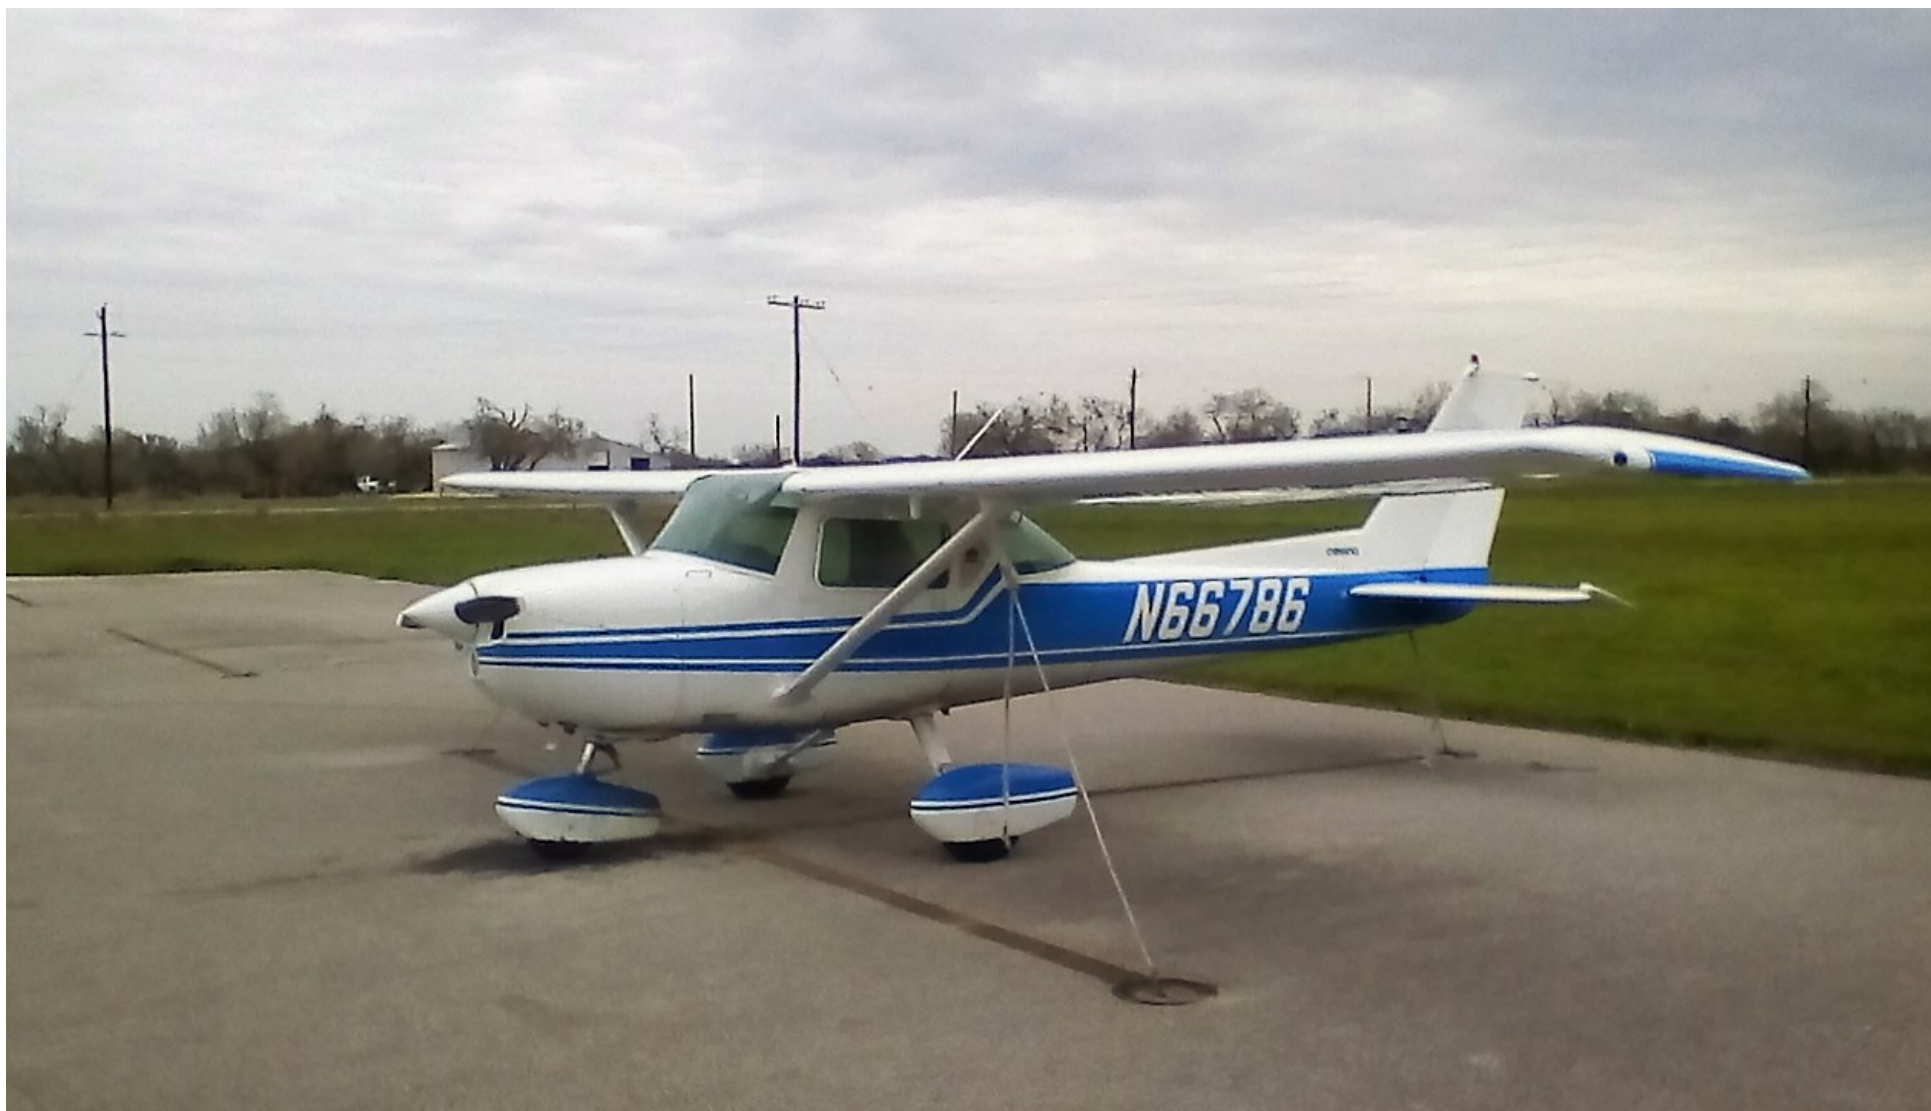
**Photo 2 – Photo of the airplane after the accident (Pilot photo)**

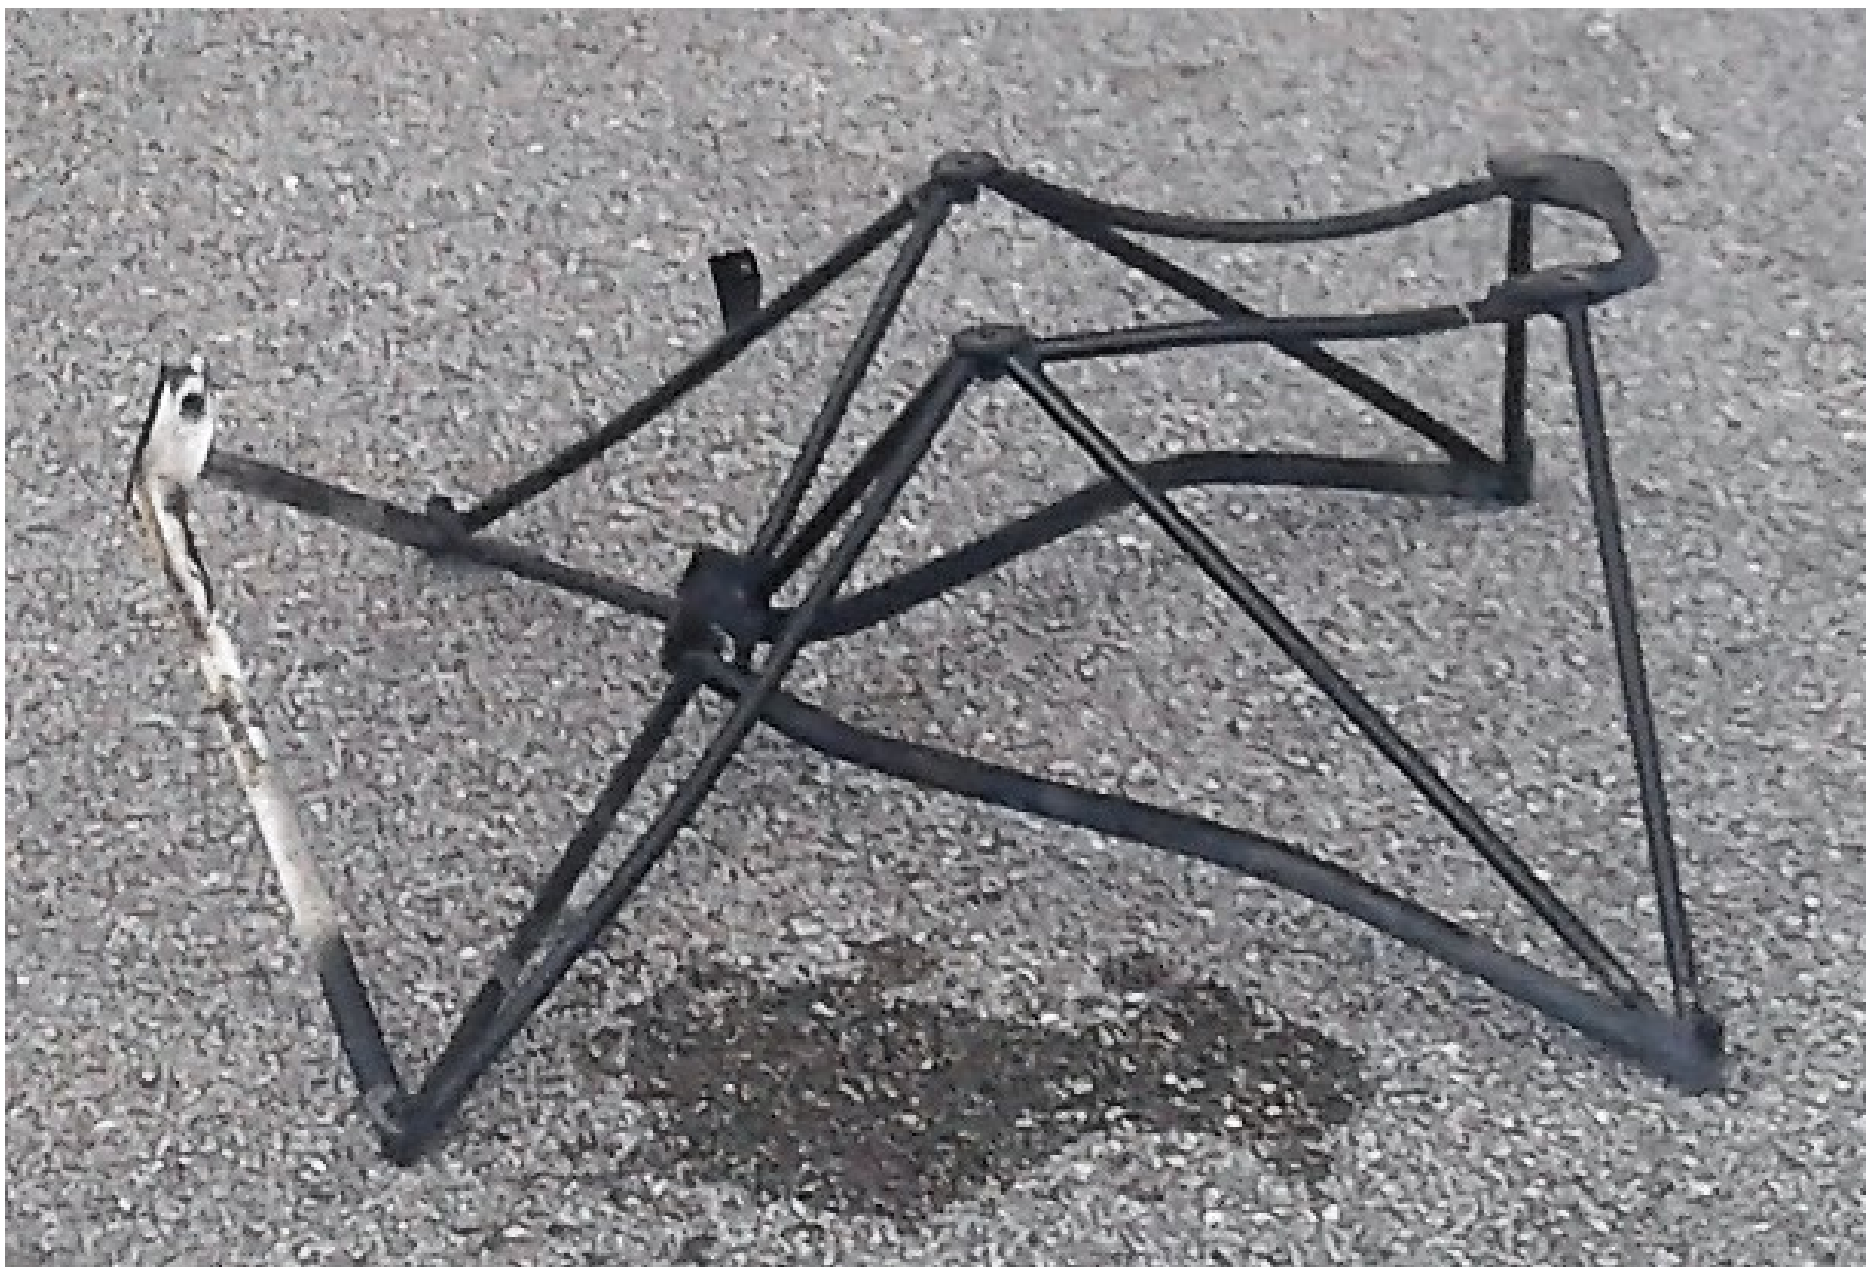
**Photo 3 – Bent engine mount (Pilot photo)**

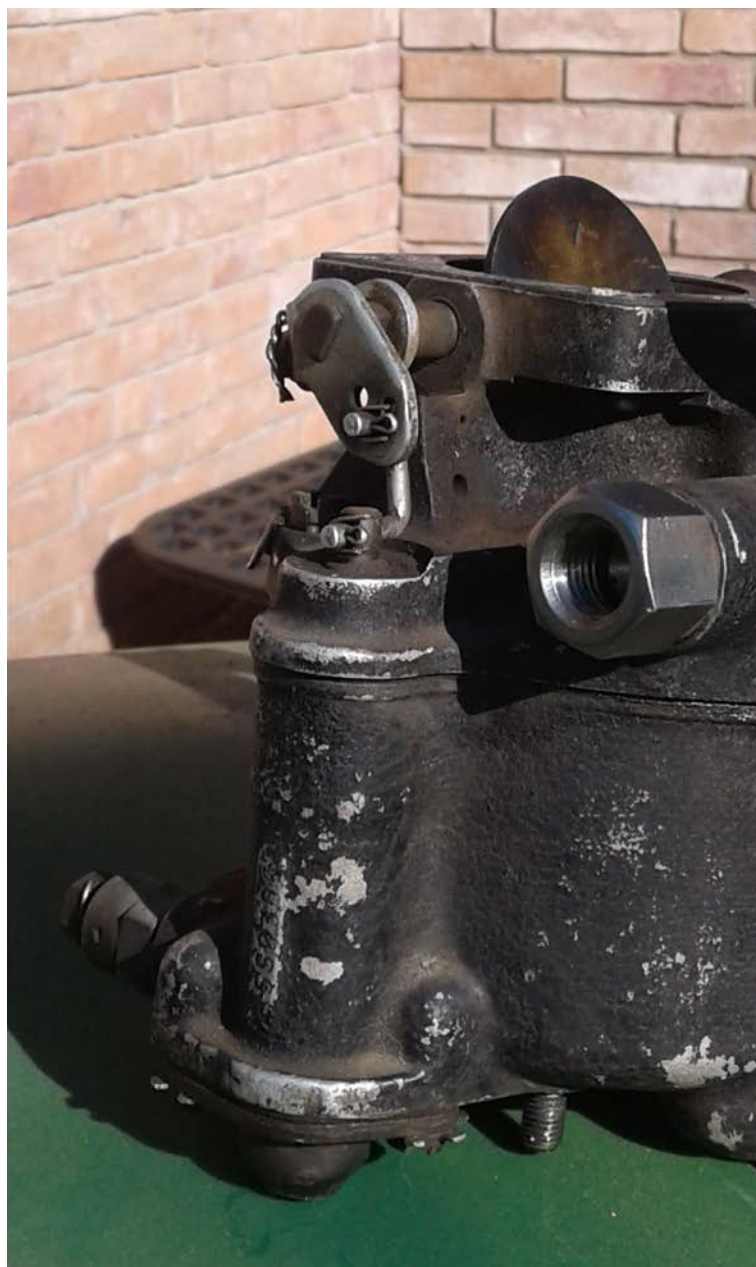
**Photo 4 – Photo of the carburetor (Pilot photo)**

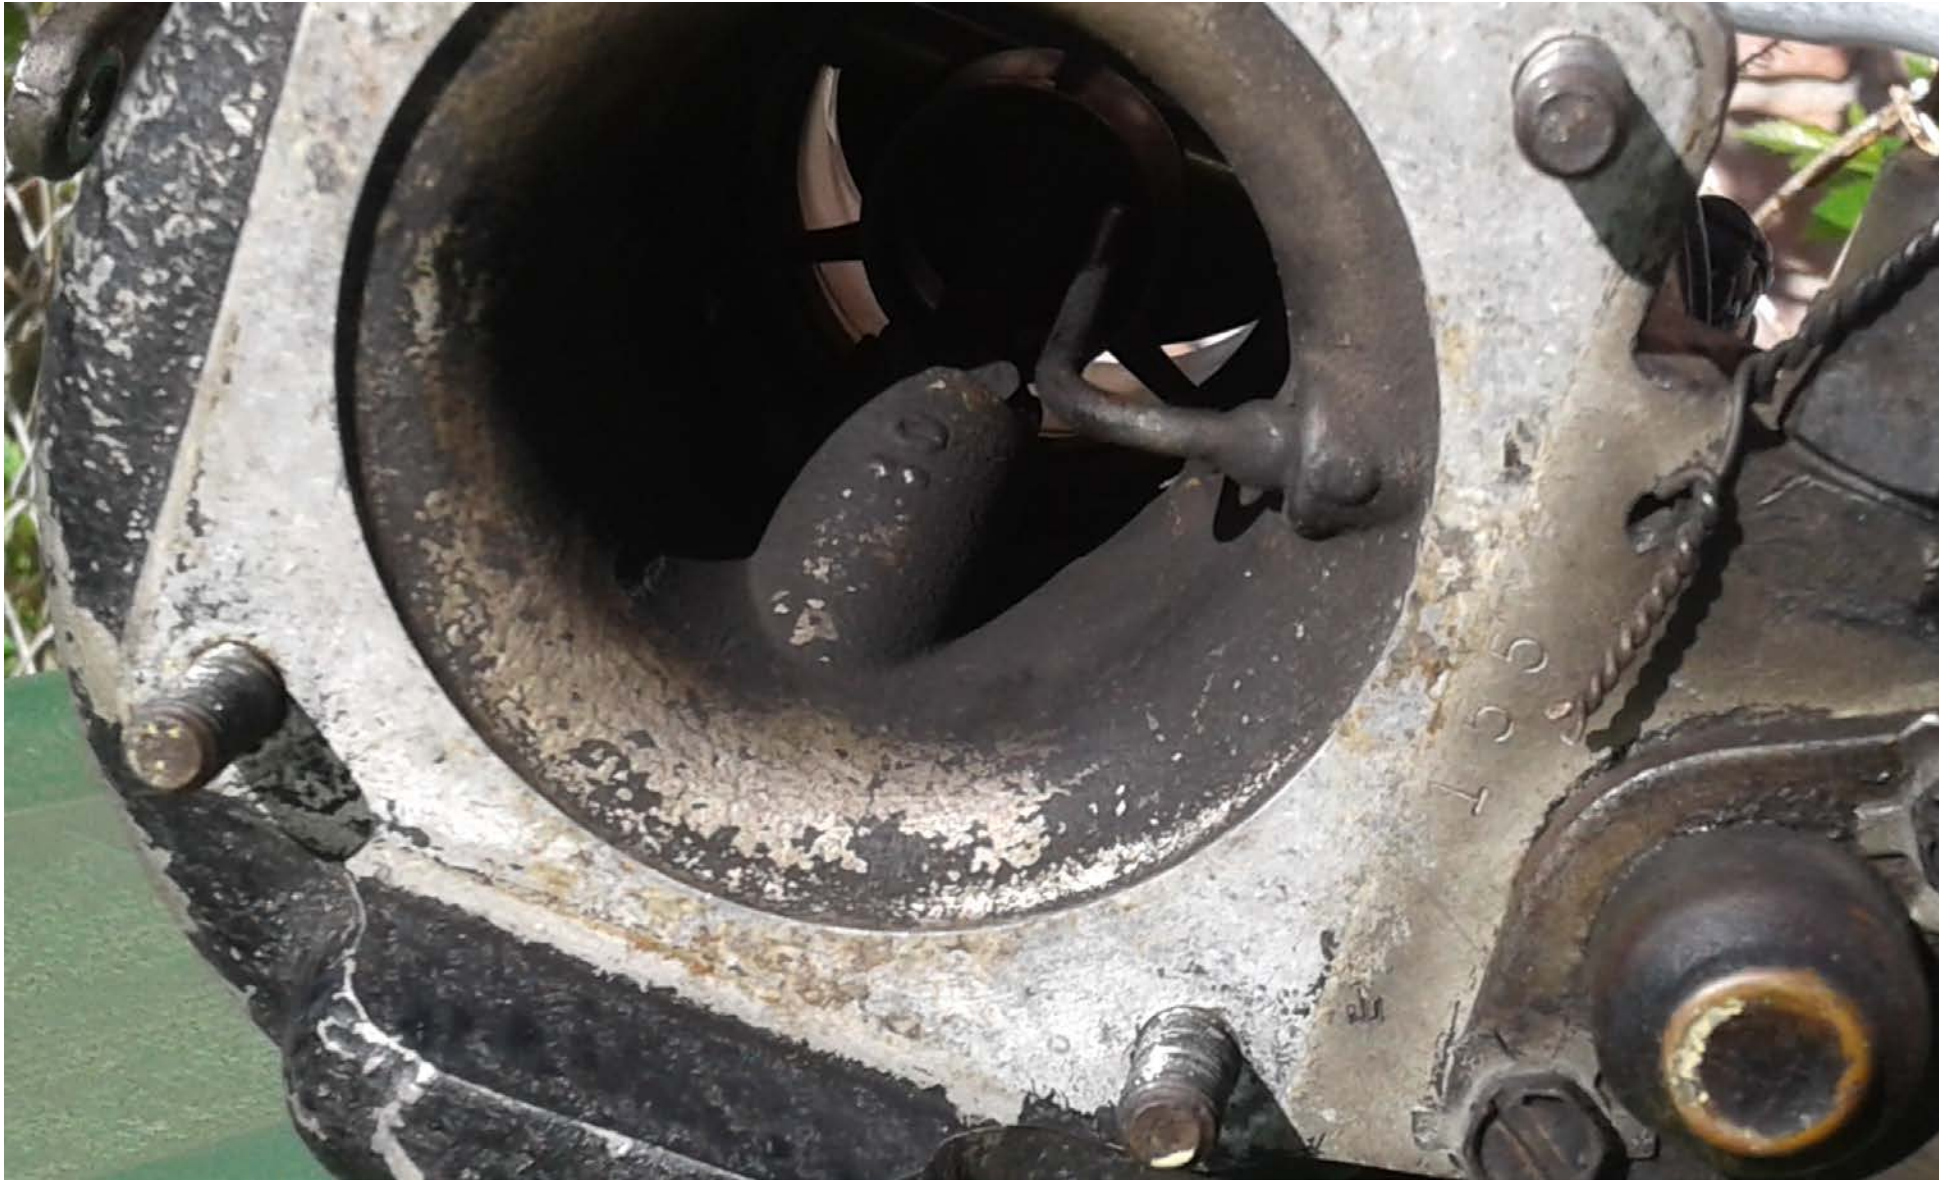
**Photo 5 – View of carburetor venturi (Pilot photo)**

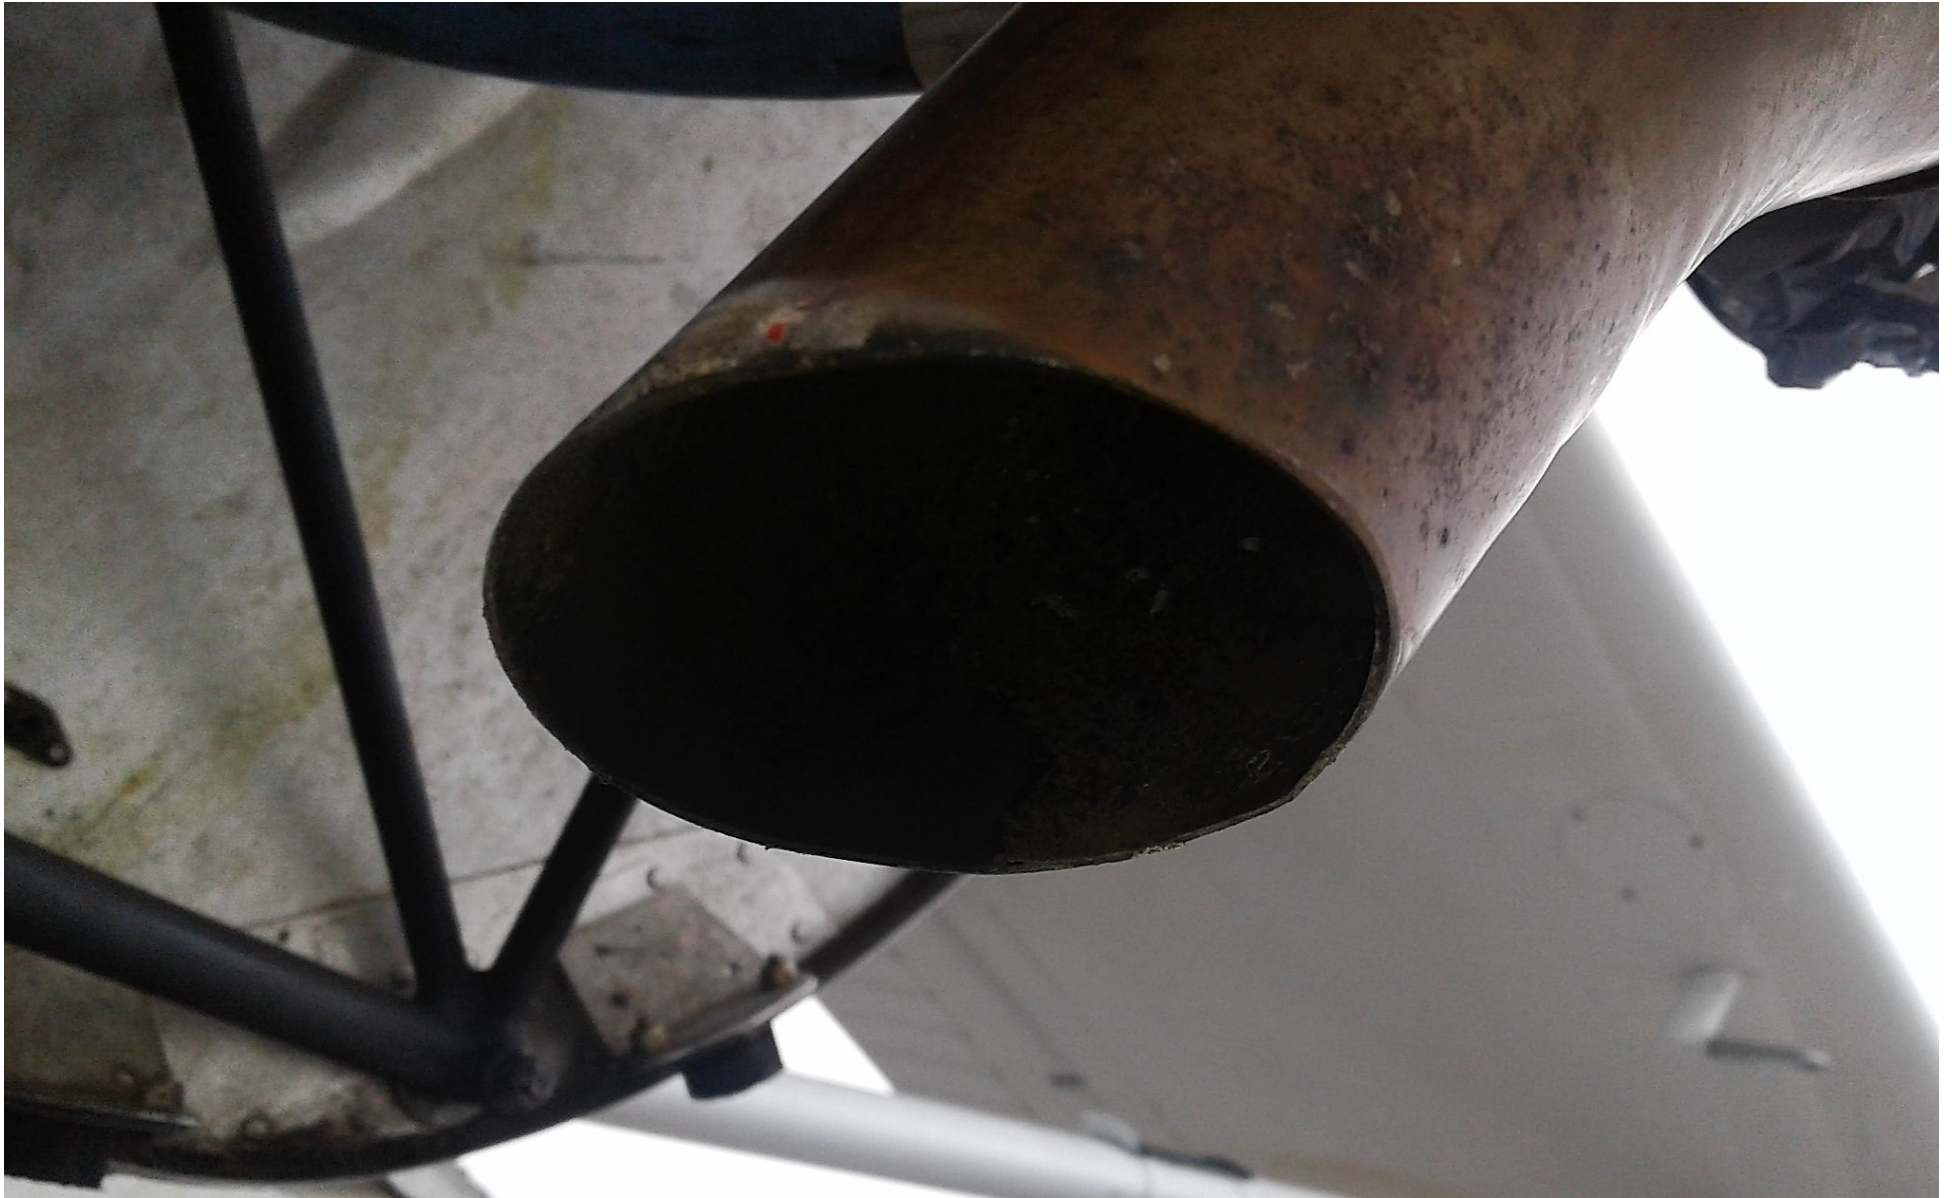
**Photo 6 – View of black carbon in engine exhaust (Pilot photo)**
