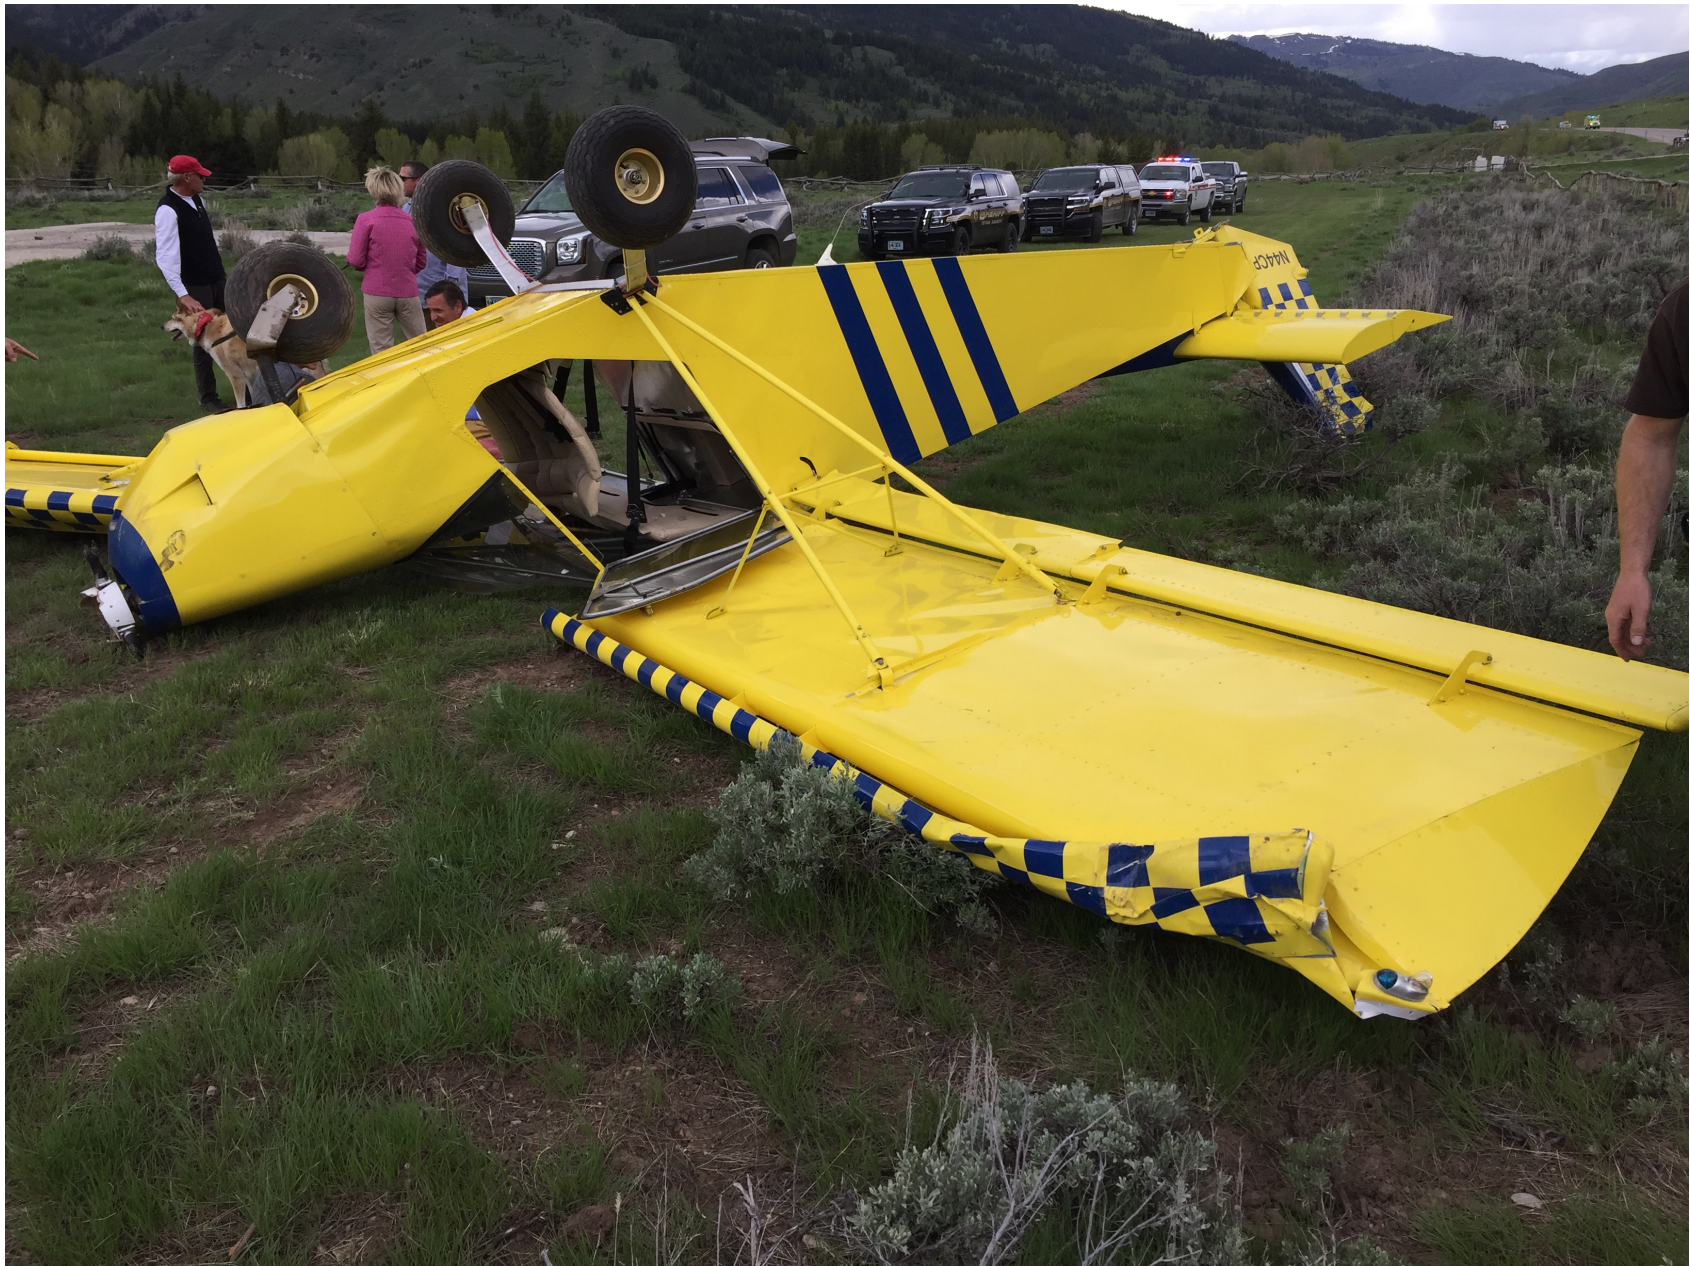
**Photo 1 – Accident Site**

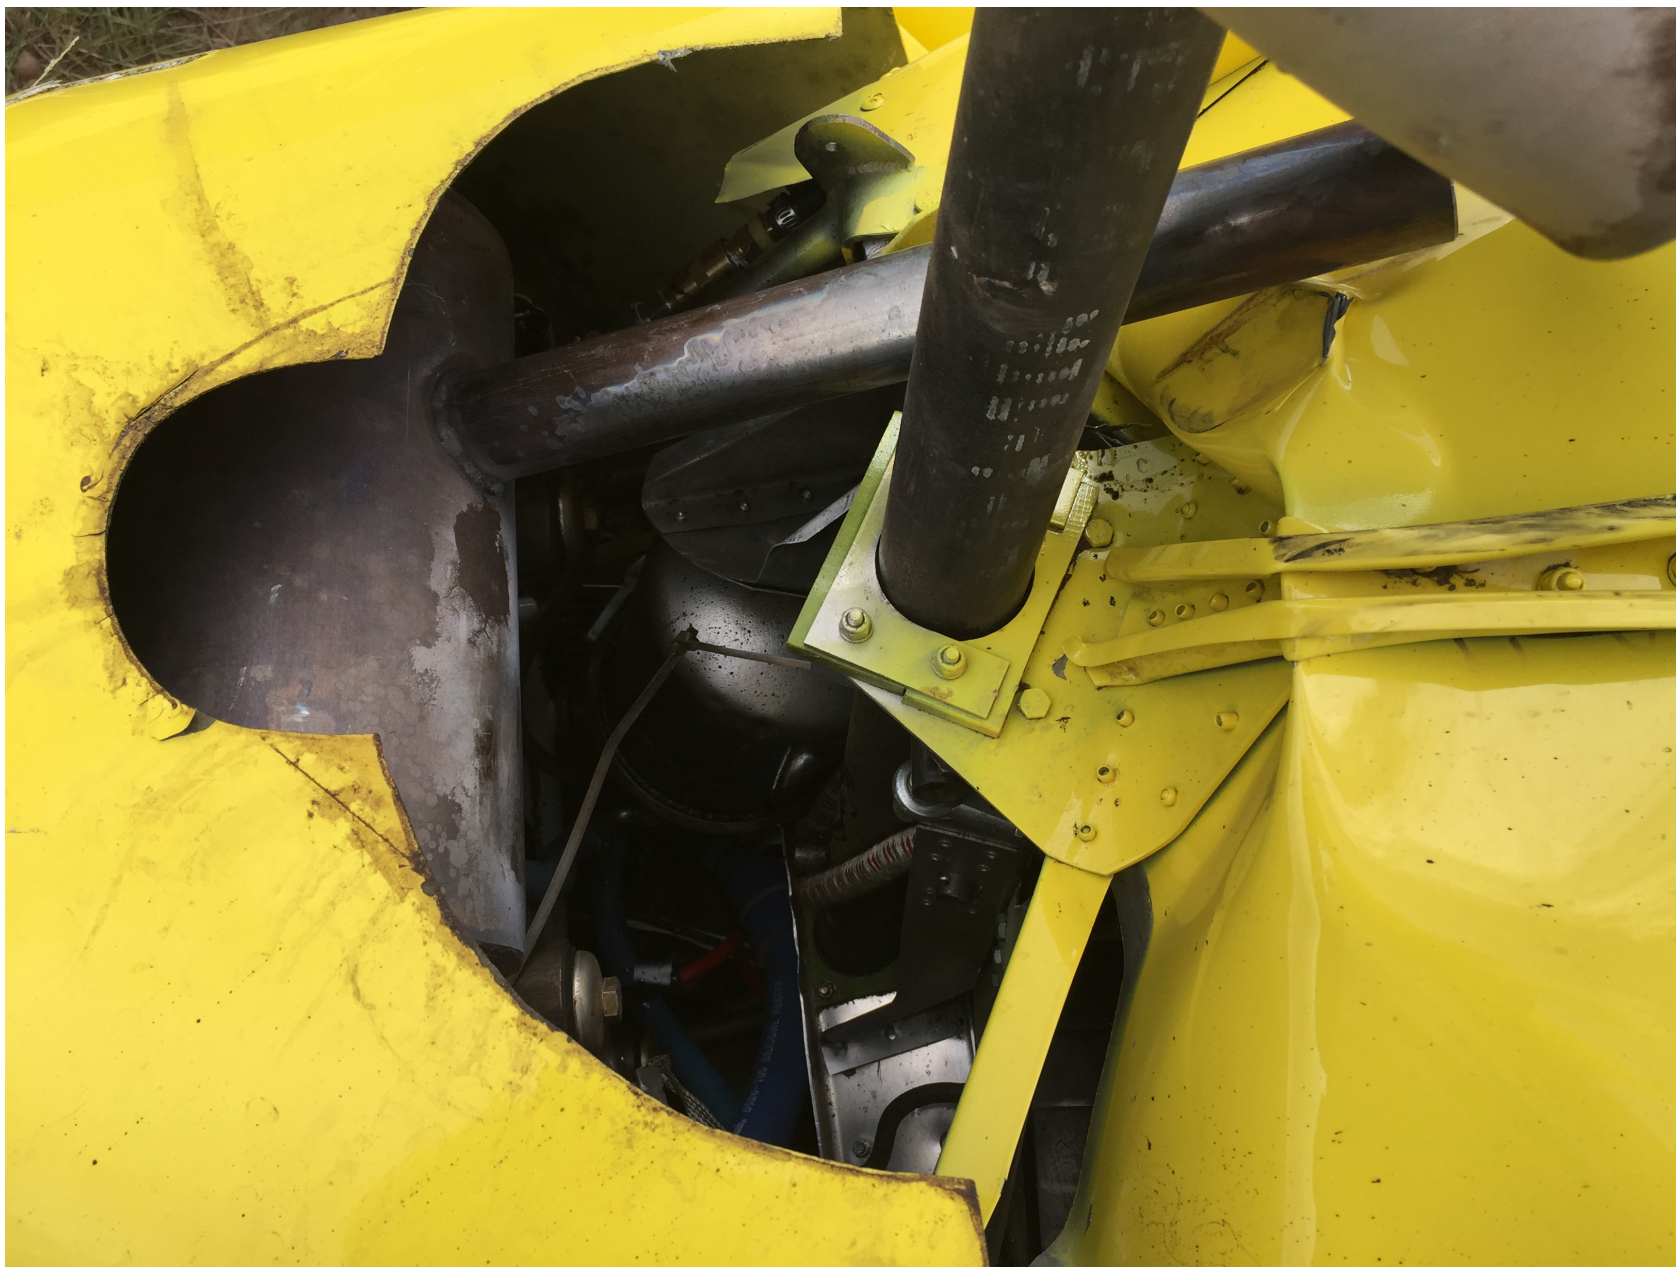
**Photo 2 – Close-up of Damage to Structure at Nose Wheel Strut**
