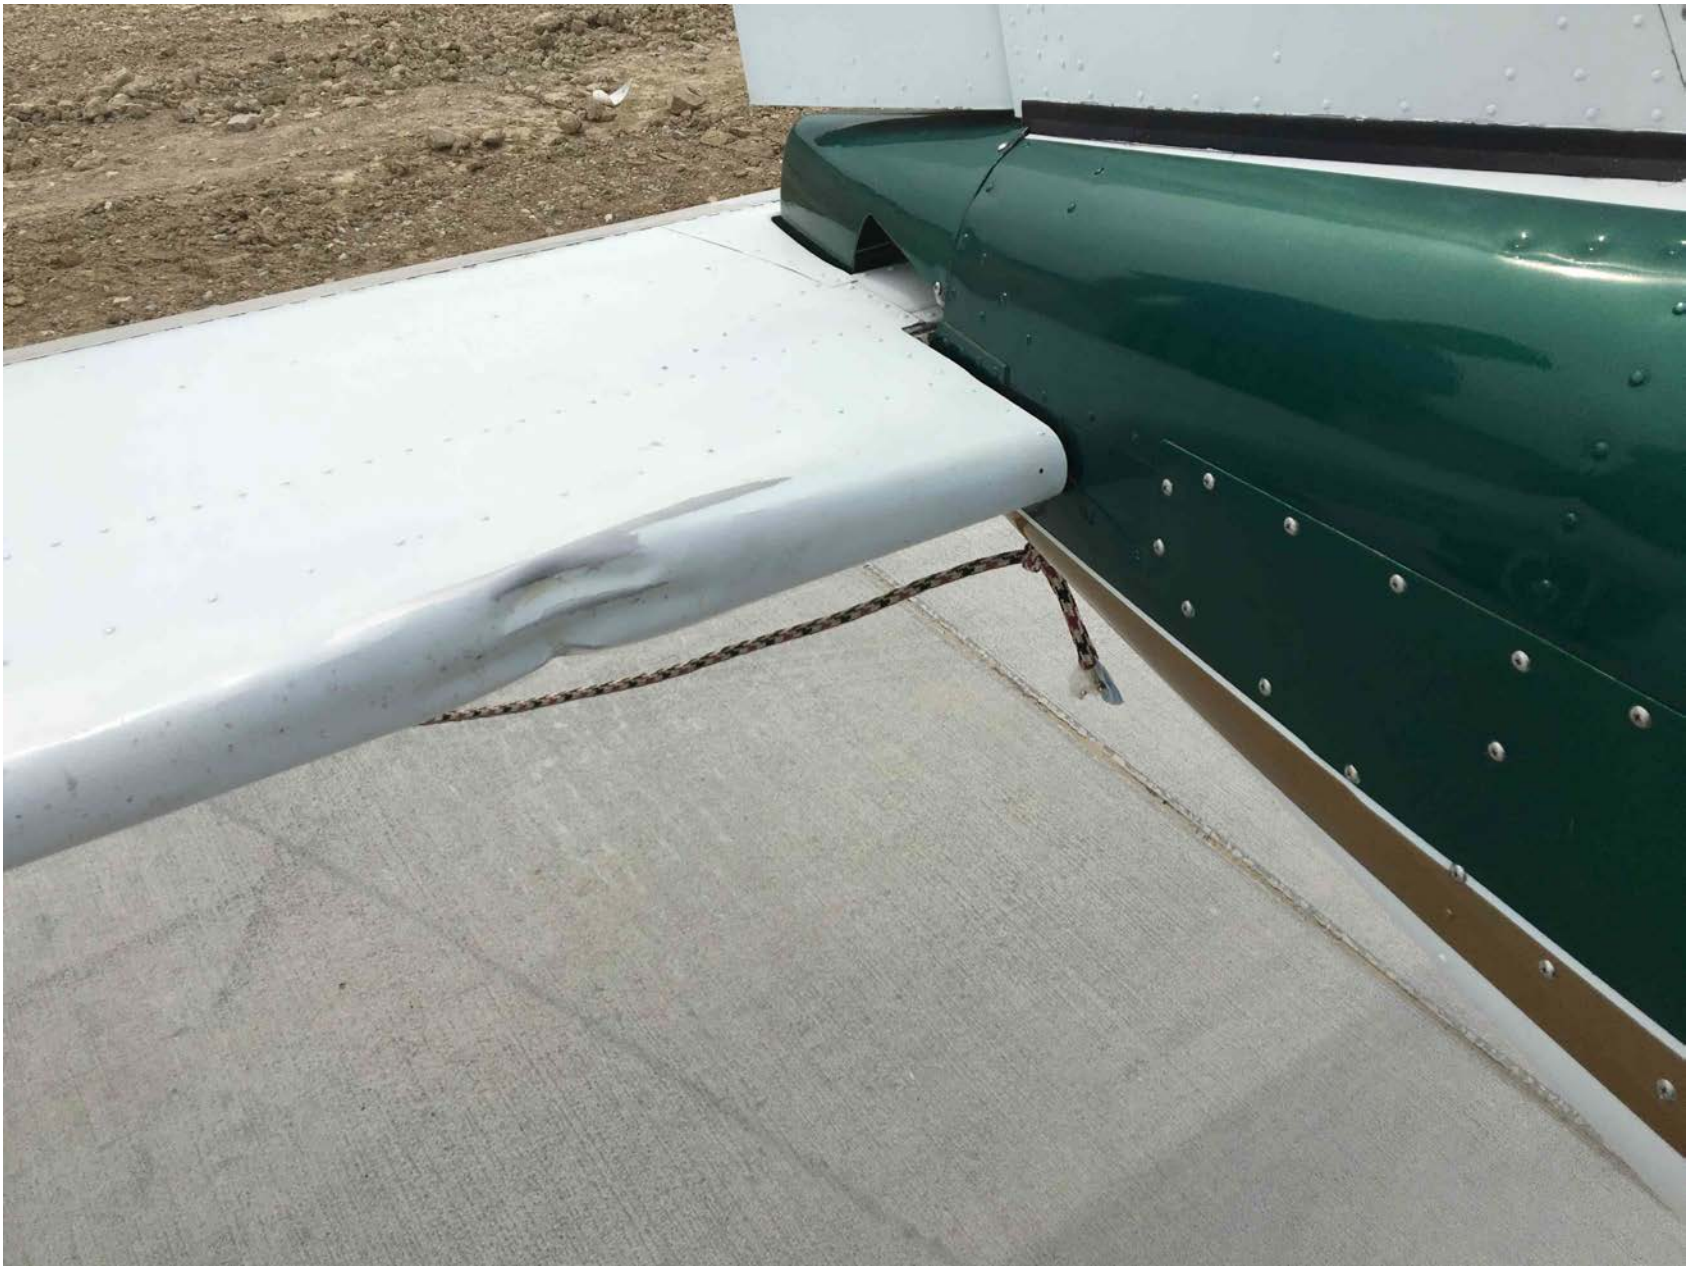
**Photo 1 – Right Side Horizontal Stabilizer Leading Edge Damage**

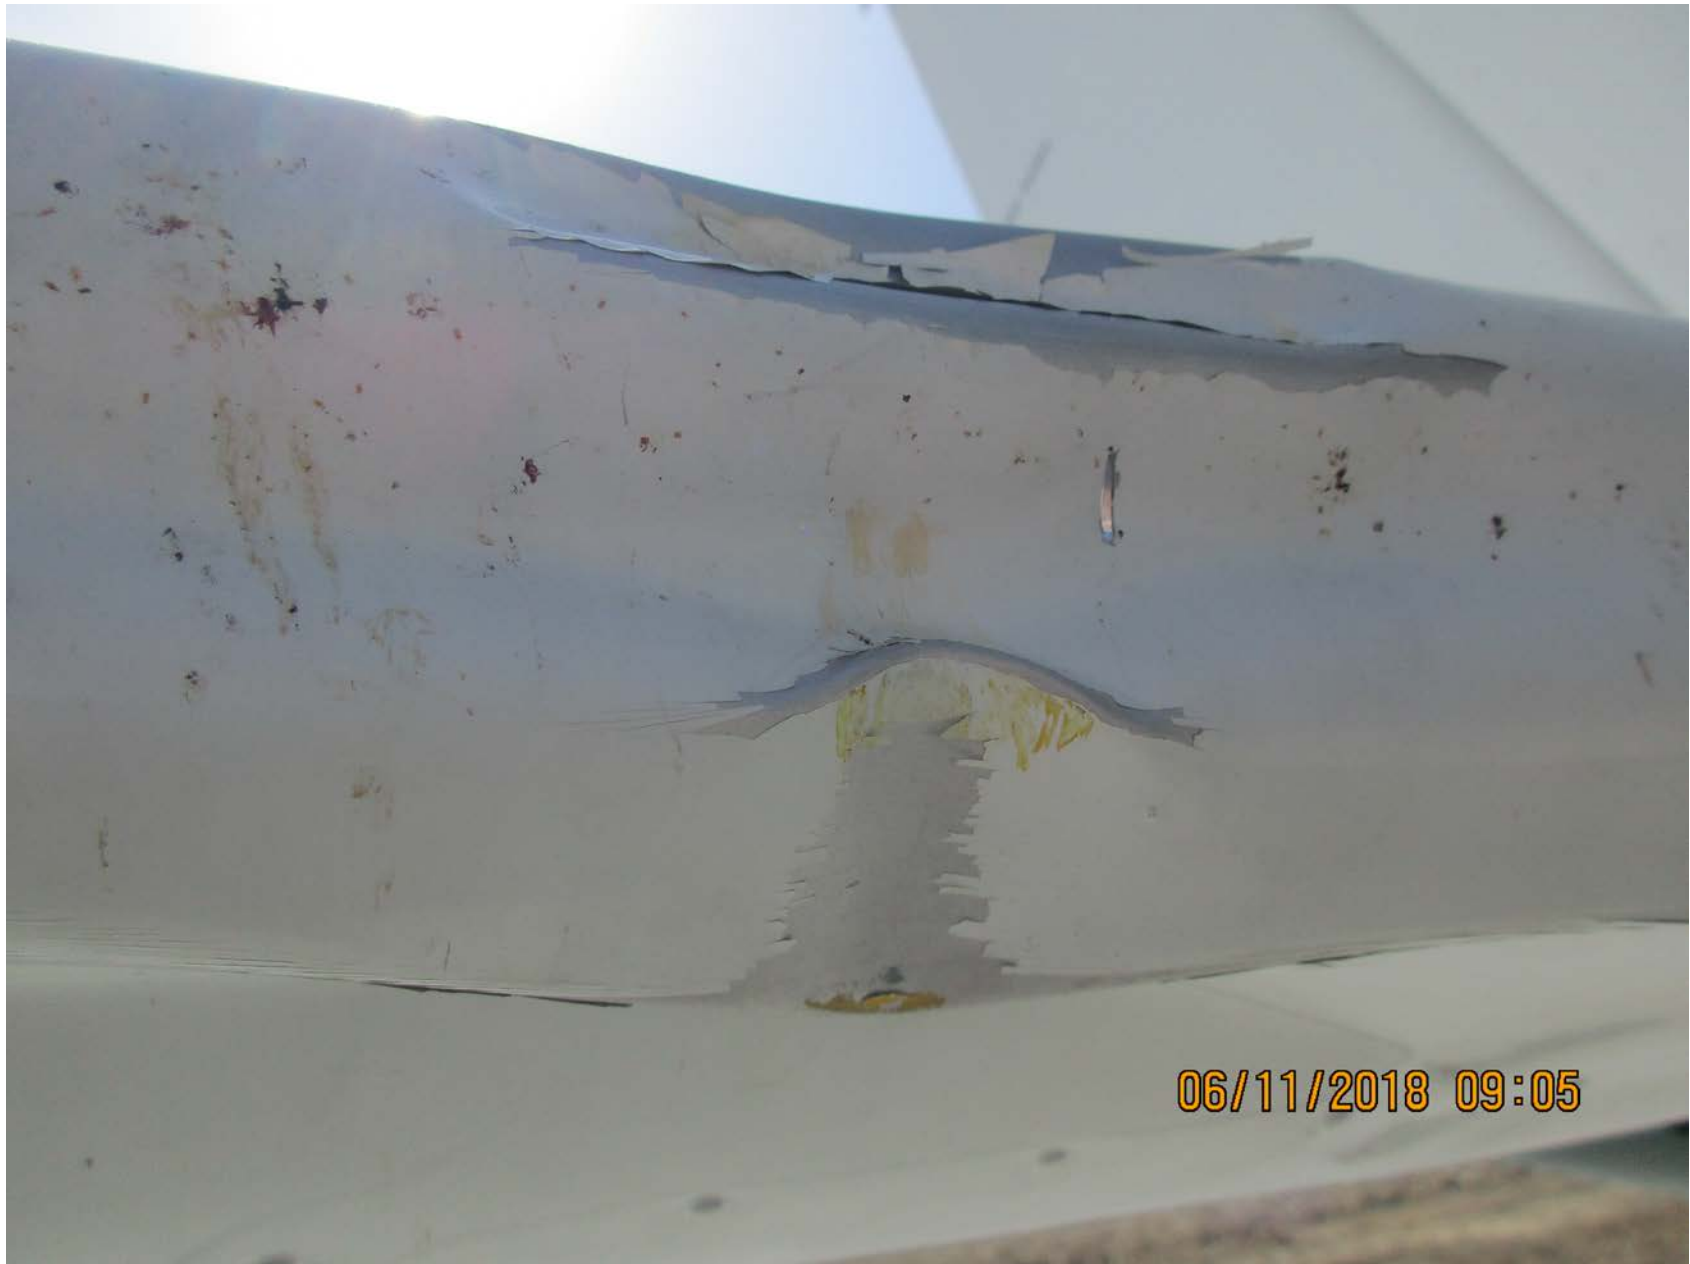
**Photo 2 – Closeup of Leading Edge Damage**
