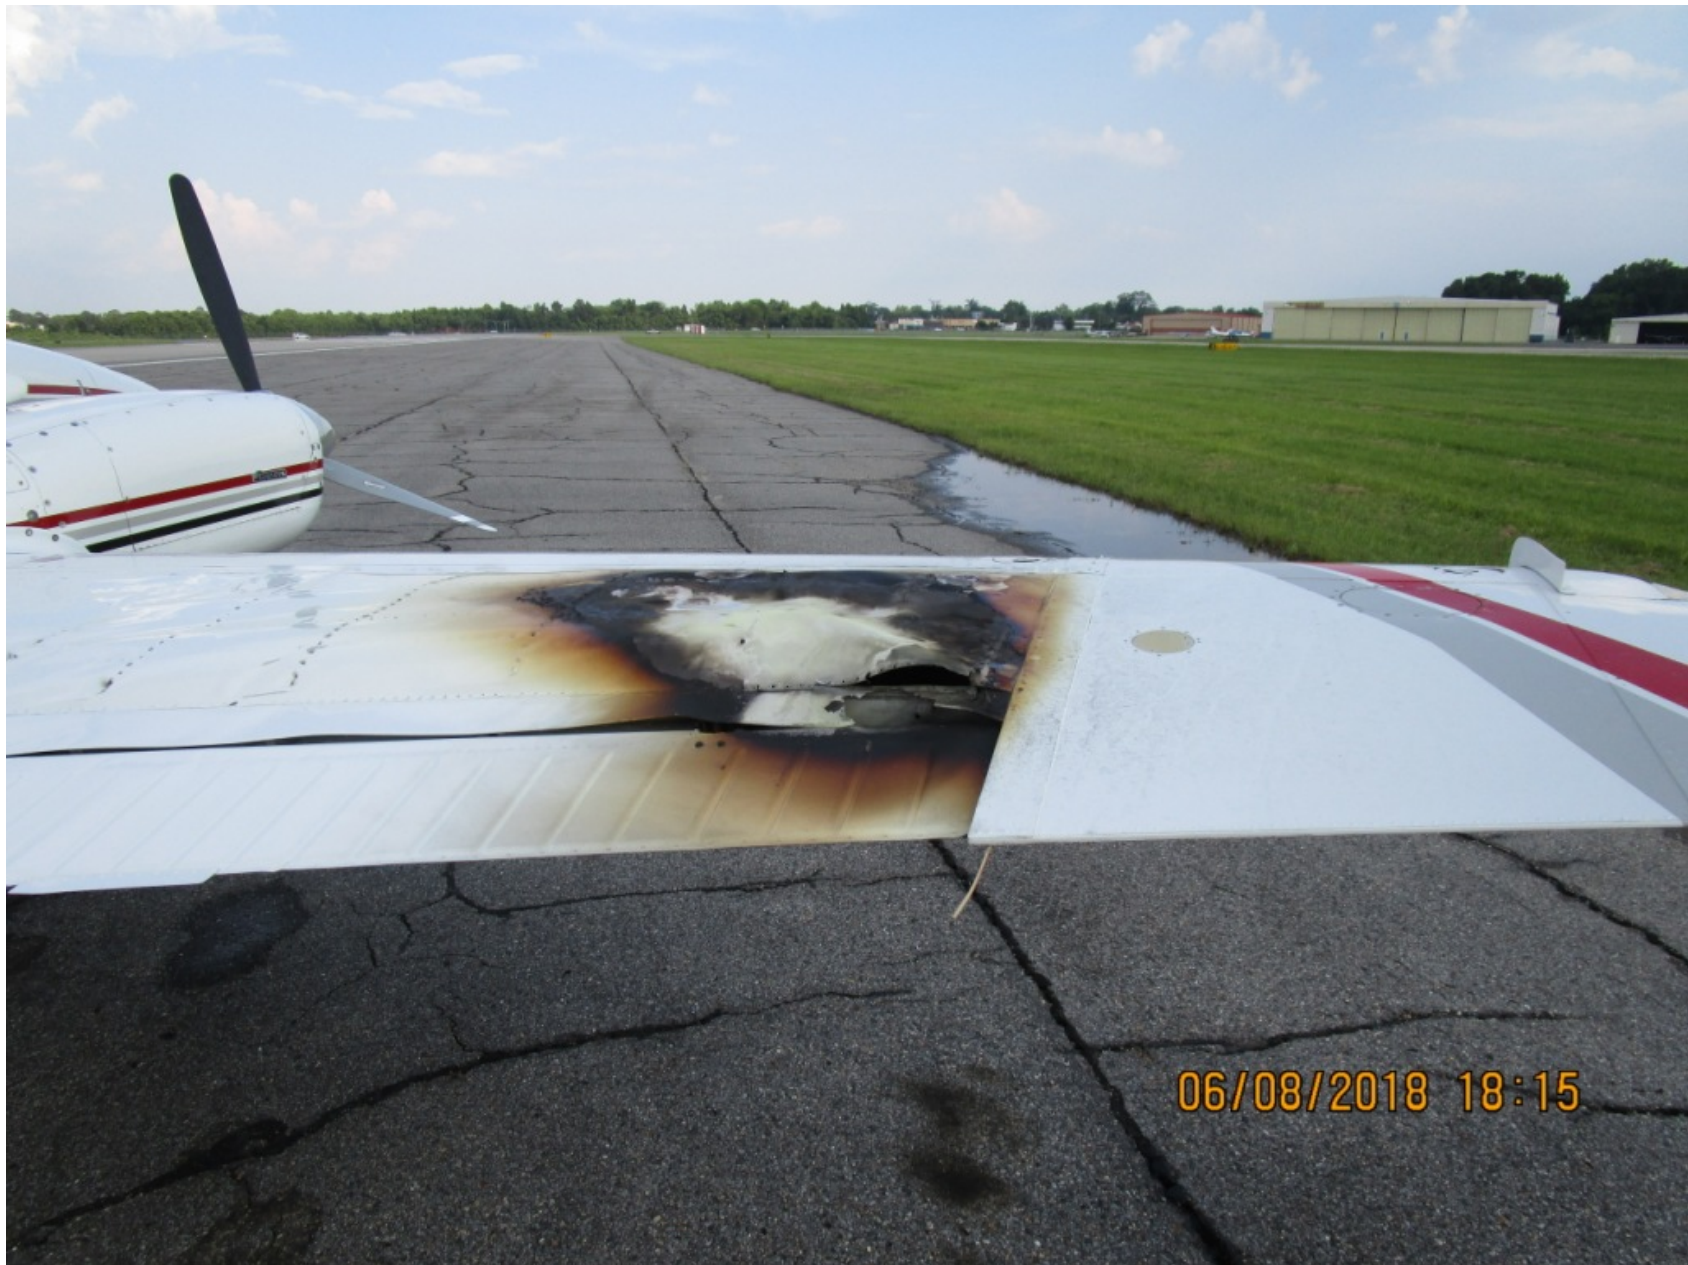
**Photo 1 – View of fire damage to the right wing (FAA Photo)**

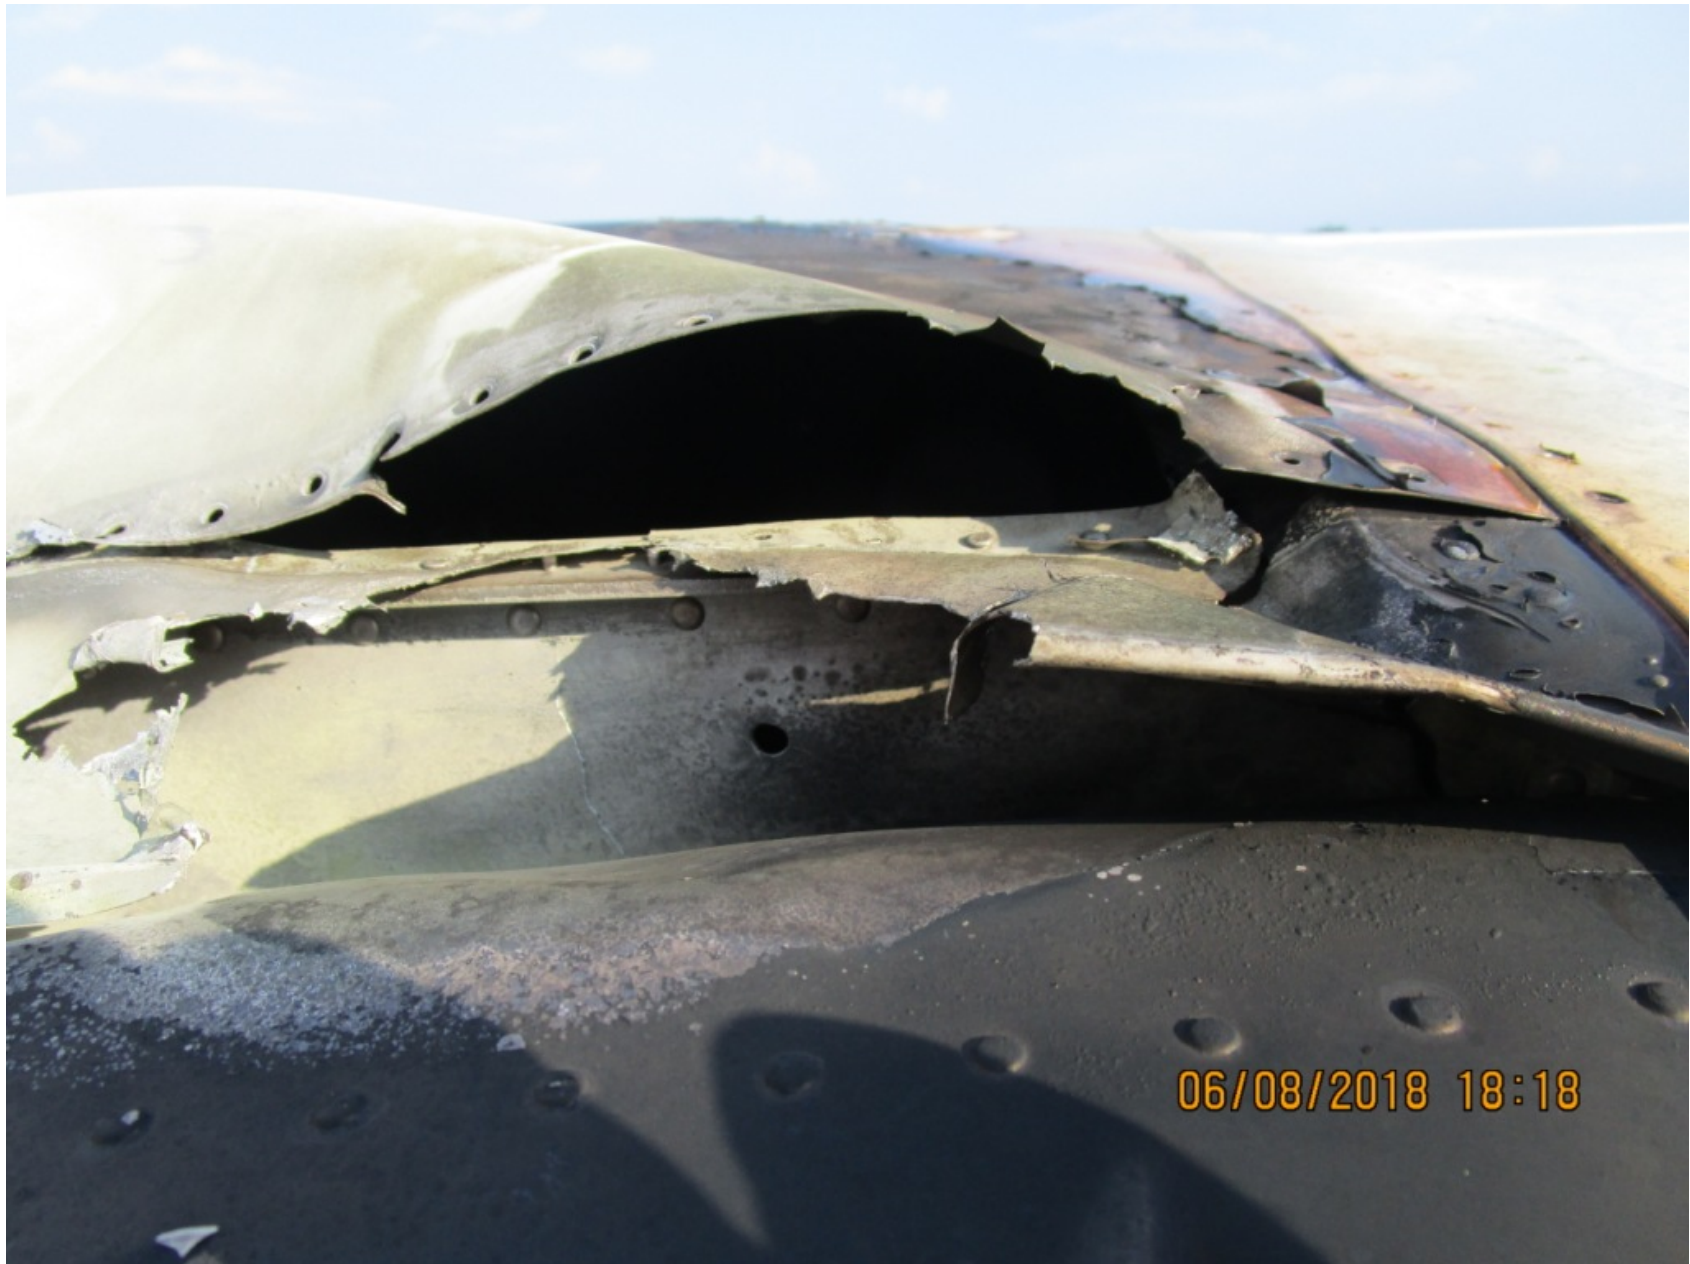
**Photo 2 – Closeup view of fire damage to the right wing (FAA Photo)**

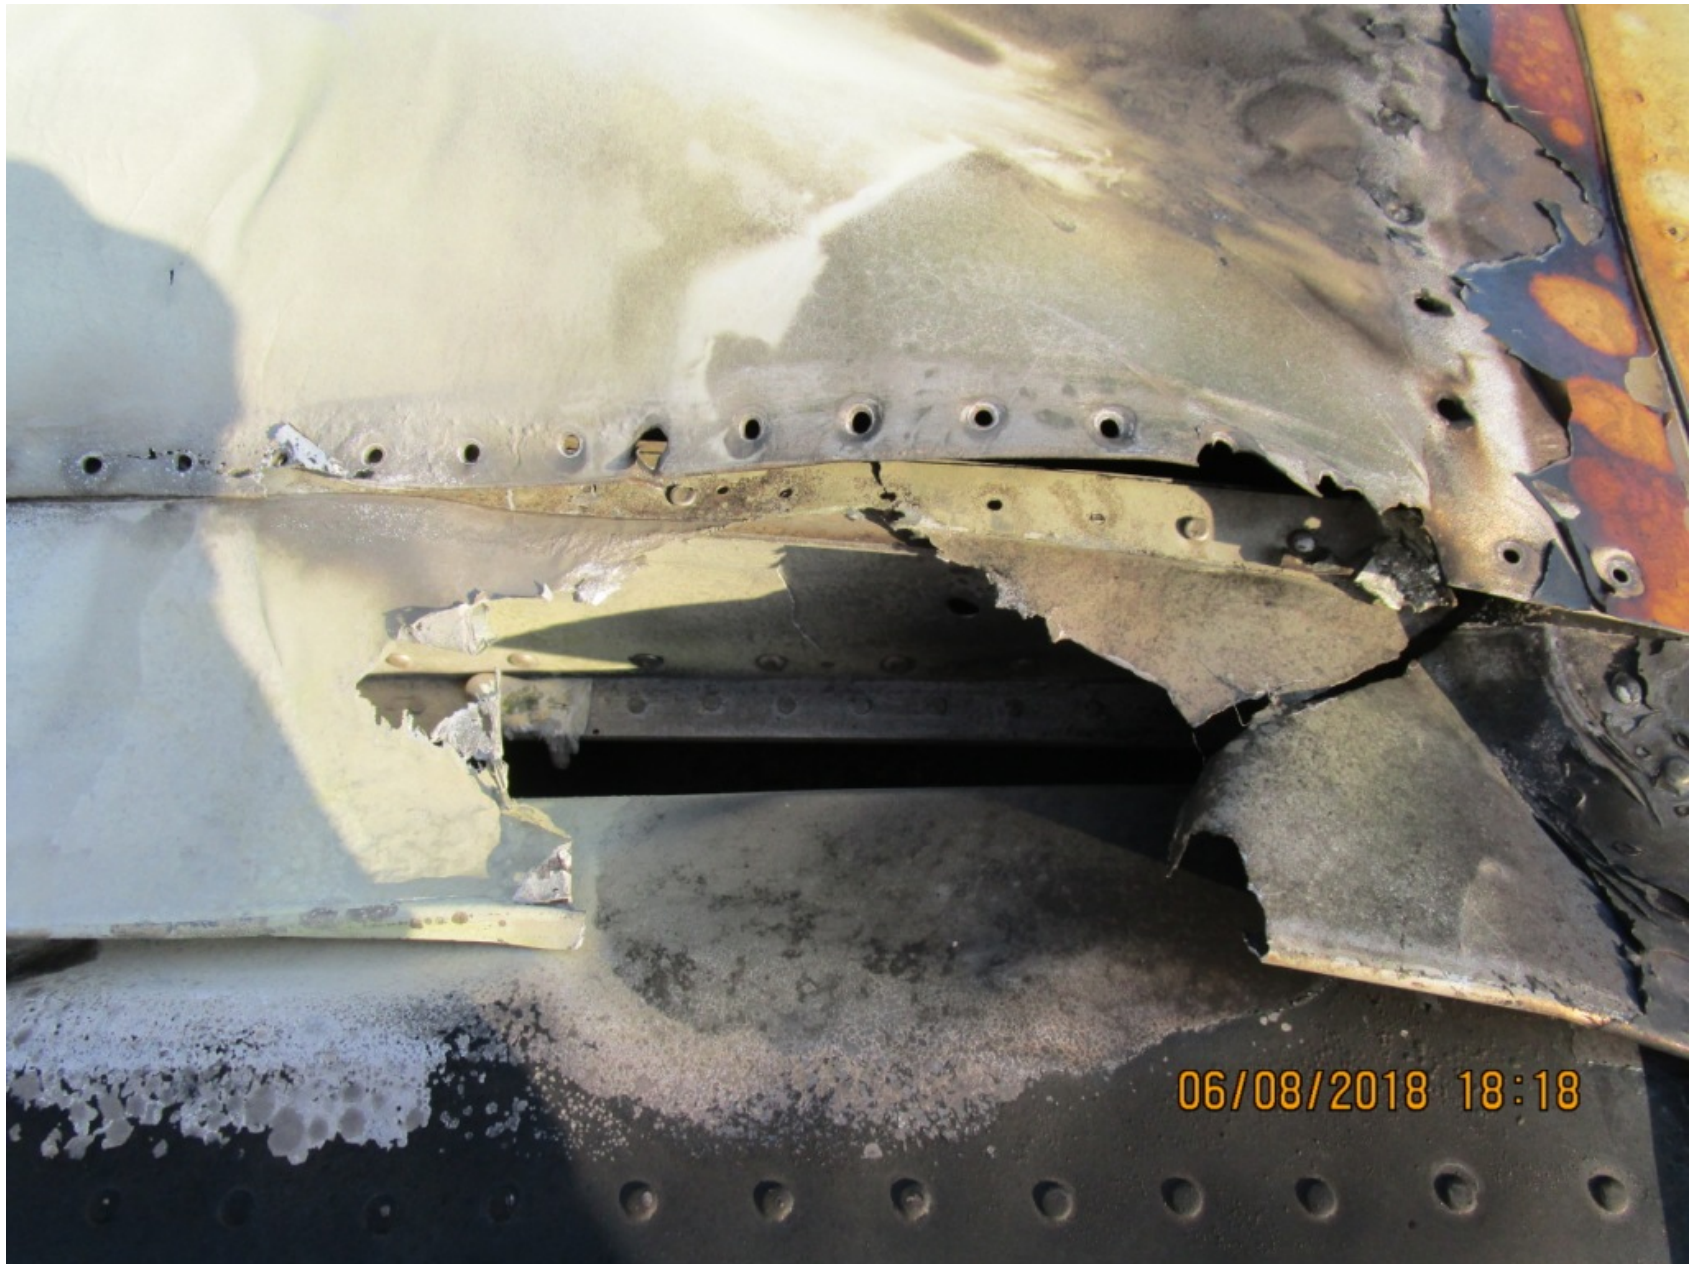
**Photo 3 - Closeup view of fire damage to the right wing (FAA Photo)**

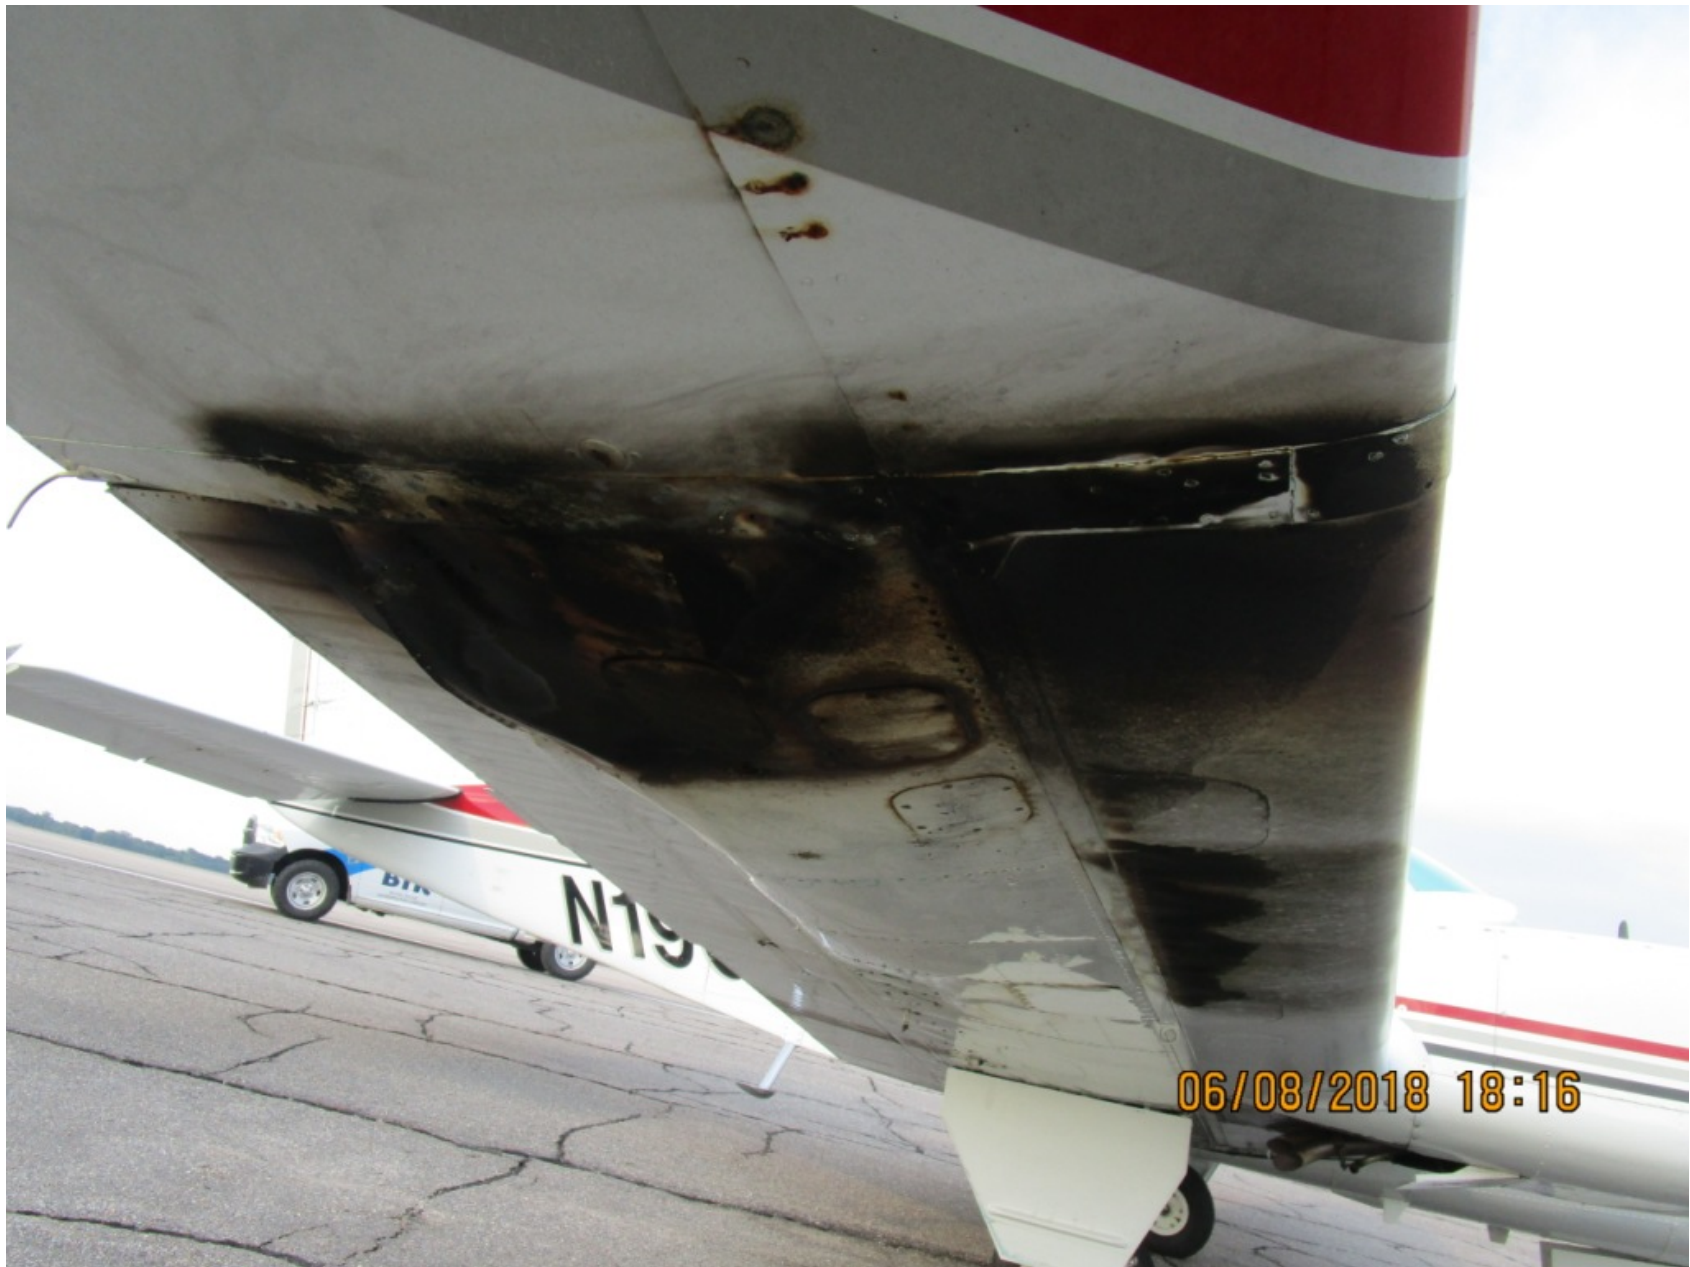
**Photo 4 – View of the fire damage to the bottom of the wing (FAA Photo)**

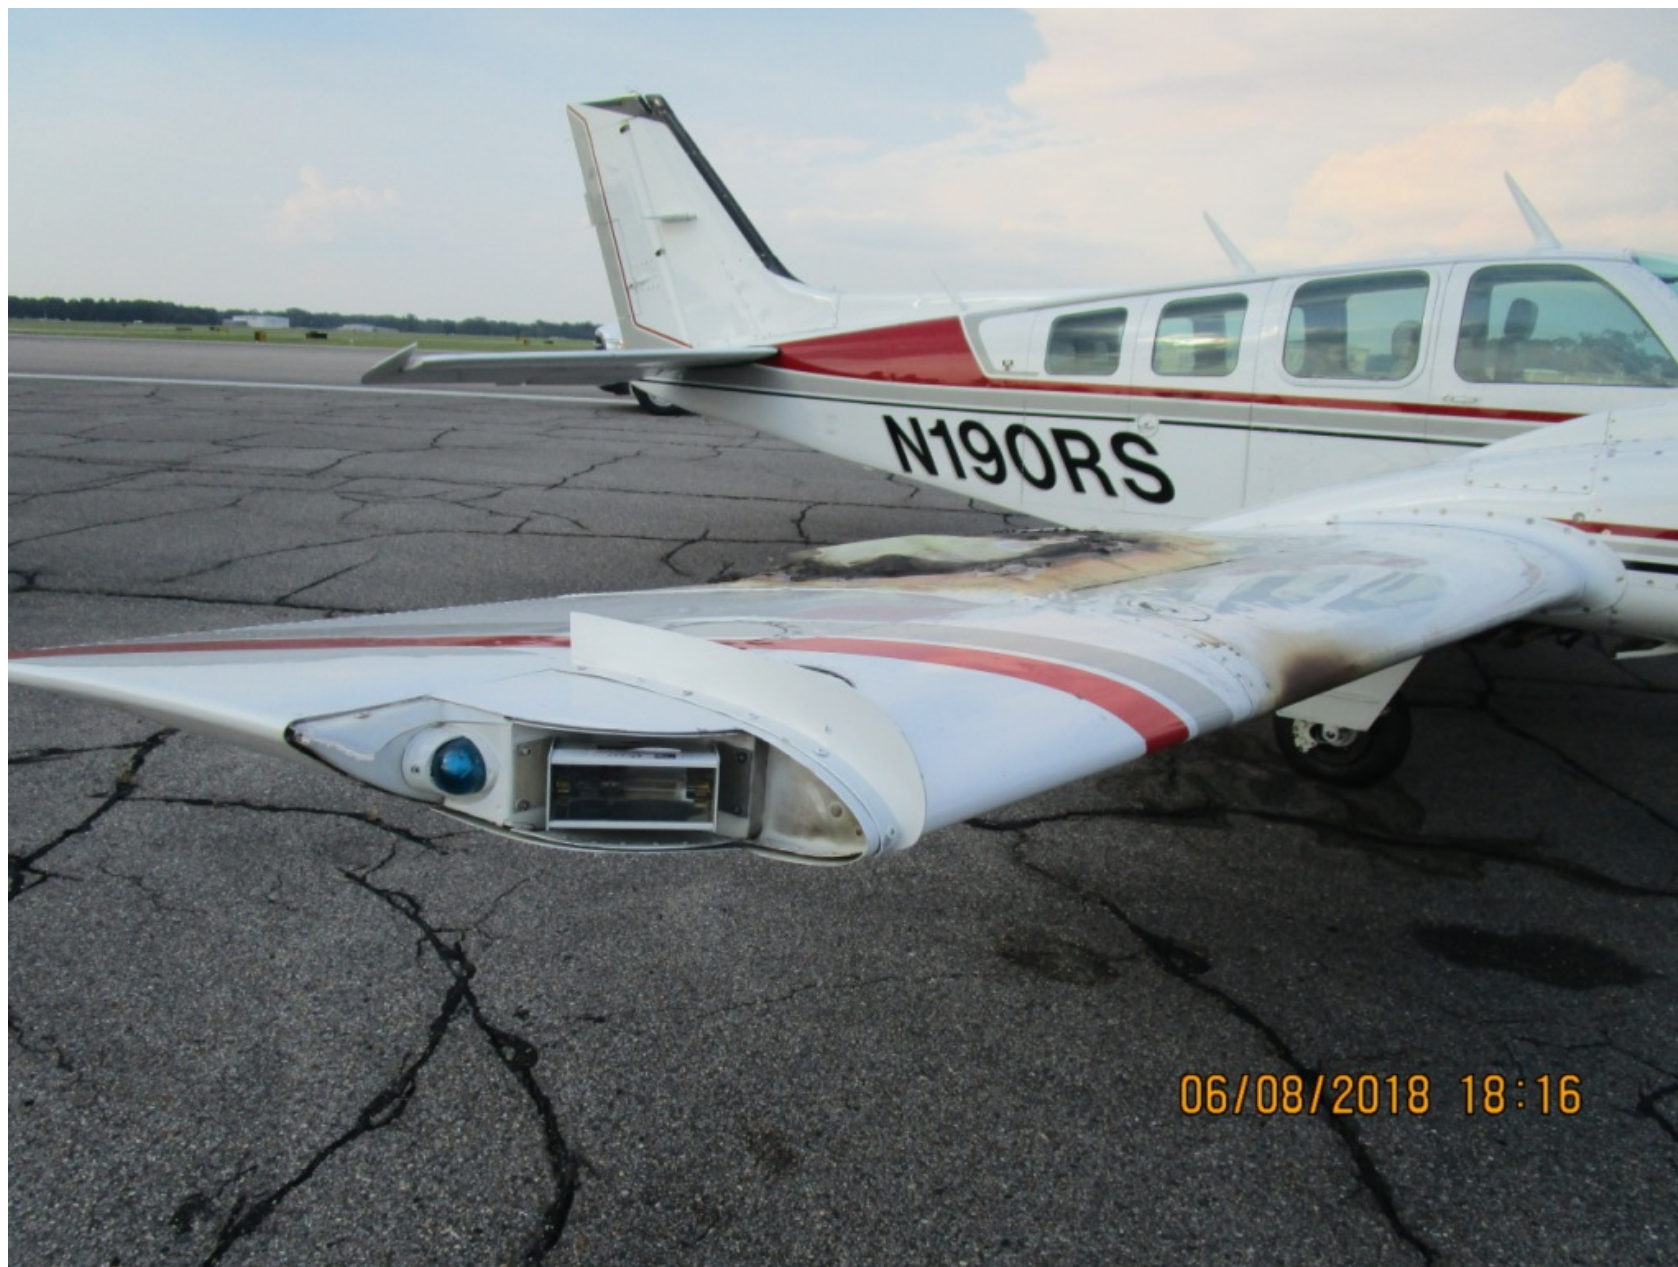
**Photo 5 – View of the right wingtip and navigation light and wing strobe (FAA Photo)**

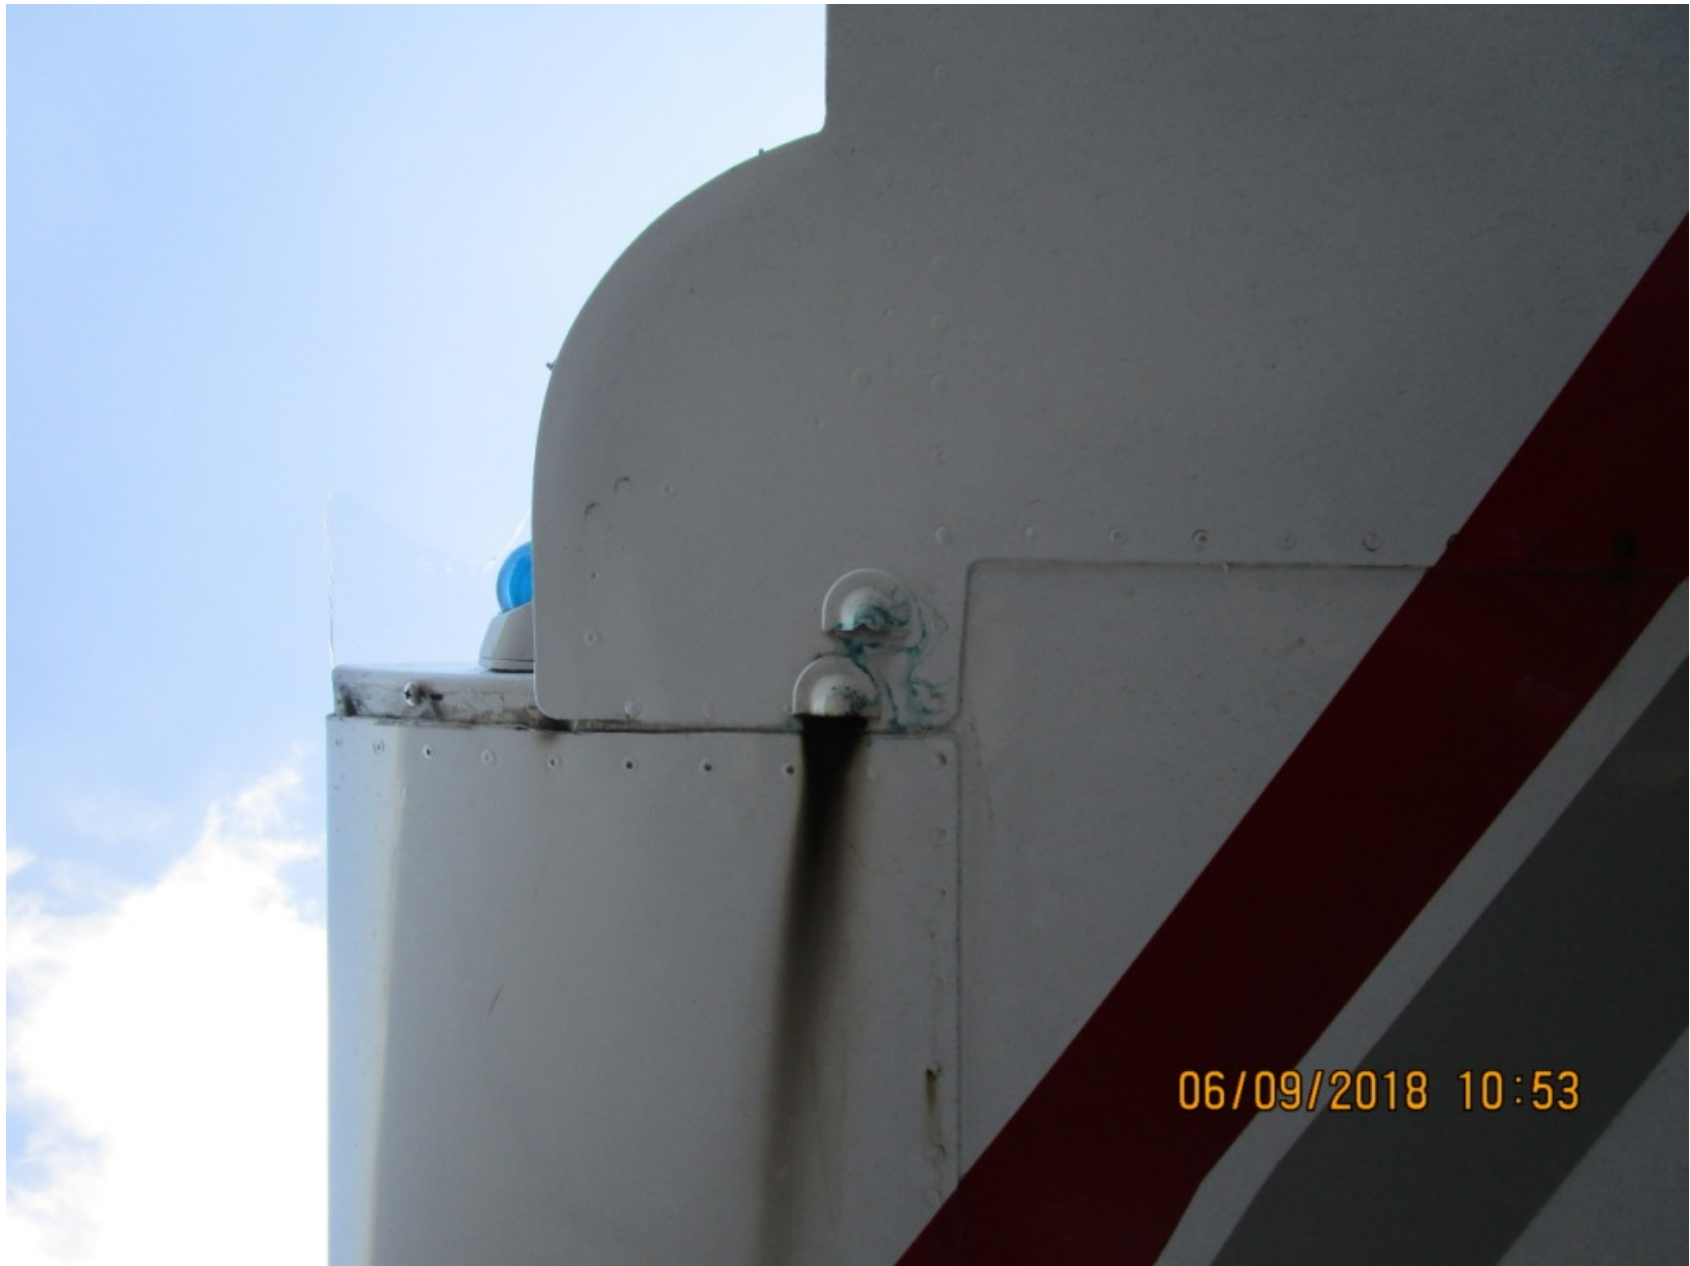
**Photo 6 – View of soot and fuel stain under the wing near navigation light (FAA Photo)**

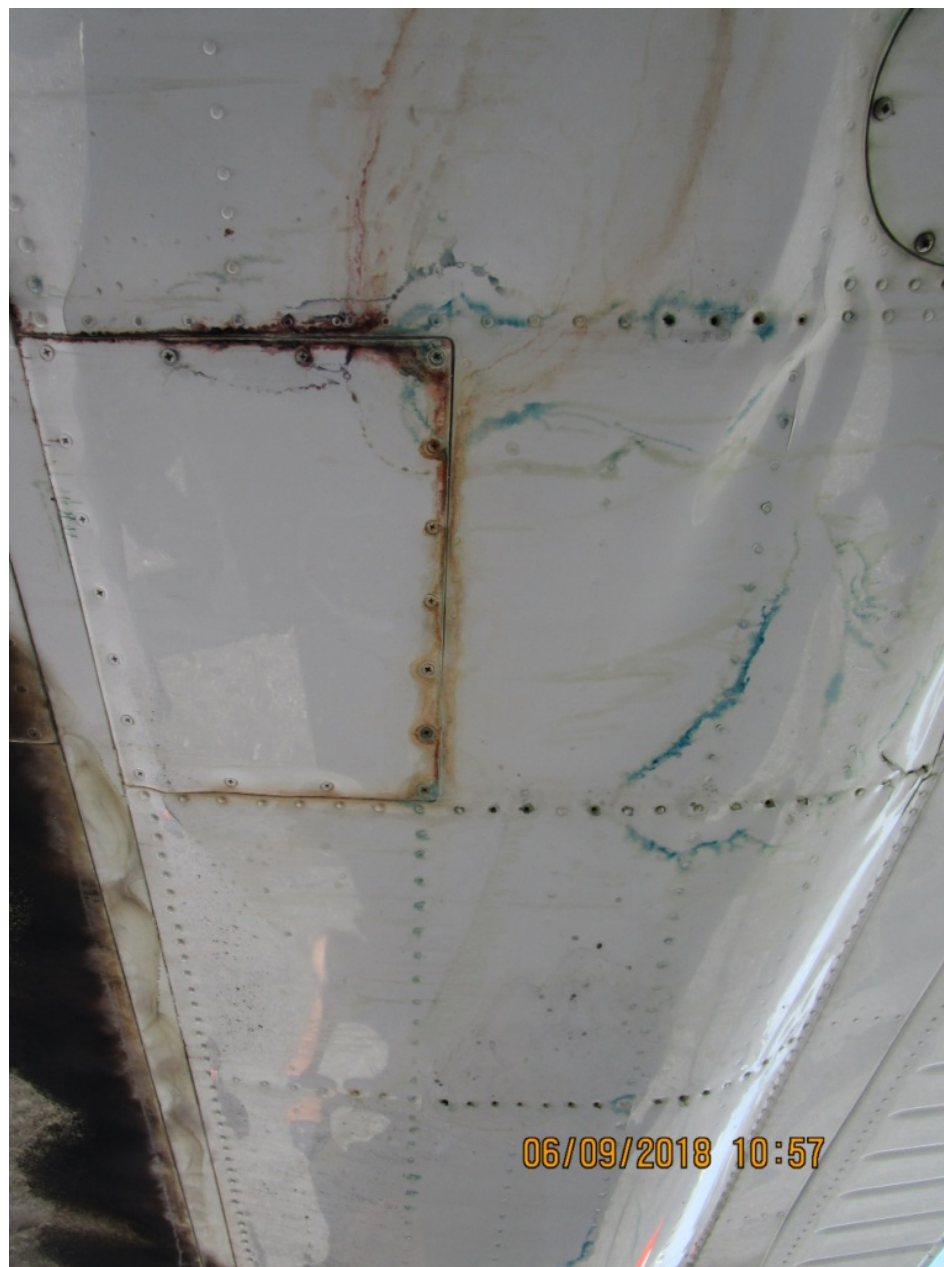
**Photo 7 – View of fuel stains on the bottom side of the right wing (FAA Photos)**

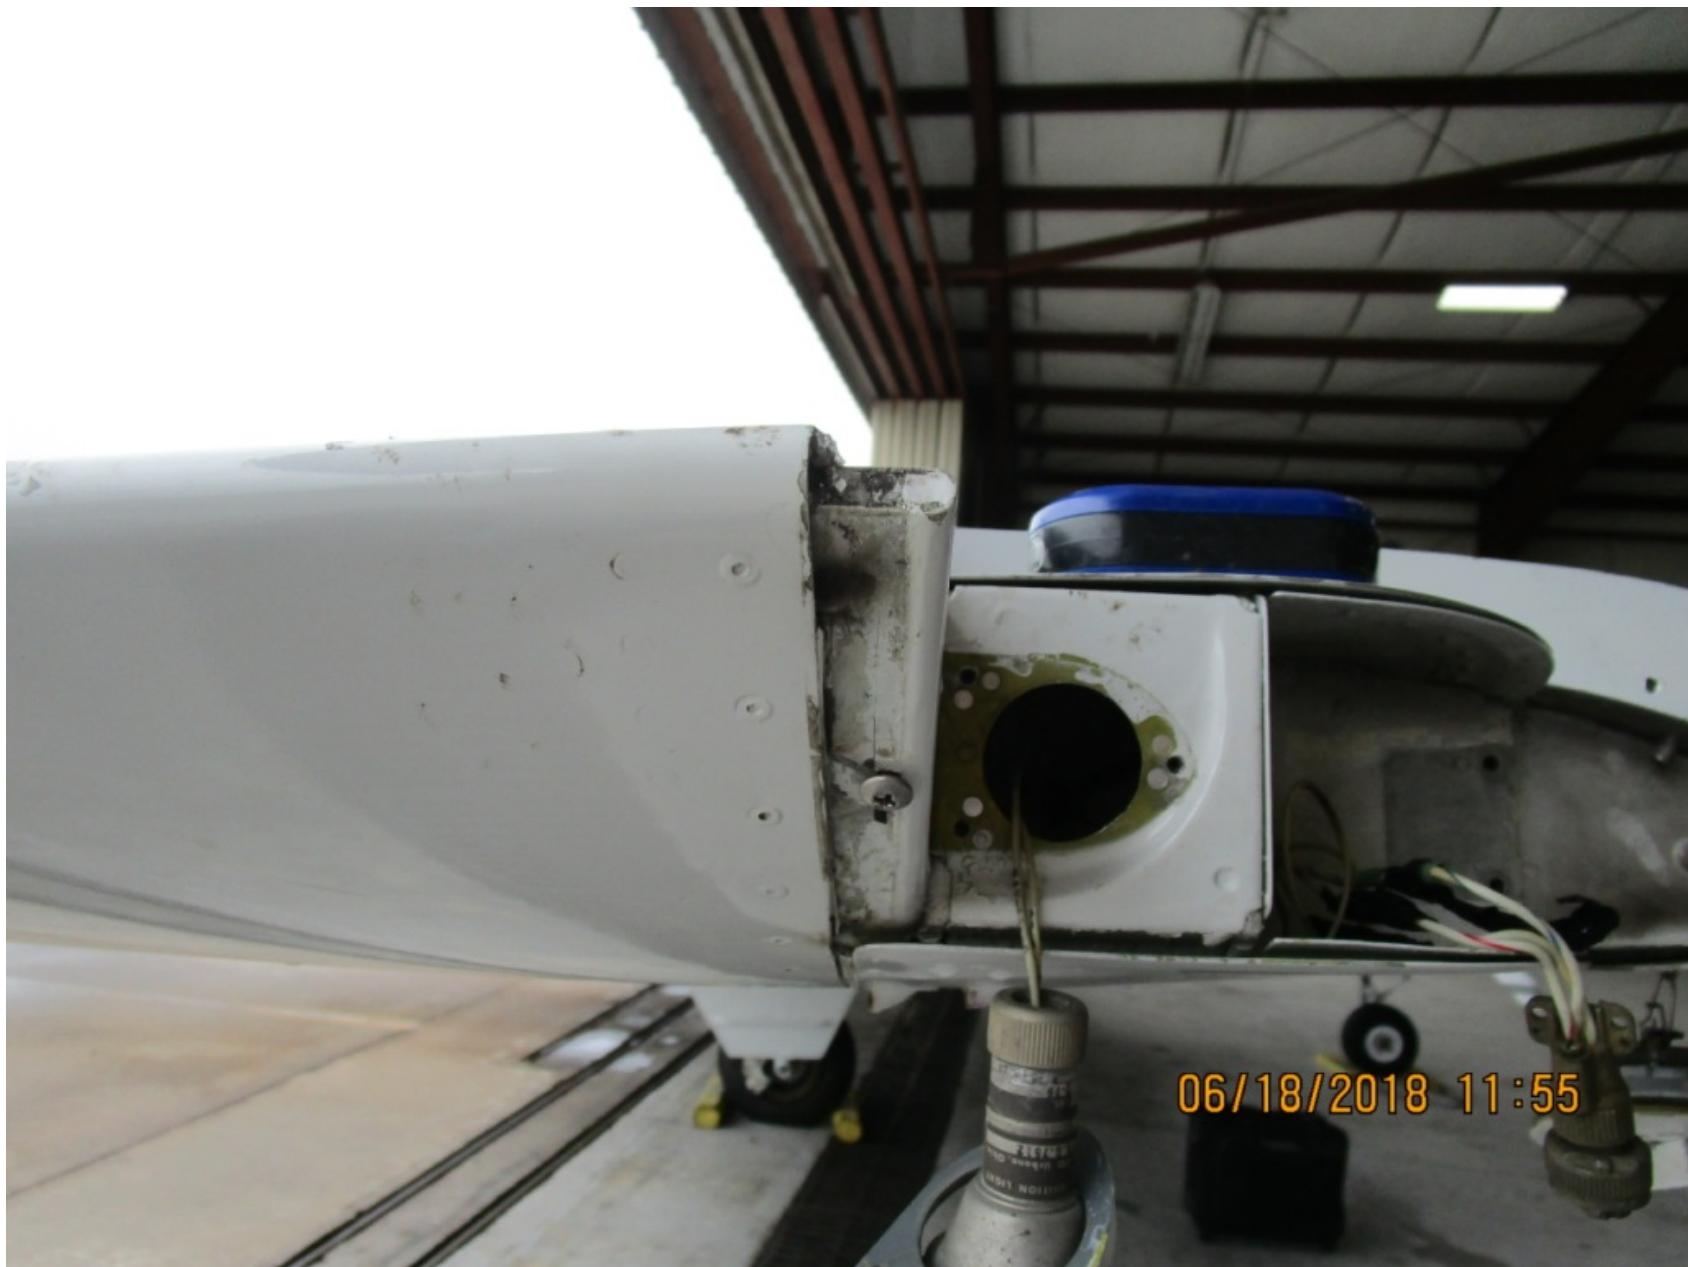
**Photo 8 – View of soot near the right navigation light (FAA Photo)**

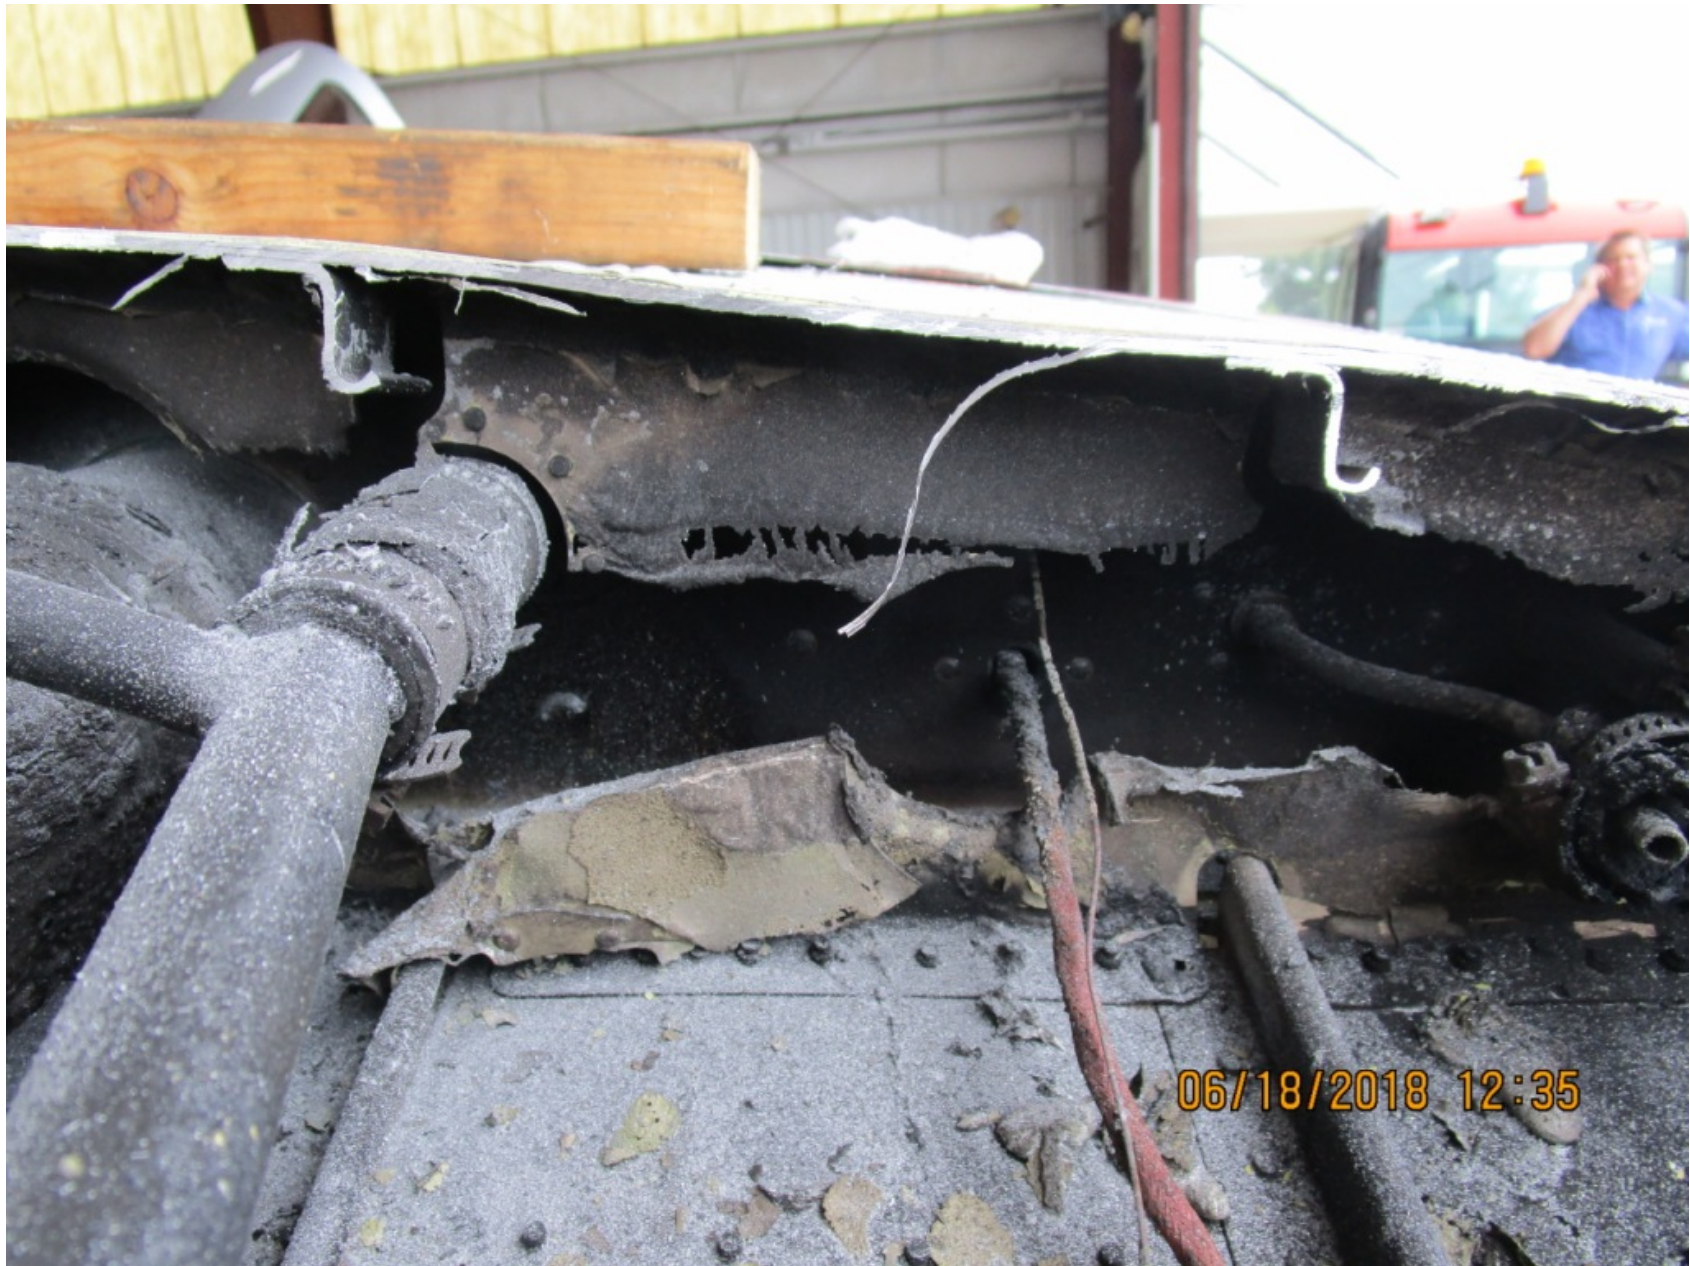
**Photo 9 – View of the fire damage to the inside of the right wing (FAA Photo)**

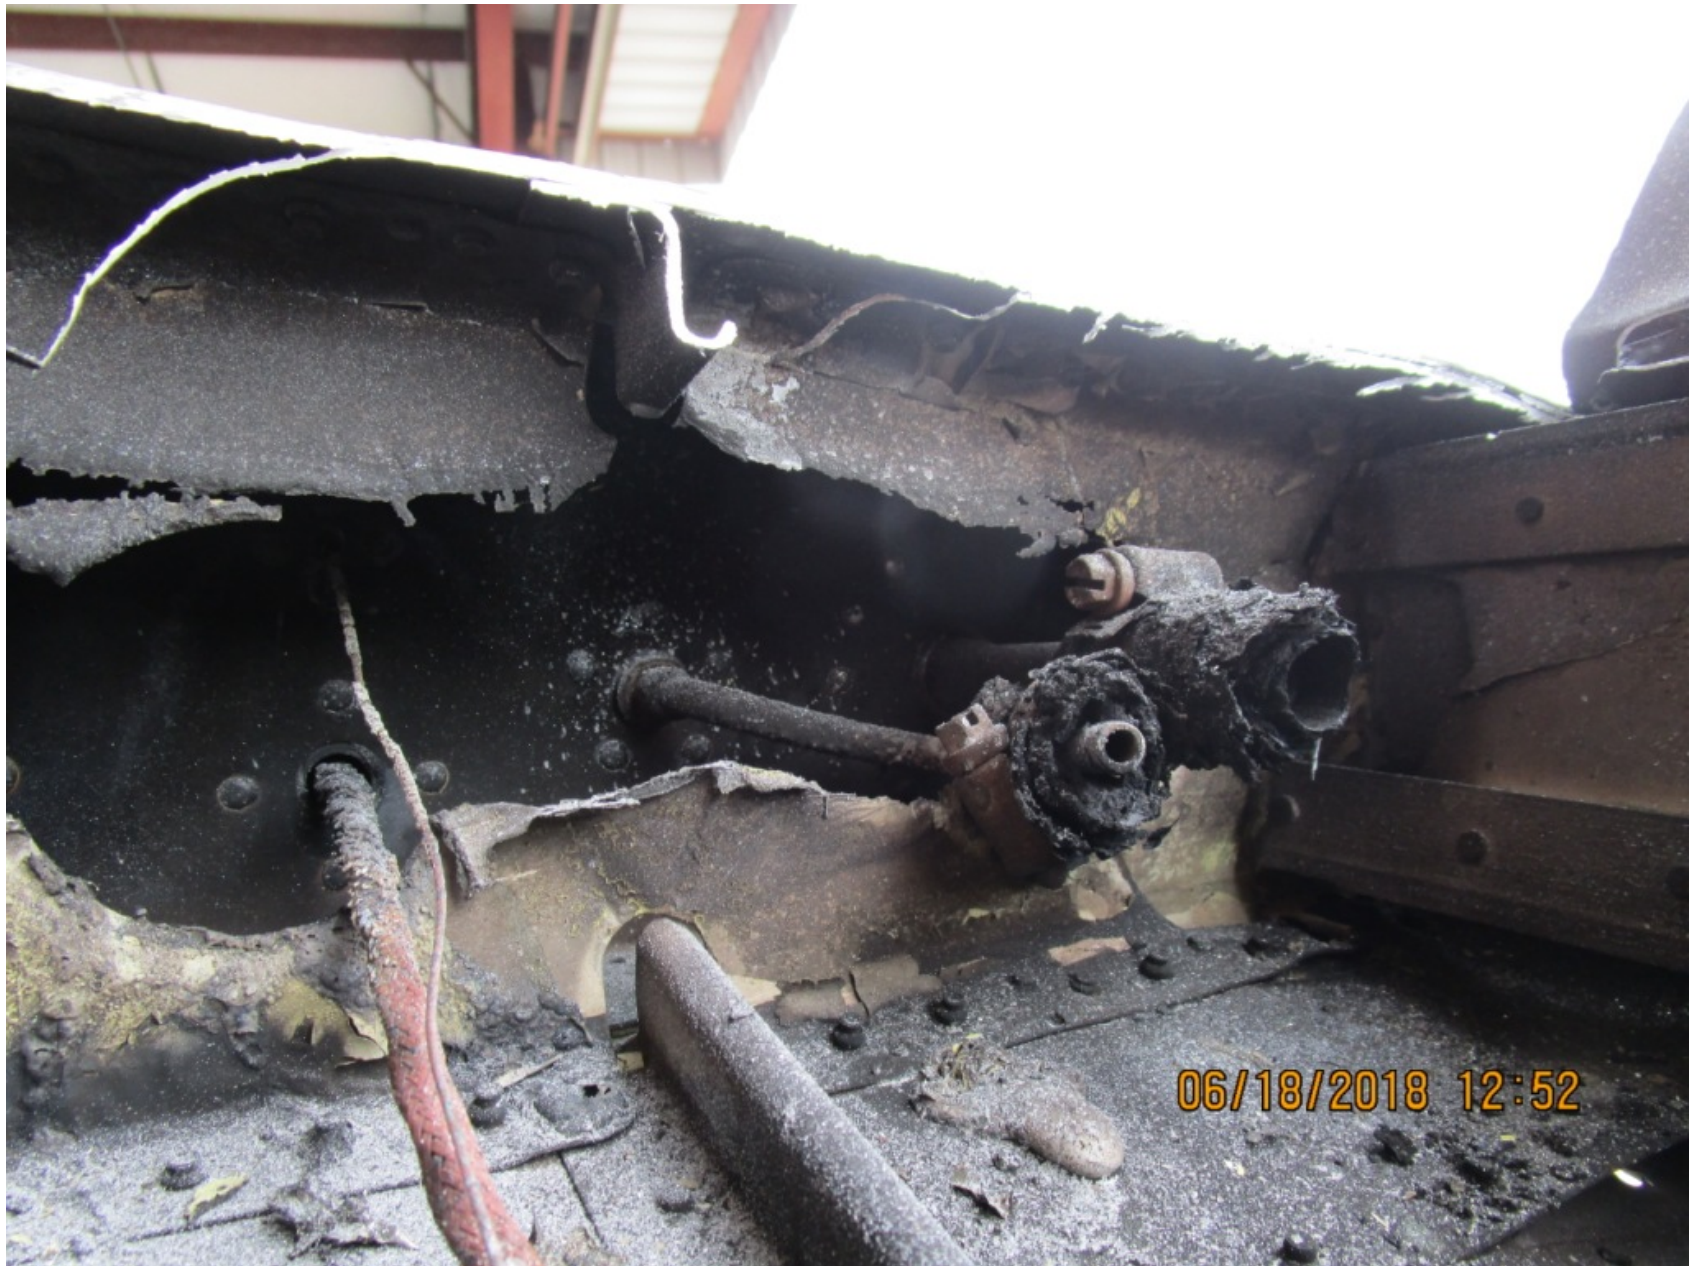
**Photo 10 – View of the fire damage to the inside of the right wing (FAA Photo)**

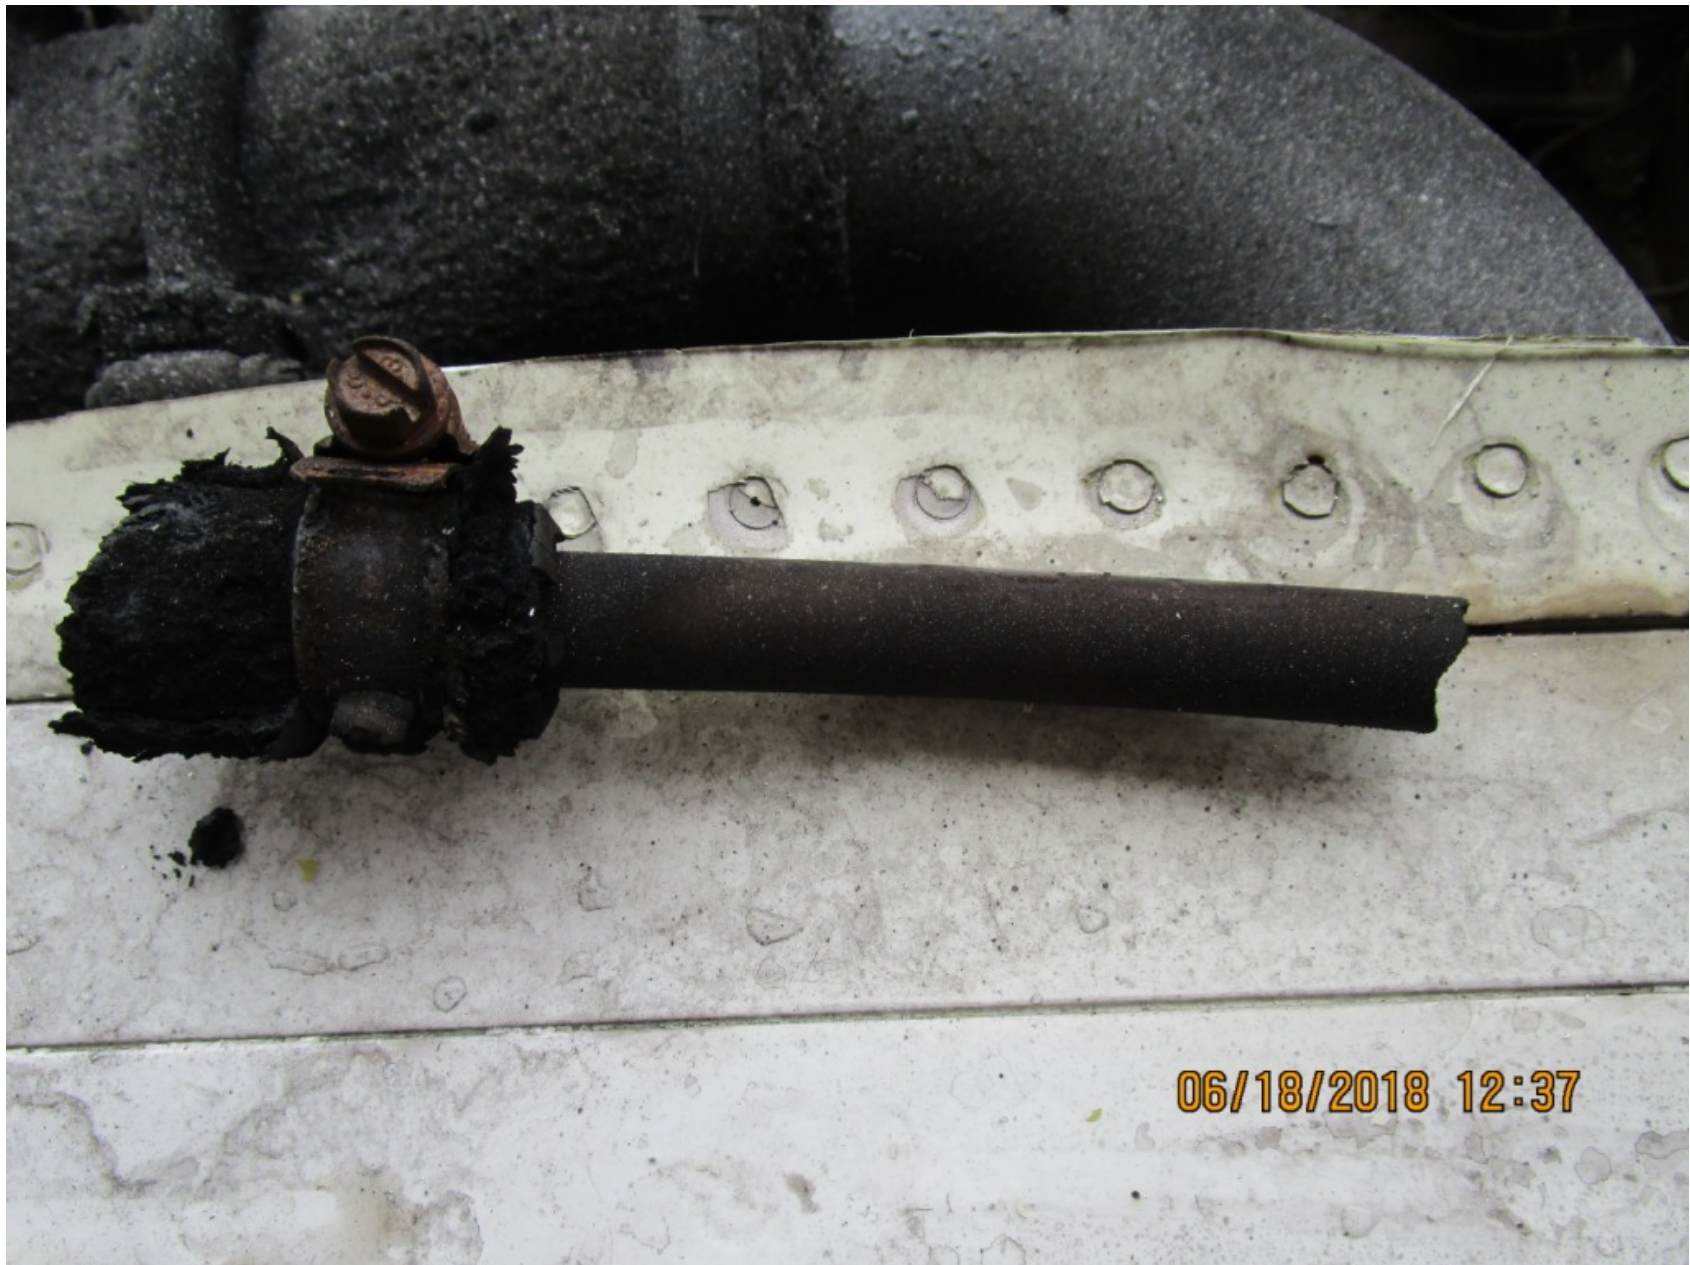
**Photo 11 - View of the fire damage to a line in the right wing (FAA Photo)**
