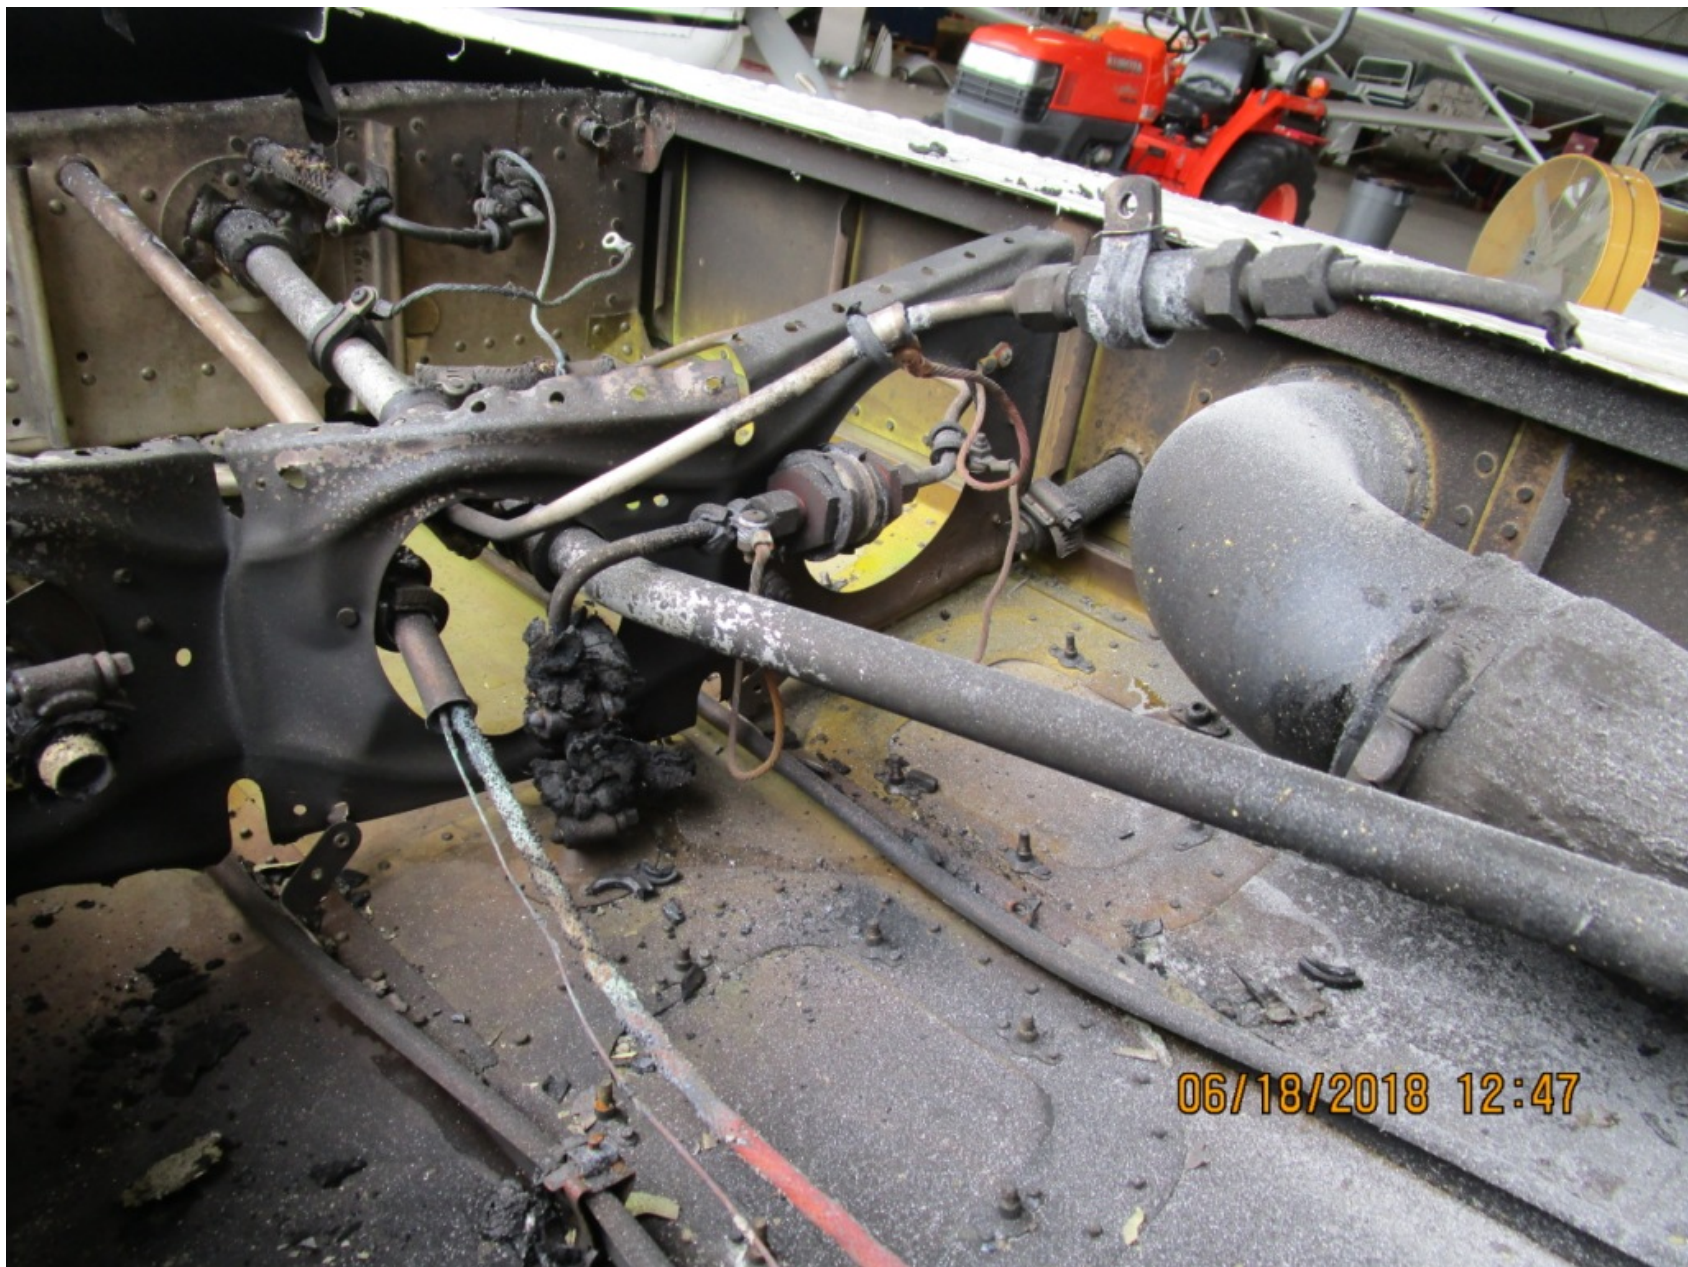
**Photo 12 - View of the fire damage to the inside of the right wing (FAA Photo)**

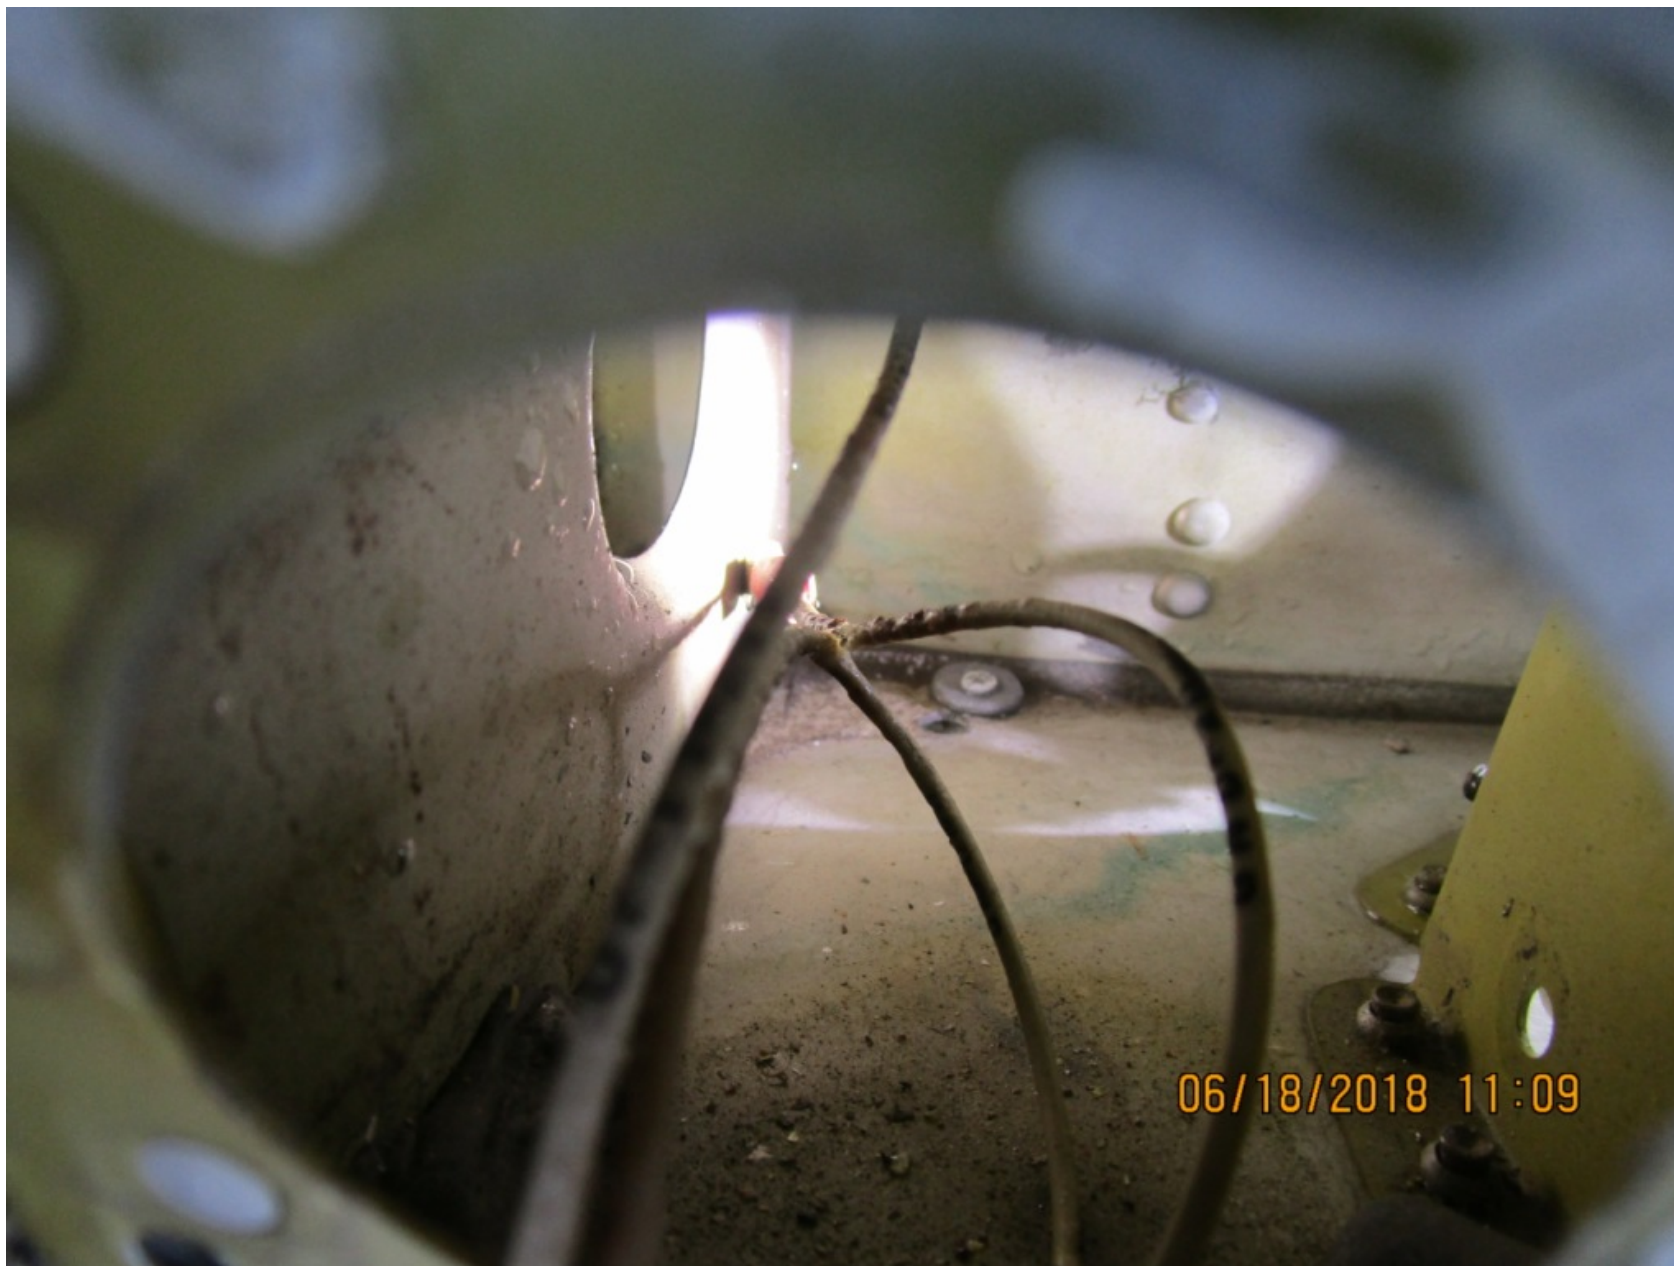
**Photo 13 – View of inside of the wingtip near navigation light (FAA Photo)**

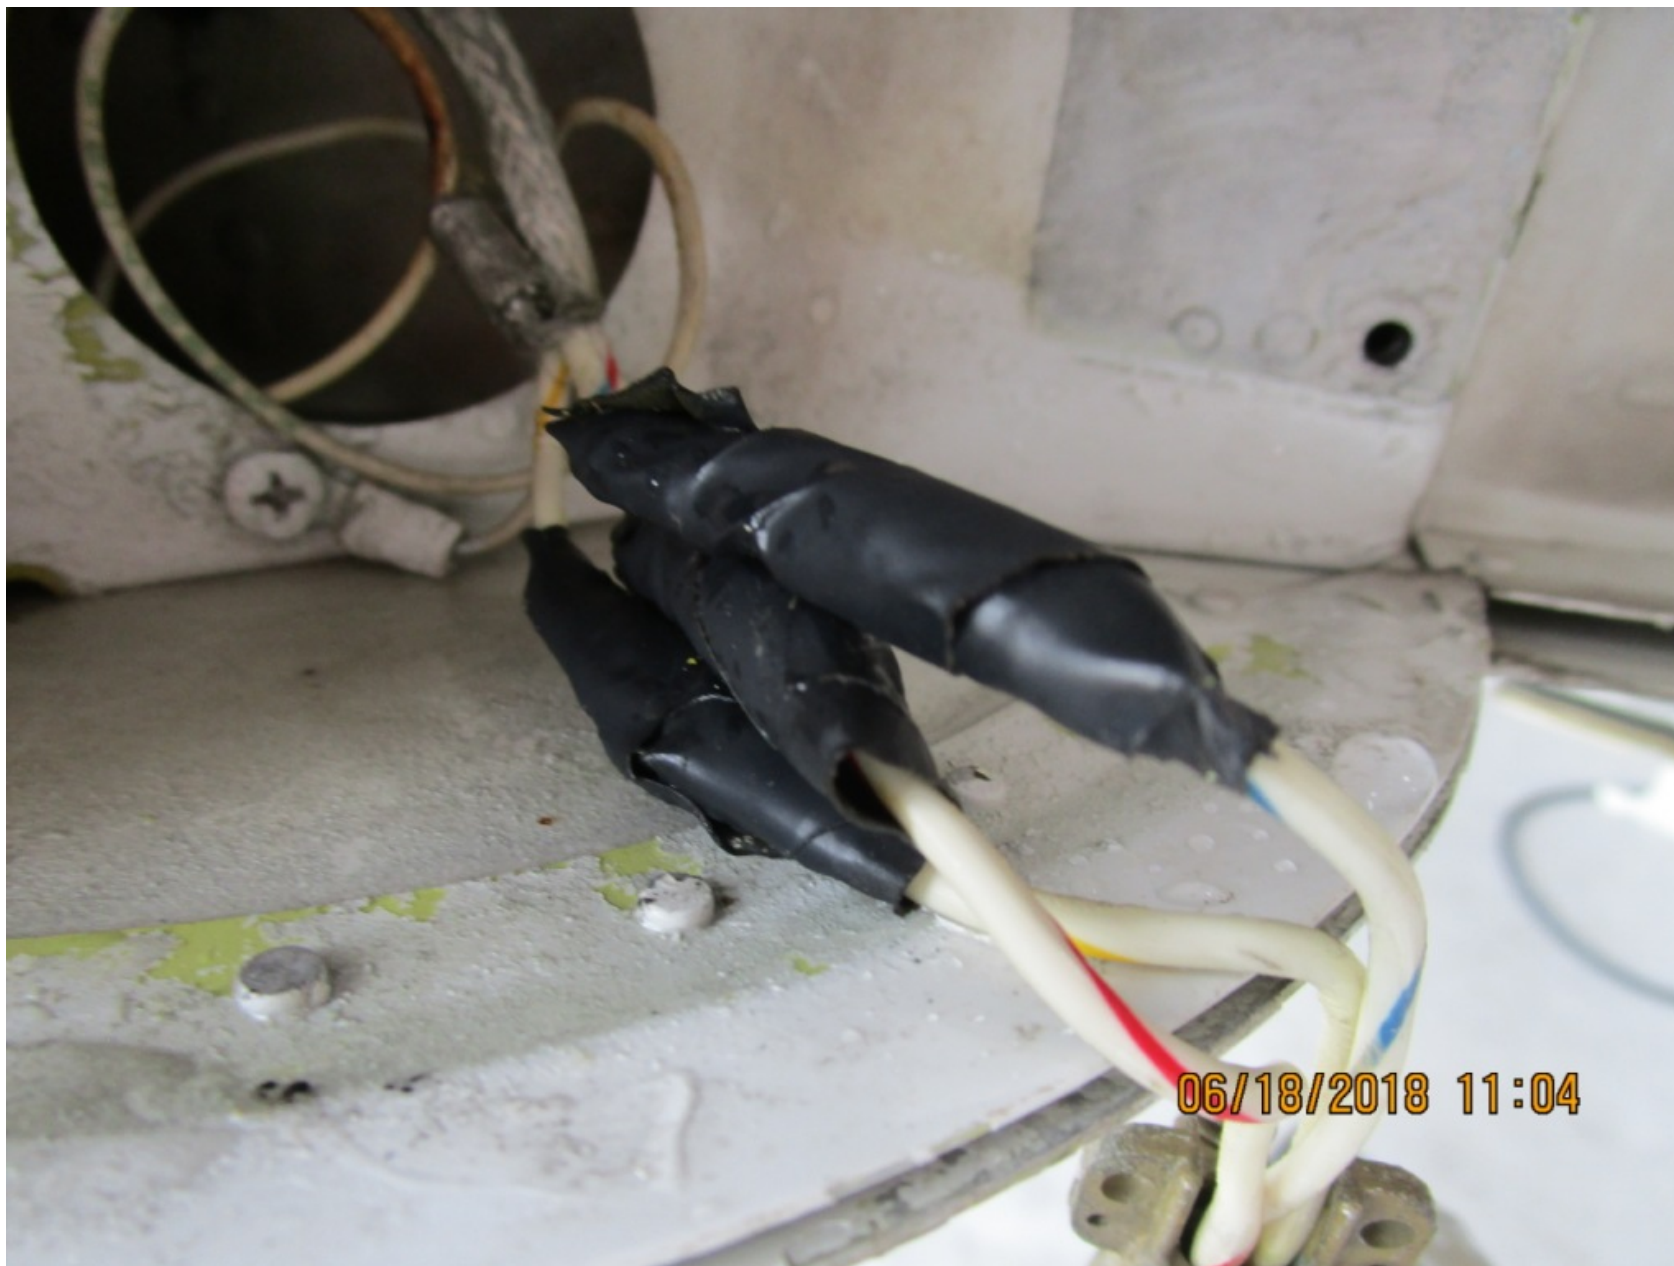
**Photo 14 – View of the wiring wrapped in electrical tape (FAA Photo)**

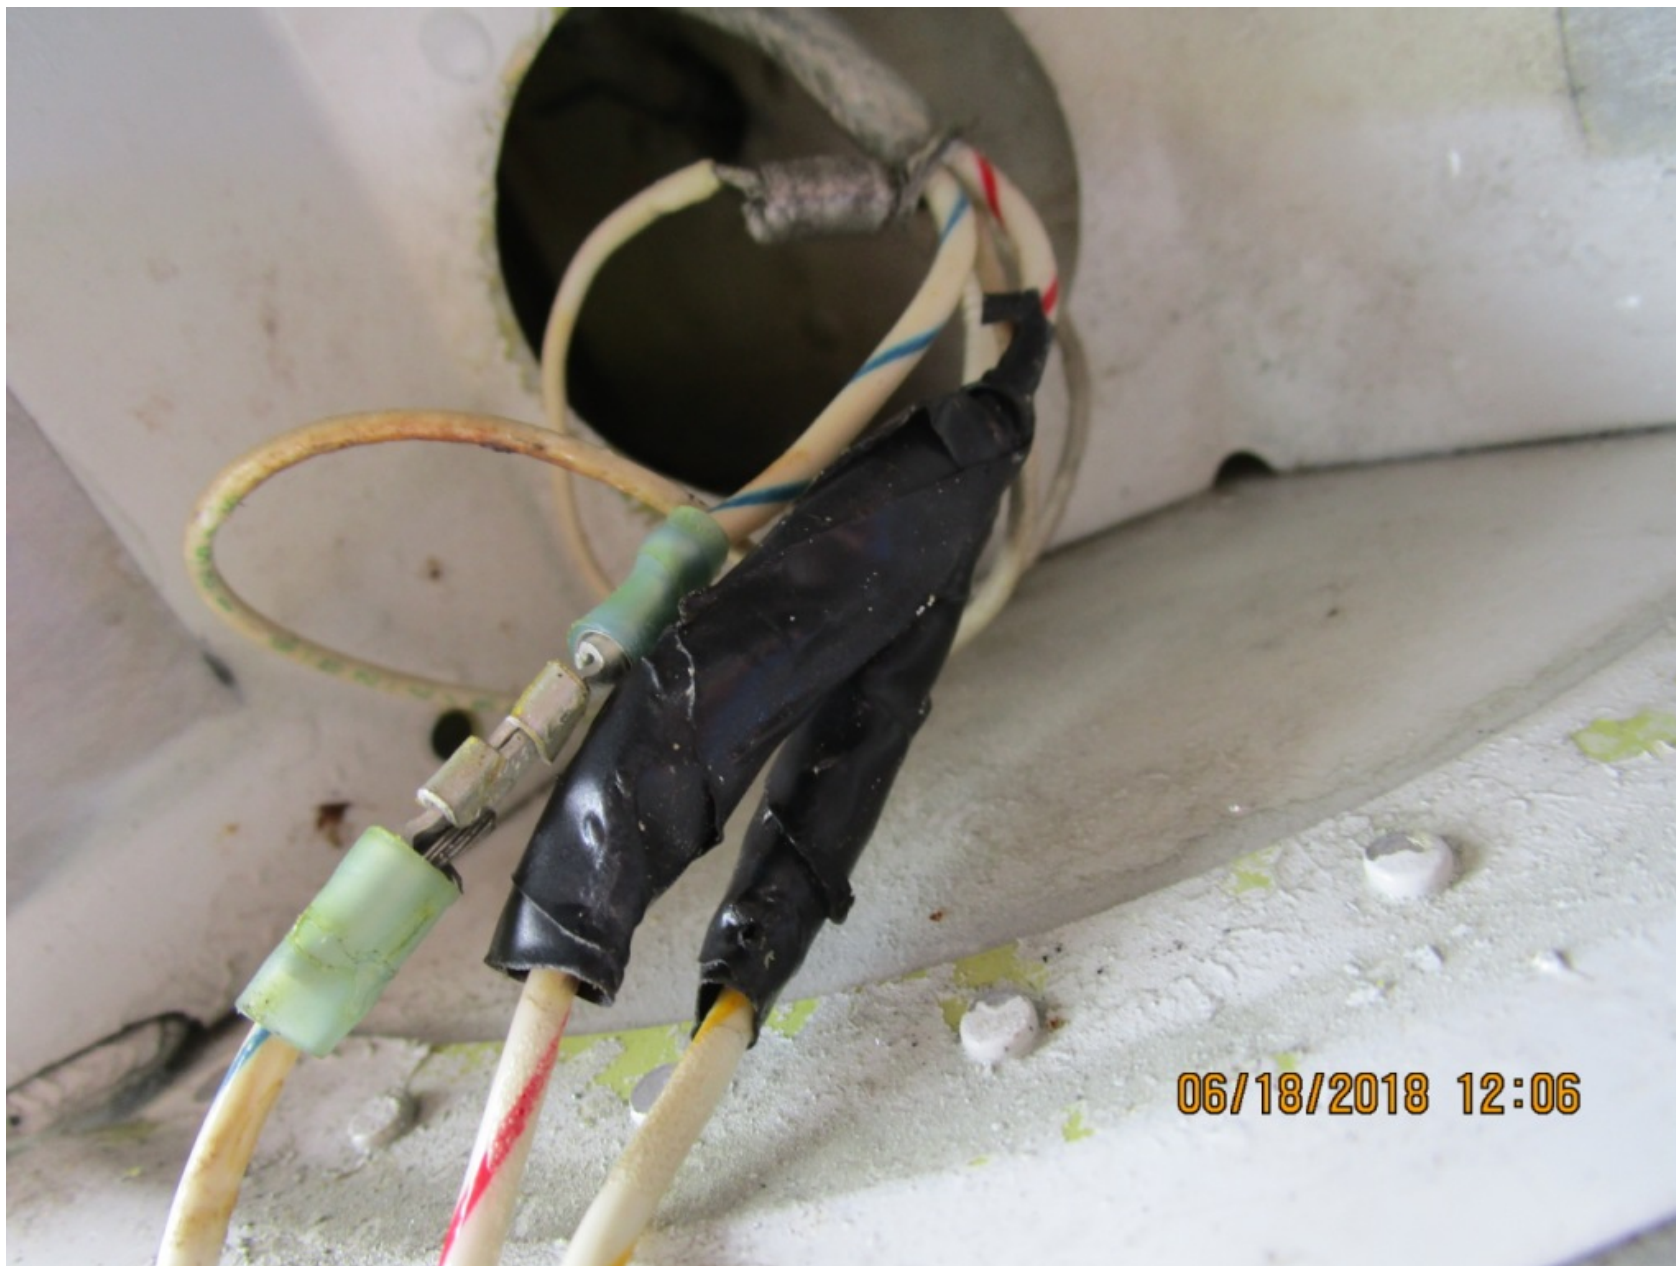
**Photo 15 - View of the wiring wrapped in electrical tape (FAA Photo)**
