# NATIONAL TRANSPORTATION SAFETY BOARD

## MATERIALS LABORATORY FACTUAL REPORT

Report No. 19-038

Place : Aguilares, TX  
Date : 7/2/2018  
Vehicle : Safari Helicopter  
NTSB No. : CEN18LA247  
Investigator : Jennifer Rodi

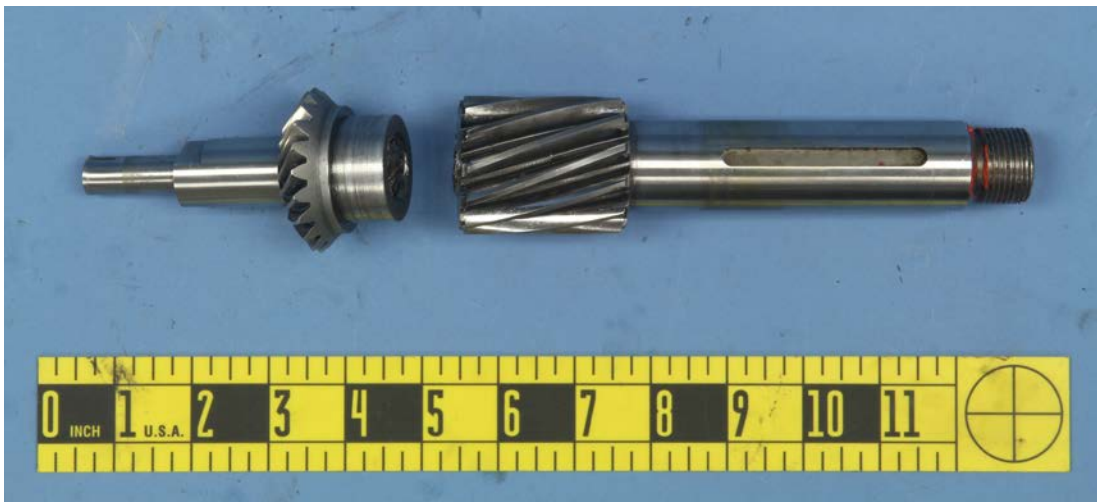
The tail rotor pinion shaft fractured between the portion carrying a beveled gear and that containing the helical gear (figure 1). The beveled gear had been attached to a keyed extension of the pinion shaft. Both halves of the pinion shaft fracture surface exhibited mechanical damage by recontact resulting in rubbing of the fracture surfaces (figures 2, 3). No evidence of a preexisting crack was observed during the examination of the fracture surfaces. The overall fracture macro-morphology was consistent with bending overstress. Spalling craters were observed on the flanks of some of the helical gear teeth (figure 4).

Figure 1: Two portions of a tail rotor pinion shaft as received.

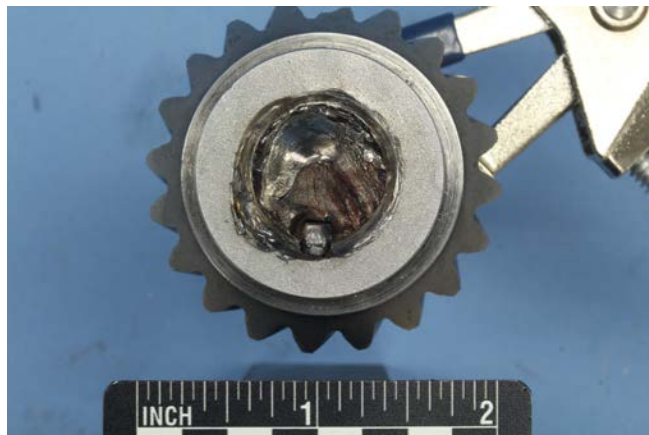
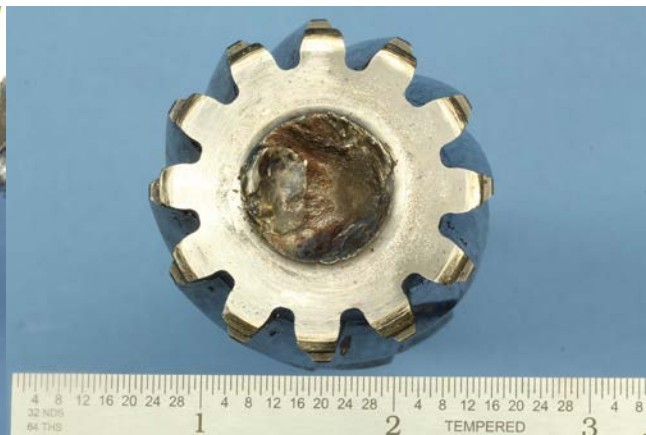
Figure 2: Fracture surface on both the beveled gear side and helical gear side.

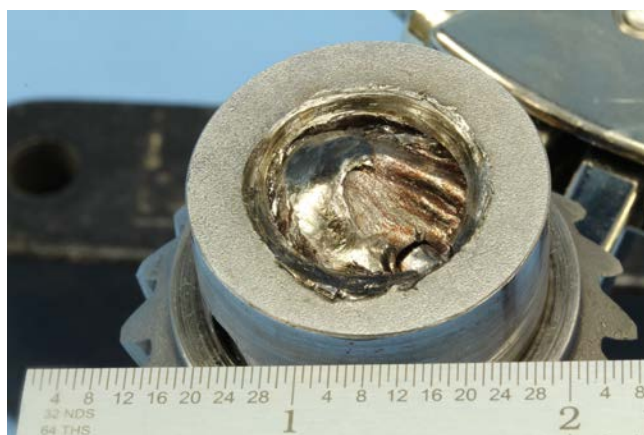
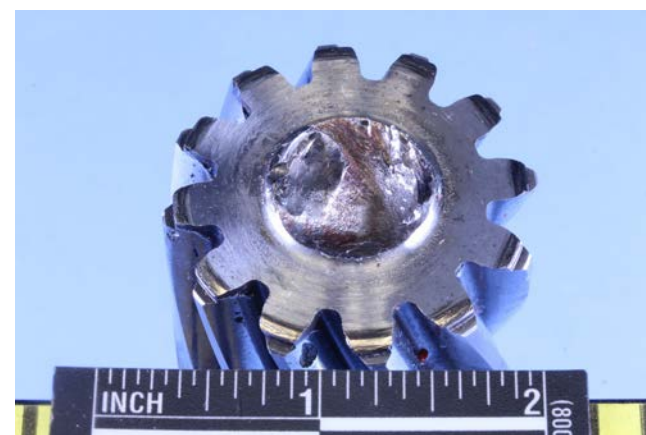
Figure 3: Fracture surface on both the beveled gear side and helical gear side.

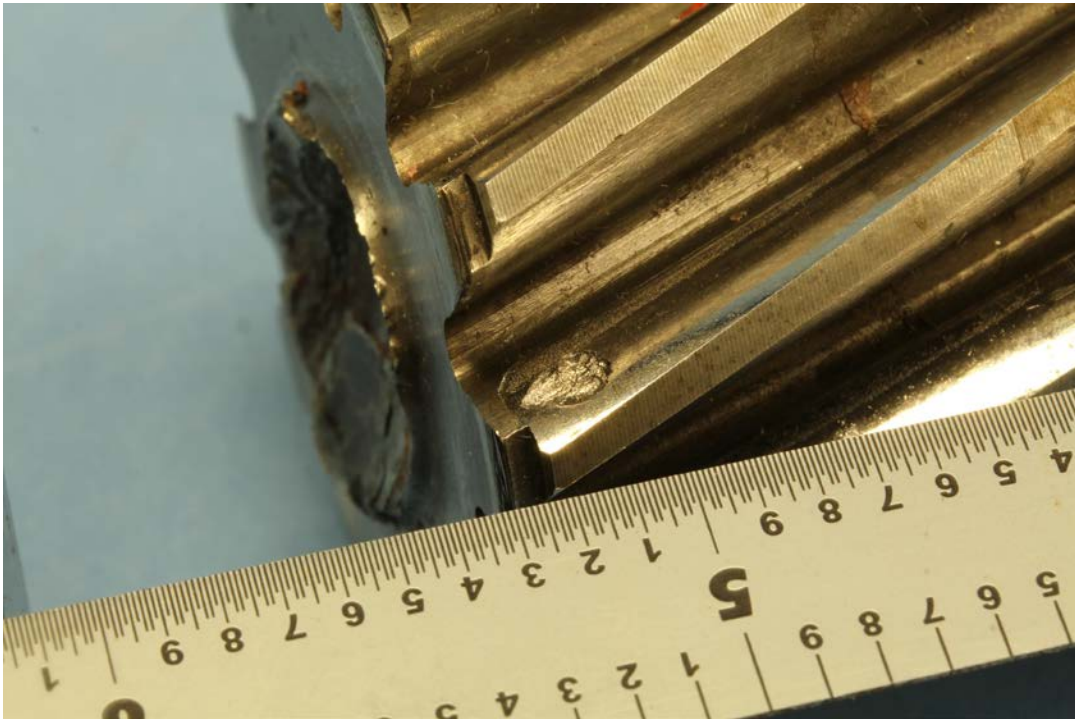
Figure 4: Spalling crater on flank of helical gear tooth.

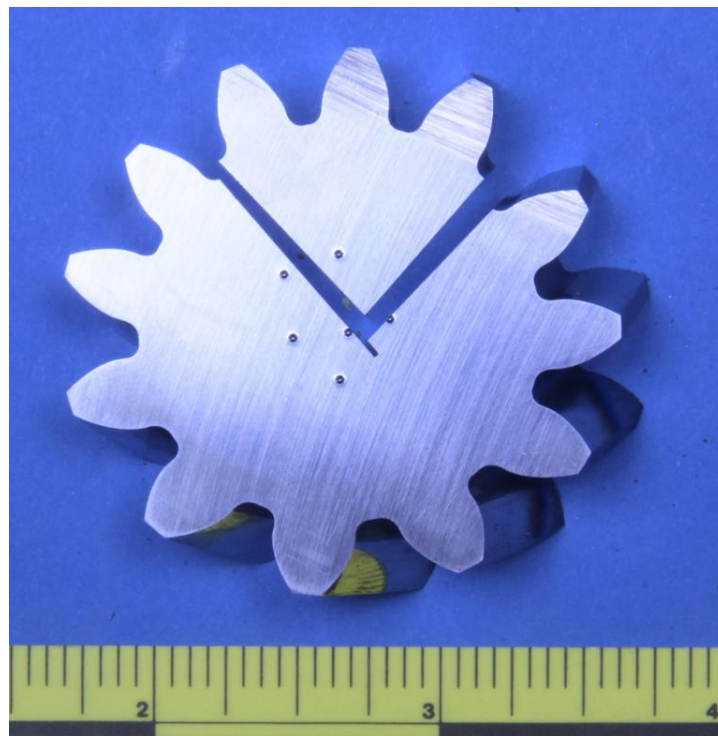
The pinion shaft was sectioned as shown in figure 5. A metallurgical mount was prepared from a portion of that section to examine the pinion shaft and helical gear tooth microstructure. The micrographs in figures 6, 7 exhibit a martensitic microstructure consistent with carburization case hardening.

Figure 5: Section cut from helical gear portion of pinion shaft for metallographic examination.

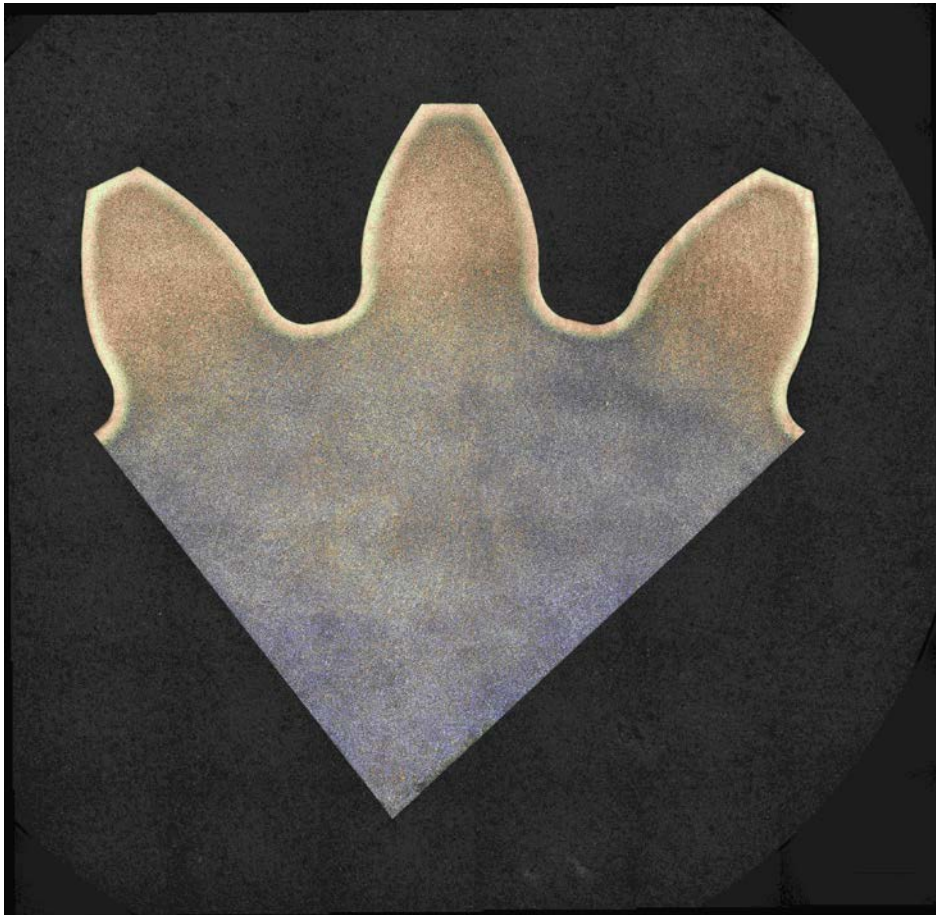
Figure 6: Micrograph of polished and etched portion of the pinion shaft and helical gear.

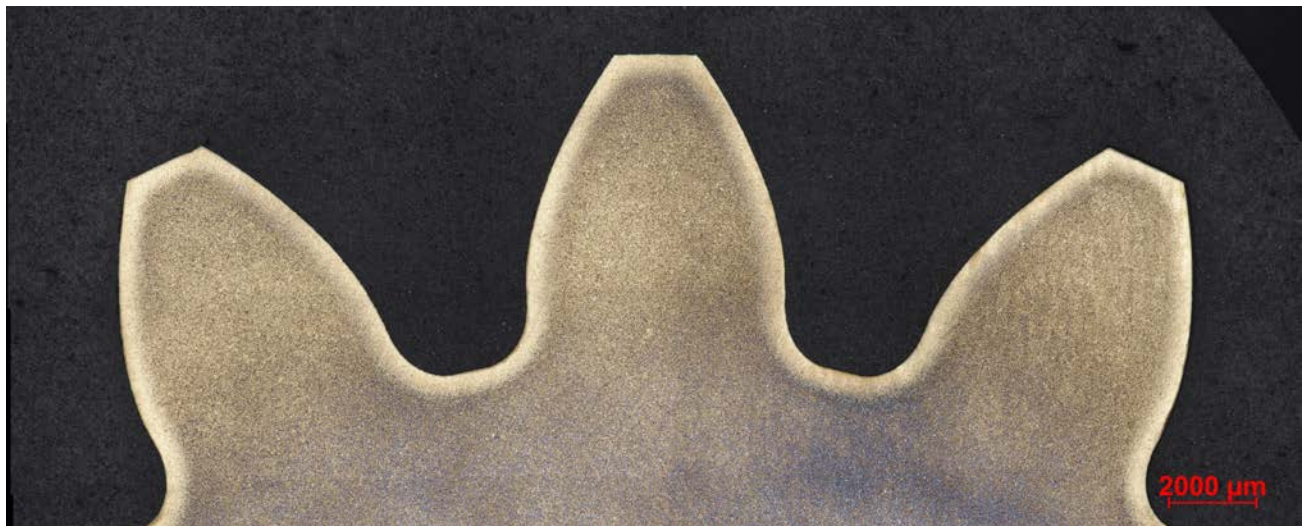
Figure 7: Micrograph of polished and etched portion of the pinion shaft and helical gear.
