# NATIONAL TRANSPORTATION SAFETY BOARD

## MATERIALS LABORATORY FACTUAL REPORT

Report No. 18-071

Place : Lago Vista, TX  
Date : 7/1/2018  
Vehicle : Cessna 180, N2469C  
NTSB No. : CEN18LA250  
Investigator : Andrew Todd Fox

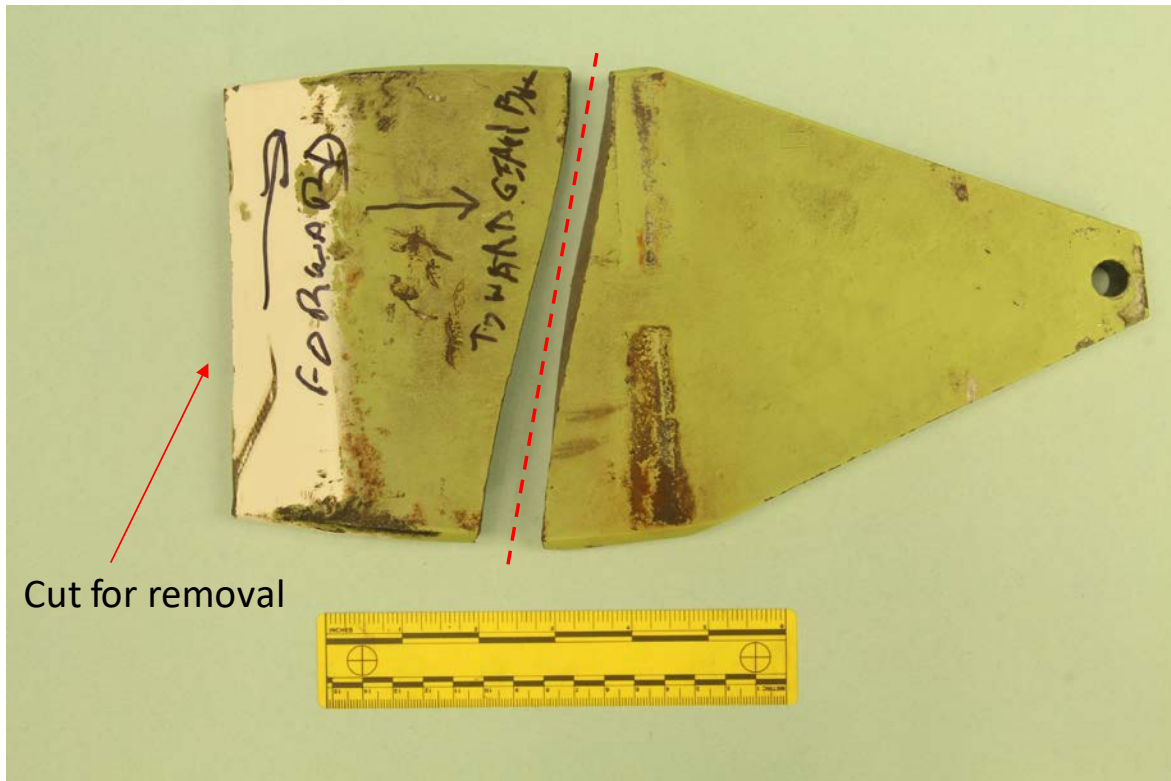
Portions of left main landing gear (figure 1).

Figure 1: Portions of main landing gear spring as received. Fracture along dotted line.

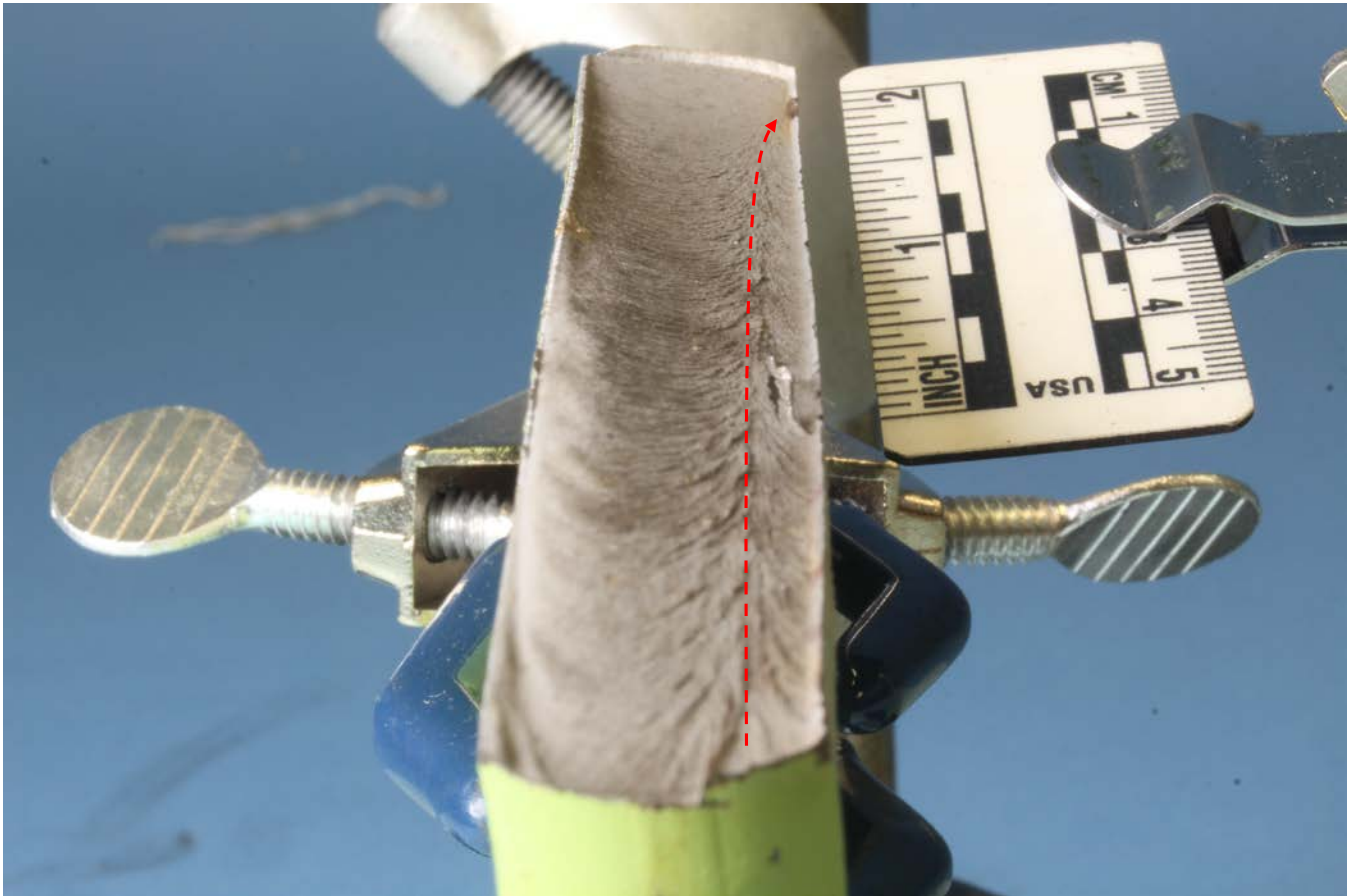
The fracture surface between the two portions of the left main landing gear spring was a relatively flat surface with a distinct shear lip along the periphery. Close examination of the fracture surface revealed a chevron pattern indicating the direction of crack propagation. The chevron pattern was traced back to an initiation point (figure 2) where a distinct thumbnail shaped area was identified (figure 3). The thumbnail shaped area is consistent with a multiple-origin fatigue crack (figure 4). The approximate dimension of the fatigue crack was 0.14 inch wide and 0.04 inch deep. The location of the fatigue crack is shown in figure 5 along with the outline of contact points of the spring with the landing gear fixation hardware.

Figure 2: Fracture surface with chevron marks leading back to a fracture origin.

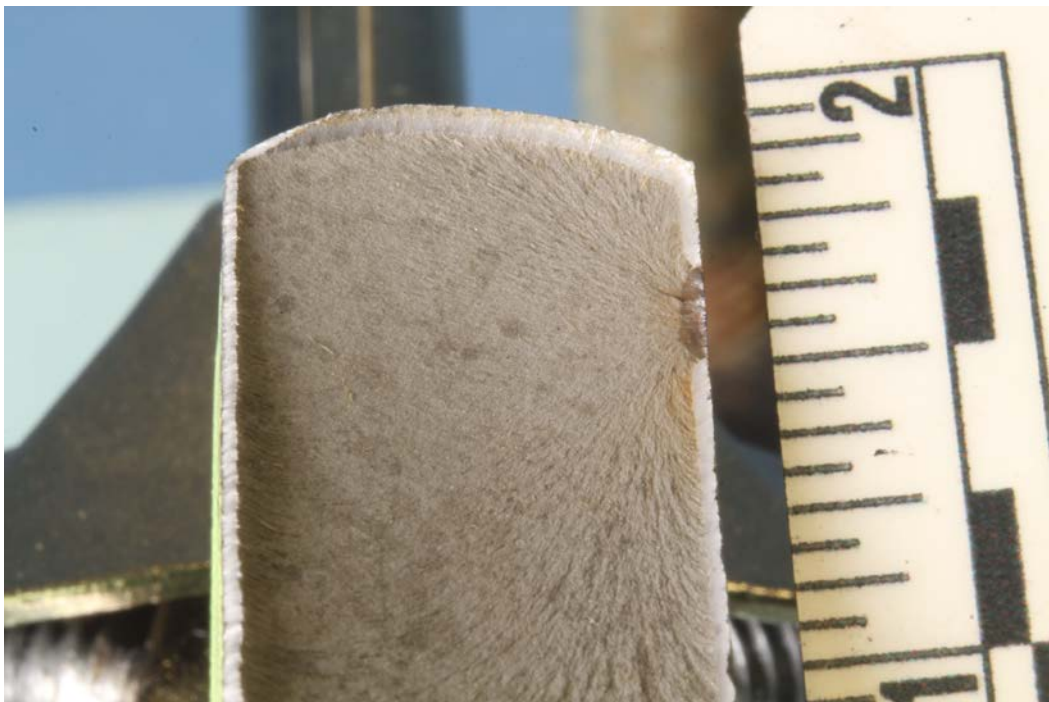
Figure 3: Thumbnail shaped area at the fracture origin.

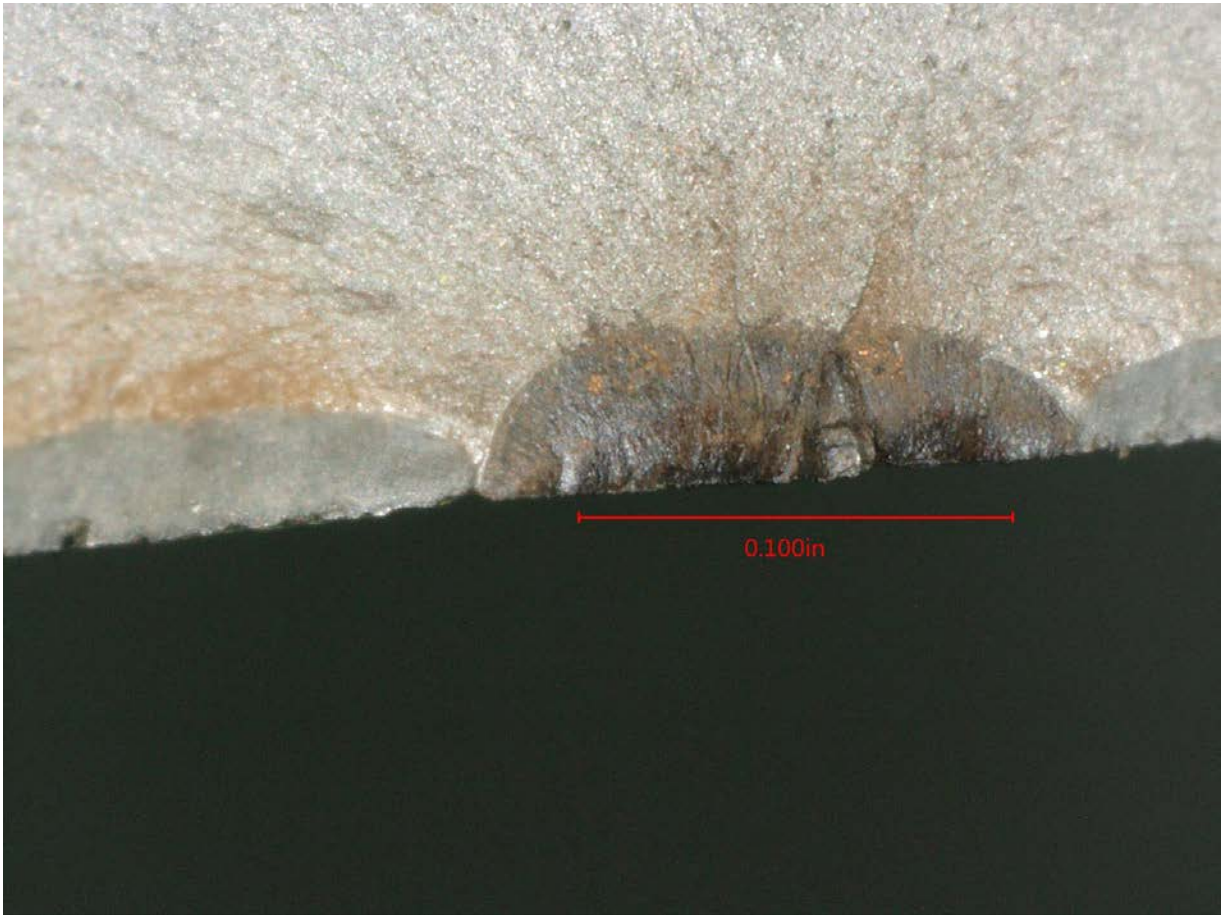
Figure 4:Thumbnail shaped fatigue crack at fracture origin.

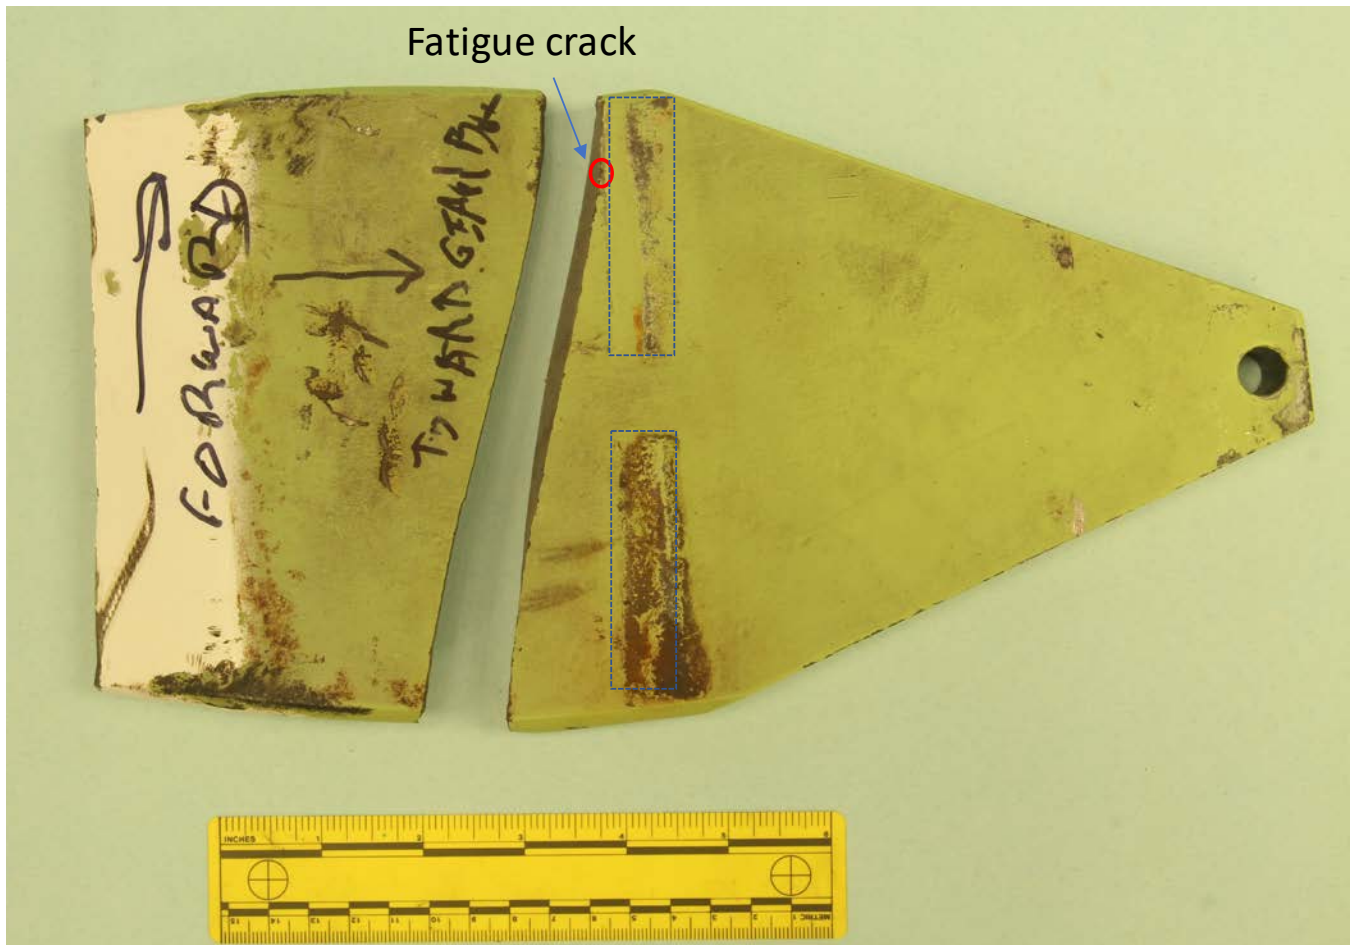
Figure 5: Location of fatigue crack relative to spring and spring fixation contact points. Fixation contact points outlined in blue dotted line. Fatigue crack circled in red.
