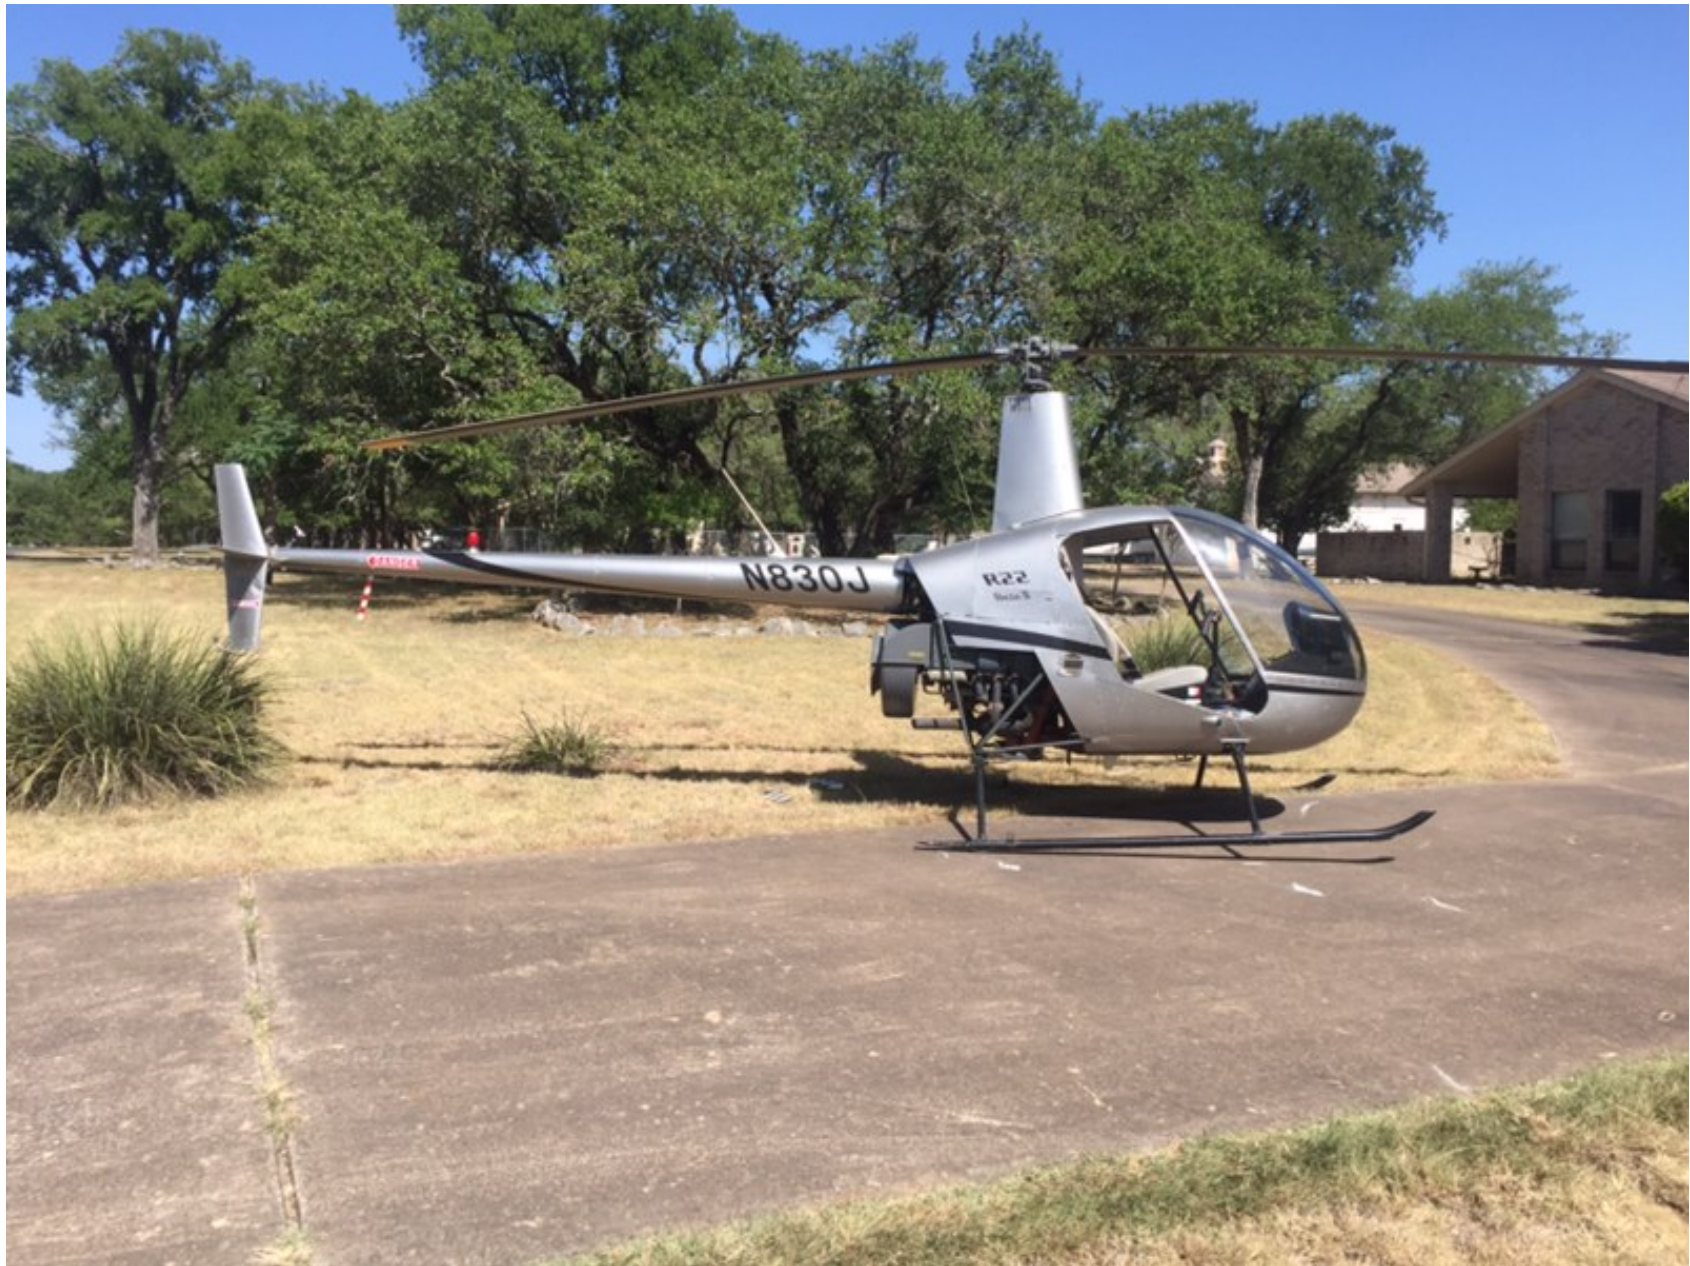
**Photo 1 – View of the helicopter in the residential community (courtesy of the flight instructor).**

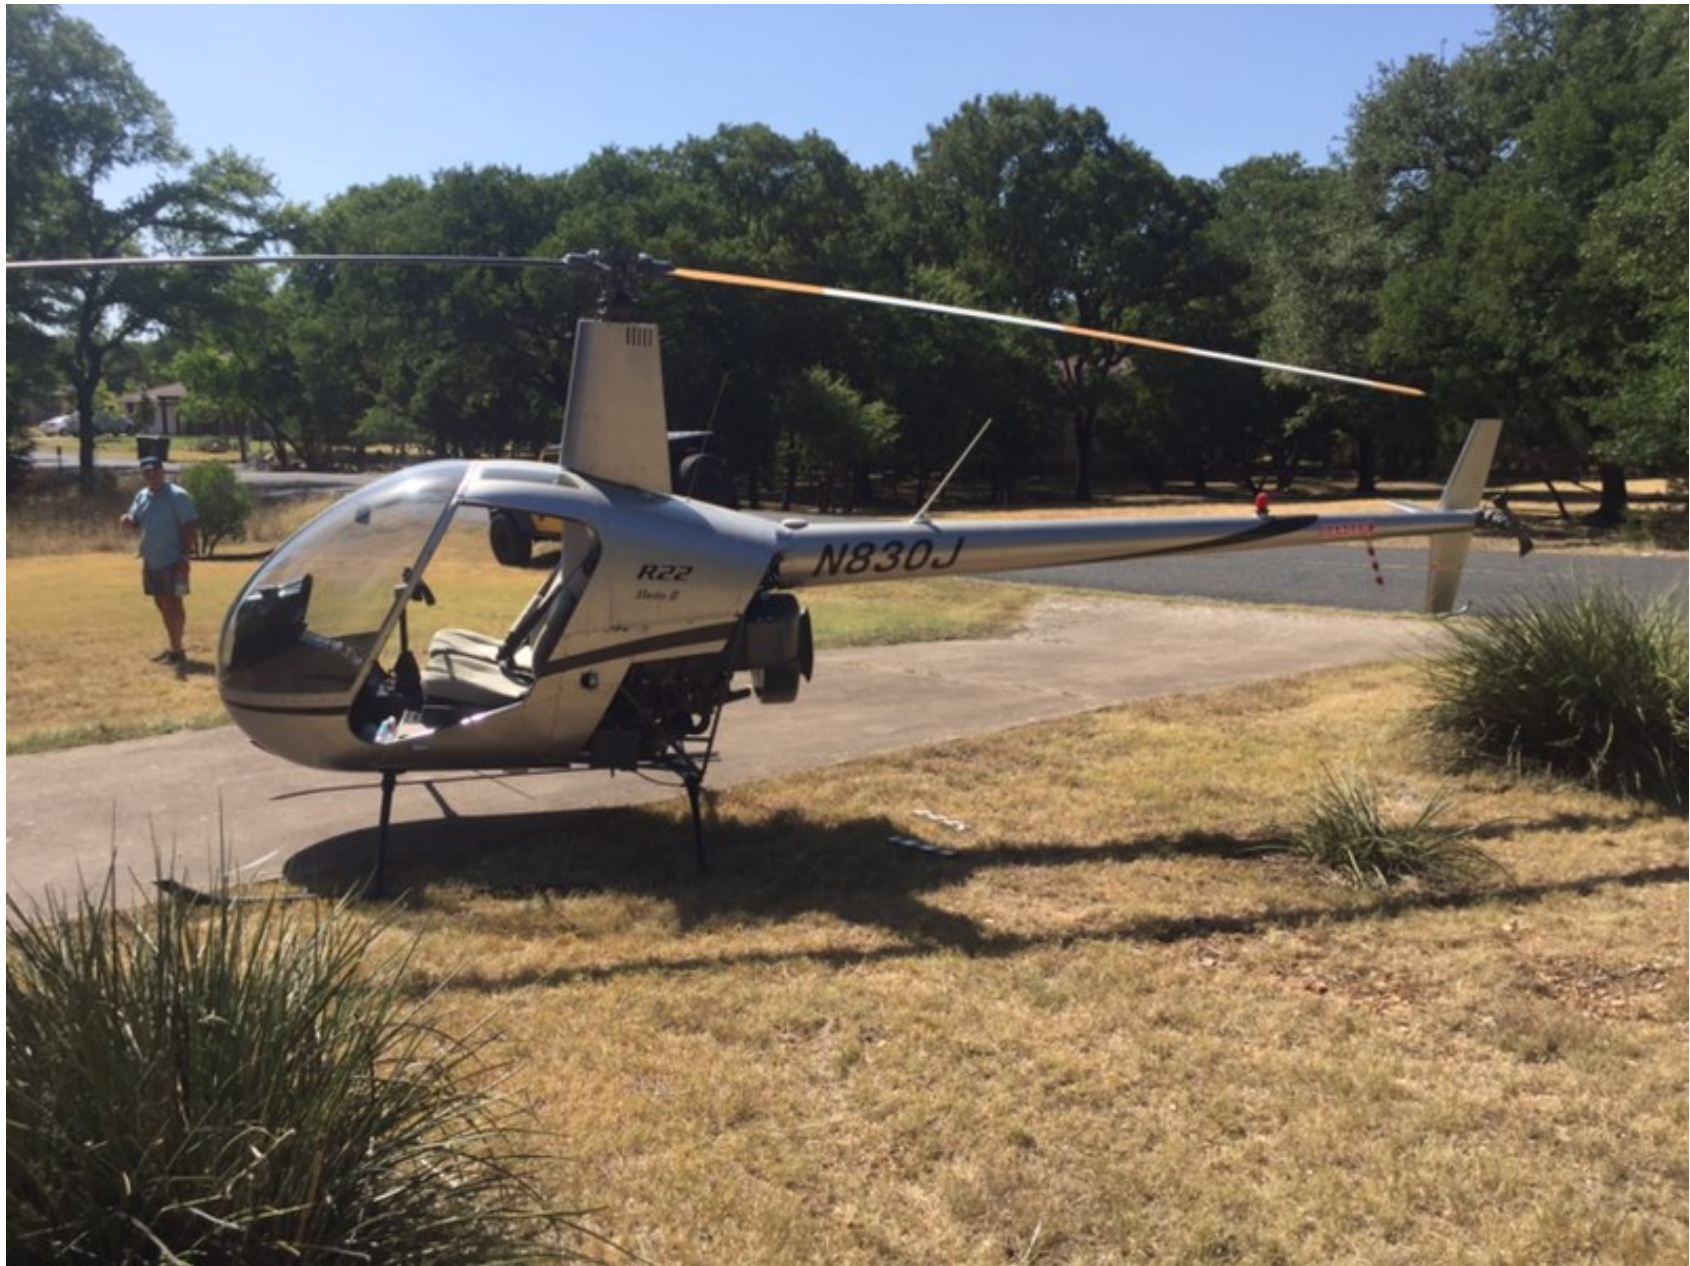
**Photo 2 – View of the helicopter in the residential community (courtesy of the flight instructor).**

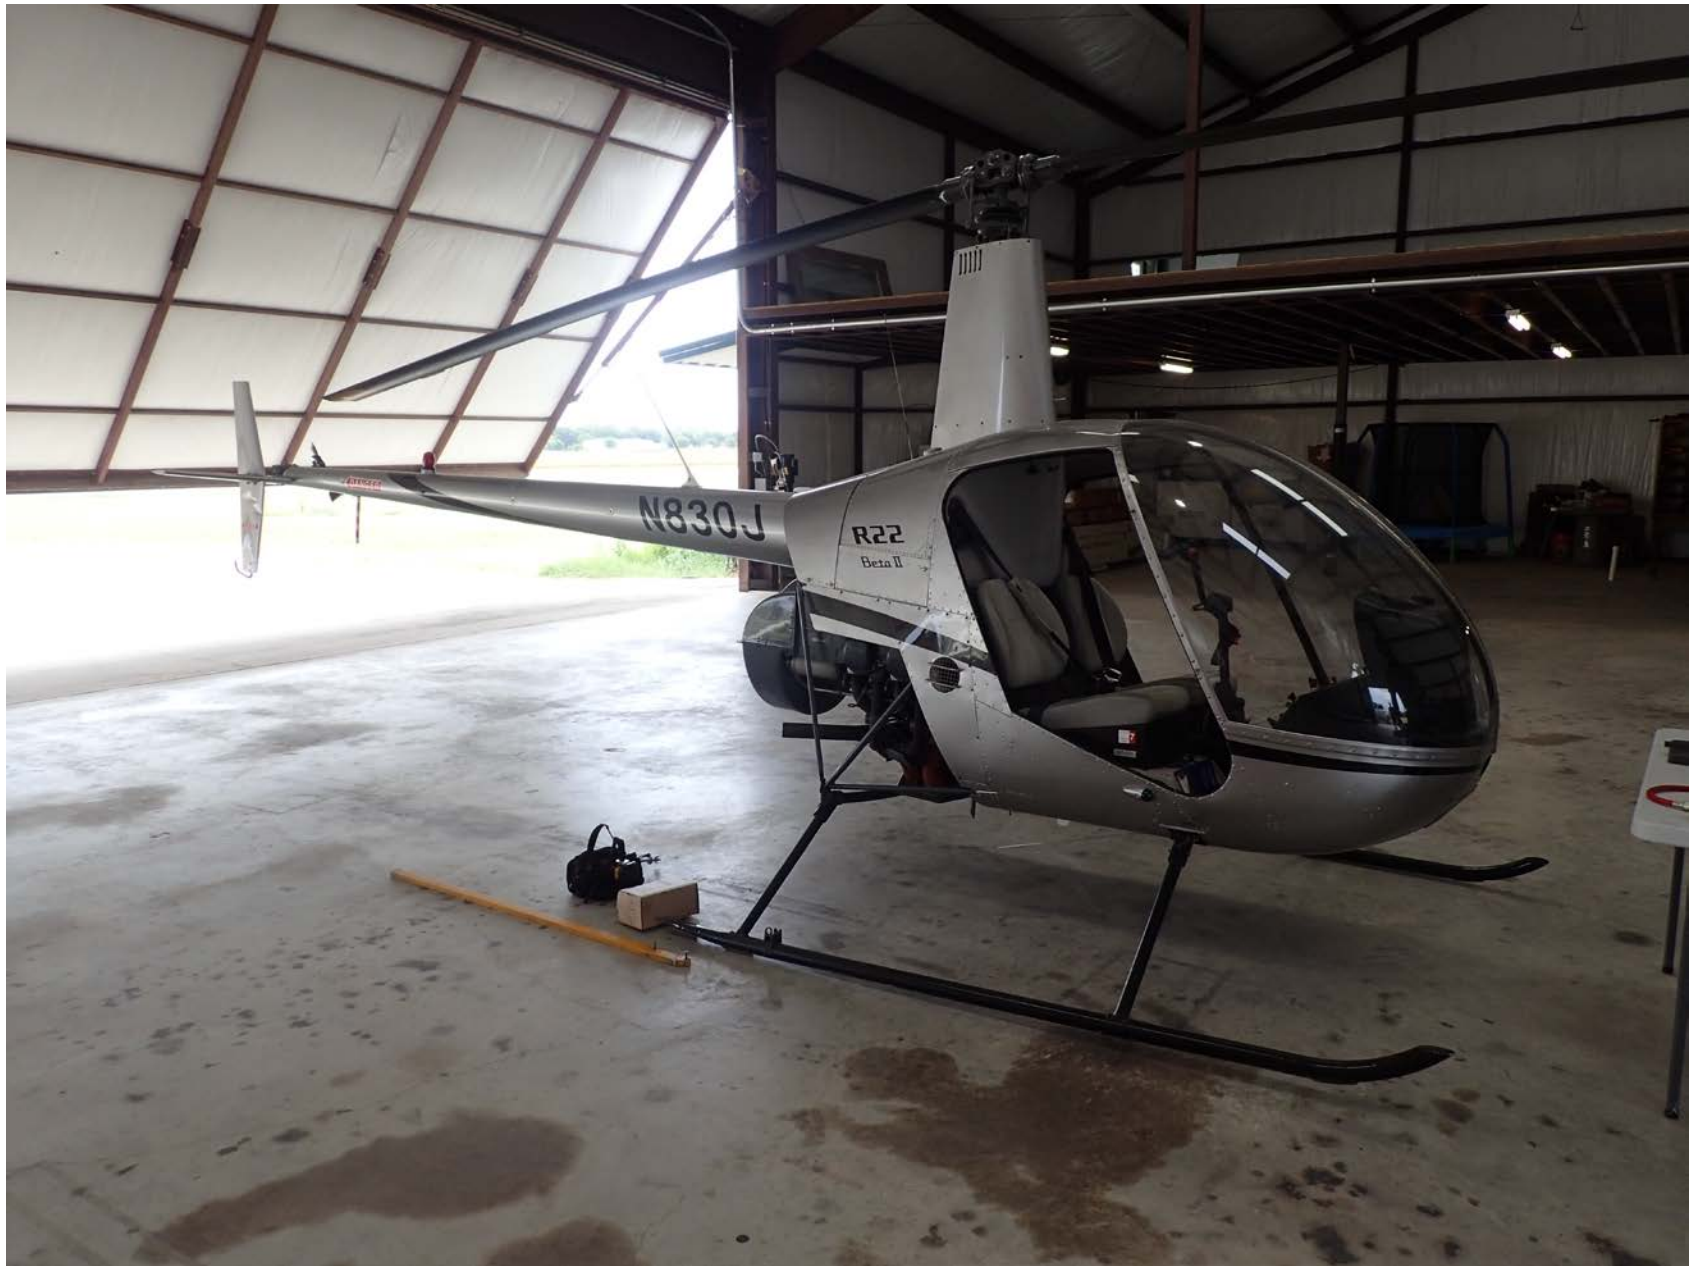
**Photo 3 – View of the helicopter recovered to the operator’s facility.**

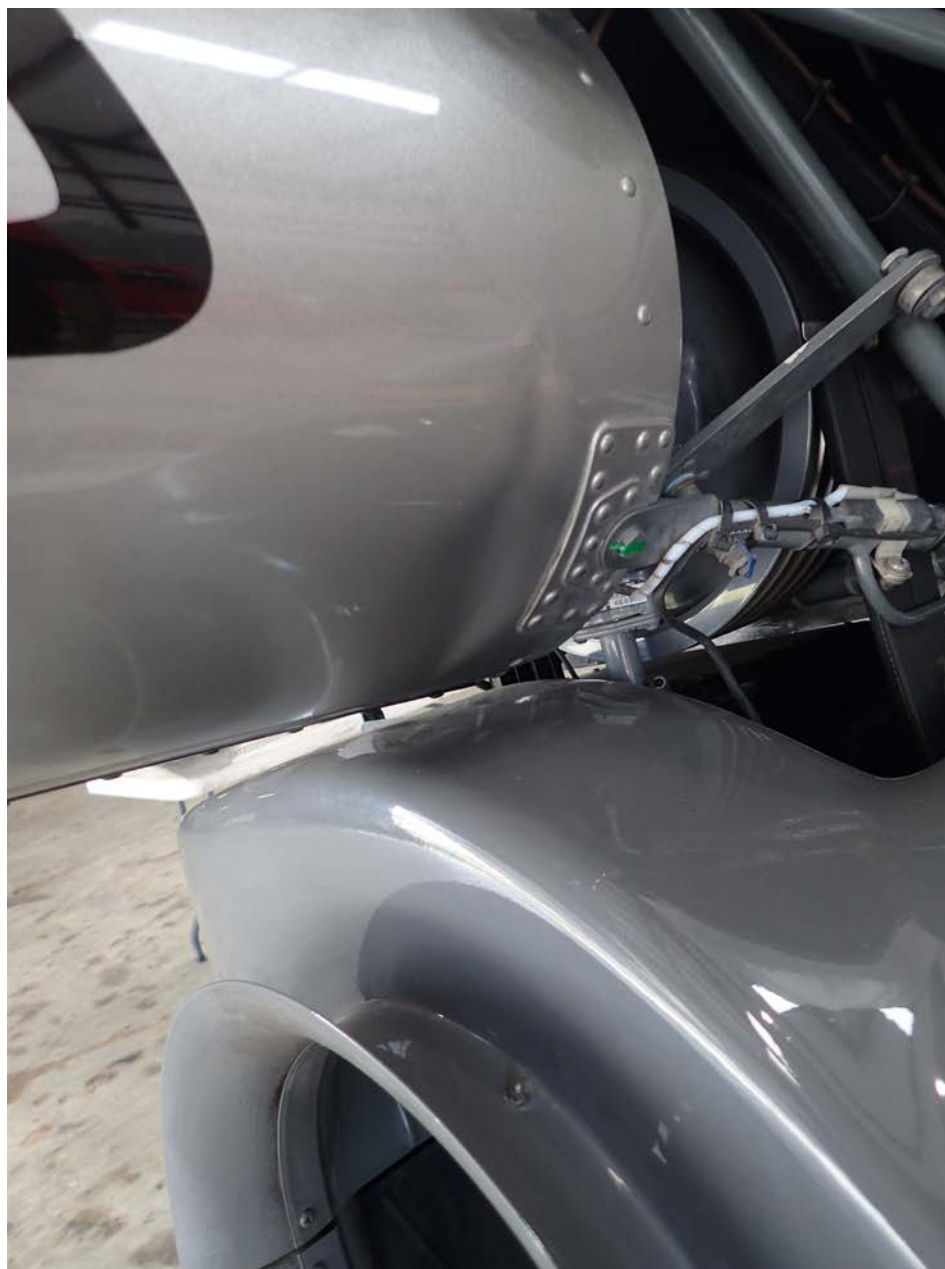
**Photo 4 – View of the substantial damage to the tail boom.**

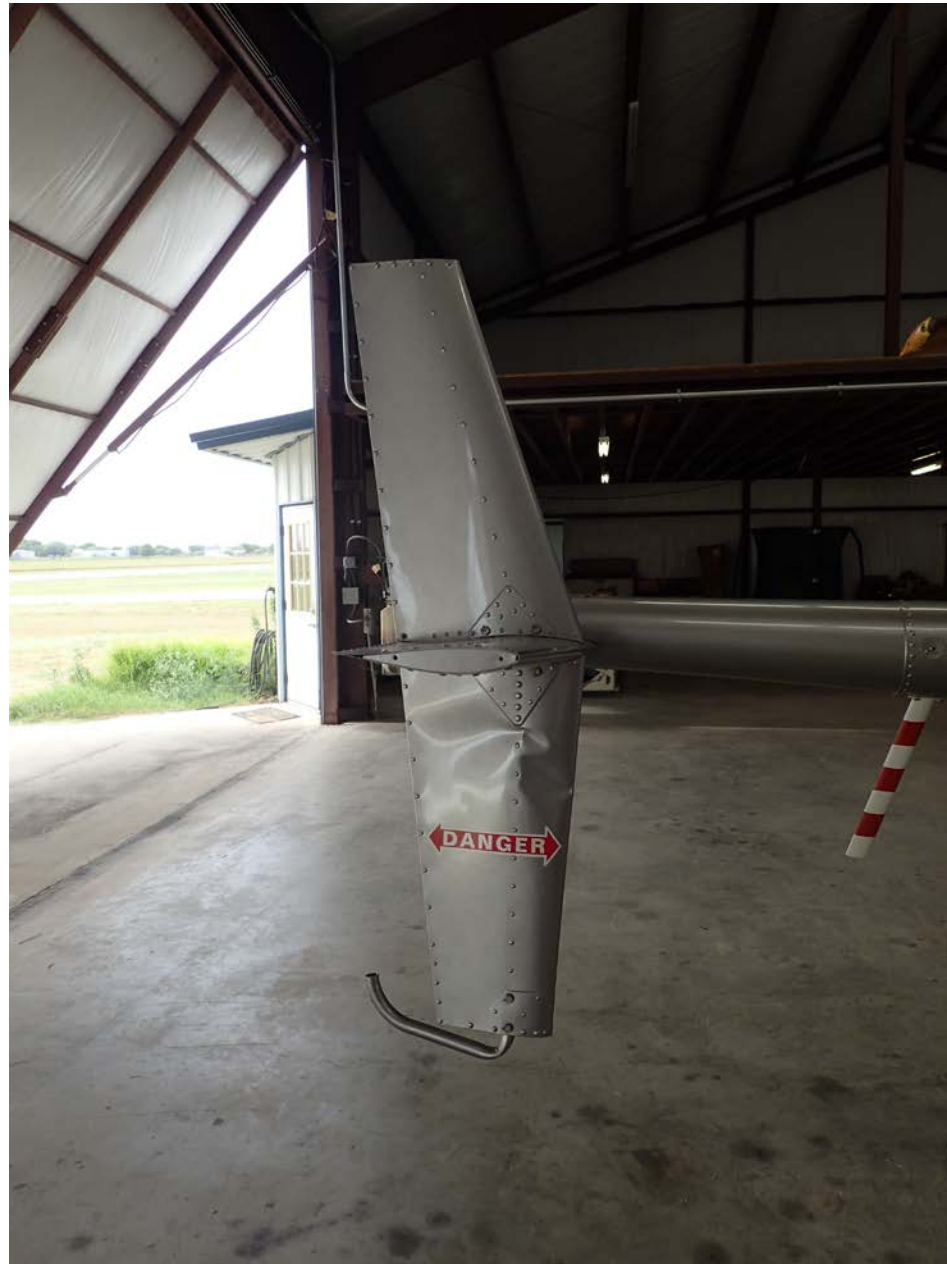
**Photo 5 – View of the substantial damage to the vertical stabilizer.**

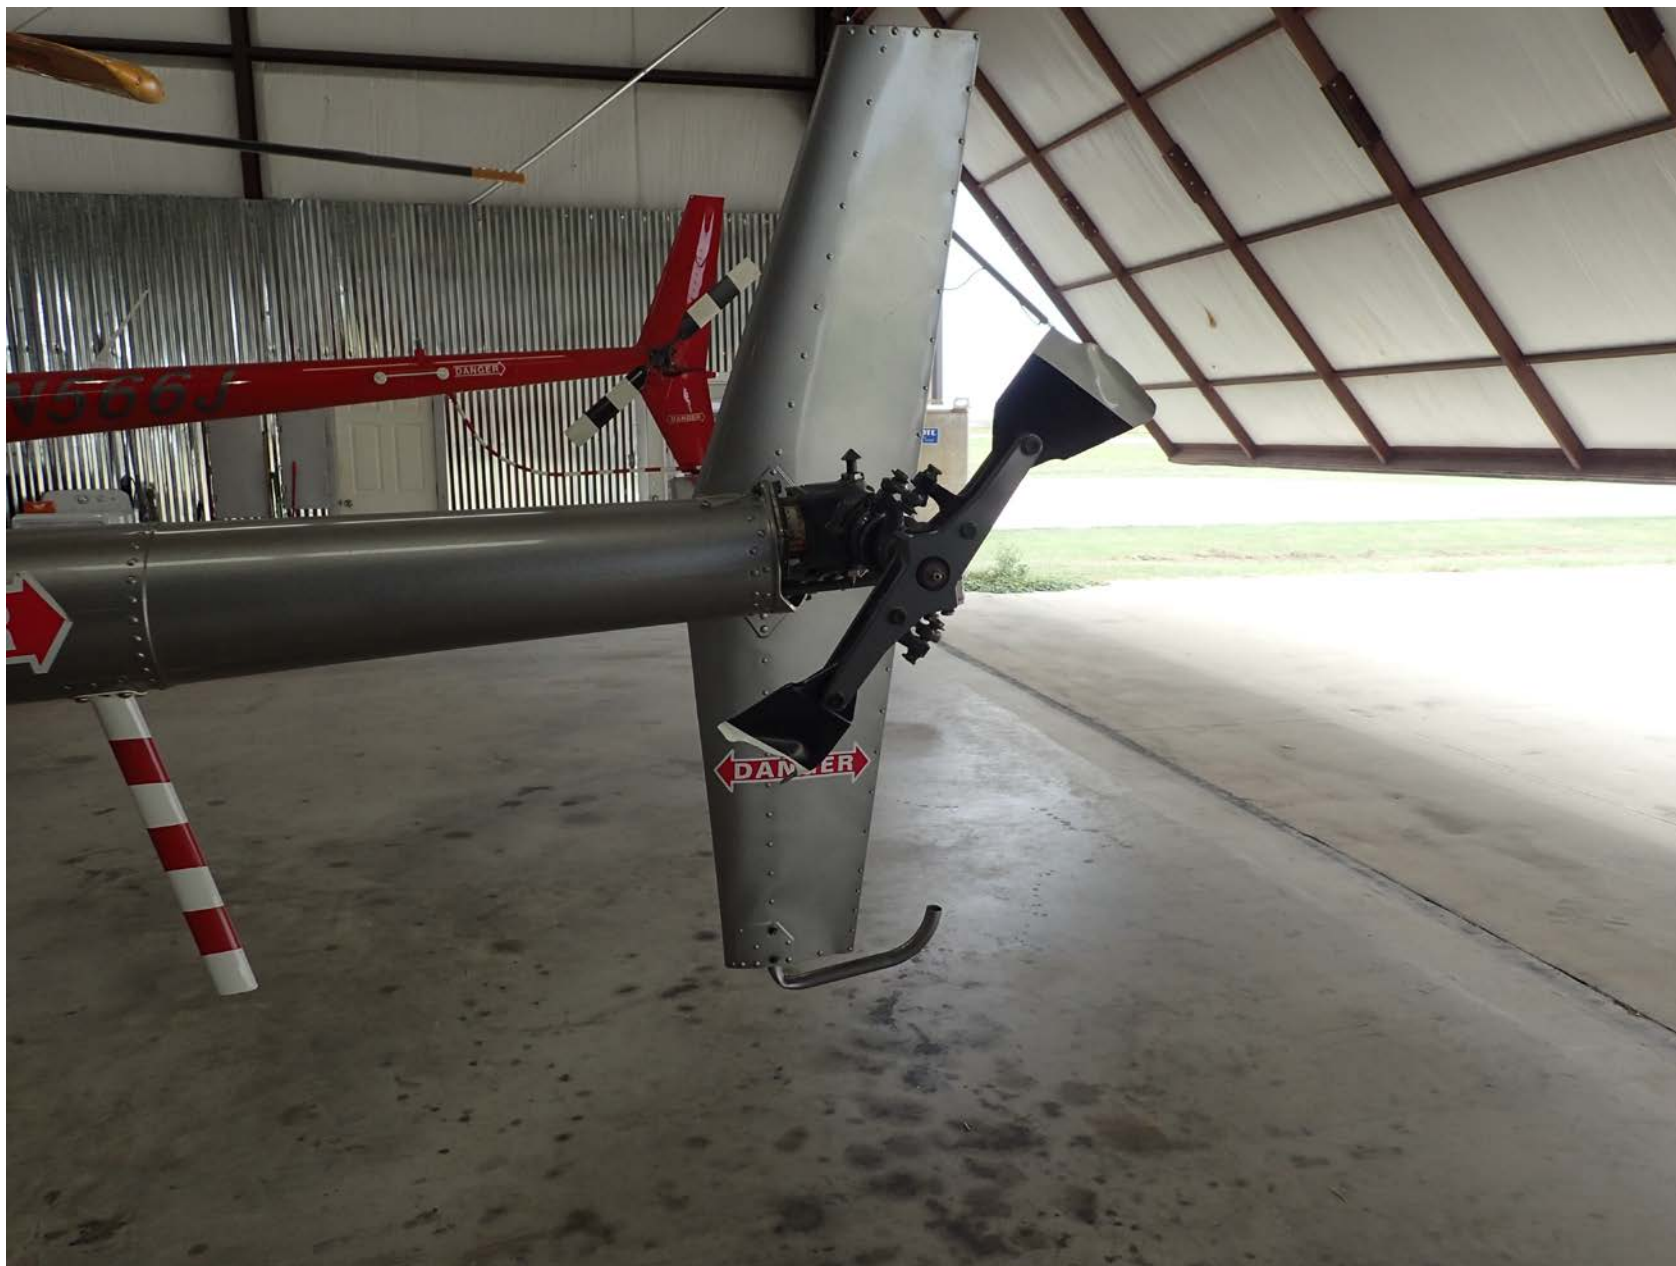
**Photo 6 – View of the impact damage to the tail rotor blades.**
