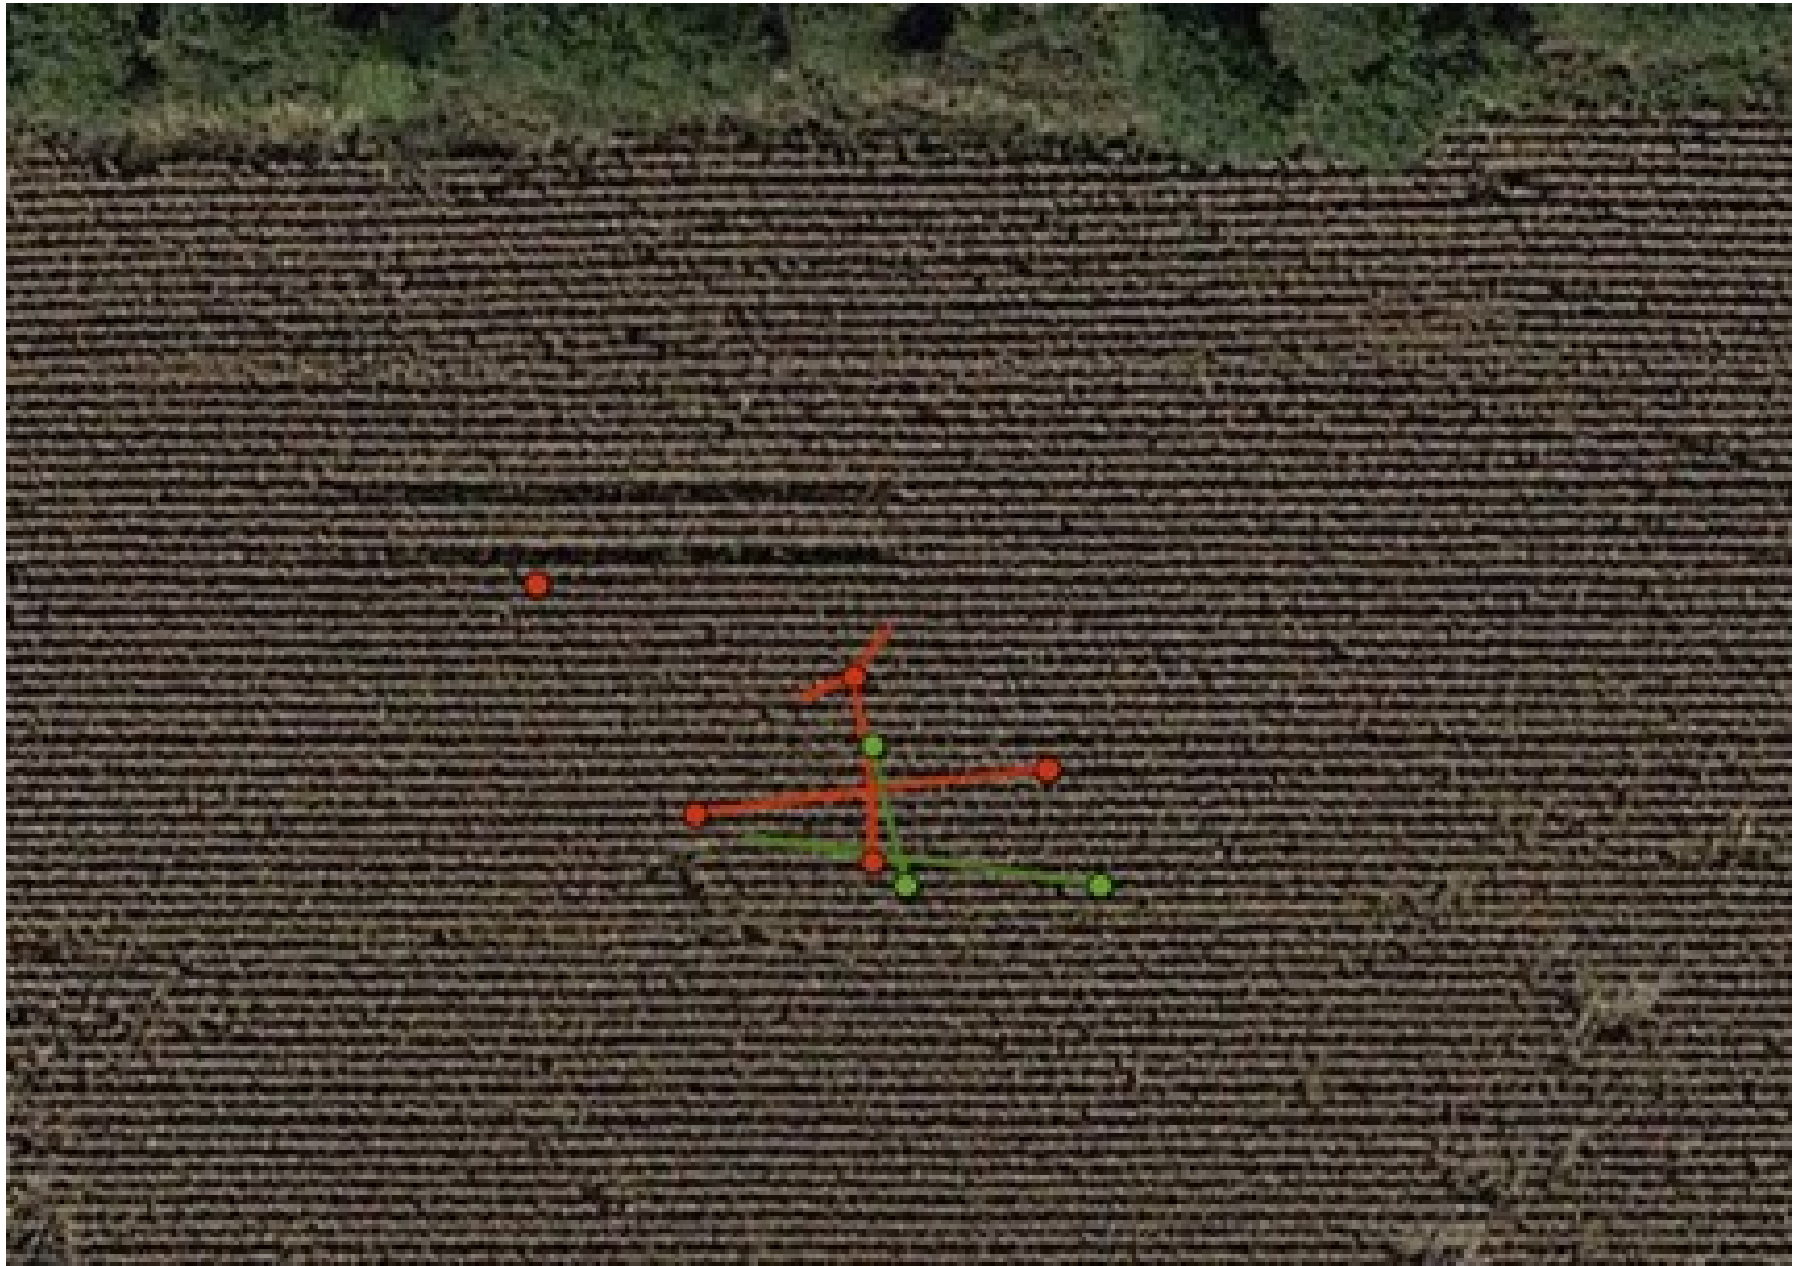
**Photo 1 – Overhead Figure of Wreckage Position**

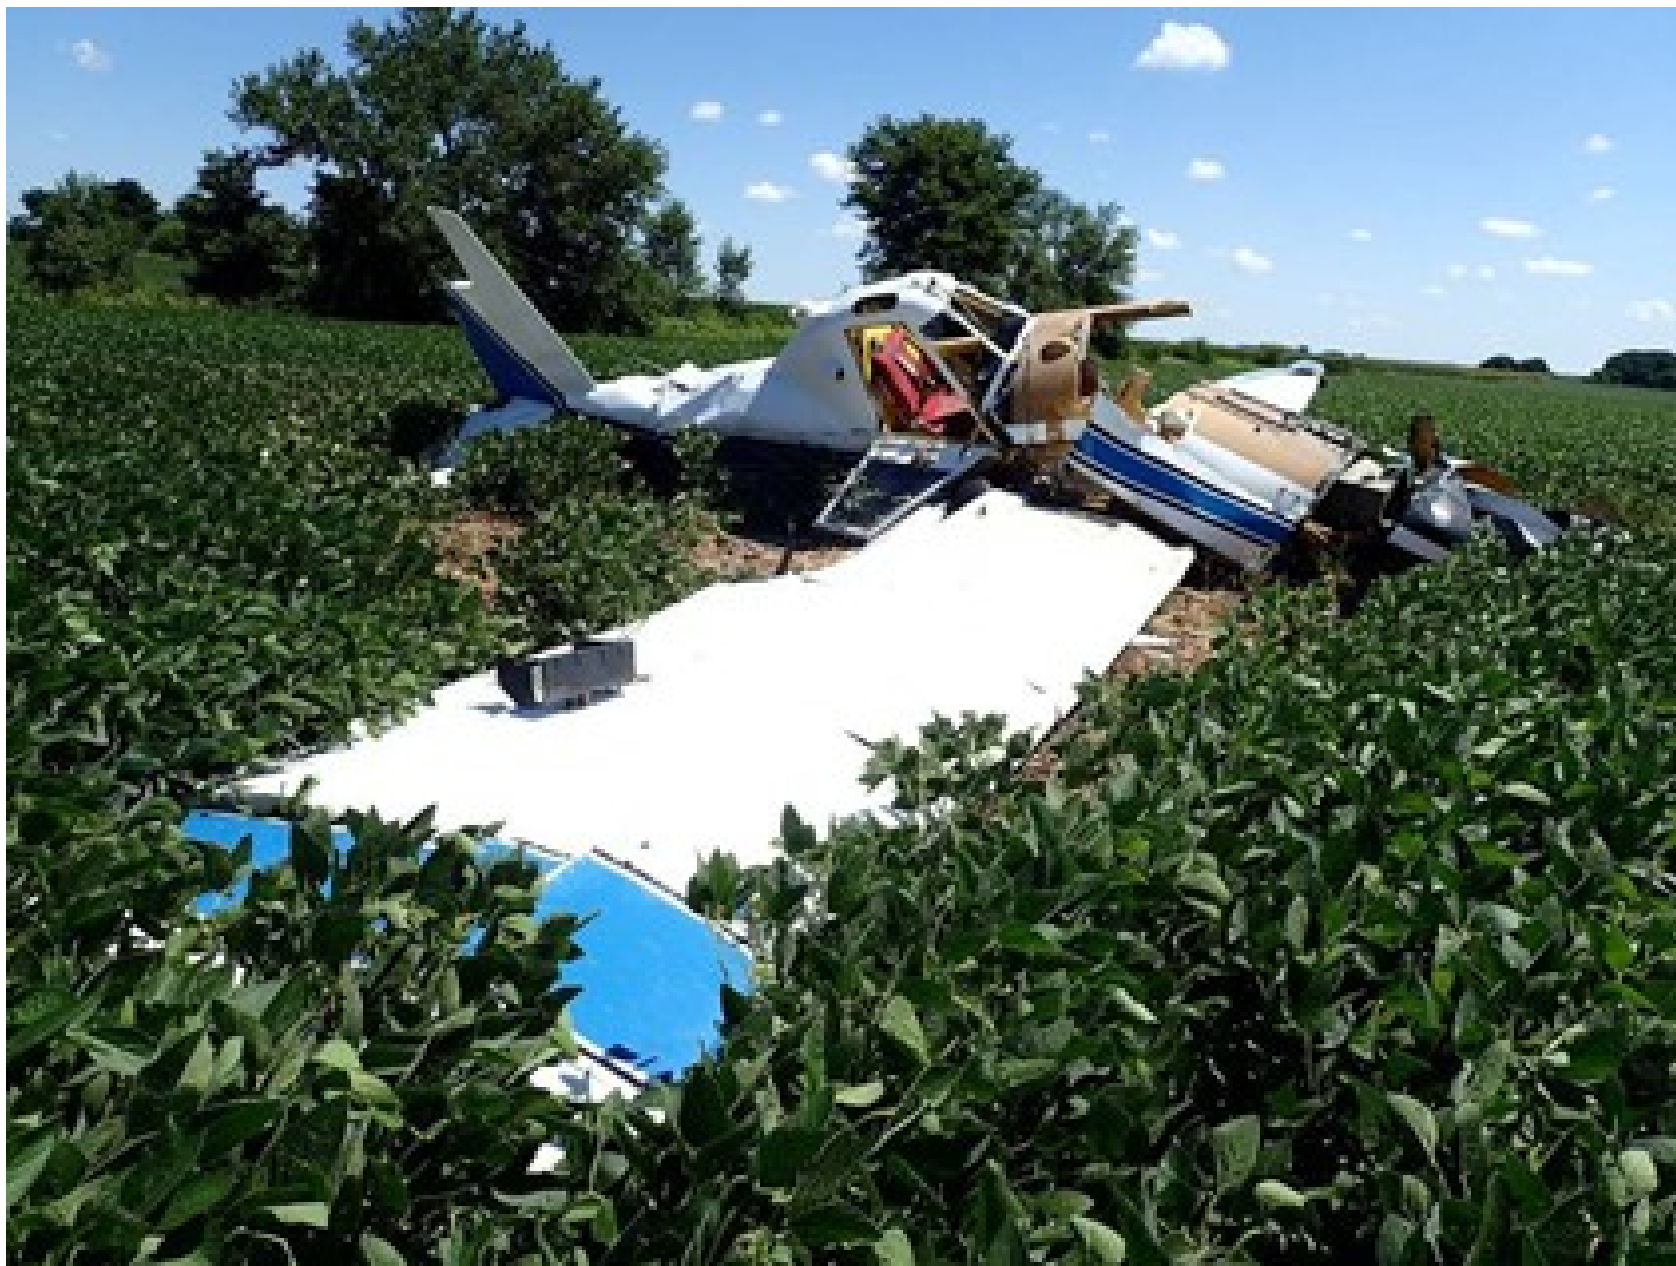
**Photo 2 – View of Wreckage Right Side**

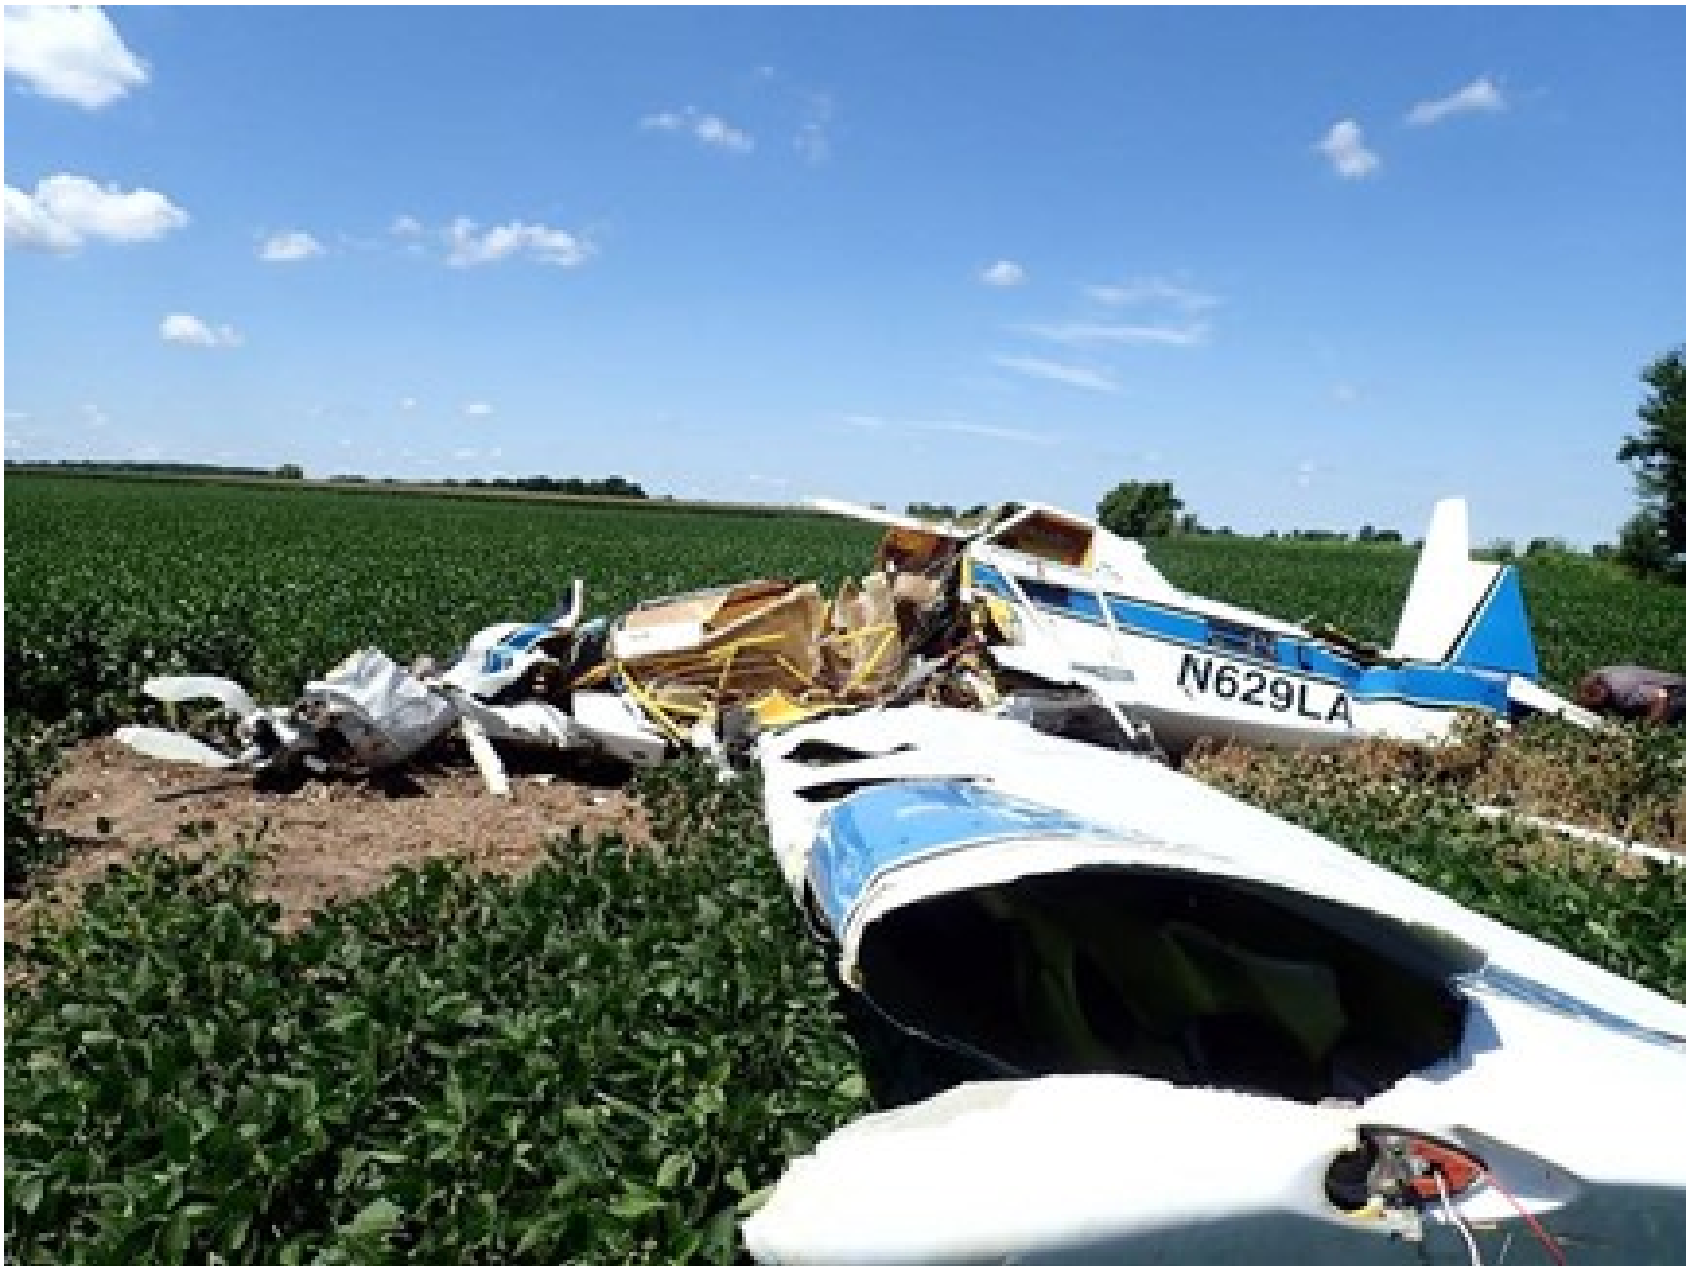
**Photo 3 – View of Wreckage Left Side**

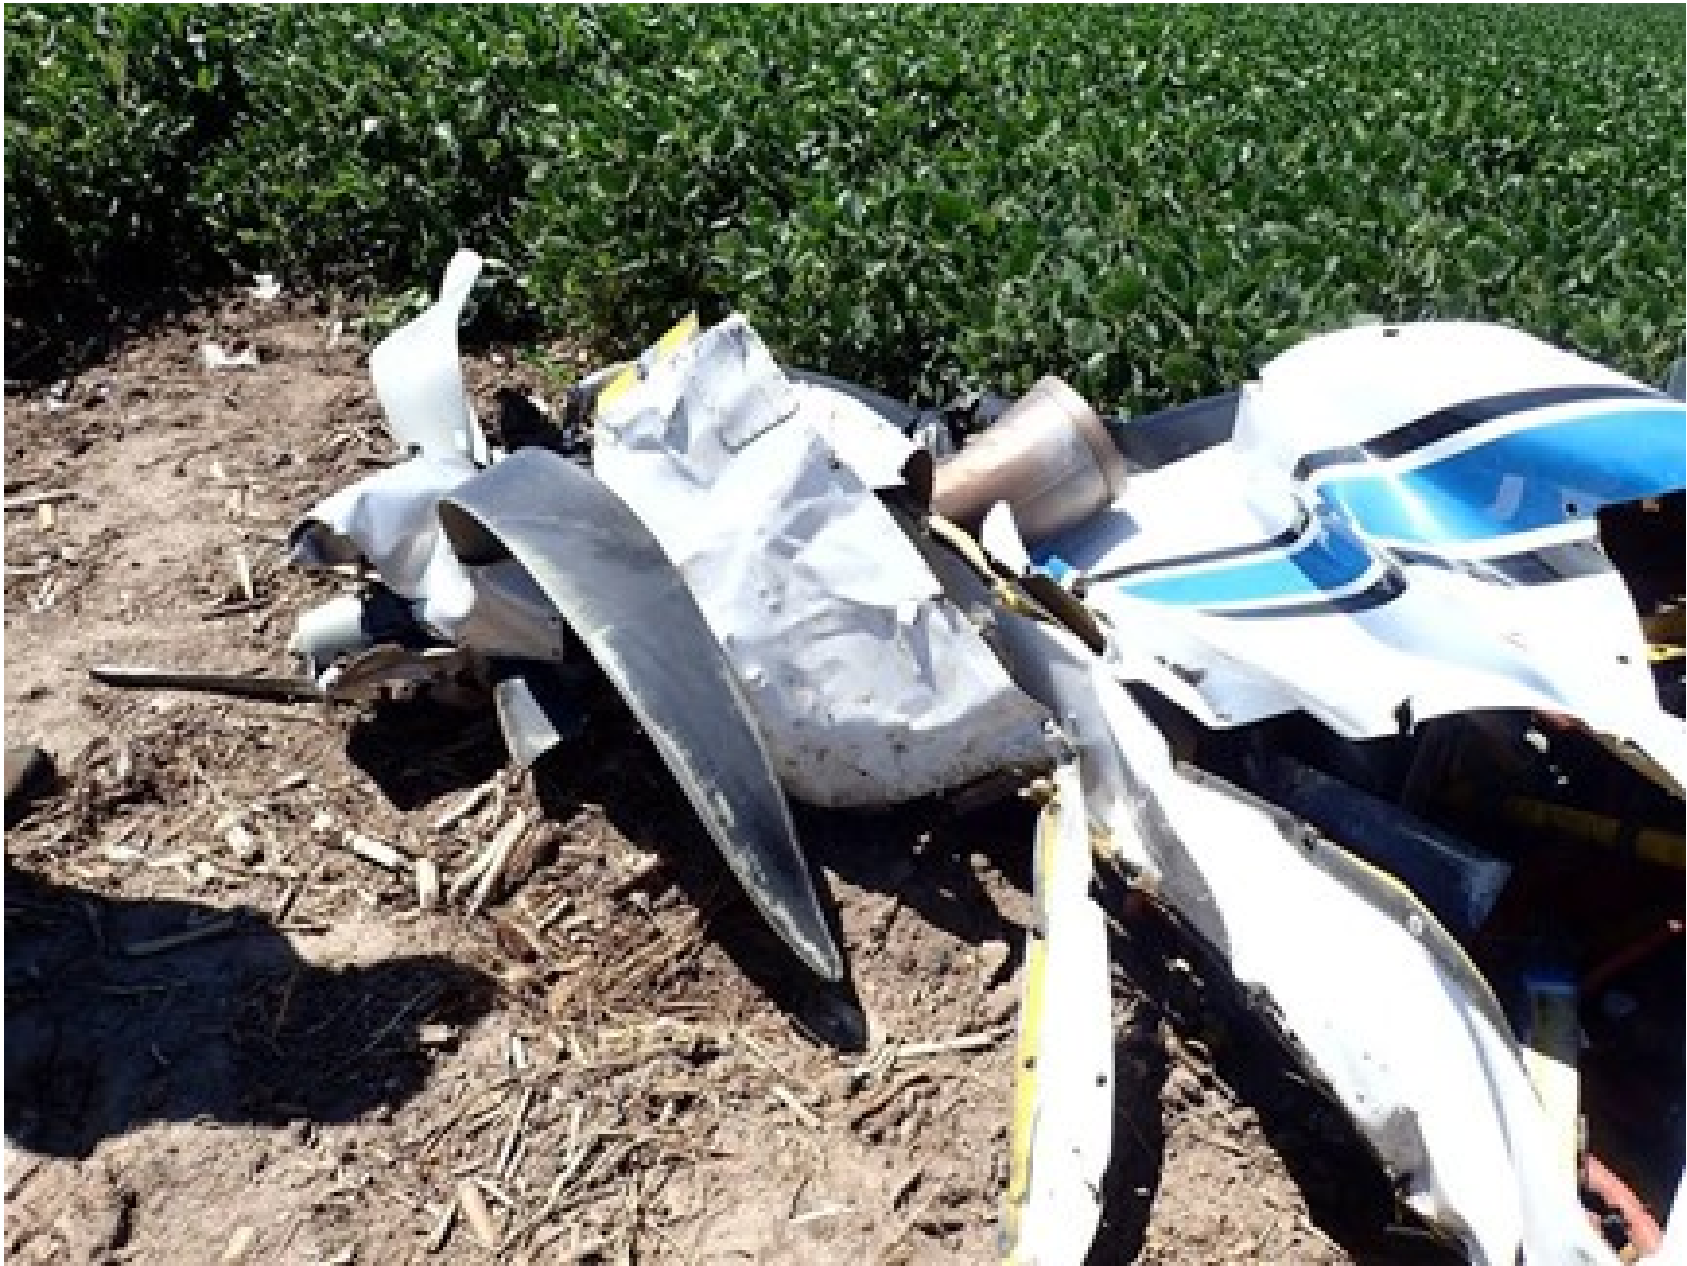
**Photo 4 – View of Engine and Propeller with Chordwise Damage**
