# The National Transportation Safety Board

Office of Aviation Safety  
Central Region  
Memorandum for the Record  
Airframe Examination  
Findings  
CEN18LA270  
Bismarck Illinois  
July 13 2018

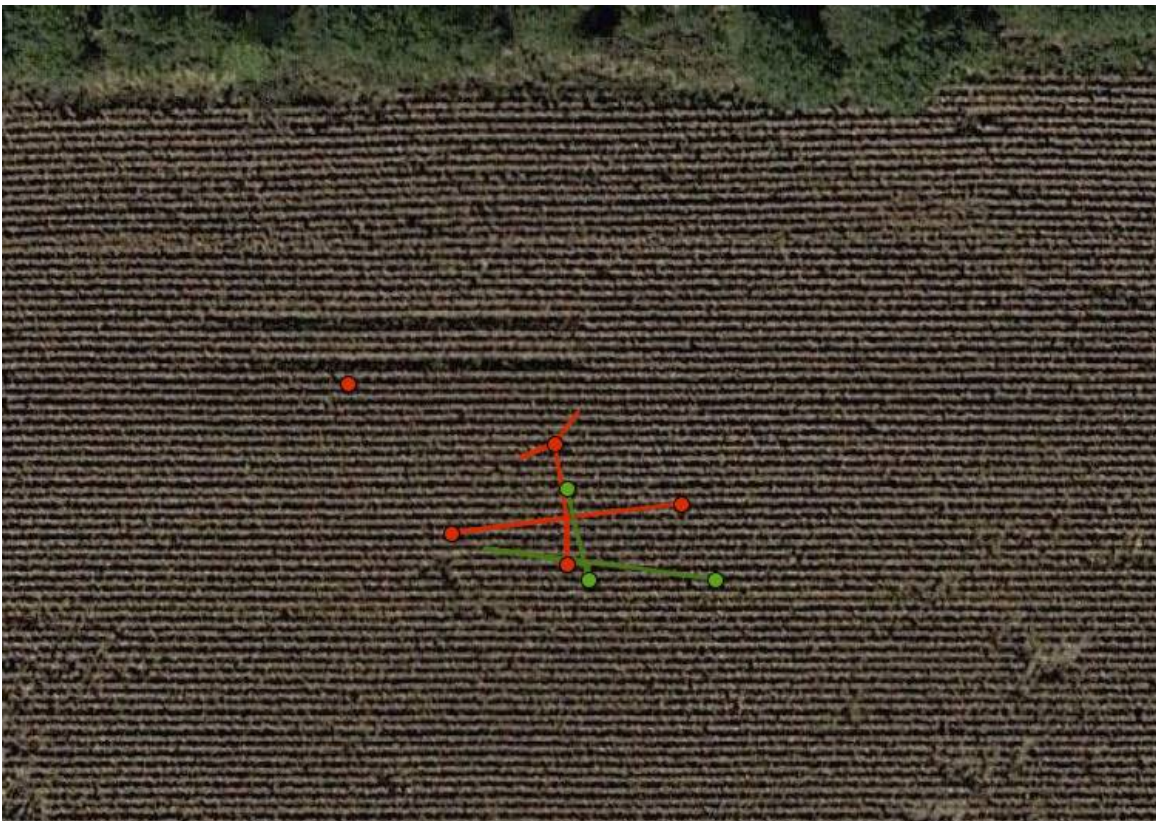
The accident site was located about 800 feet east of the edge of a corn field. There were some large trees along a fence line about 125 feet to the north of the impact site. These trees showed no signs of impact or damage. There were no large trees, electric lines, or transmission towers noted between the accident site and the field that the pilot was spraying. There was no evidence of pre-impact or post-impact fire. There was no noticeable smell of jet fuel present at the scene. The aircraft data plate was missing. The Hobbs hour meter remained intact in the cockpit and showed 6,388.7 hours-time-in-service on the airframe. The engine power section revealed a serial number of PC-E 84242. The wreckage was found in an upright position with the fuselage leaning to the right and oriented toward the south. The forward fuselage was crushed in the upward and aft direction. There was no horizontal ground scar but there was an impression in the soybeans that indicated an initial impact location slightly southeast of the final wreckage location. See the figure below which shows the aircraft location (red) and ground scar location (green) overlaid on an undated satellite image of the field. The single red dot located to the northwest of the wreckage was the location of the rudder, which was found approximately 50 feet away from its proper location on the fuselage.
