# NATIONAL TRANSPORTATION SAFETY BOARD

## MATERIALS LABORATORY STUDY REPORT

Report No. 19-052

Place : Brazoria, TX  
Date : July 23, 2018  
Vehicle : Grumman AA-5B (N74420)  
NTSB No. : CEN18LA292  
Investigator : Todd Fox (AS-CEN)

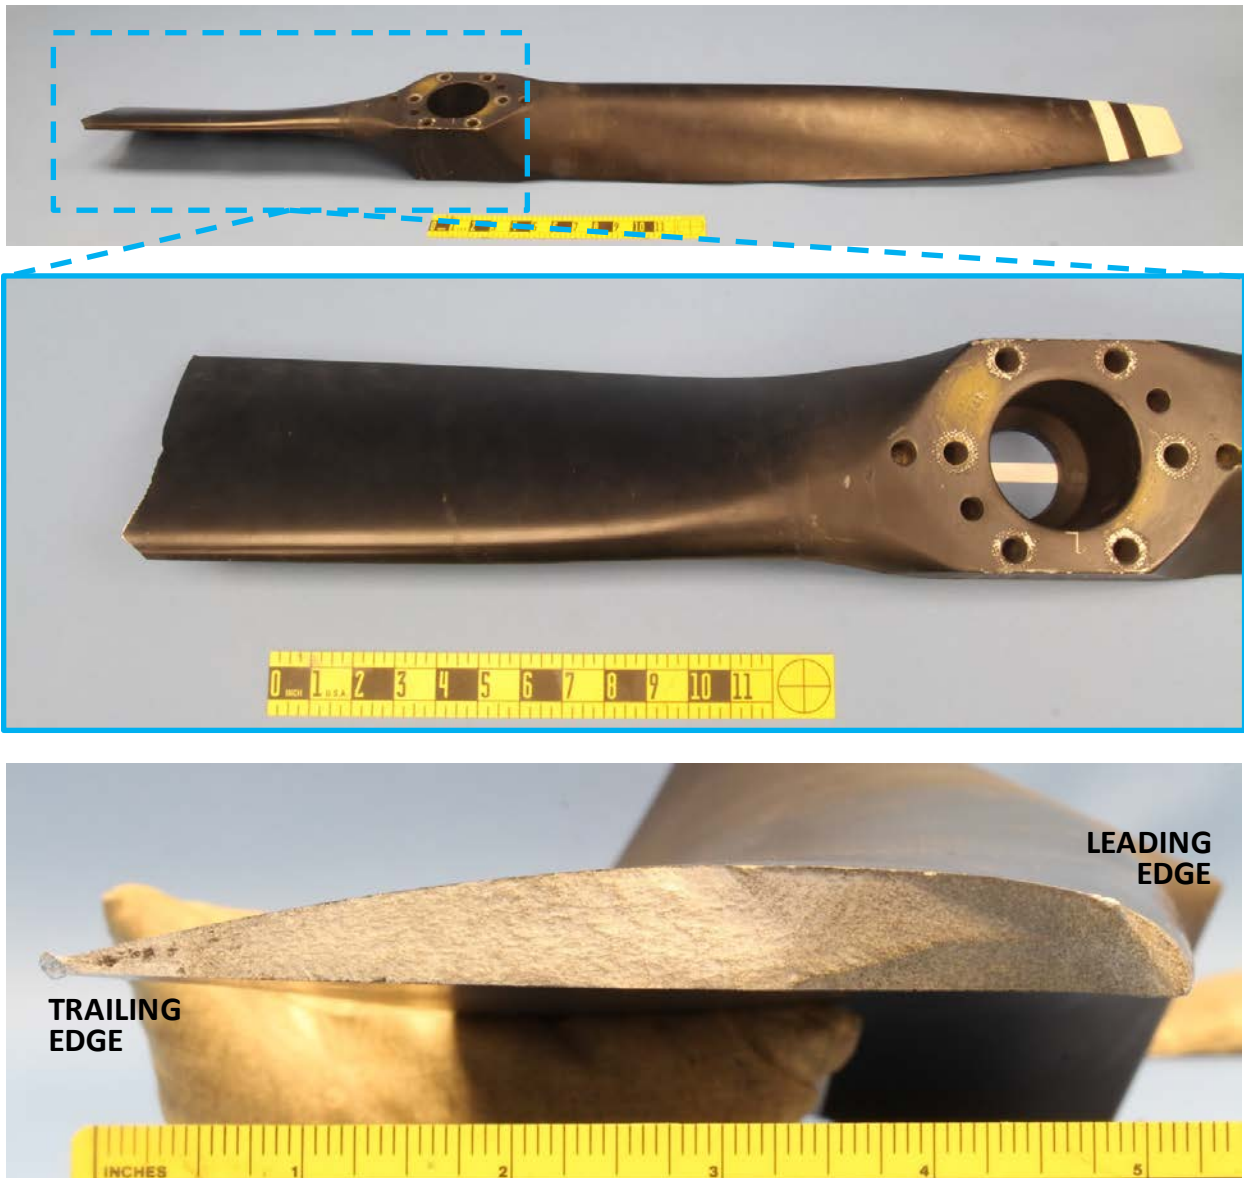
Approximately half of one blade had separated and was missing. The fracture surface was flat from the trailing edge through roughly two-thirds of the chord length, before angling from the center outwards adjacent to the blade surface.

Figure 1: Macro photos of the submitted propeller with the separated blade.

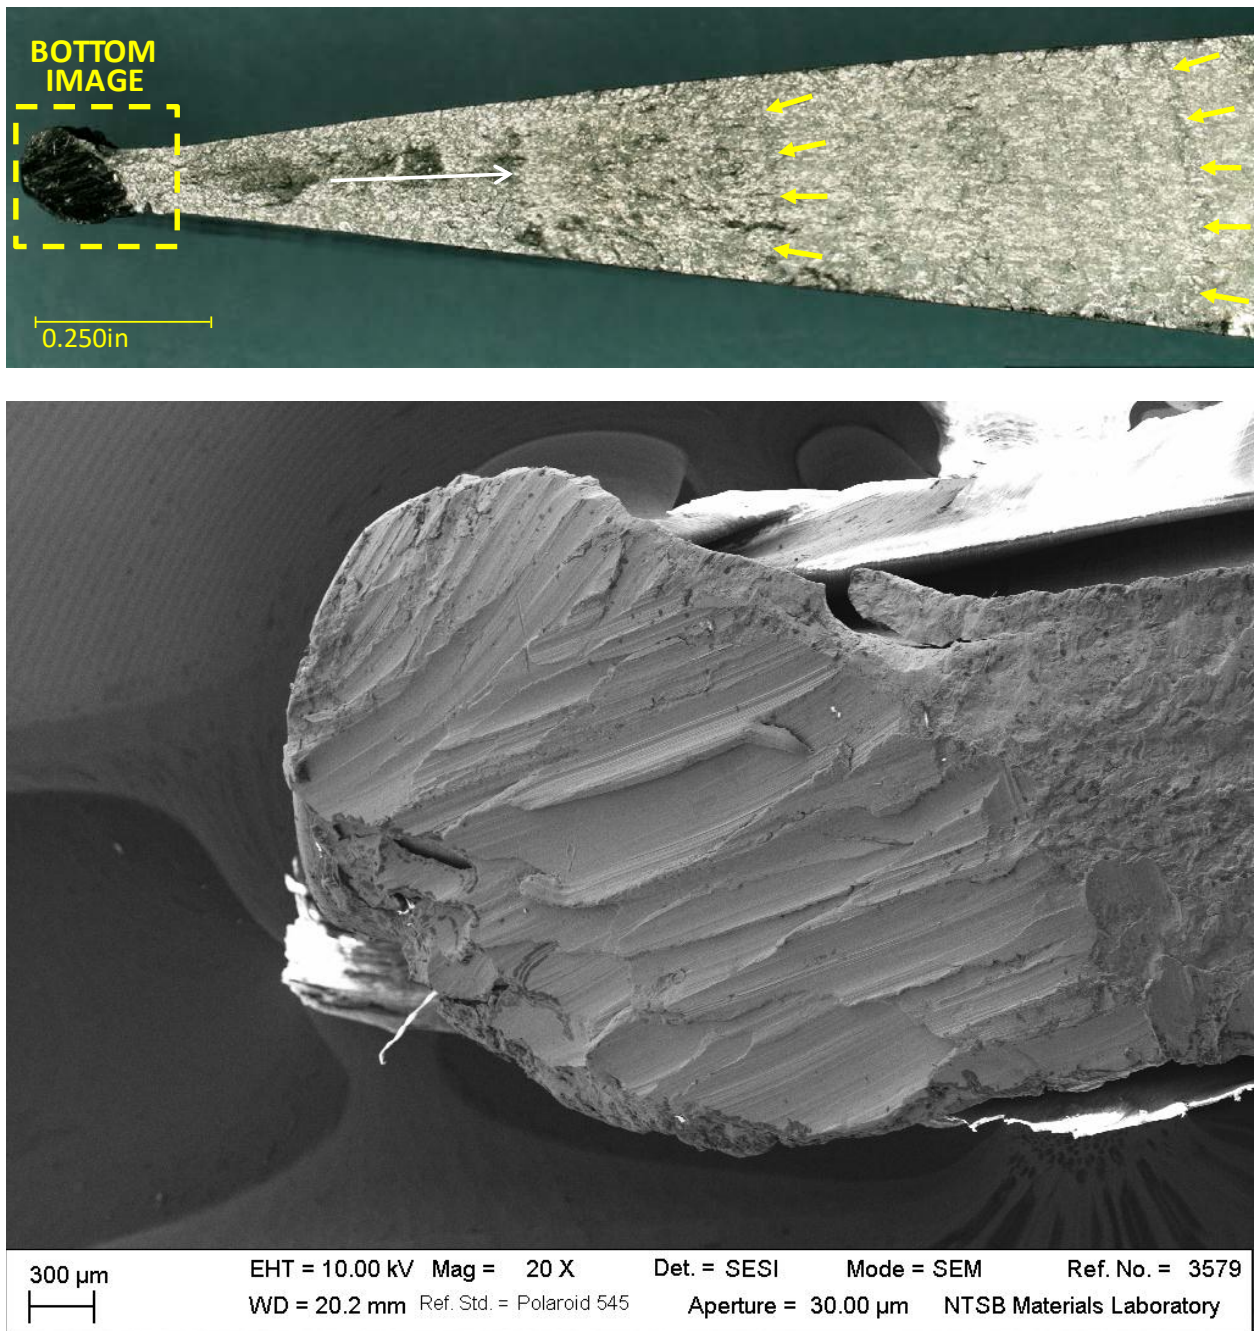
The fracture surface was sectioned from the blade and examined using a digital microscope and a Zeiss Auriga 40 field emission (FE) scanning electron microscope (SEM). A digital microscope image of the flat area on the fracture surface is shown in the top of Figure 2. SEM images of the fracture surface are shown in Figures 3 and 4. Yellow arrows in Figures 2 and 3 point to faint crack arrest lines observed within the flat area. The pattern of the crack arrest lines emanated from the trailing edge tip of the blade. Post-separation damage was observed on the fracture surface at this location (bottom image of Figure 2).

The flat fracture surface, crack arrest lines, and striations are consistent with fatigue cracking. The pattern of the crack arrest lines indicated the fatigue cracking

emanated from the trailing edge tip of the blade. The white arrow in Figure 2 indicates the direction of fatigue cracking propagation. The damage on the fracture surface at the trailing edge tip of the blade obscured the exact initiation of the fatigue cracking.

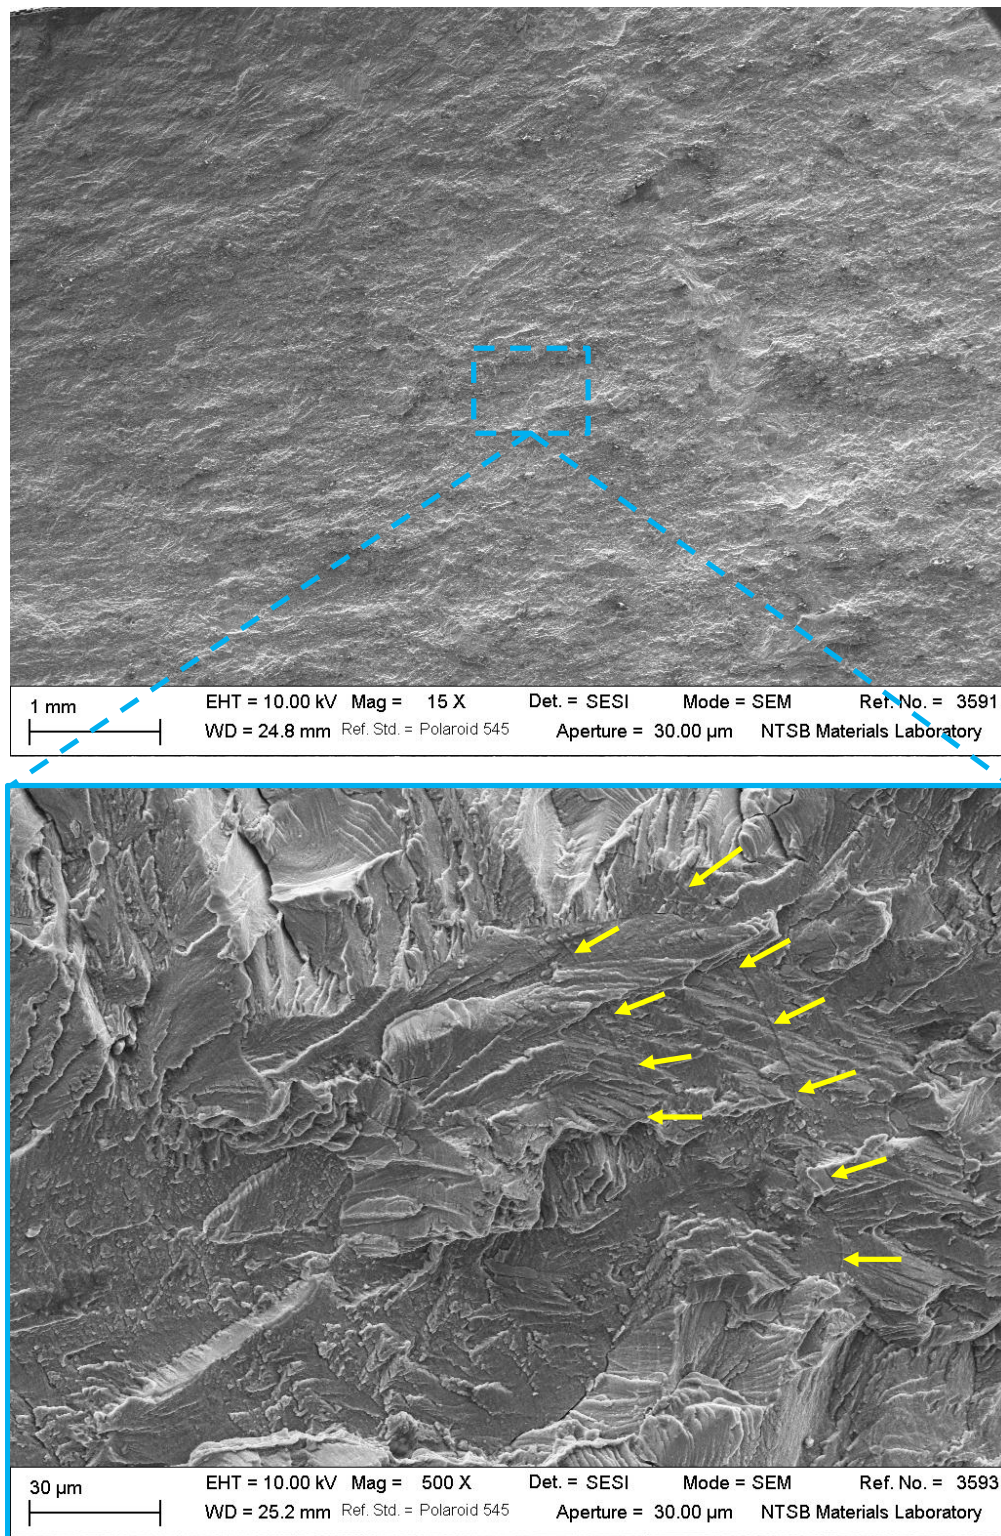
The finer features on the fracture surface were feathery and transgranular, which is consistent with fatigue cracking. Striations were observed on the fracture surface in some locations. Exemplar striations are shown in Figure 4.

Figure 3: SEM images of feathery, transgranular features on the separated blade fracture surface. The yellow arrows in the bottom image point to crack arrest lines.

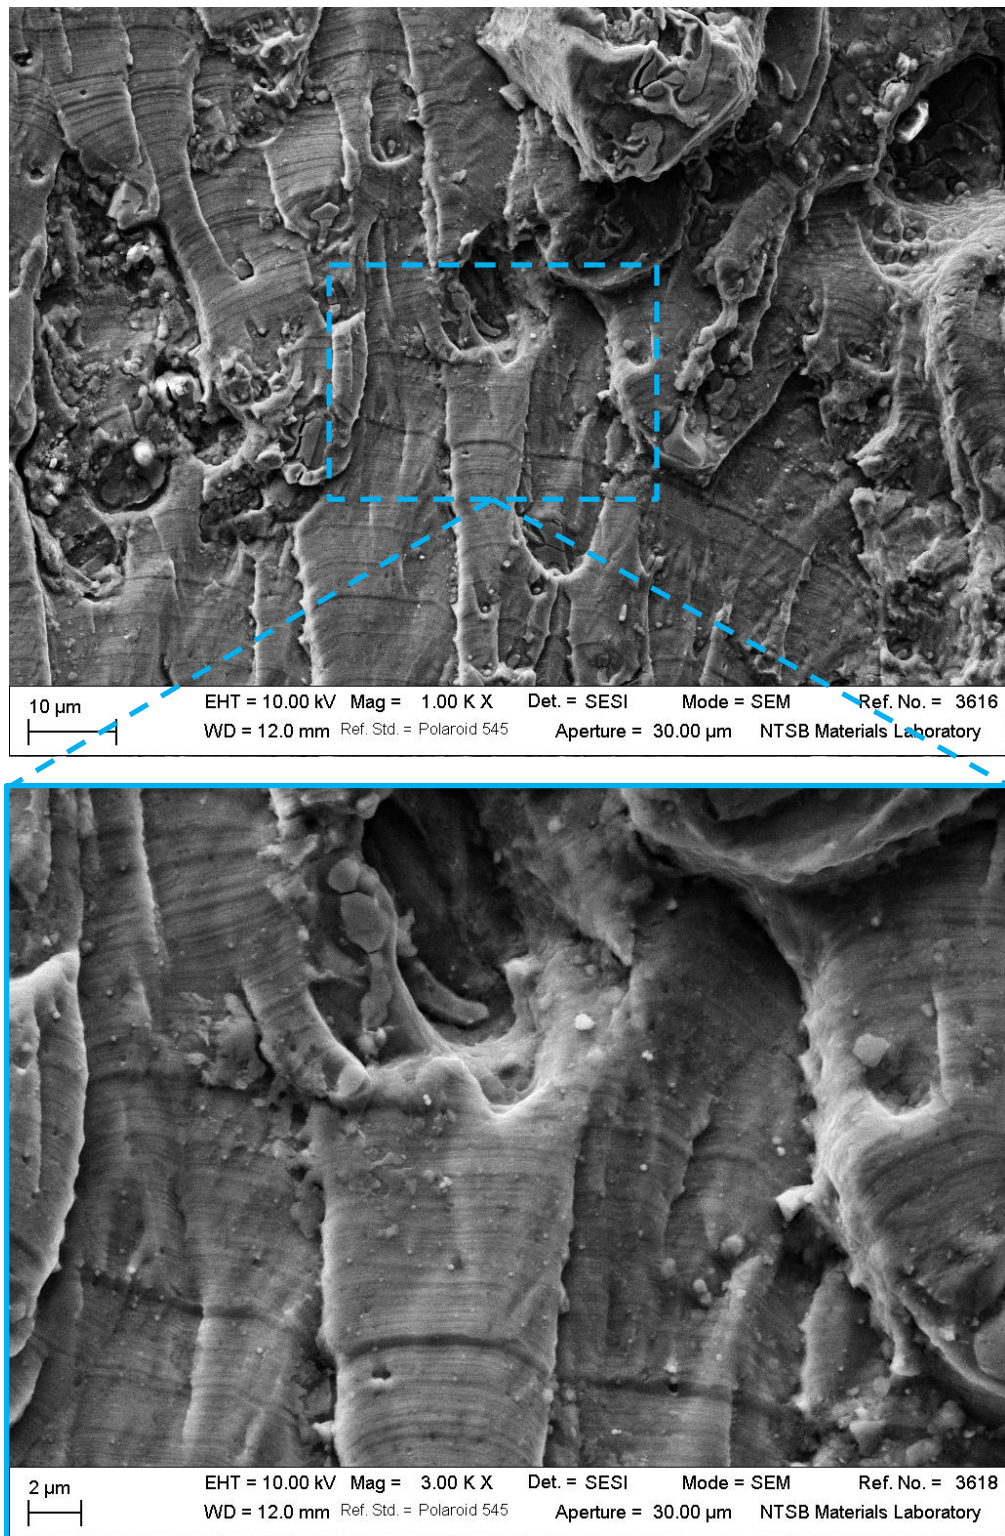
Figure 4: SEM images of striations on the separated blade fracture surface.
