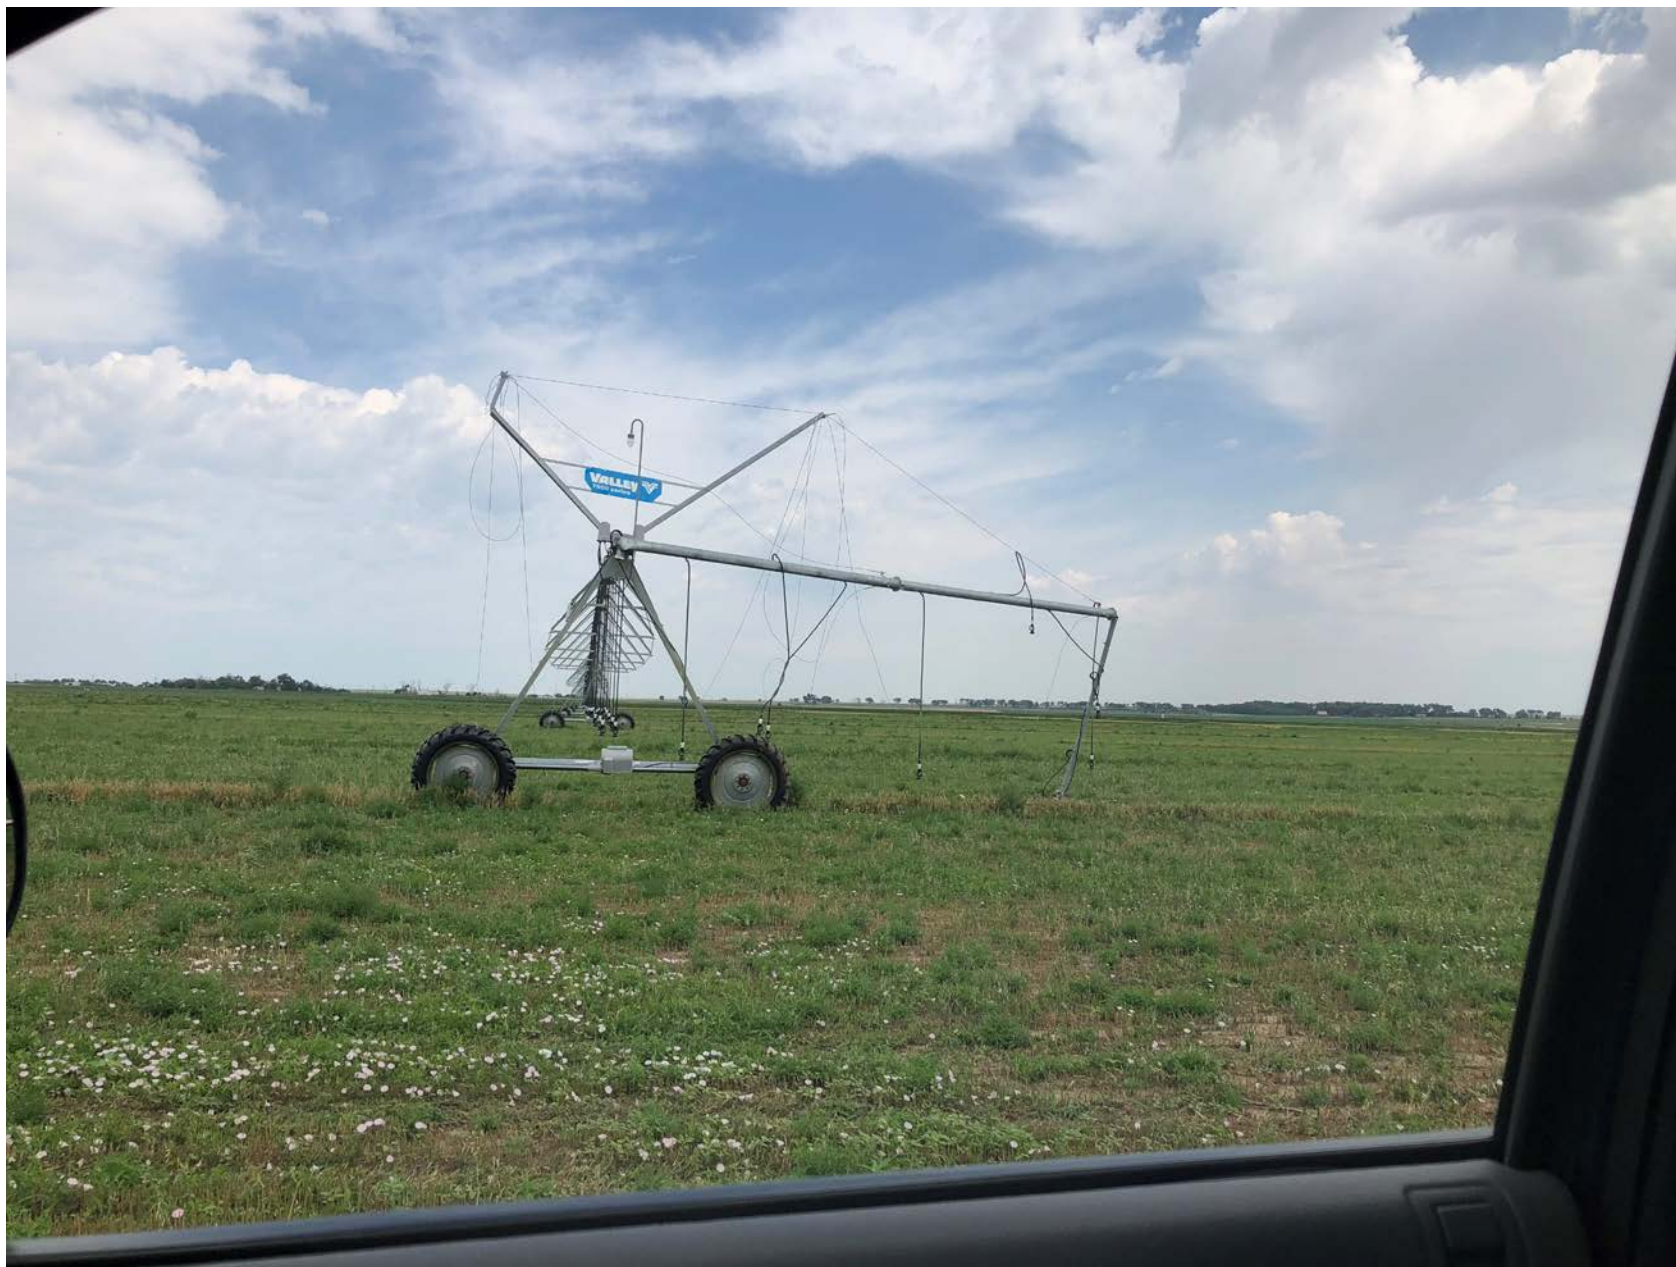
**Photo 2 - Image sent by the pilot's family member of the pivot sprinkler system near the accident site that exhibits damage to its outboard section.**
