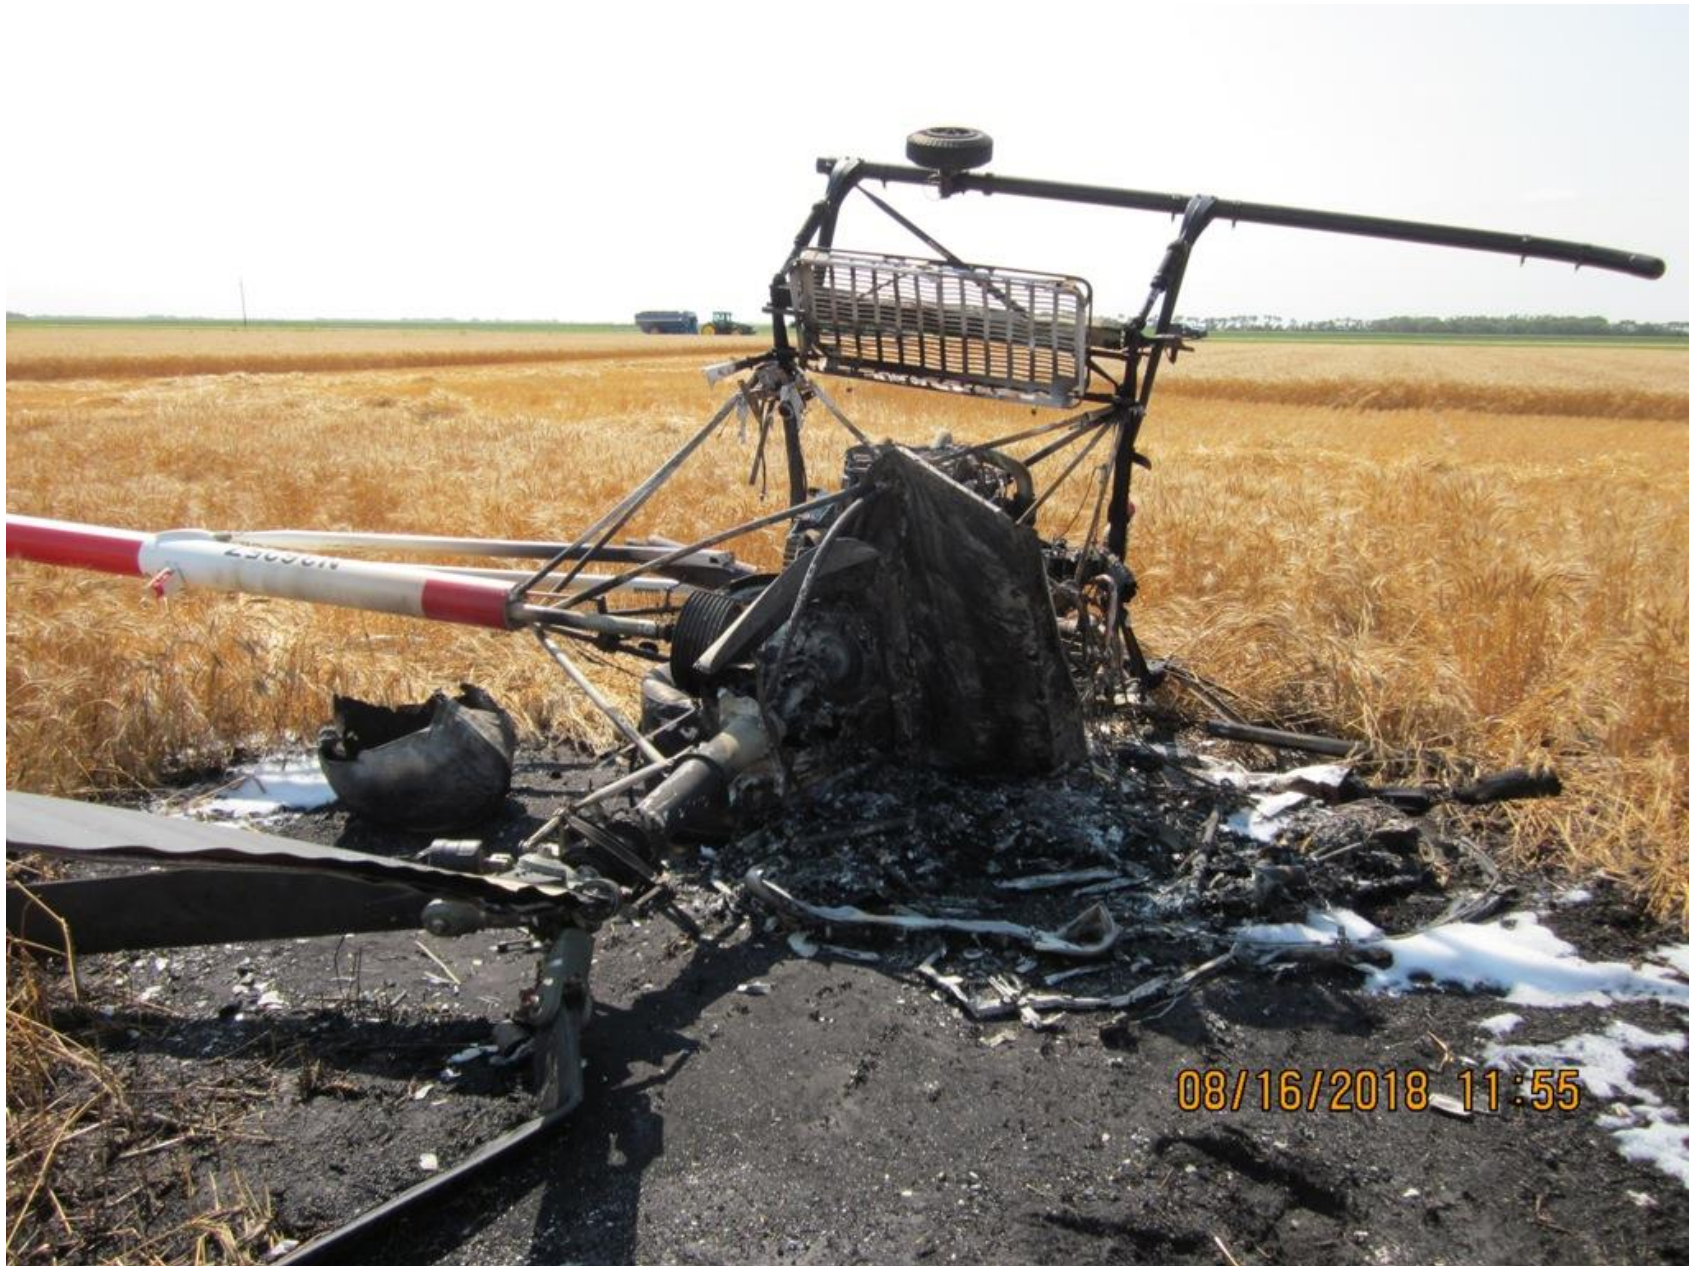
**Photo 1 – Helicopter Wreckage at Accident Site**

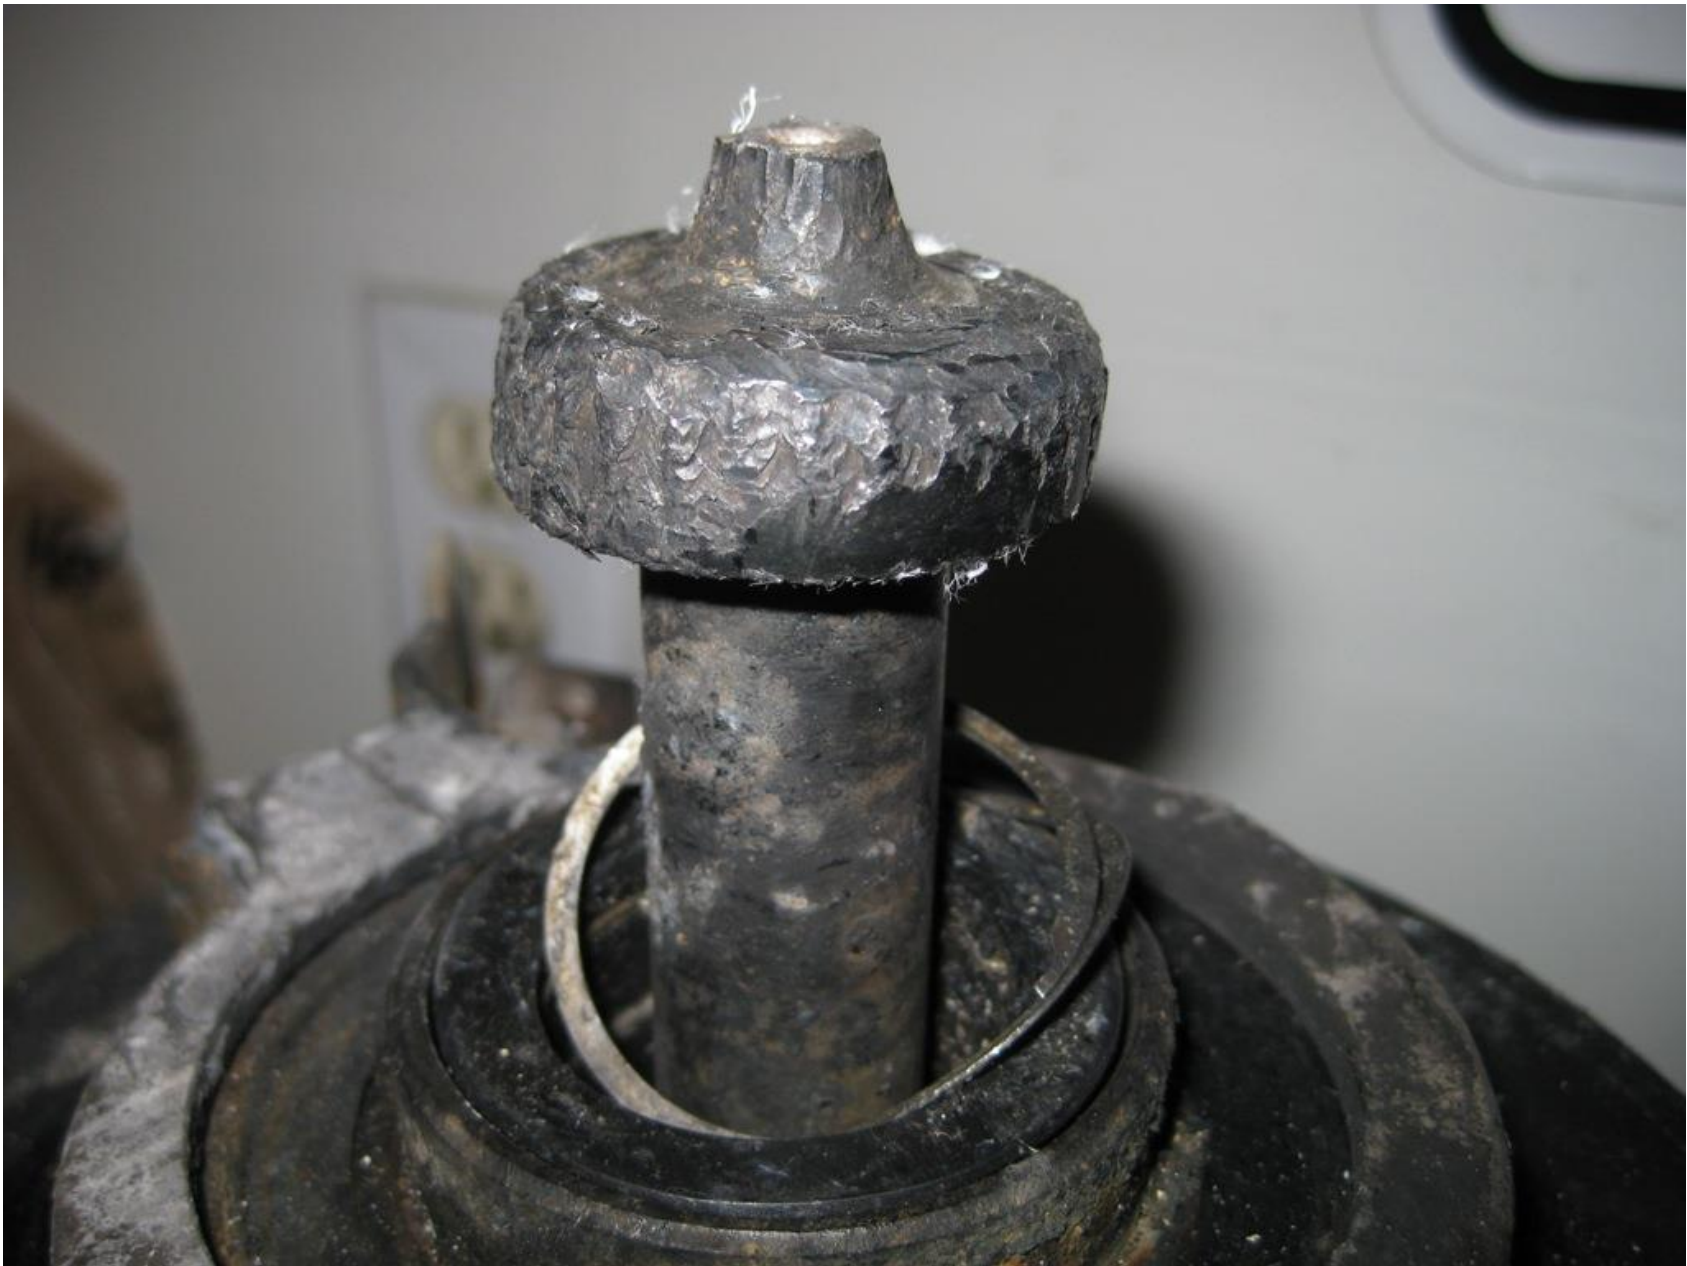
**Photo 2 – Lower Coupling Drive Shaft, Forward End**
