# Continental Motors

## ENGINE RUN REPORT

**N6860W**

| ENGINE MODEL | TSIO-520-UB (12B) |

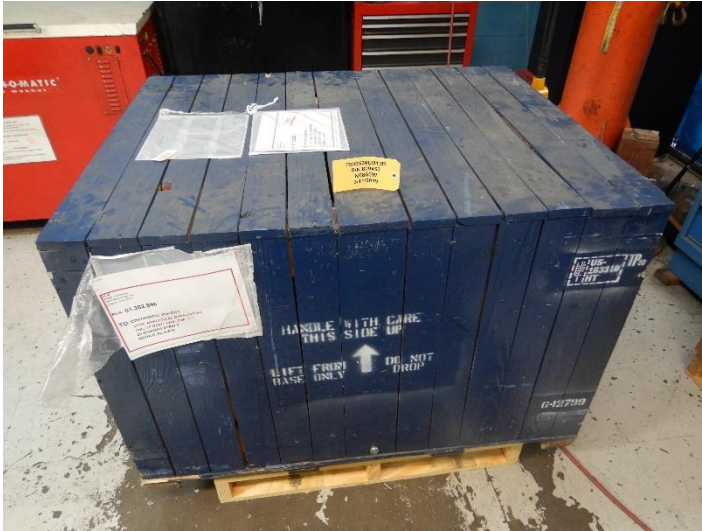
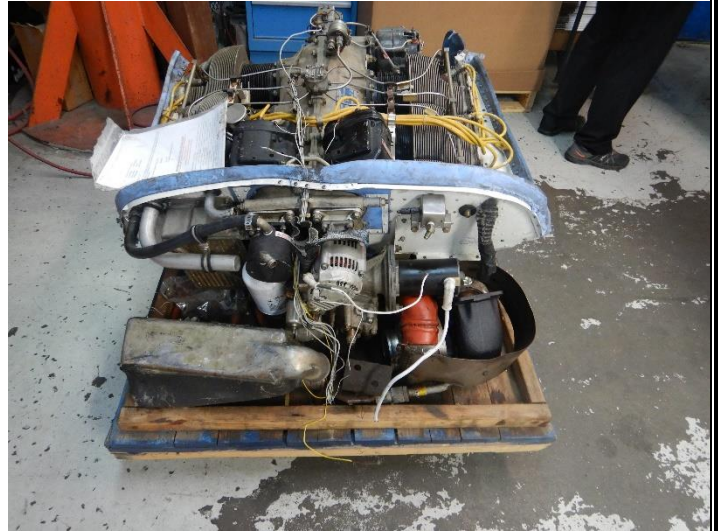
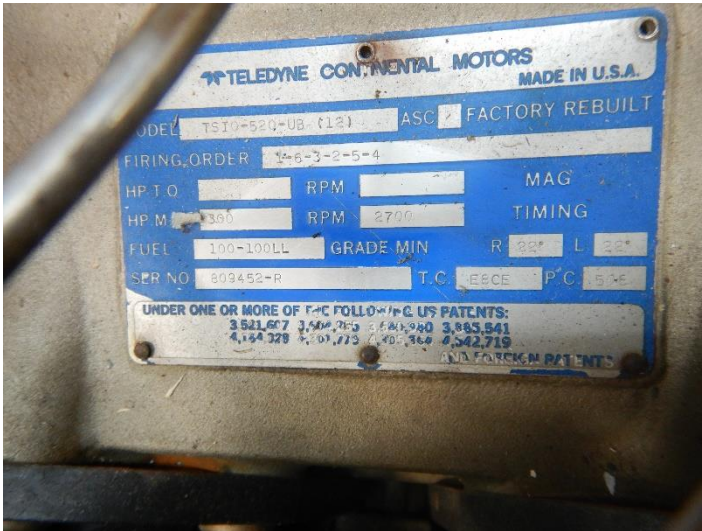
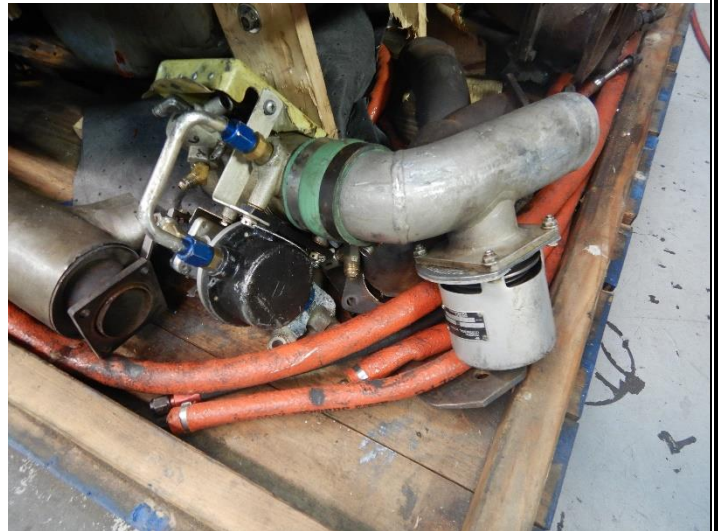
The engine was received in a shipping crate supplied by Continental Motors. The shipping crate was opened in the presence of the FAA Inspector who was acting as Governmental oversight approved by the NTSB IIC. All four engine mounts were broken as a result of impact damage. The exhaust system was crushed on the right and left side. The forward induction balance tube was impact damaged. The number 6 bottom ignition lead was damaged. The turbo discharge hose to the aftermarket intercooler was torn with oil saturation on the torn surface. The additional turbo discharge hose from the intercooler to the overboost valve was torn with evidence of red RTV repairs near the tear. The check-valve on the turbo oil feed was broken. The oil inlet fitting was damaged at the wastegate controller.

The turbocharger/tailpipe v-band clamp was damaged and consistent with side-overload caused by corresponding impact forces on the tailpipe.

Several exhaust flange nuts were missing:

Cylinder # 1- one nut was backed off approximately half way, three other nuts were tight.

Cylinder # 2- two exhaust nuts missing.

Cylinder # 4- three exhaust nuts missing.

Cylinder # 6- all four exhaust nuts missing.

Note: This condition may have been a result of the engine removal process after the accident.

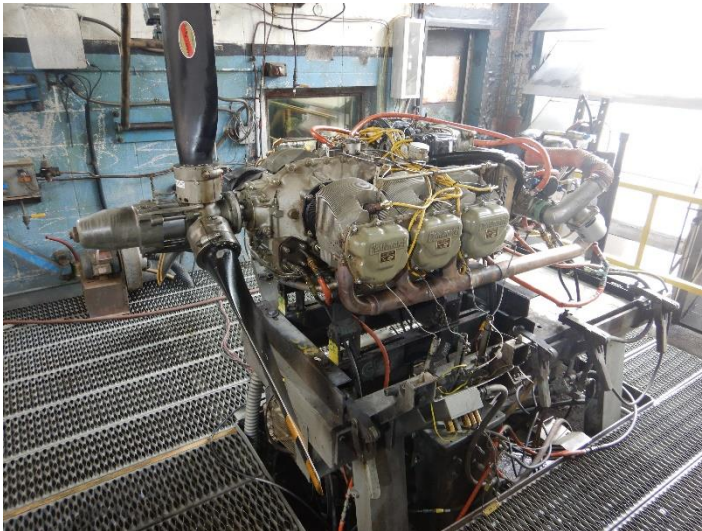
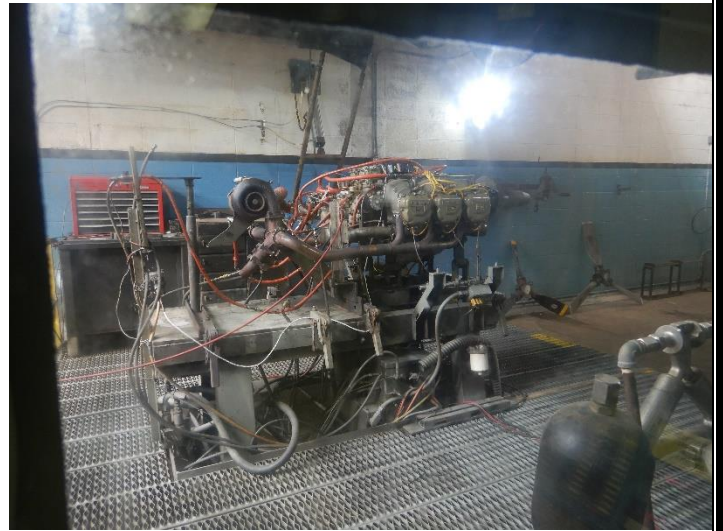
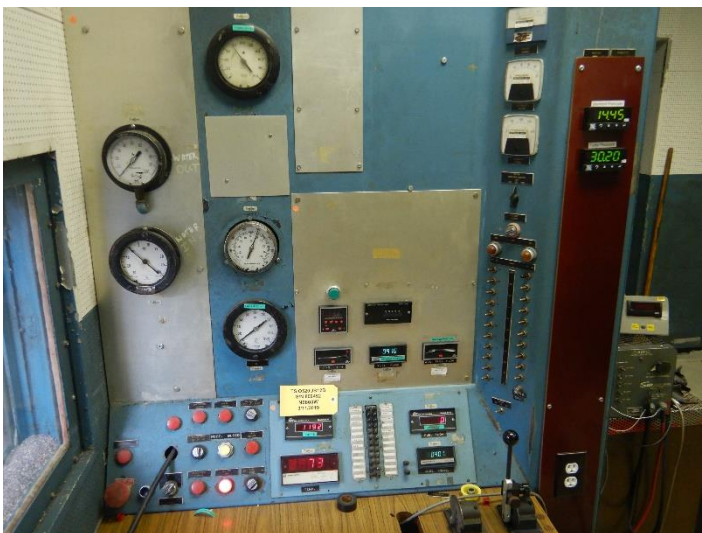
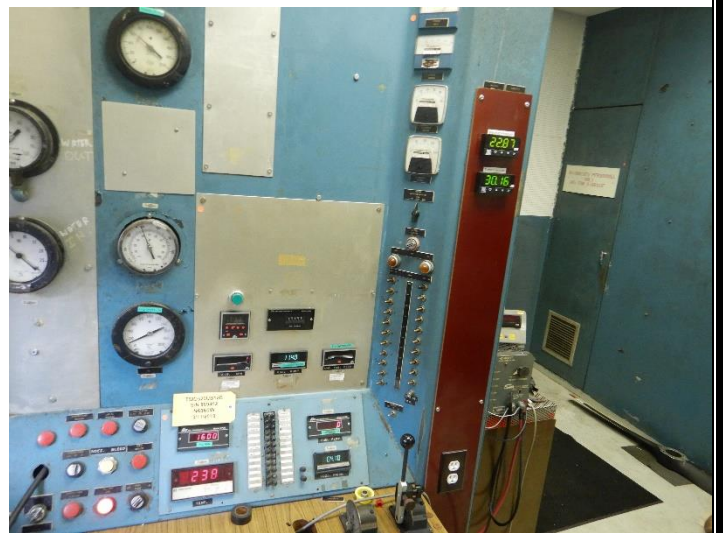
The engine experienced a normal start on the first attempt without hesitation or stumbling in observed RPM. The engine RPM was advanced in steps for warm-up in preparation for full power operation. The engine throttle was advanced to 1200 RPM and held for five (5) minutes to stabilize. The engine throttle was advanced to 1600 RPM and held for five (5) minutes to stabilize. The engine throttle was advanced to 2450 RPM and held for five (5) minutes to stabilize. The engine throttle was advanced to full open position and held for five (5) minutes to stabilize. The engine throttle was rapidly advanced from idle to full throttle five times where it performed normally without any hesitation, stumbling or interruption in power.

Throughout the test phase, the engine accelerated normally without any hesitation, stumbling or interruption in power and demonstrated the ability to produce rated horsepower.
