**[Docket No. FAA-2017-0288; Product Identifier 2017-CE-007-AD; Amendment 39-19231; AD 2018-06-11]**

#### **Airworthiness Directives; Textron Aviation Inc. Airplanes**

**2018-06-11 Textron Aviation Inc.:** Amendment 39-19231; Docket No. FAA-2017-0288; Product Identifier 2017-CE-007-AD.

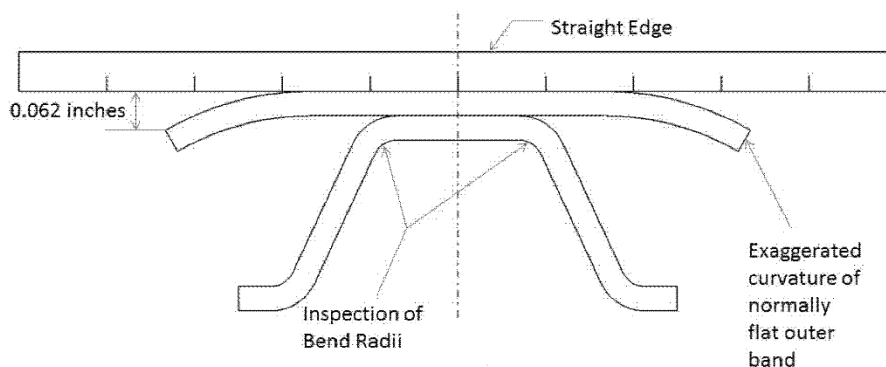
Figure 1 to paragraphs (k)(1)(iii) and (v) of this AD: Cross section of v-band coupling

(iii) Visually inspect the flatness of the outer band using a straight edge. Lay the straight edge across the width of the outer band. The gap must be less than 0.062 inches. See figure 1 to paragraphs (k)(1)(iii) and (v) of this AD. If the gap exceeds 0.062 inches between the outer band and the straight edge, do not re-install the v-band coupling. Before further flight, you must install a new v-band coupling and restart the hours TIS for the repetitive replacement of the v-band coupling.

(v) Visually inspect the bend radii of the coupling v-retainer coupling segments for cracks. Inspect the radii throughout the length of the segment. See figure 1 to paragraphs (k)(1)(iii) and (v) of this AD. If any cracks are found, do not re-install the v-band coupling. Before further flight, you must install a new v-band coupling and restart the hours TIS for the repetitive replacement of the v-band coupling.
