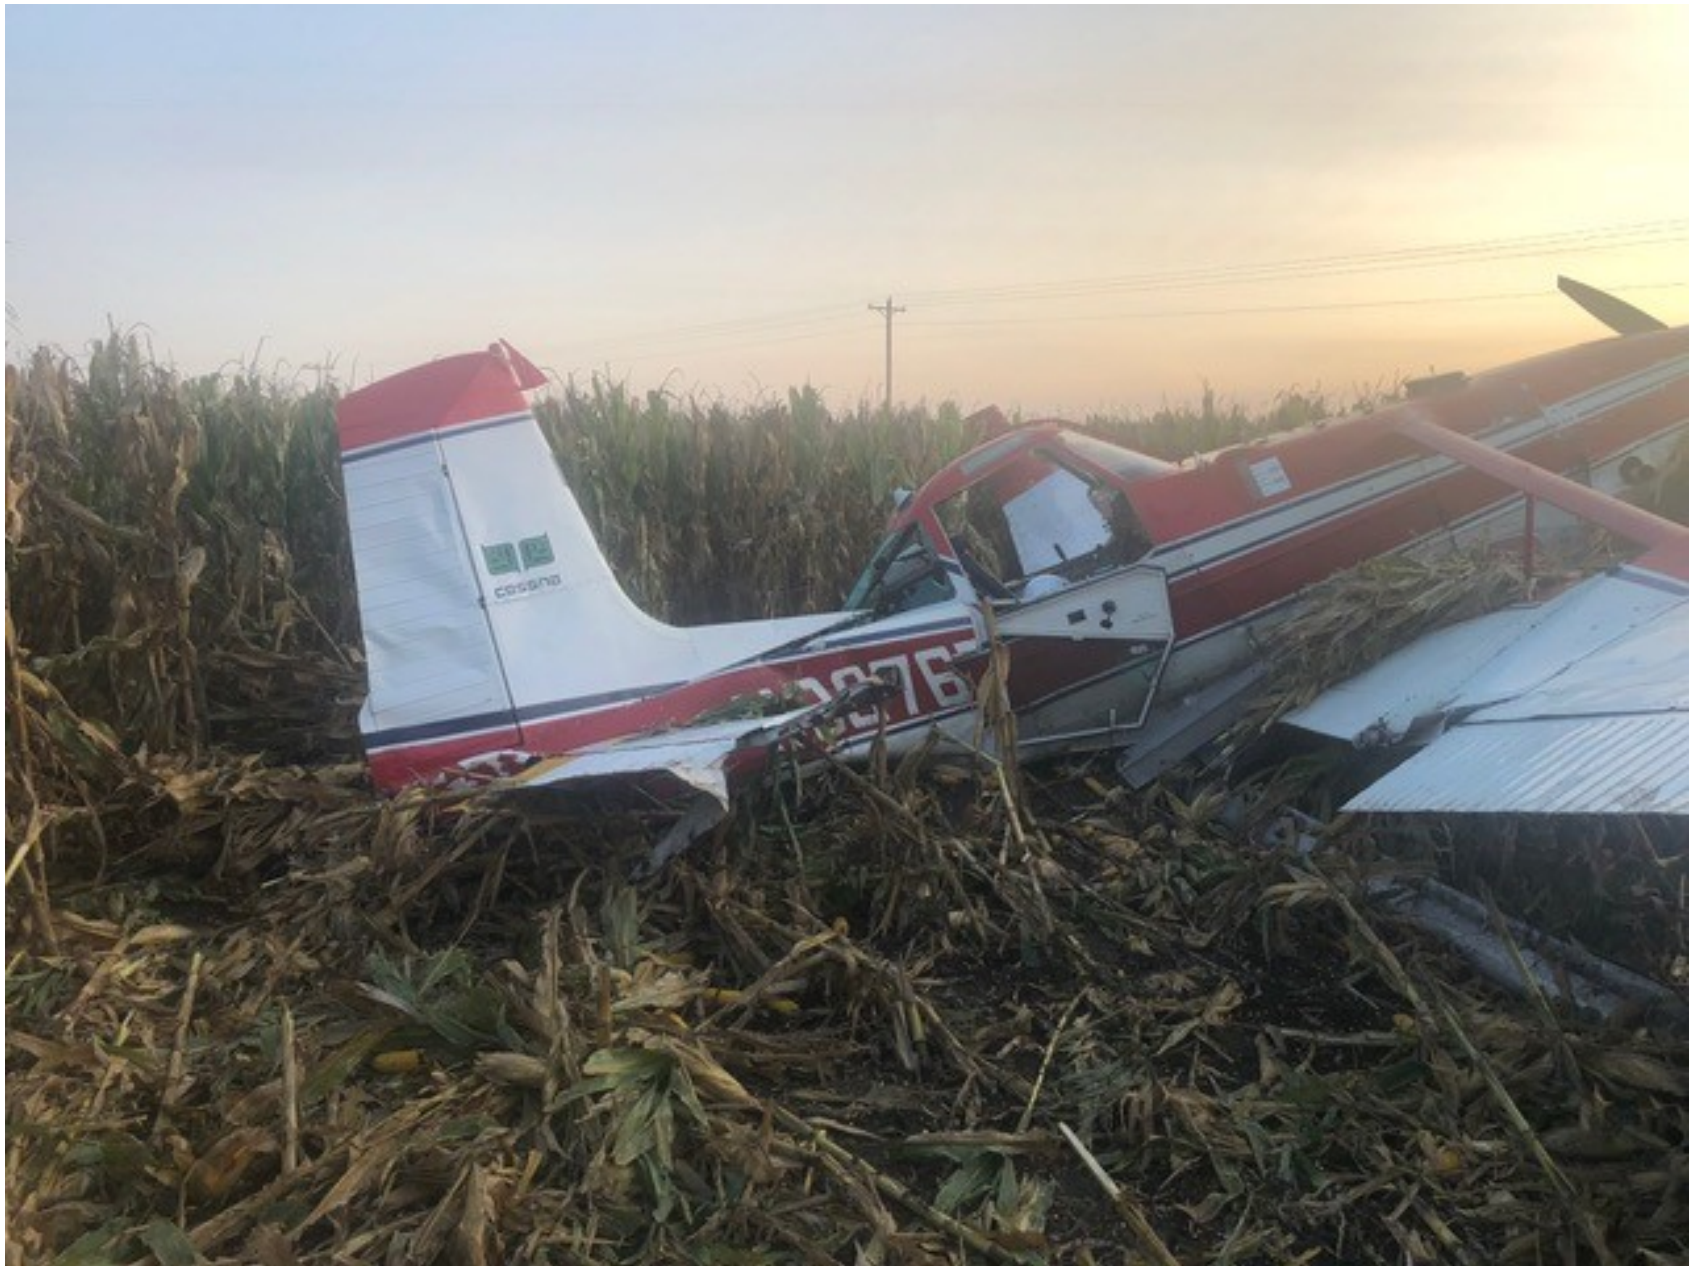
**Photo 1 – Damage Overview (Photo from Pilot)**

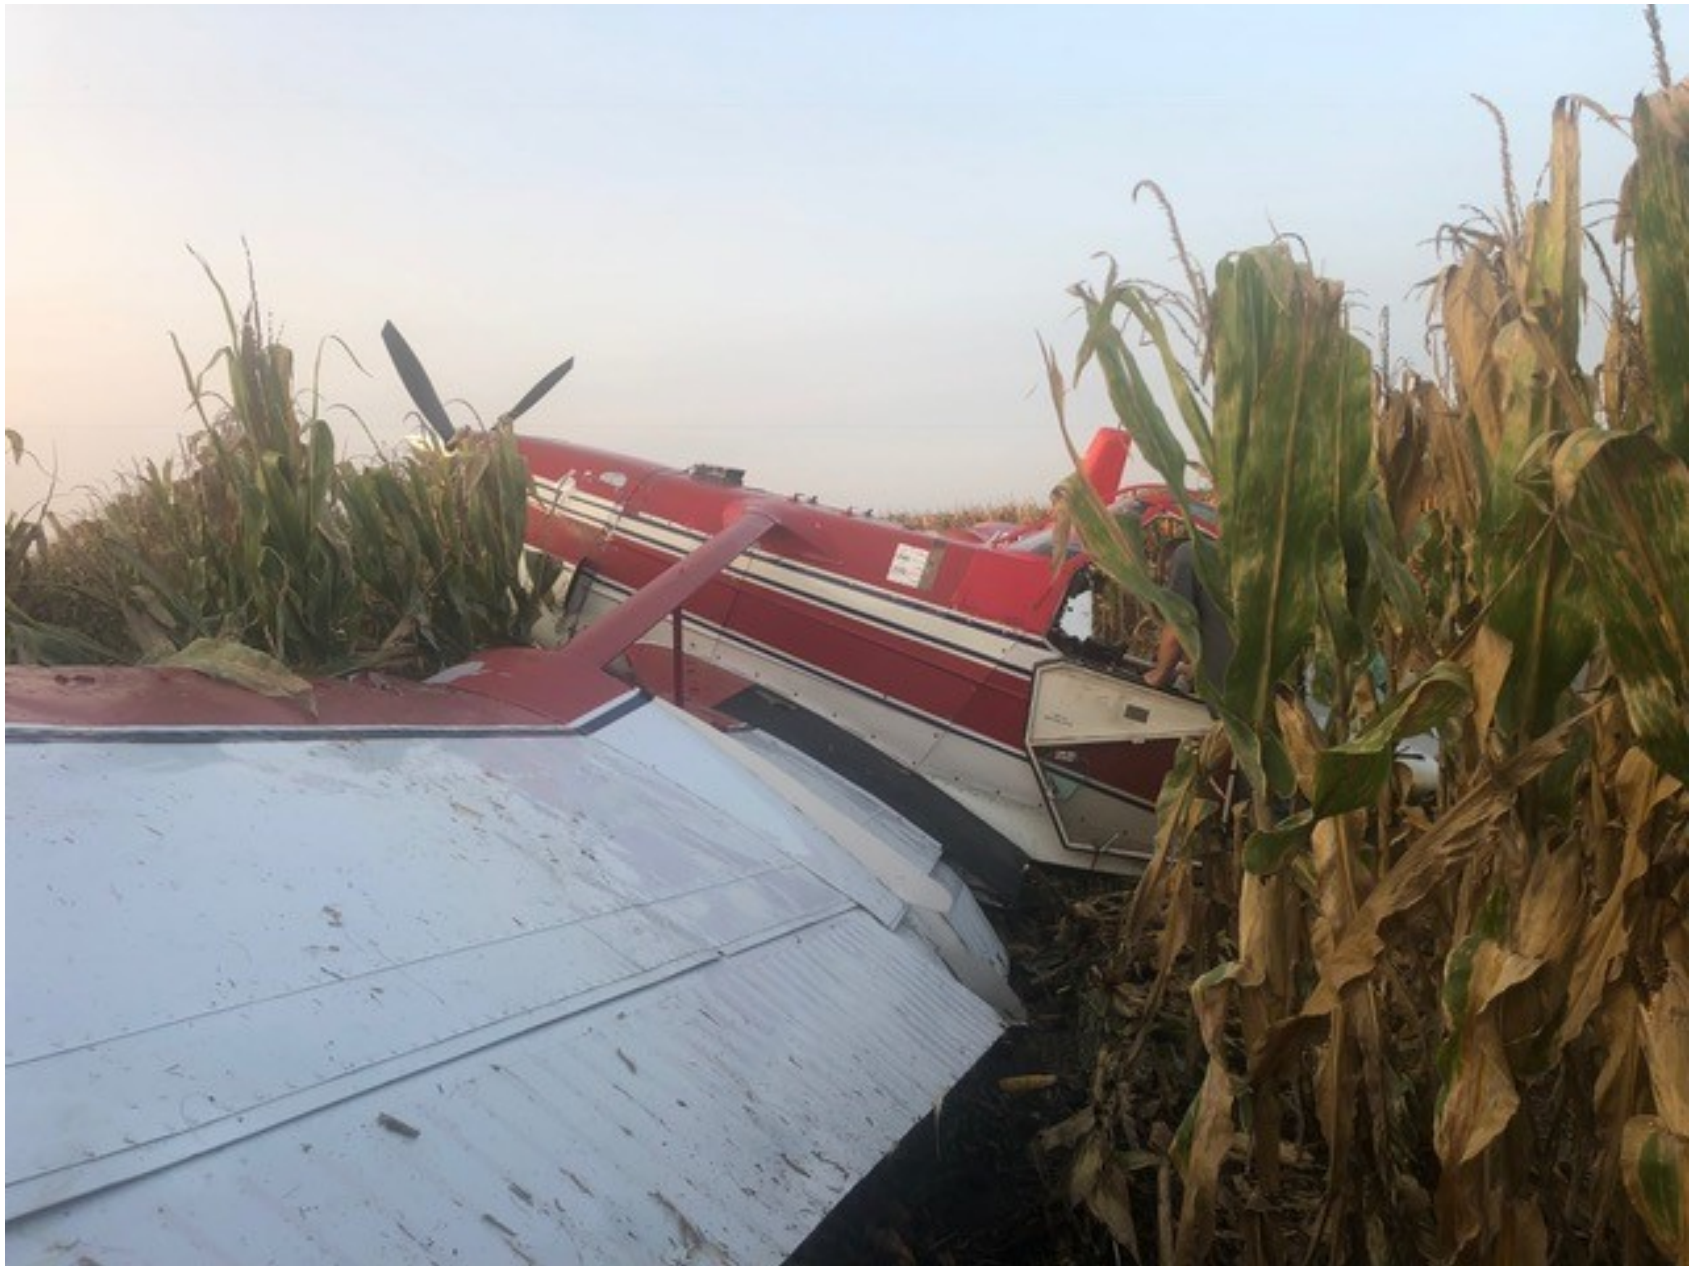
**Photo 2 – Left Wing (Photo from Pilot)**

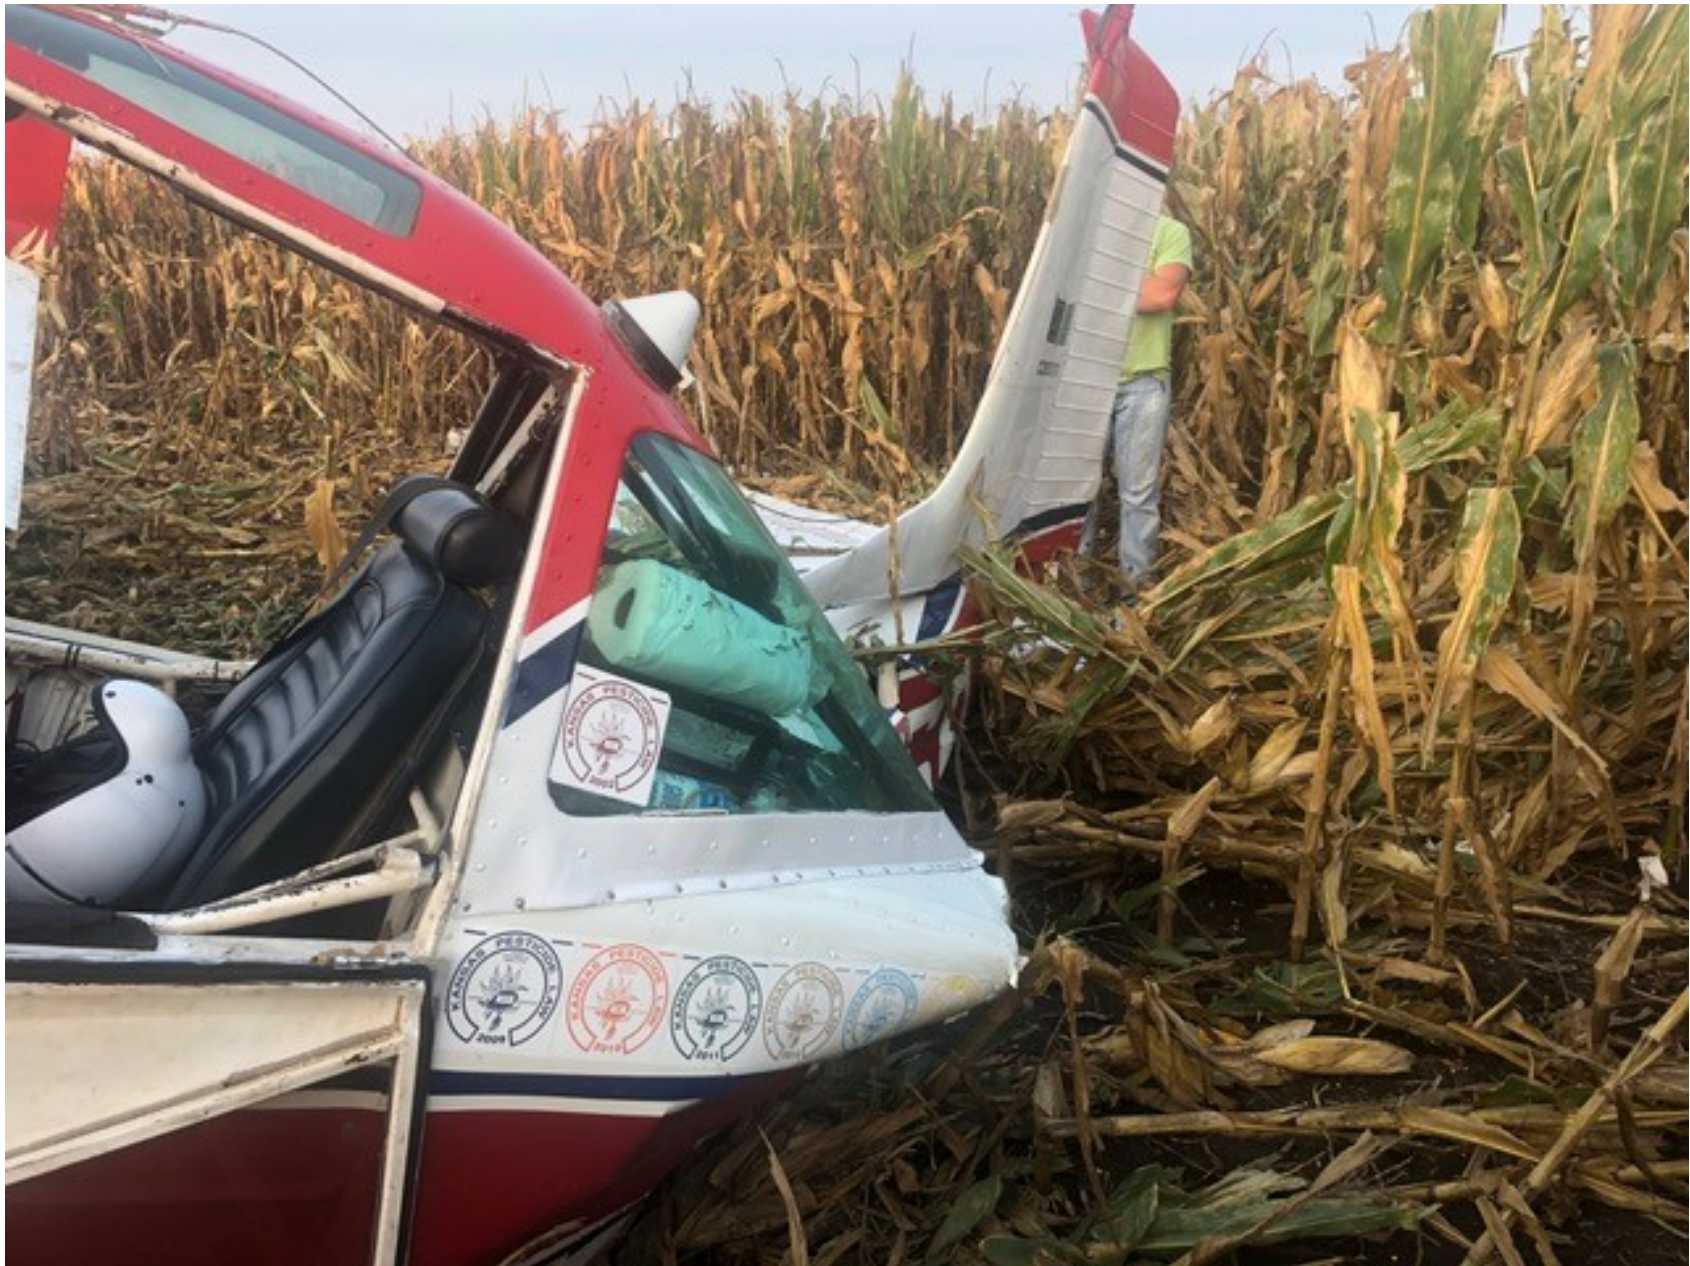
**Photo 3 – Empennage Damage (Photo from Pilot)**
