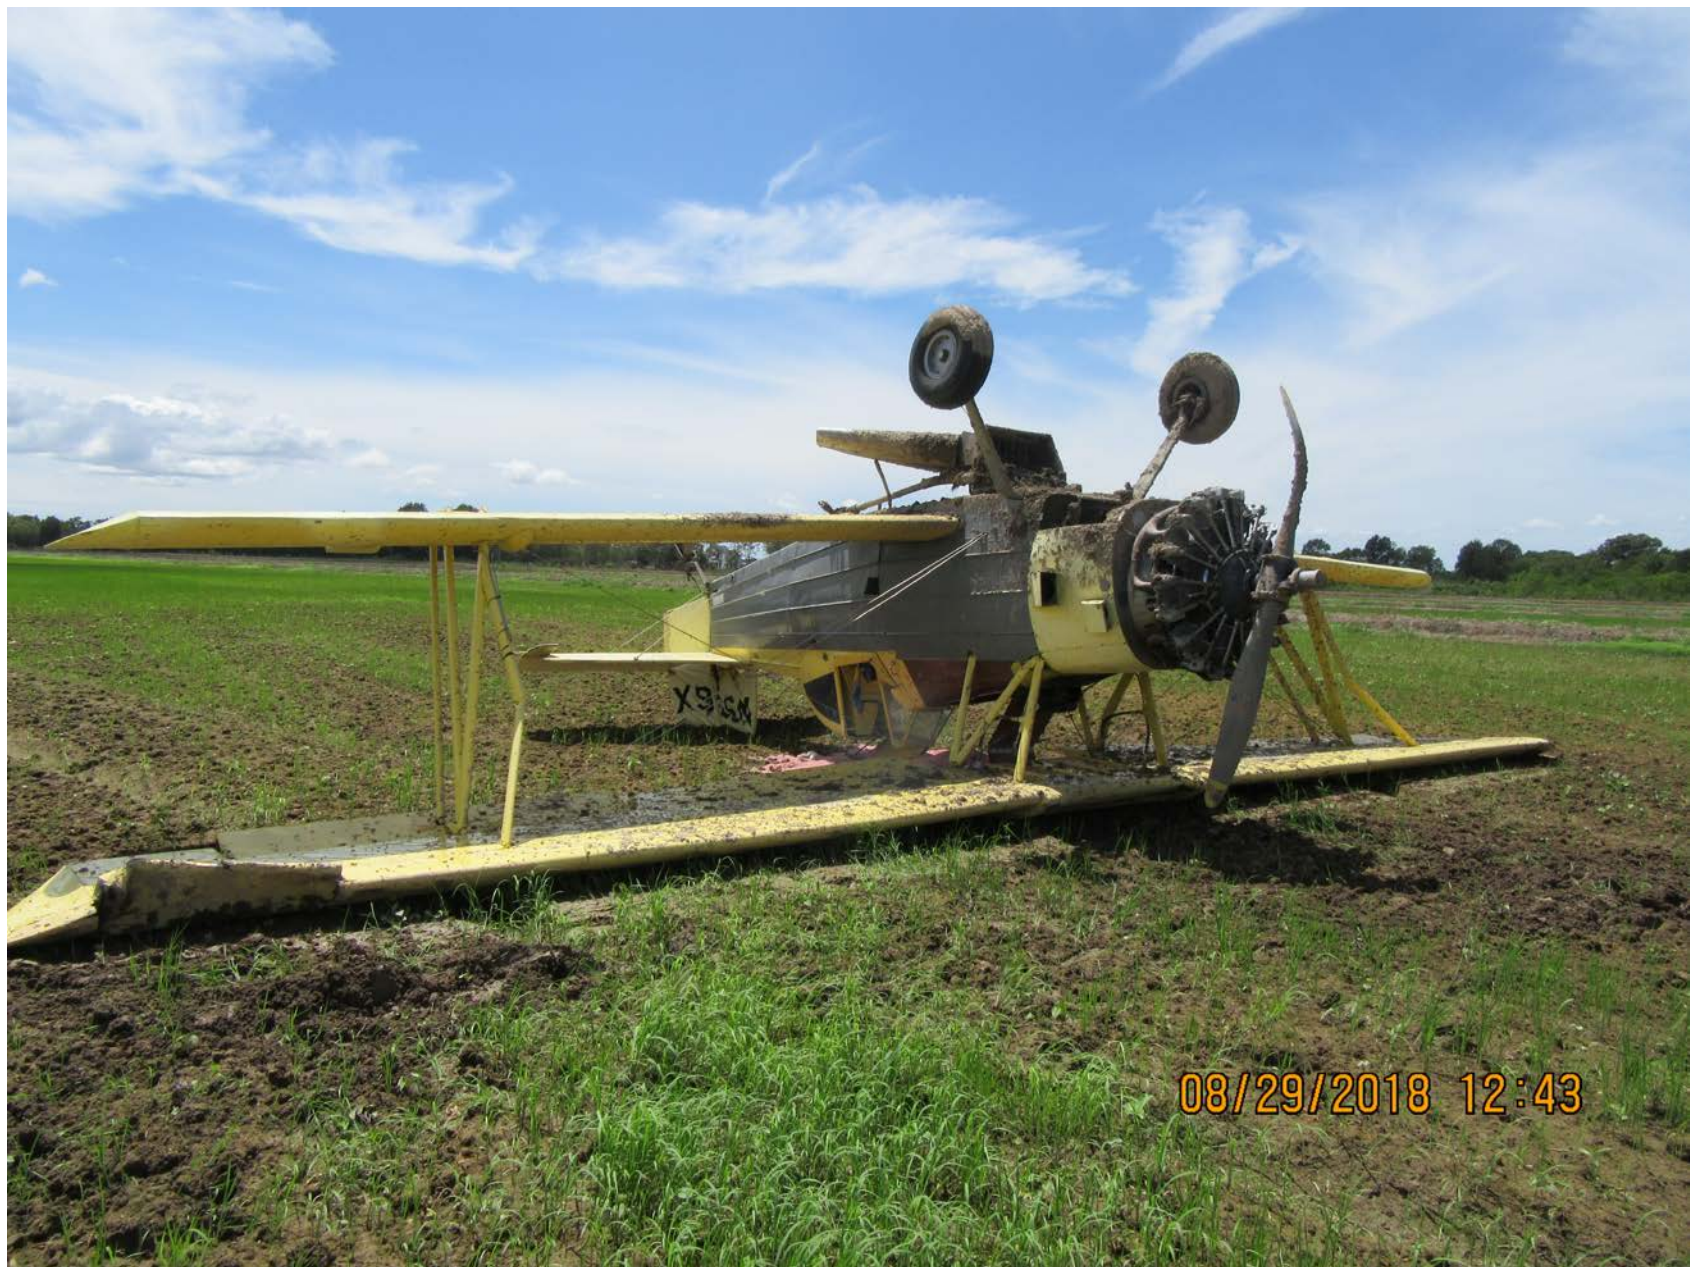
**Photo 1 – N956X lies inverted in an open muddy field near Opelousas, Louisiana.**

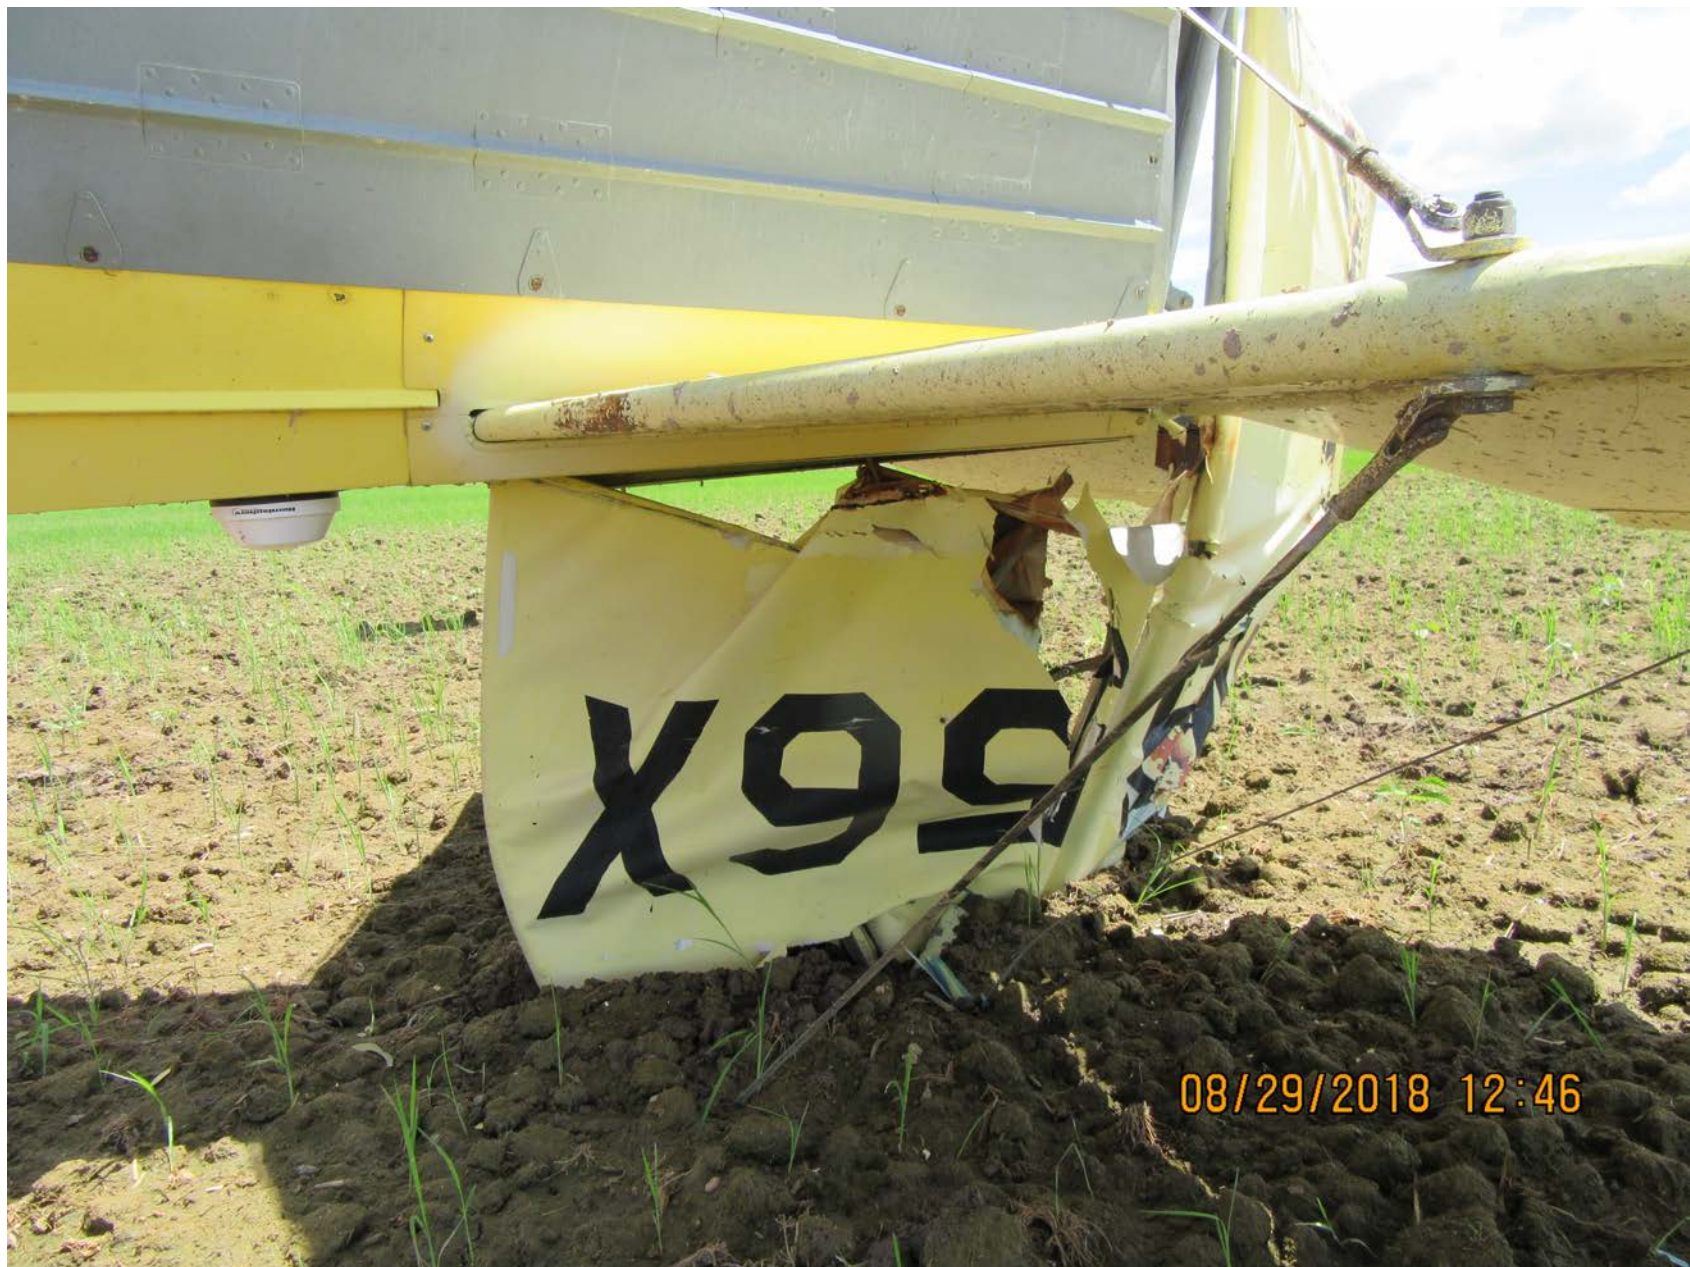
**Photo 2 – Rudder and vertical stabilizer were crushed when the airplane overturned.**

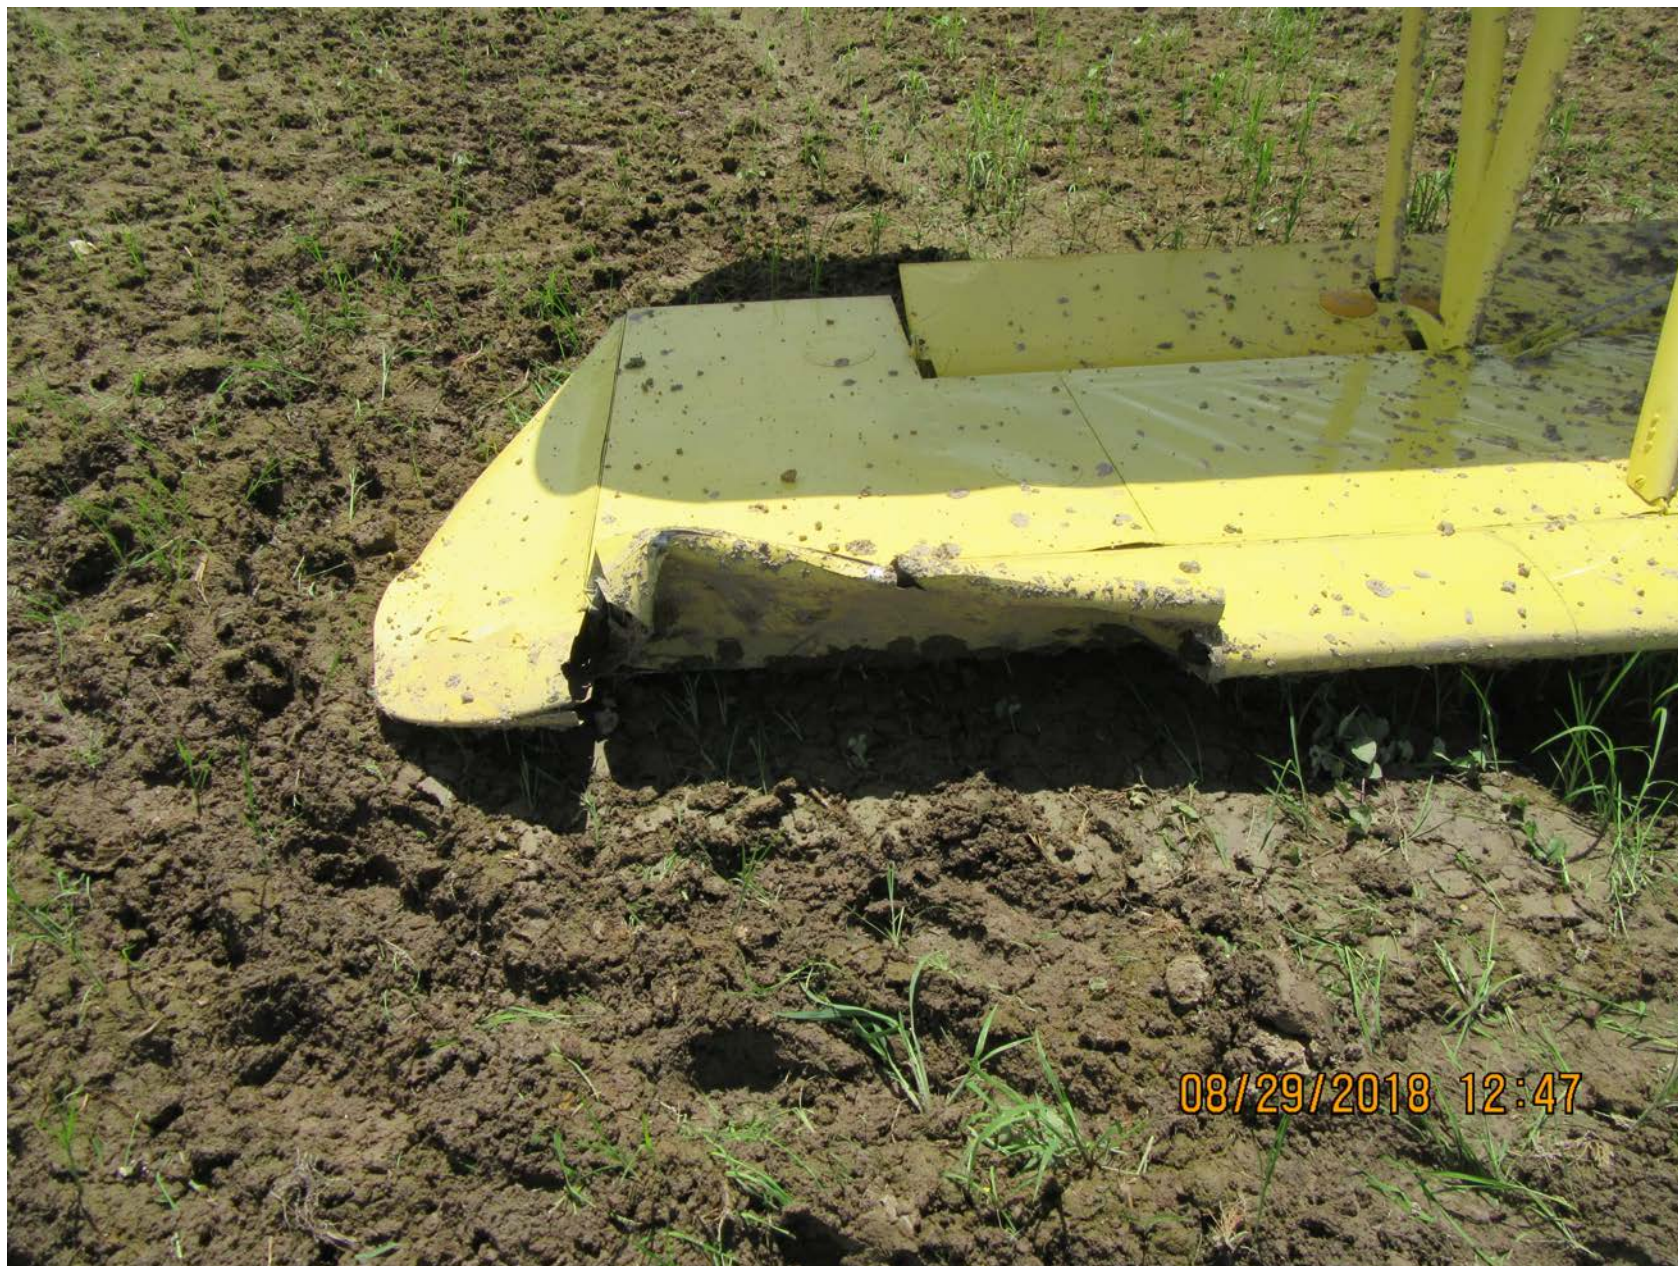
**Photo 3 – Both upper wings sustained damage in the accident. This is the left upper wing leading edge.**
