Federal Aviation Administration (FAA)  
Flight Standard District Office (FSDO)  
Cincinnati, Ohio 4

NTSB accident # CEN18LA362 / FAA Accident # AGL0518010  
N2305K Accident at New Carlisle, OH August 31, 2018  
Report Written By Andrew Porter on September 26, 2018

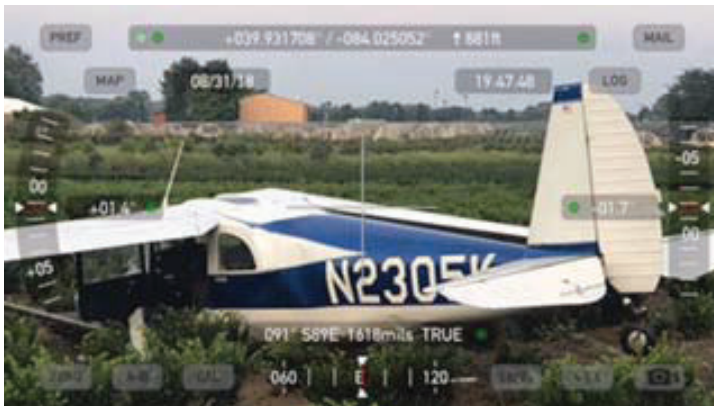
The aircraft impacted the ground at a moderate angle producing major damage to the aircraft. The main wreckage was located in one central location and there was no indication of fire or smoke damage in the wreckage. Eyewitnesses and police officers on scene reported a strong smell of fuel and witnessed fuel leaking from the engine compartment; an aircraft mechanic from the local airport turned the right main fuel selector to the off position on arrival. There was major damage to the nose and wings of the aircraft due to ground impact. The nose of the aircraft sustained substantial damage. All three landing gear were either bent or separated from the aircraft. The tail of the aircraft had little to no obvious damage

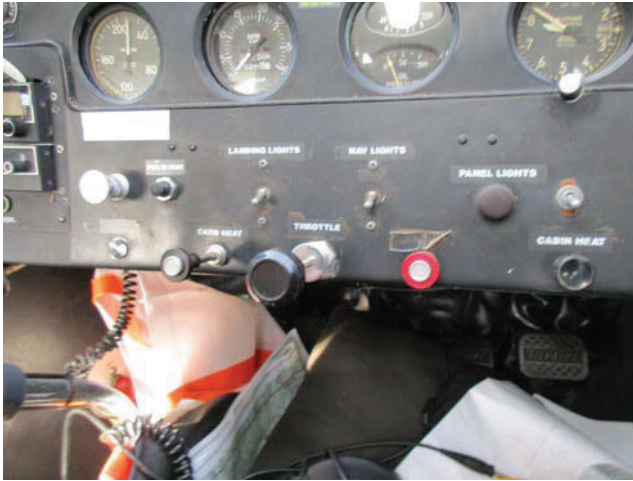
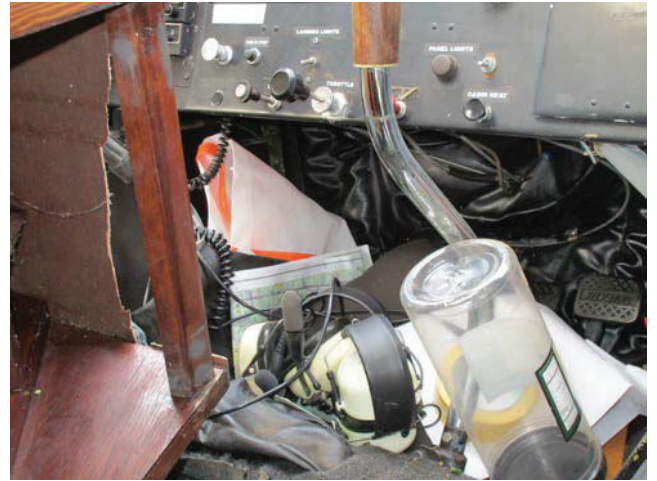
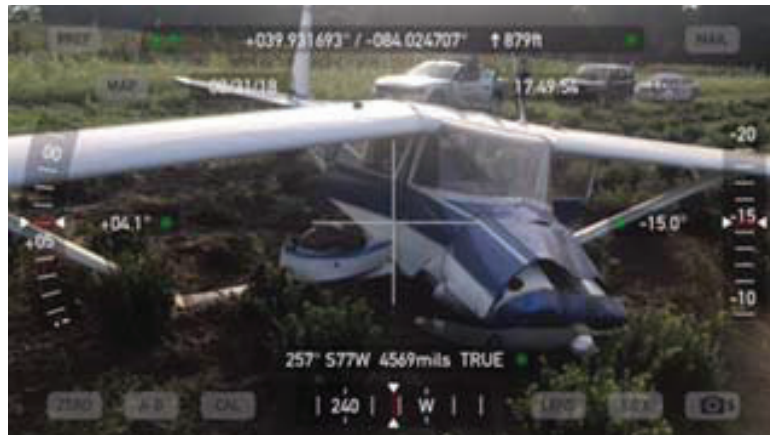
The fuselage sustained moderate damage to the nose and front of the aircraft, both Main gear were broken off. The cabin area sustained damage to the forward section, floor and control panel area.

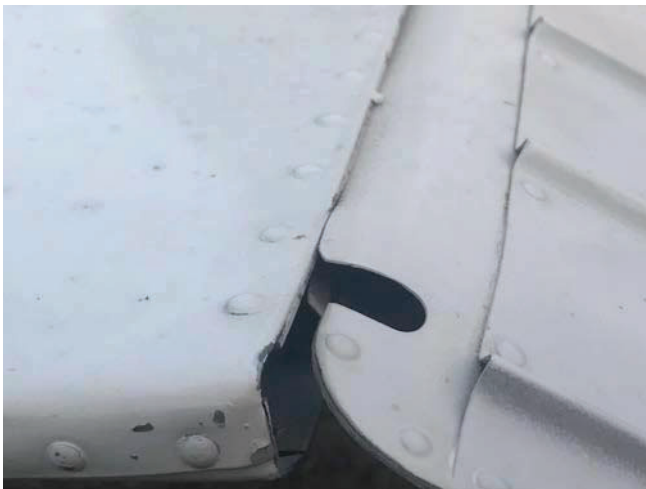
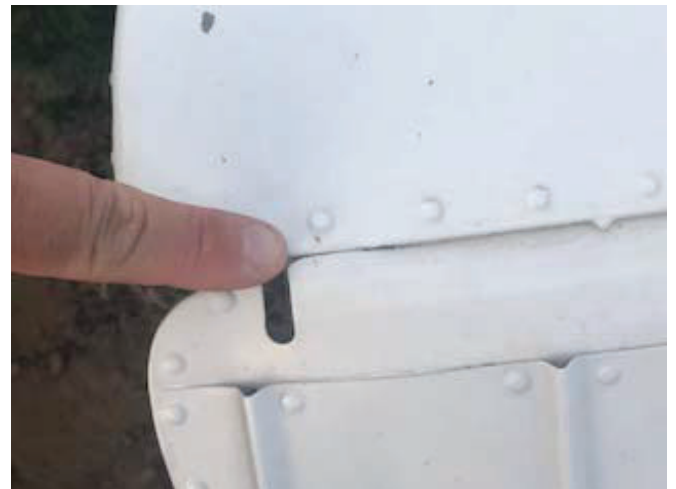
Only notable issue on the empennage was a binding issue on the left elevator to horizontal, binding did prevent elevator movement until elevator put back into position. No control issues noted by the pilot at the time of the accident.

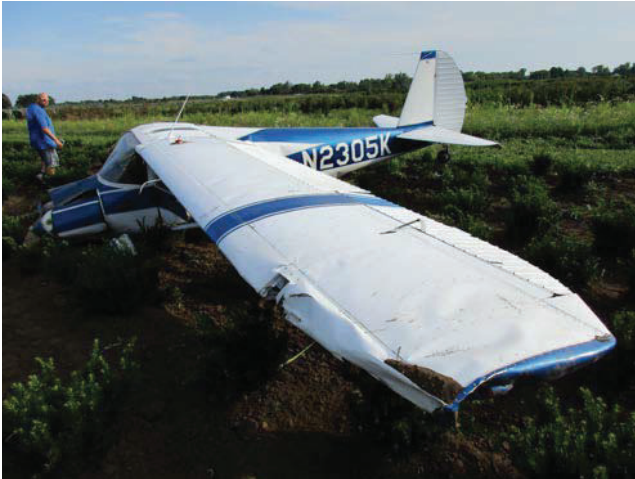
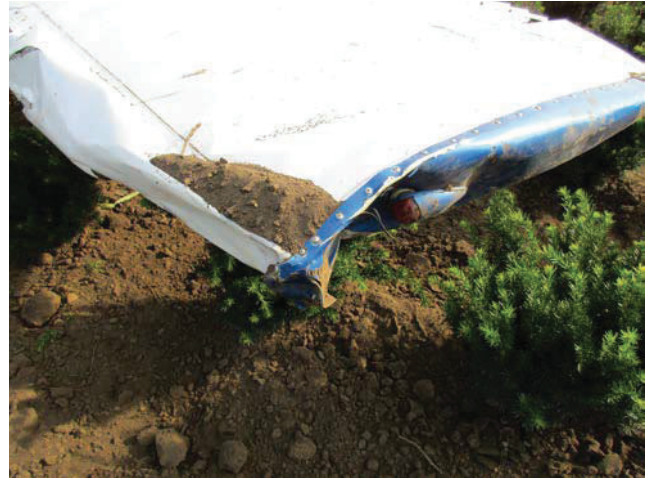
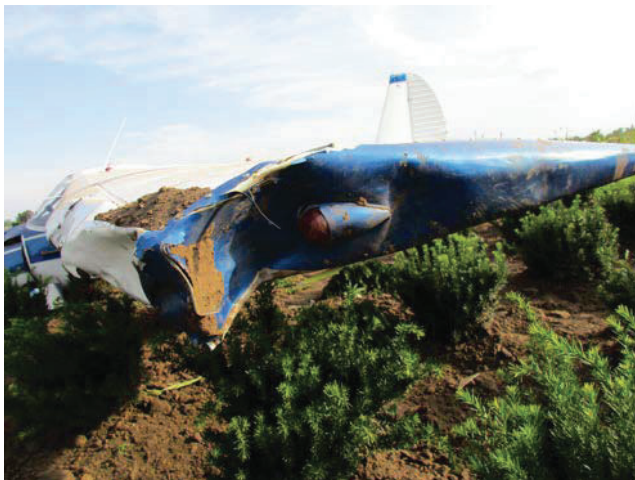
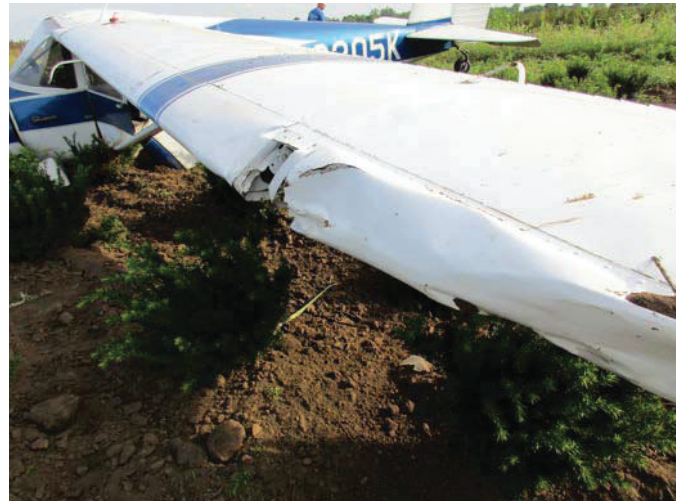
Left wing Picture above

The left wing was found intact still attached to the fuselage, the left aileron was still attached to the wing and we confirmed cable continuity to the control column. The left wing leading edge and wing tip contacted the ground causing major damage to the wing. Fuel tanks were intact 6.75 gallons of 100LL was removed

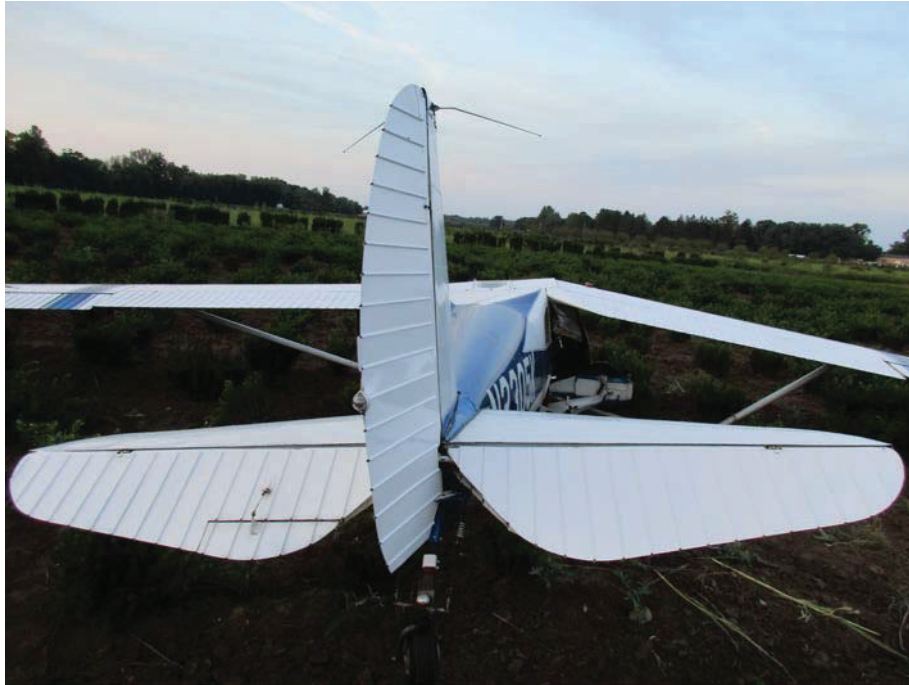
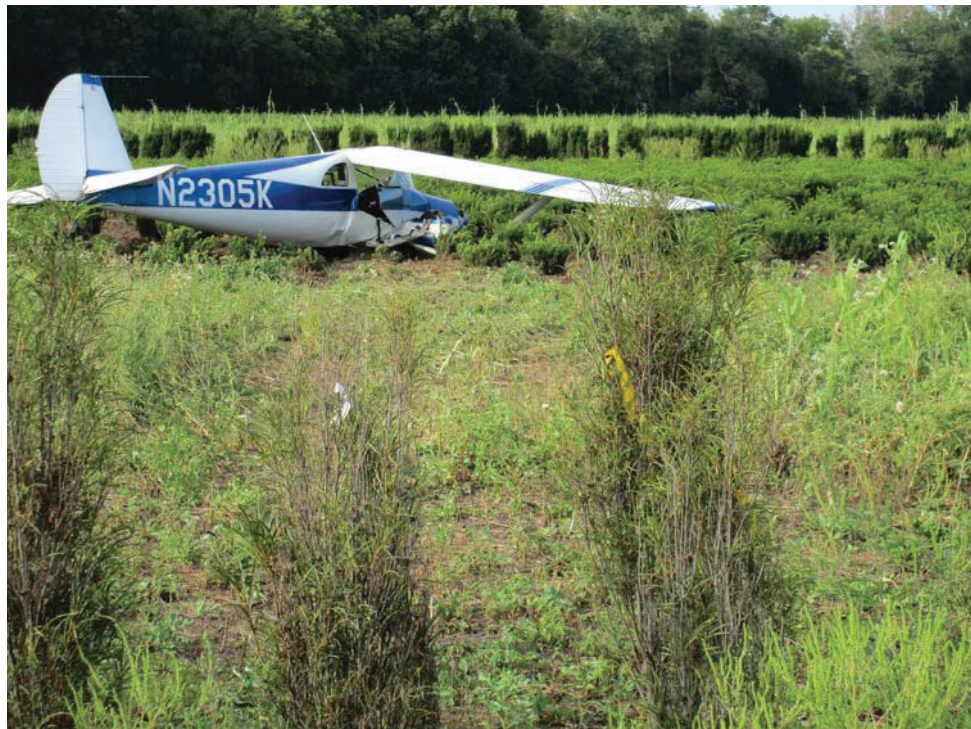
The right wing attach area is either bent or broken the attach points, the wing strut failed. The right aileron was still attached to the wing and confirmed cable continuity to the control column.

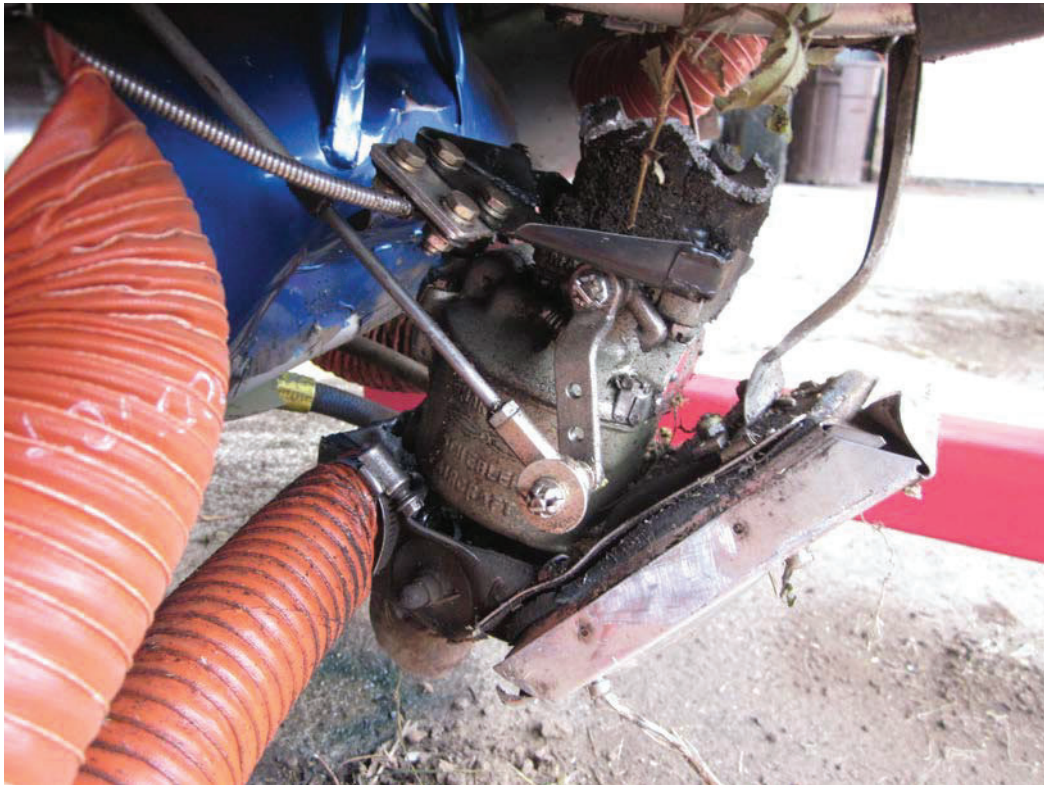
The engine was mainly intact, except the carburetor intake was broken and separated from the engine.

Fuel manifold broke from apparent ground impact.

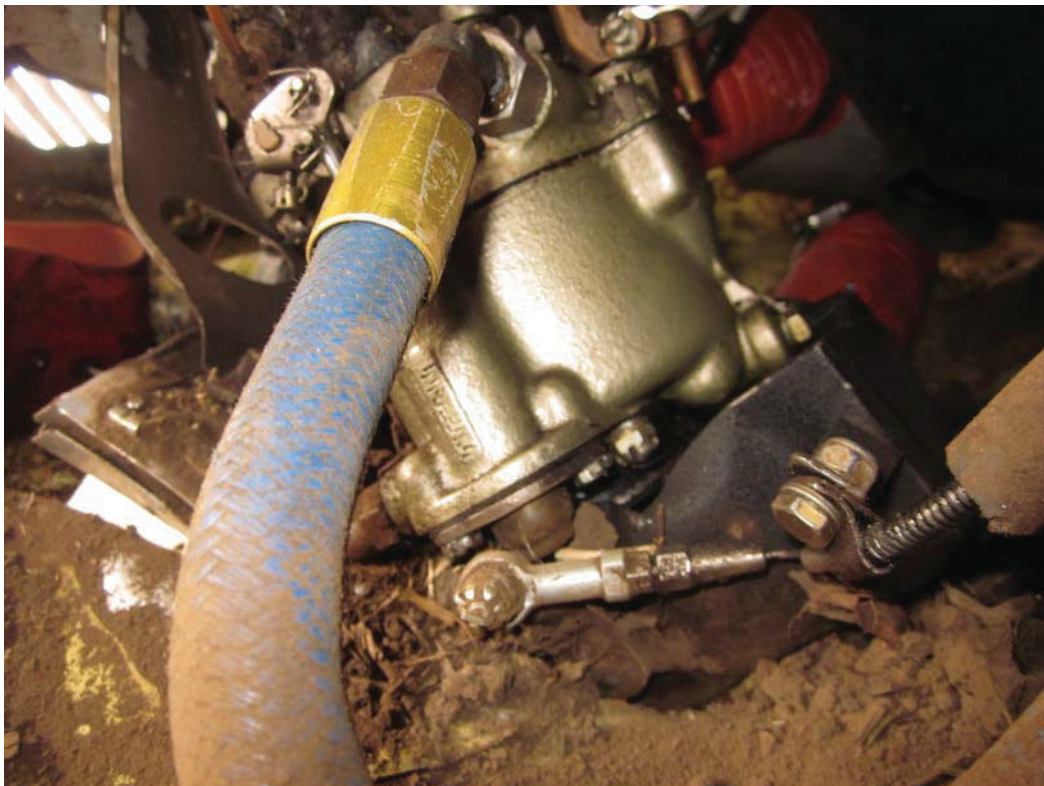
- Throttle cable moved freely from stop to stop.
- Mixture control cable moved freely from stop to stop.
- Carburetor heat control cable was bent 90 degrees from probable impact damage, however the linkage was intact. The heat box was packed full of dirt from impact and severely deformed preventing any movement.

Carburetor heat linkage bent 90 degrees, unable to actuate due to damage.

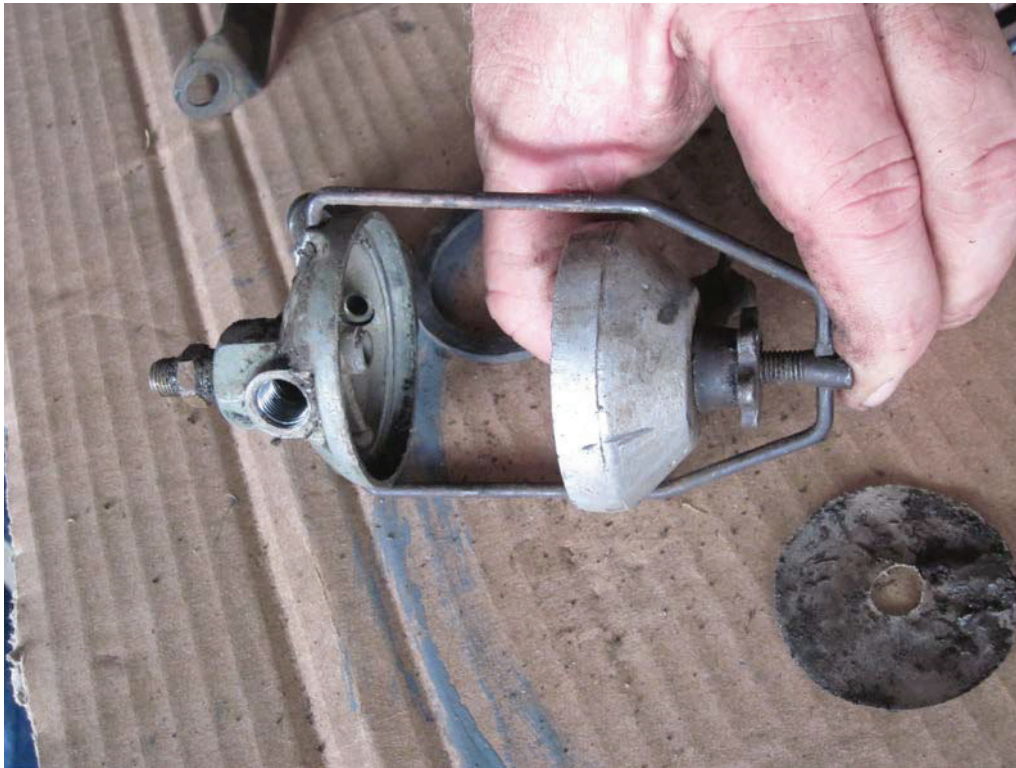
- Aircraft was placarded for Auto Gas. But the previous owner stated they never used auto gas, only 100LL.
- The fuel gascolator glass bowl was found shattered inside nose cowl.

Reassembled gascolator, the wire clip, tightening nut, gasket, broken glass bowl and filter screen was found in the lower cowling on removal. The filter screen seen in the lower right is packed with dirt from the ground impact.

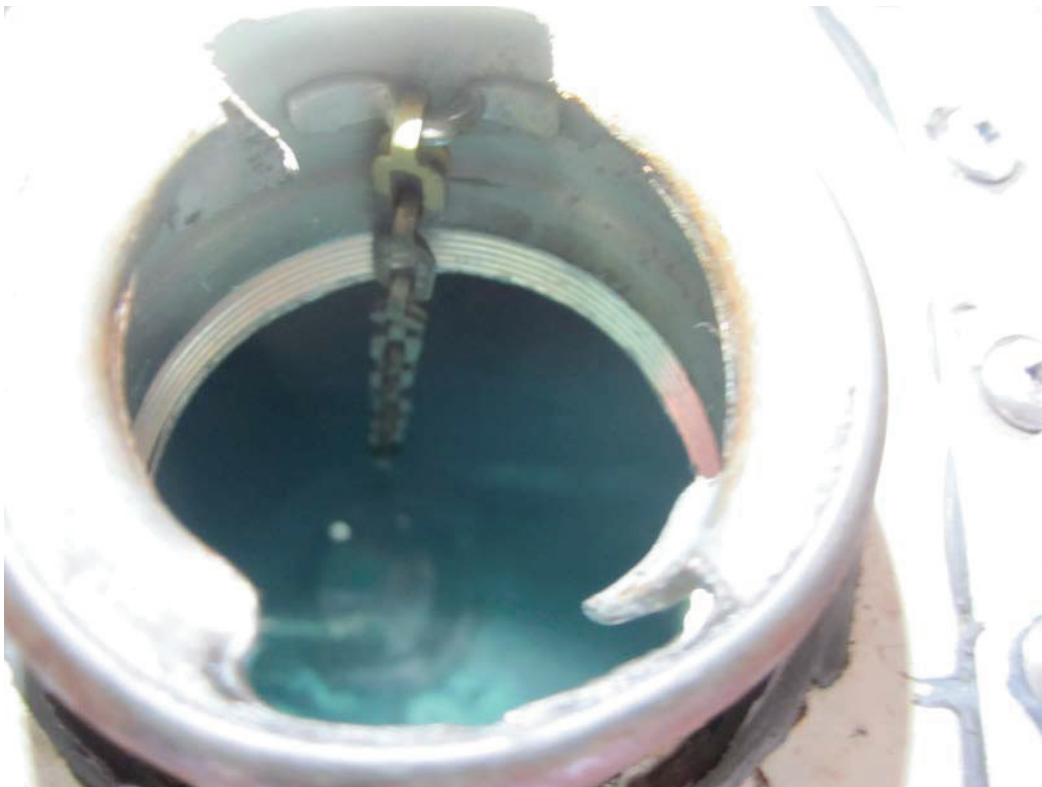
- Aircraft is placarded for 12.5 gallons of fuel per side. Drained 5 gallons of 100LL (clear and bright blue tint) from RH tank, small amount of sediment was detected. Drained 6.75 gallons (clear and bright) from LH tank small amount of sediment was detected.

Fuel in right tank prior to draining, light blue tint indicates 100LL in the tank, removed approximately 5 gallons of fuel.

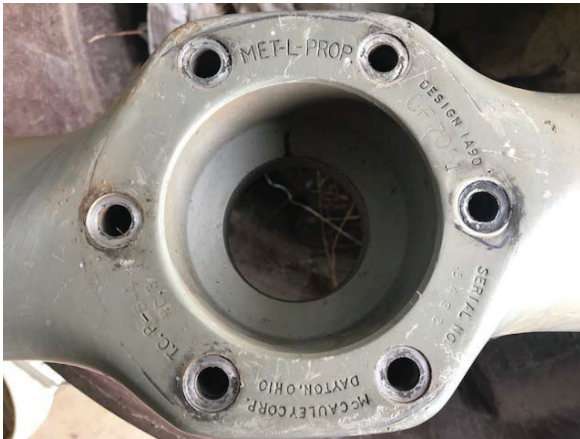
The propeller was damaged due to ground impact; only one blade was bent and there is no rotational scarring indicated

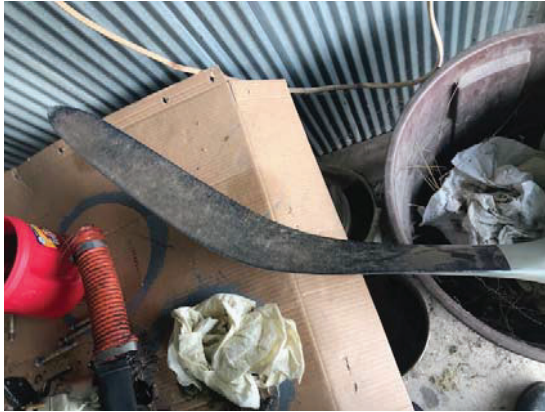
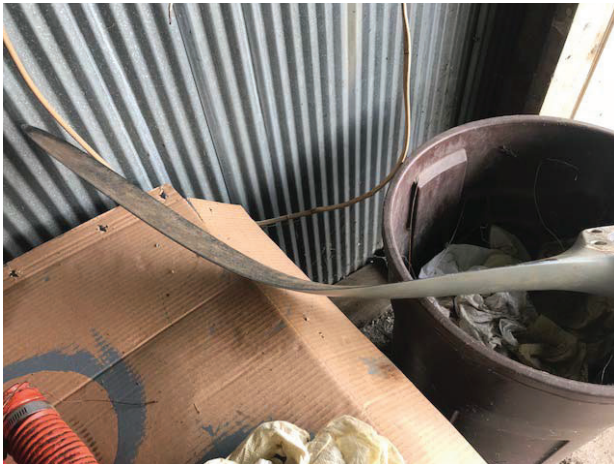
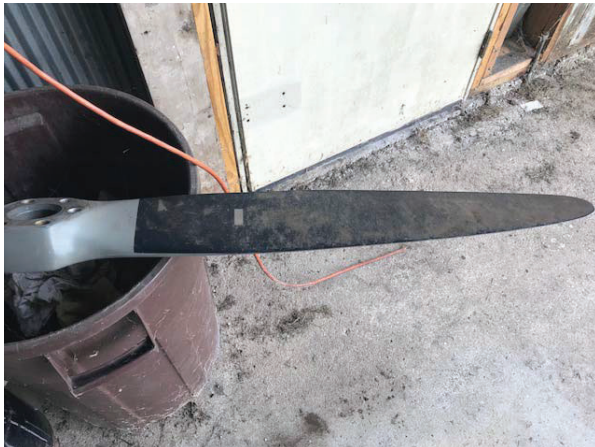
Prop hub was still attached to engine shaft.
