## ENGINE RUN REPORT

| ENGINE MODEL | IO-550-P (converted to a turbo normalized engine by Vitatoe Aviation) |
| AIRCRAFT MAKE & MODEL | Cessna P210N |

| <b>EXAMINATION</b> | | <b>ACCIDENT DATA</b> | |
|---|---|---|---|
| <b>DATE</b> | 04/03/2019 – 04/04/2019 | <b>NTSB ACCIDENT #</b> | CEN19LA363 |

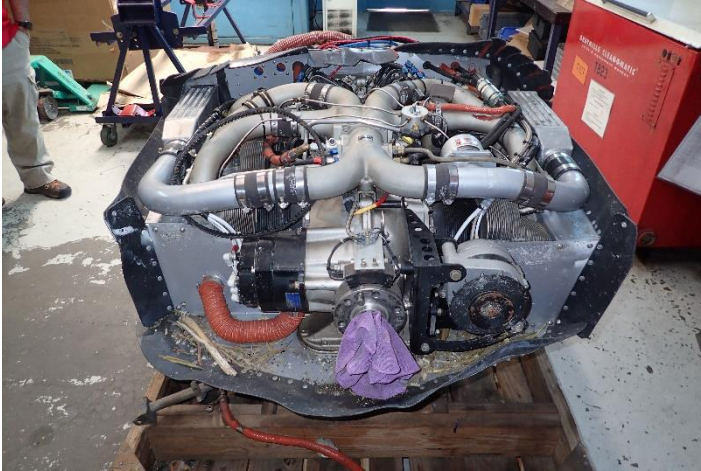
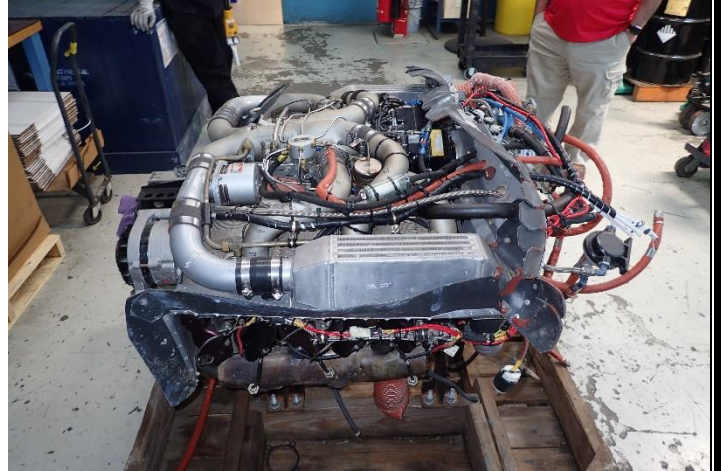
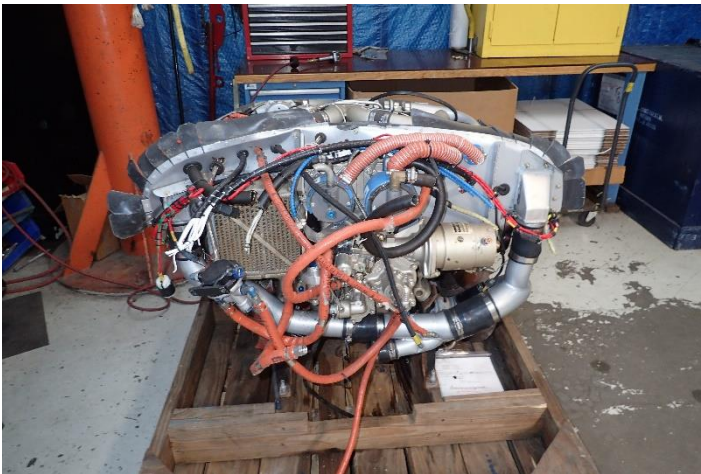
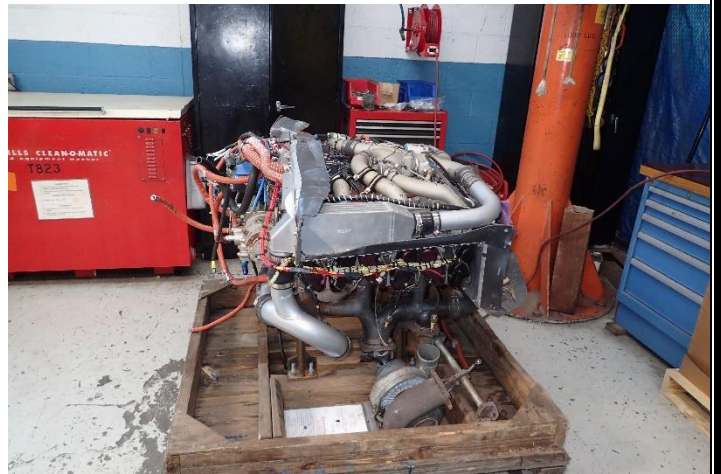
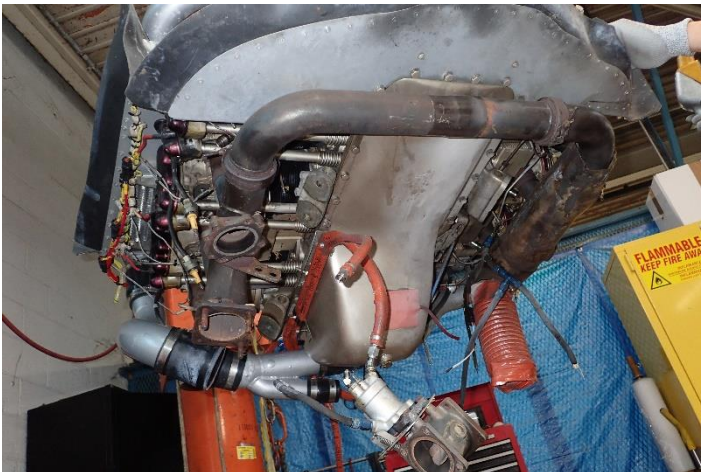
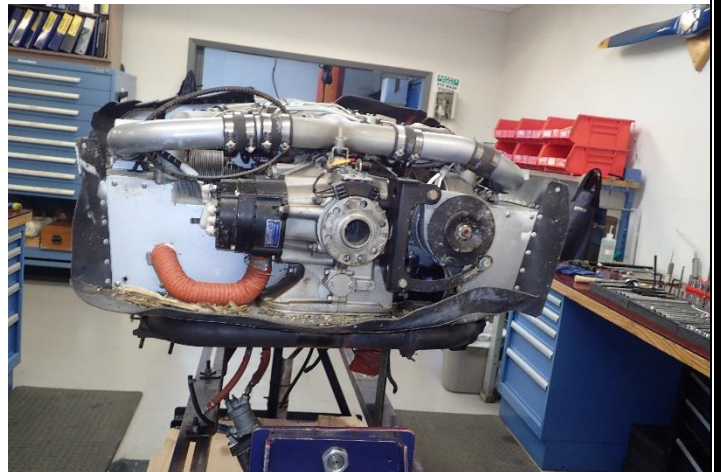
The engine was sent in a crate and was mounted properly on all four engine mounts. The engine displayed minor impact damage signatures to the induction and the exhaust. The crankcase remained intact and there were no signs of a catastrophic internal engine failure. The propeller flange remained attached to the crankshaft and was undamaged. All six cylinders remained attached to their cylinder bays and were undamaged.

Both of the magnetos remained attached to their installation points and the magnetos were undamaged; however, one of the pressurization lines had broken free from one of the magnetos. The ignition harness remained attached to both of the magnetos and to each of the spark plugs; there were no signs of damage to the harness. All of the spark plugs remained installed in their cylinders and were undamaged.

The turbocharger had been removed and was placed in the crate. The turbocharger was undamaged, and both the compressor and turbine blades were undamaged and were capable of normal rotation. The wastegate had been partially removed and was undamaged; it was noted that the pin that connects the actuator to the wastegate valve was missing (according to the FAA they had removed the pin during their initial examination and the pin was lost). The controller was secured to the engine by hoses and was undamaged. The overboost valve remained attached to its installation point and was undamaged.

The induction system displayed impact damage signatures to the rear induction pipes. Both of the intercoolers remained attached to the engine and displayed minor impact damage. There were no signs of induction leaks noted.

The exhaust system remained attached to the engine and displayed impact damage signatures. There were no signs of exhaust leaks or blockages noted.

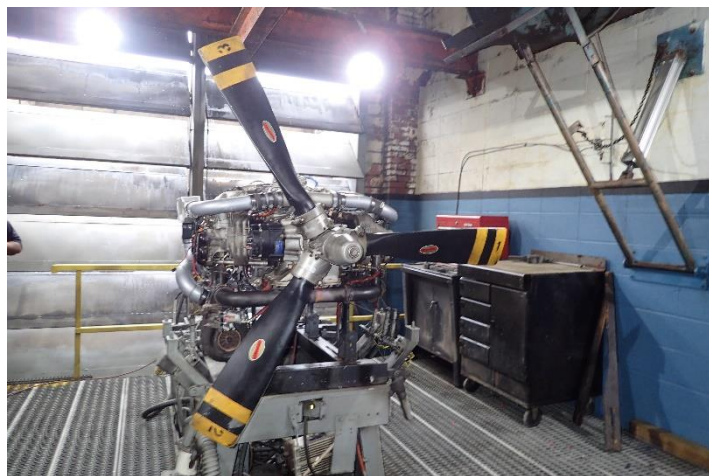
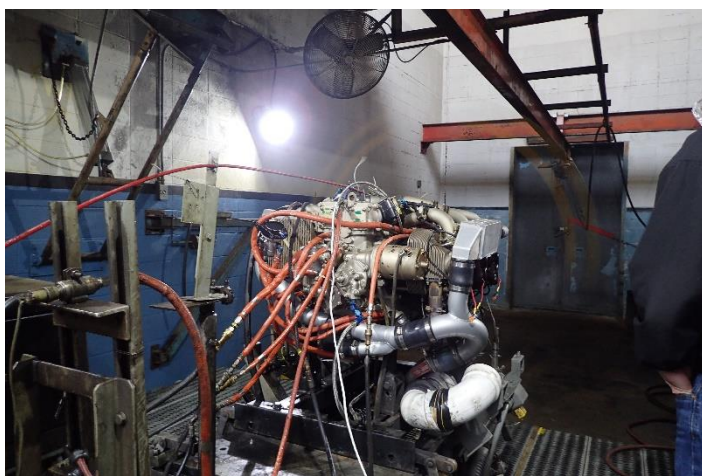
The engine started without hesitation or stumbling. The engine was warmed up to operating temperature and the engine was advanced; it was noted that the engine began to stumble at higher RPM and manifold pressure settings. It was determined that the turbocharger installation required induction scoop to prevent the compressor from cavitating in the test cell. An induction scoop was installed onto the turbocharger and the engine was restarted. The engine RPM was advanced to 1200 RPM and was held for five minutes to stabilize. The engine was then advanced to 1600 RPM and held for five minutes to stabilize. The engine RPM was then advanced to 2100 RPM and held for five minutes to stabilize; during this period a magneto check was performed, and the magnetos operated normally. The engine RPM was then advanced to 2450 RPM and held for five minutes to stabilize. The engine throttle was then advanced to full open and held for five minutes to stabilize. The engine RPM stabilized at 2676 RPM and the manifold pressure stabilized at 32.54" Hg. The fuel flow at full throttle was noted to be 201.68 lbs/hour (approximately 33.61 gallons per hour), and the unmetered fuel pressure was 20.31 psi. The specifications in the Vitatoc STC Instructions for Continued Airworthiness specified an RPM of 2700 RPM (+/- 25 RPM), a maximum manifold pressure of 31.0" Hg (+/- .2" Hg), a full throttle fuel flow of 35-37 GPH, and full throttle unmetered fuel pressure of 19-23 psi. According to the Continental Motors M-0 standard practices manual the IO-550-P should have the following: maximum RPM of 2700 RPM, unmetered fuel pressure of 28.0-30.0 psi, and a fuel flow of 25.6-27.3 gph. There is no specification for manifold pressure for an IO-550-P due to the engine being a normally aspirated engine.

After running the engine at full power, the engine RPM was brought back to a lower RPM and was advanced quickly to full throttle several times. The engine did not stumble or hesitate and was capable of normal operation.
