## **NATIONAL TRANSPORTATION SAFETY BOARD**

# **ENGINE EXAMINATION**

**CEN18LA382**

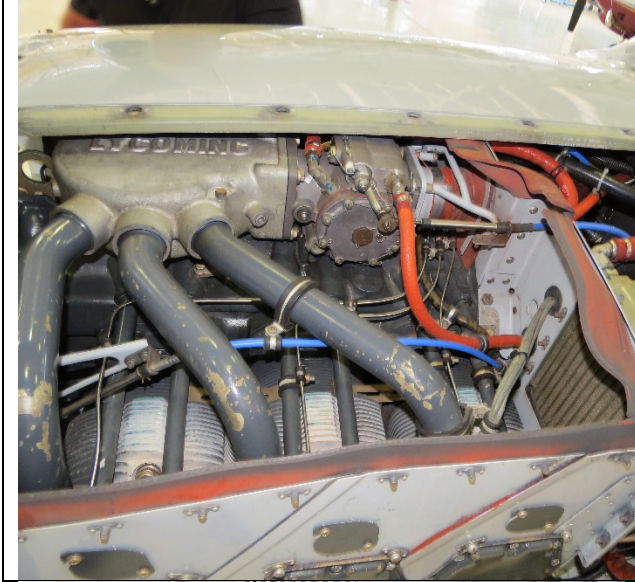
Overall condition of the engine.

A visual inspection of the exterior of the engine did not identify any abnormalities.

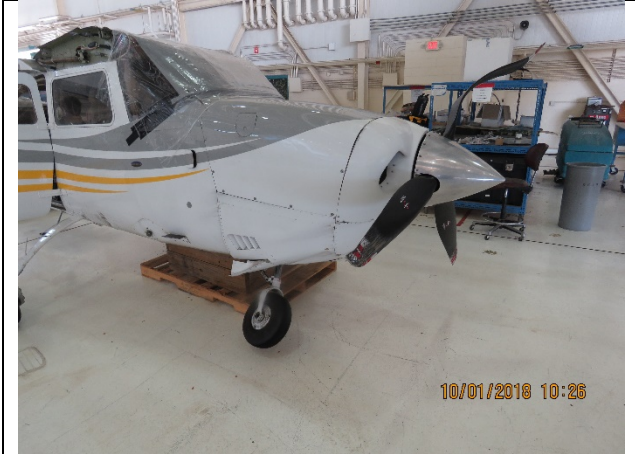
The propeller was rotated by hand; the prop was free to move; However, the engine would not rotate; coming to hard stop.

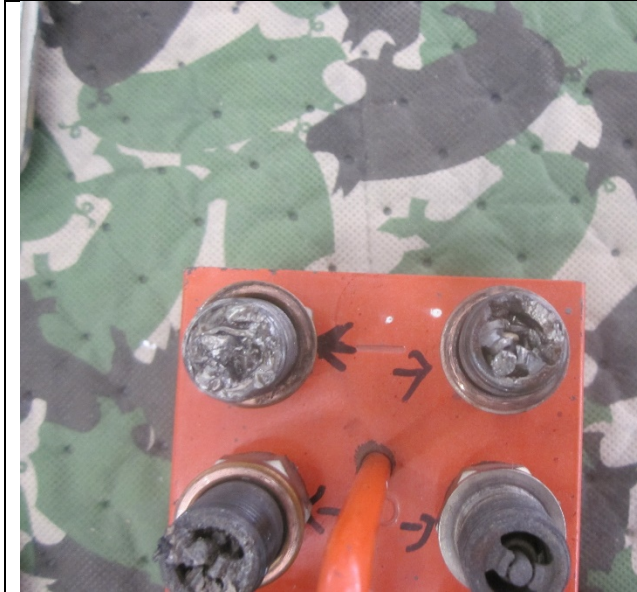
The sparkplugs were removed. Damage to the sparkplugs were noted on the number one and two cylinder plugs.

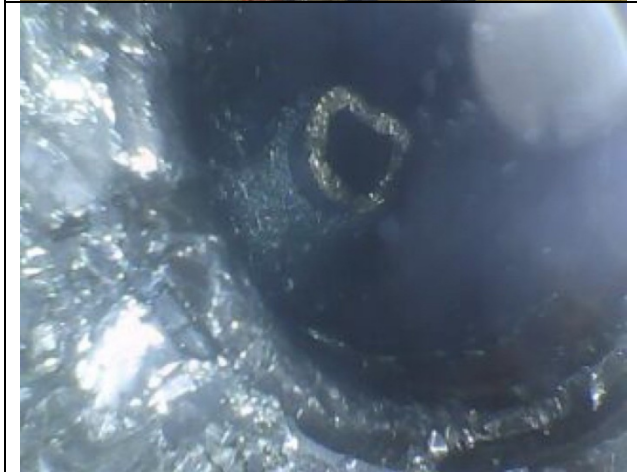
A borescope was used, and it appeared that the intake valve for the number one cylinder had failed.

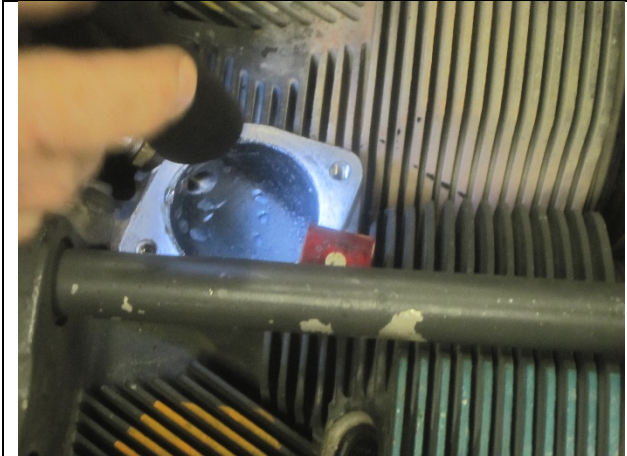
Fractured pieces of the intake valve, exited the #1 cylinder, and into the intake plenum.

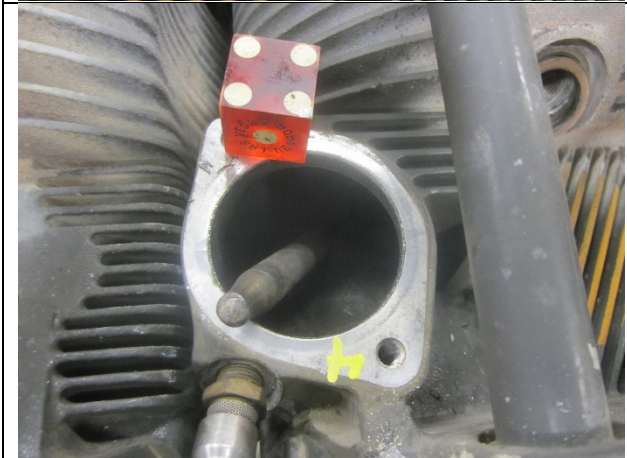
Valve stem from the #1 cylinder, setting at the #4 cylinder intake

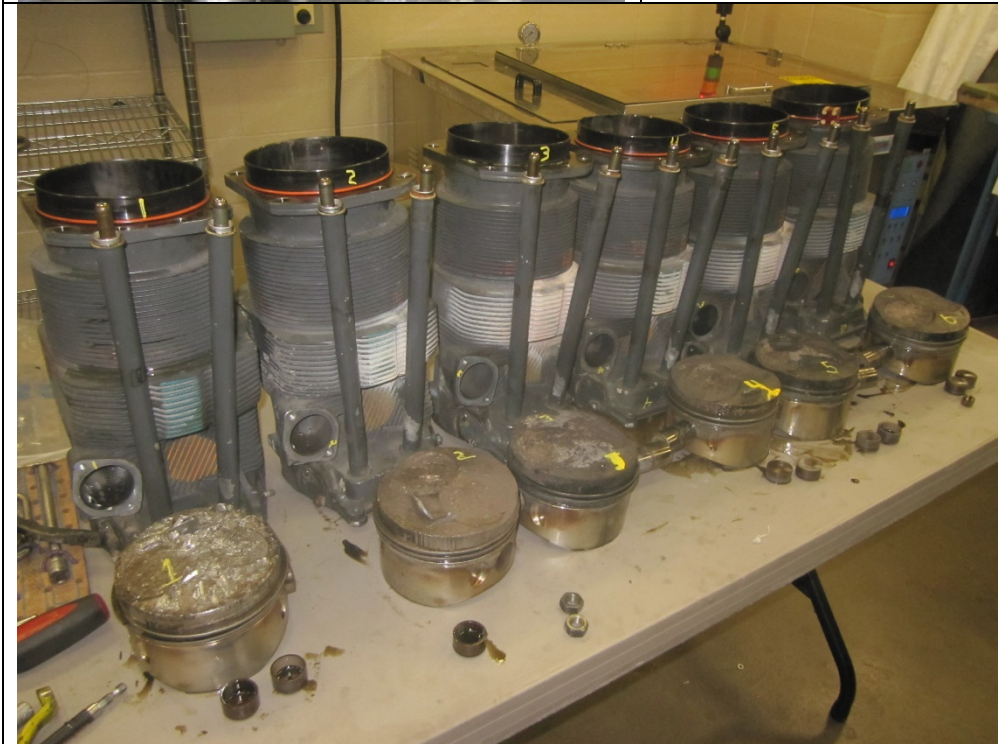
Heavily damaged #1 piston. The other pistons, had either impact marks, or pieces of valve stuck in the top of them.

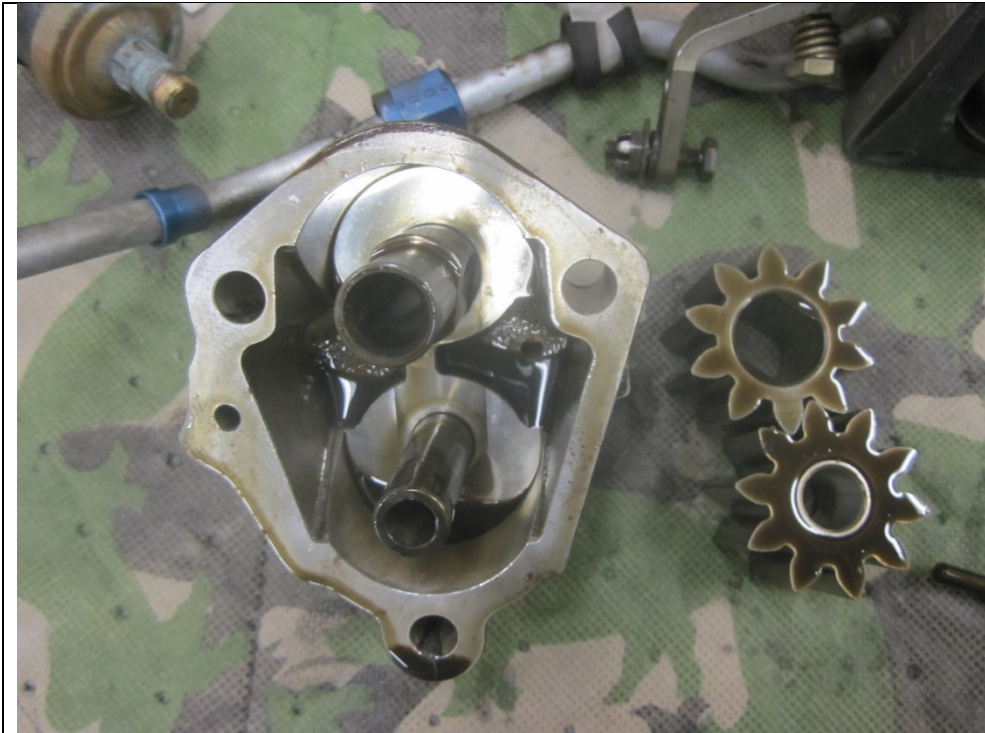
Oil pump, no sign of metal passage was noted.

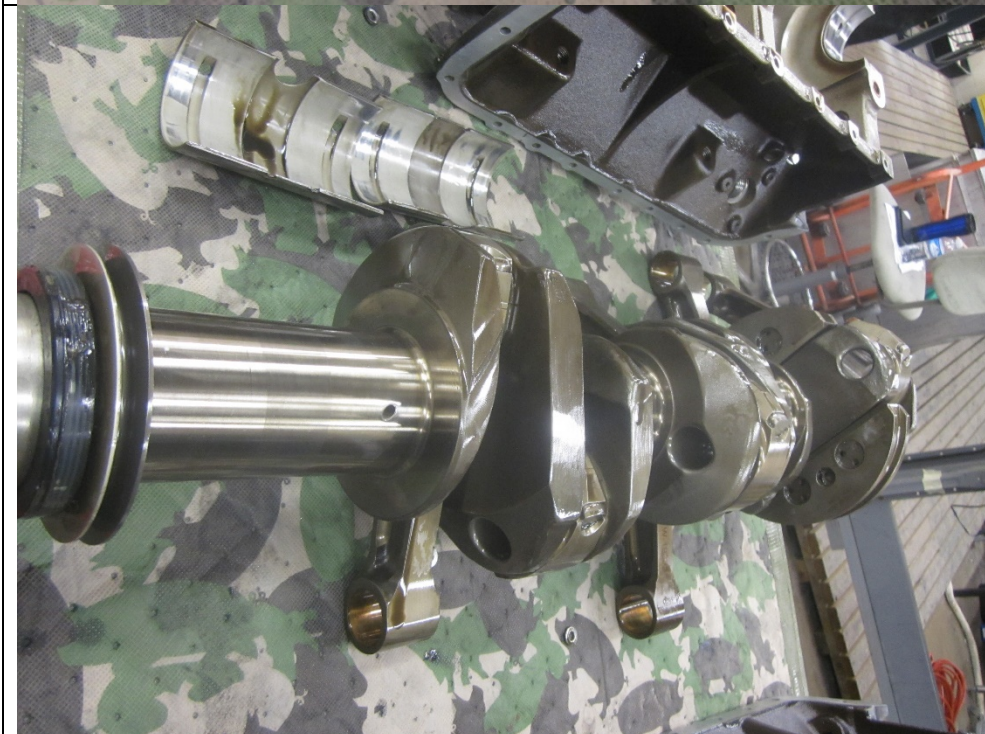
Crankshaft and bearings, all appeared normal.

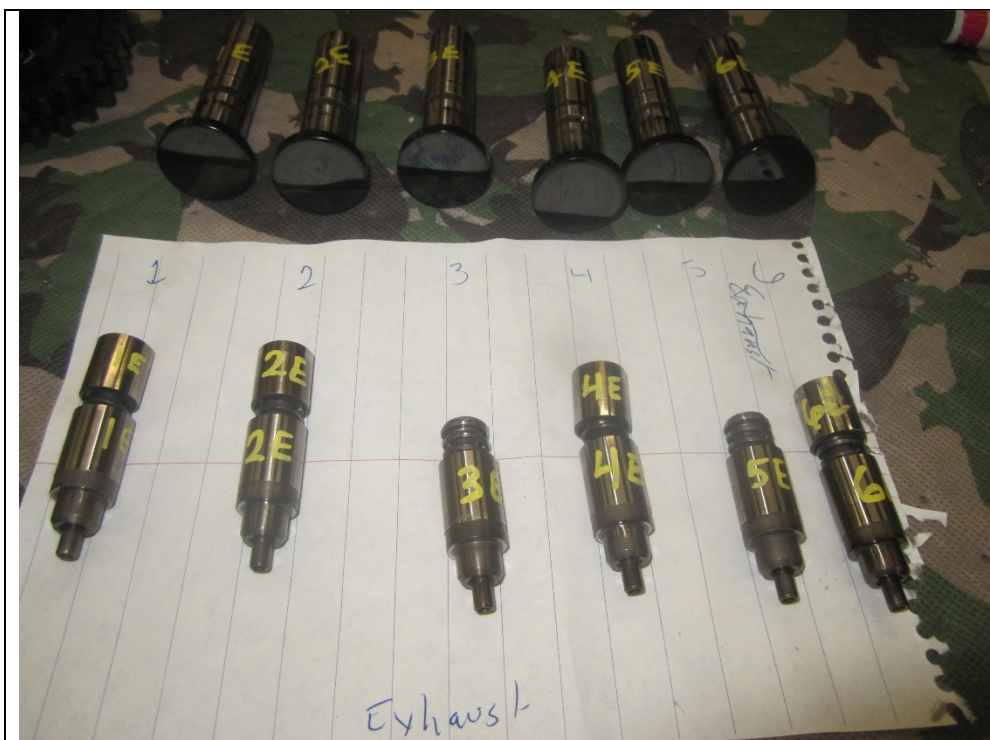
Hydraulic lifters (both exhaust and intake were visually examined)
