**FAILURE ANALYSIS AND CORRECTIVE ACTION REPORT**

**Cessna 206  
DEA Training Flight  
Accident Number: CEN18LA382**

19 MAR 19

Cessna 206  
DEA Training Flight  
Accident Number: CEN18LA382  
AmSafe Part Number: 3114-3-031-2396

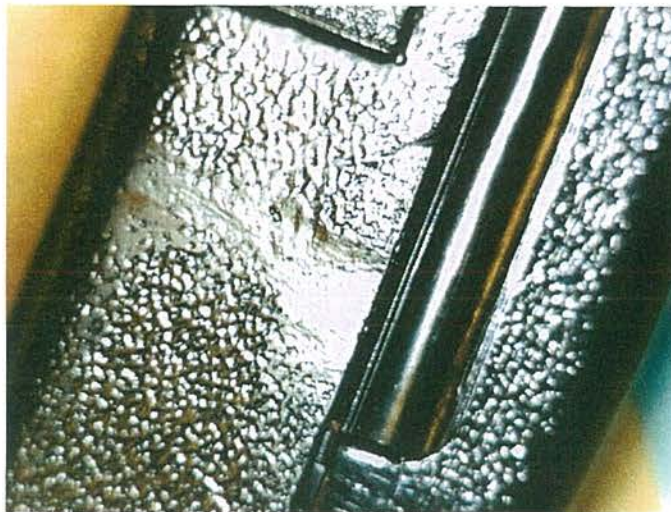
**Figure 1 – Possible Crush Damage**

Visual inspection included examining the enclosure of the buckle assembly revealed some possible tampering and or crushing damage to the width of the Buckle housing. Of note were some deformation of the upper buckle housing on the right side and a possible tampering of the buckle housing.

The failure analysis activities and findings indicate that the system assemblies housing may have taken some crushing damage, which in turn has created drag on the push button assembly, allowing a partial connection to be made with the pawl, but not full engagement.

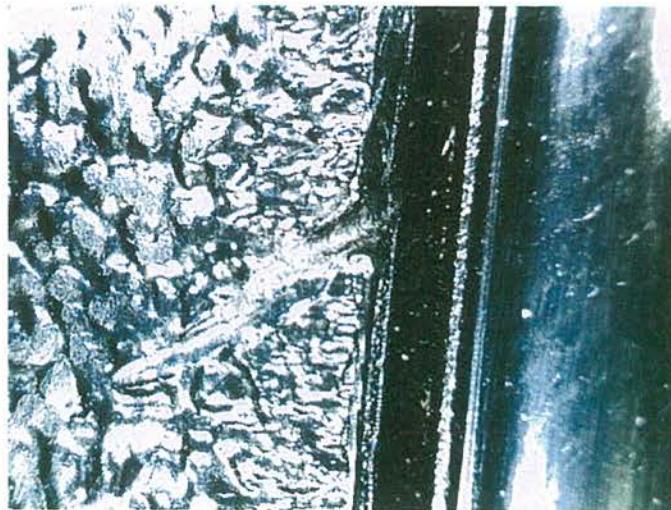
**Figure 2 – Possible Tampering**

Cut or Gash mark, possible tampering with the buckle cover to pry open cover.

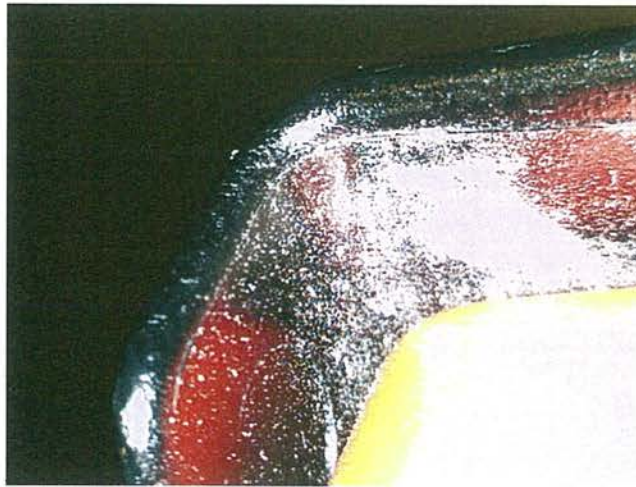
Figure 3 - Indication of Rubbing

Evidence of Rubbing within the buckle enclosure along the inner top right side.

Abrasion was shown in the inner half of the top and side buckle covers as well as along the push button, indication that the unit may have been smashed or restricted at some point.

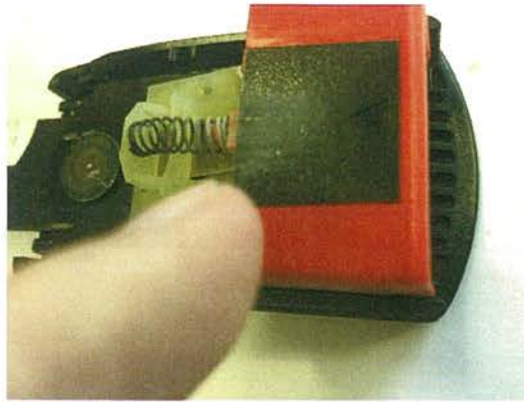
Figure 4 – Button

Upon opening and removal of the top half of the buckle cover, it was noted that the button and the cover showed signs of rubbing and abrasion between the two components. Also noted was food particulates of up to .070" in diameter were found within the cavity.

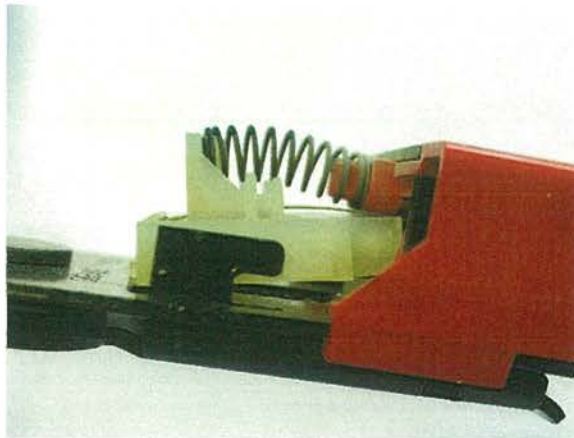
Figure 7 – Position Forward

It was noted after the removal of the top cover that the Flat Spring guide was partially moved forward out of its retaining tracks. Upon close examination of the removal video, this was likely caused by the screwdriver impacting the rear of the component during disassembly. The unit was tested with a connector half and noted to operate properly in that forward position. A side-by-side comparison to a new version of the same product shows the moved component (Figure 7) and the normal seating (Figure 8).

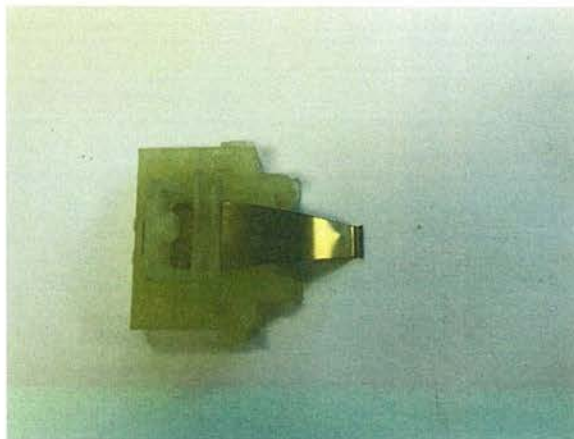
Figure 9 – Small Dimple in Spring

The internal button and spring assemblies were then removed in the third video ([img\\_0255.mov](#)). During this removal, it was noted that the Flat spring has a small indentation (Figure 9) not seen on components normally. The compression spring is in print (Figure 10). The main body of the buckle, once the springs and button were removed, has no anomalies noted (Figure 11), (Figure 12), (Figure 13) and (Figure 14).

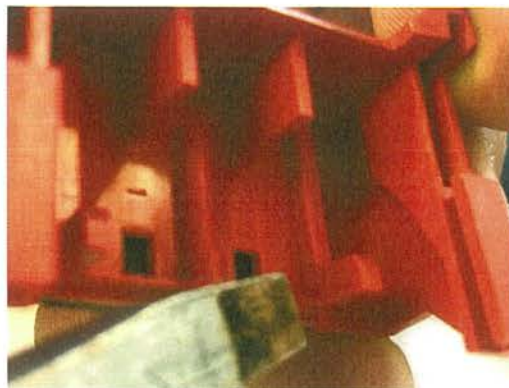
Figure 15 – Right Side Guide

Dust from Abrasion internally within the unit was noted around the spring mount for the push button as well as along the inner right side guide under the push button and along the portion where the connector slides into the buckle as shown in (Figure 15) (Figure 16) and (Figure 17).

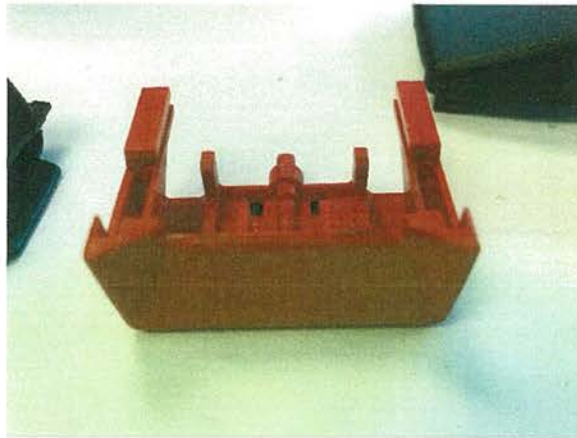
Figure 17 - Black rub marks along connector guide of the button.

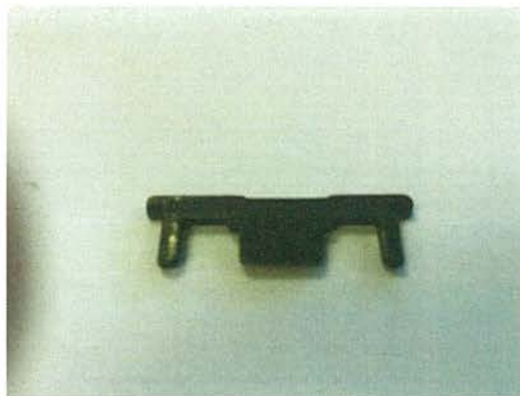
Figure 18 – Spring Guide

The spring guide was then removed from the assembly in video ([img\\_0278.mov](#)) and the guide was removed. No issues were noted with the guide shown in (Figure 18).
