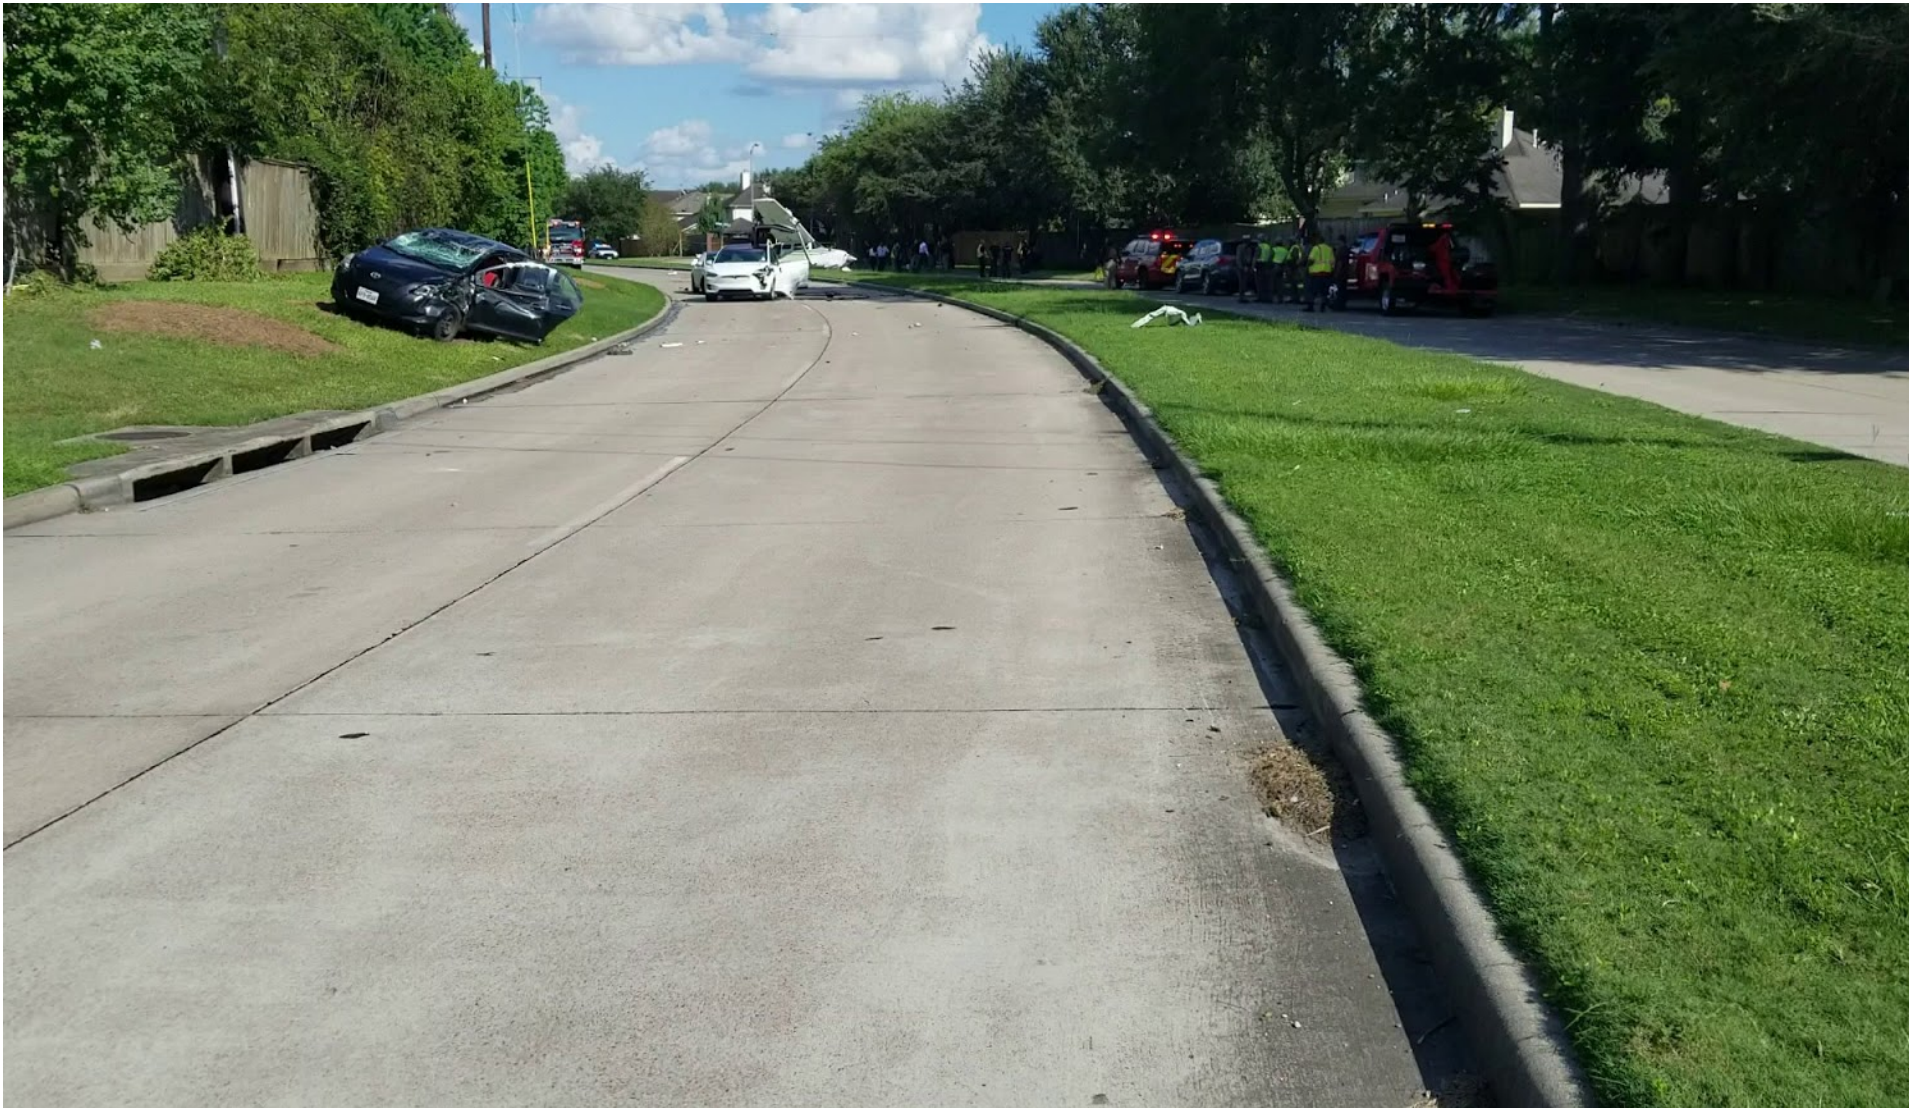
**Photo 1 – View to the east along Voss Road. Struck vehicles are also visible.**

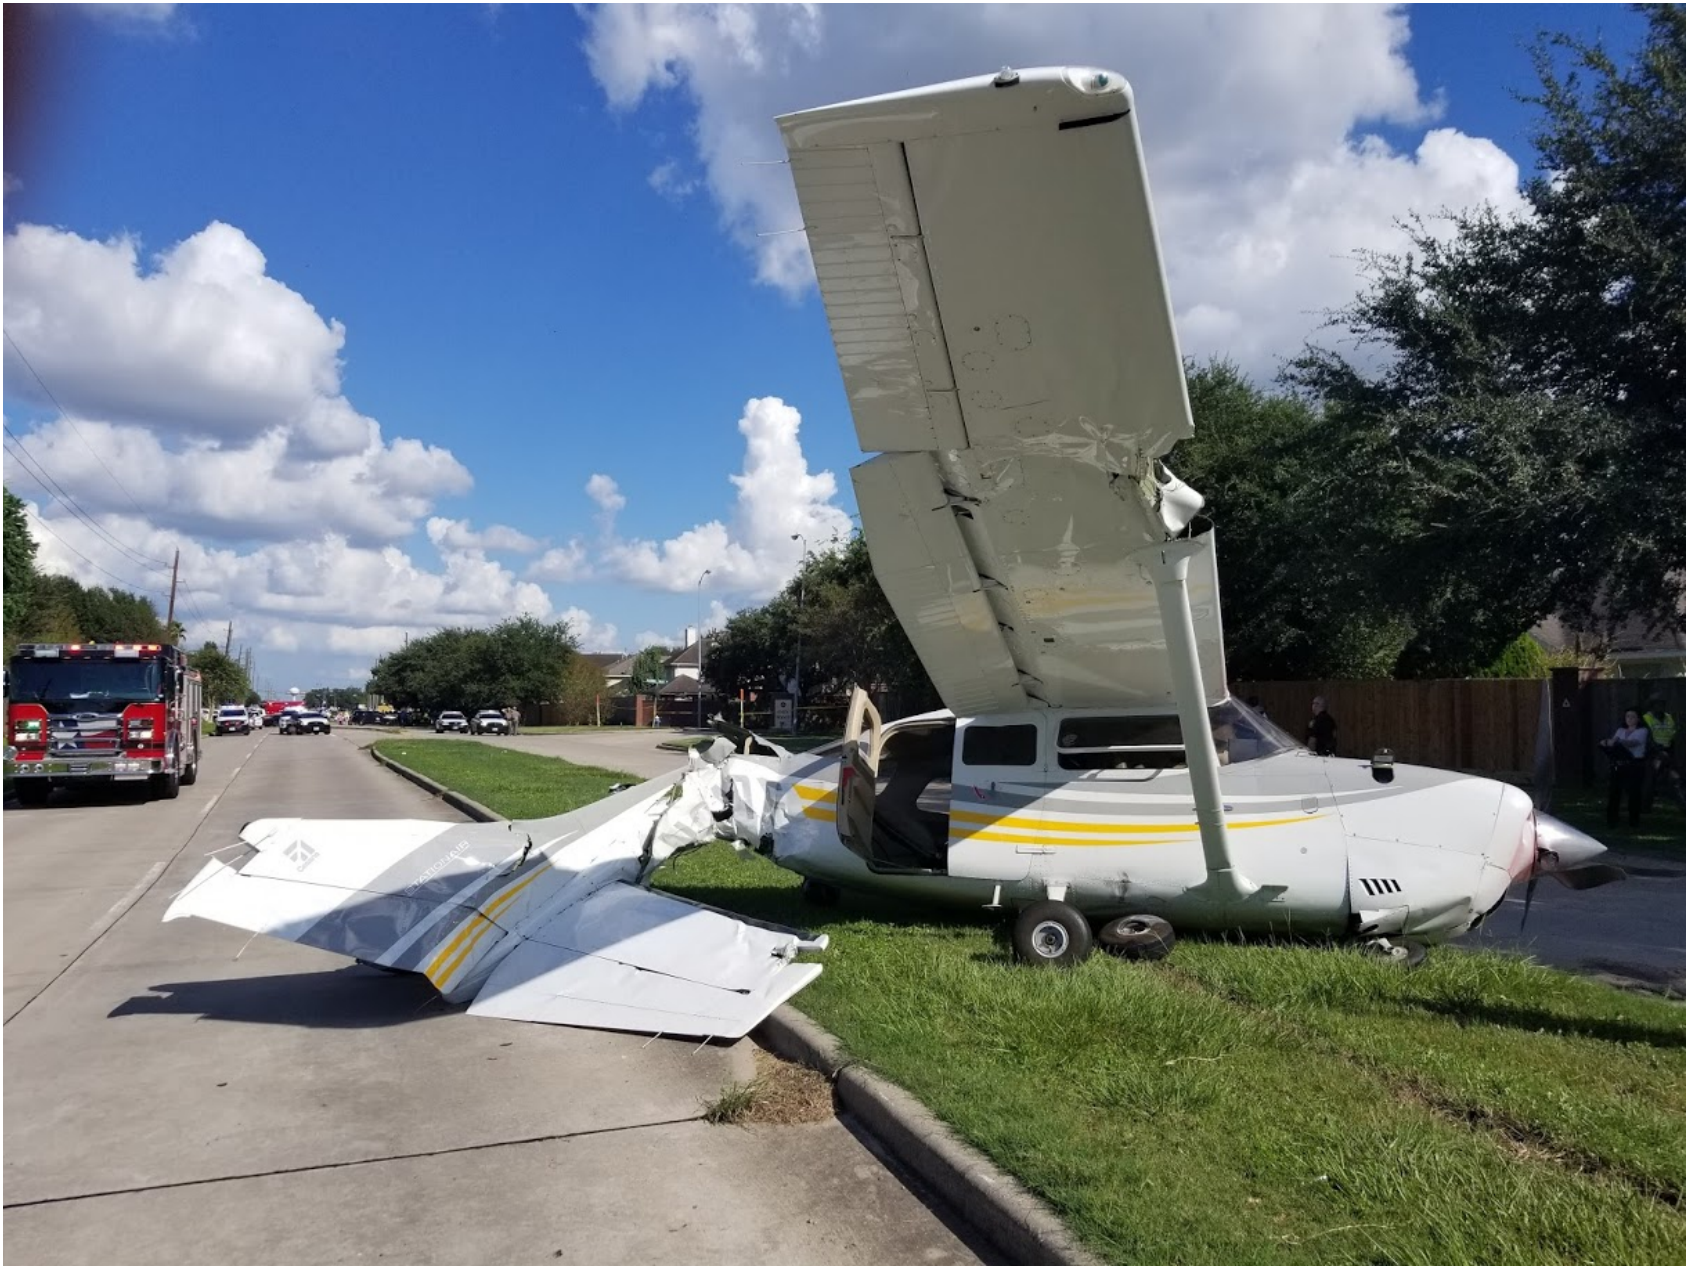
**Photo 2 – N247F in the median on Voss Road.**

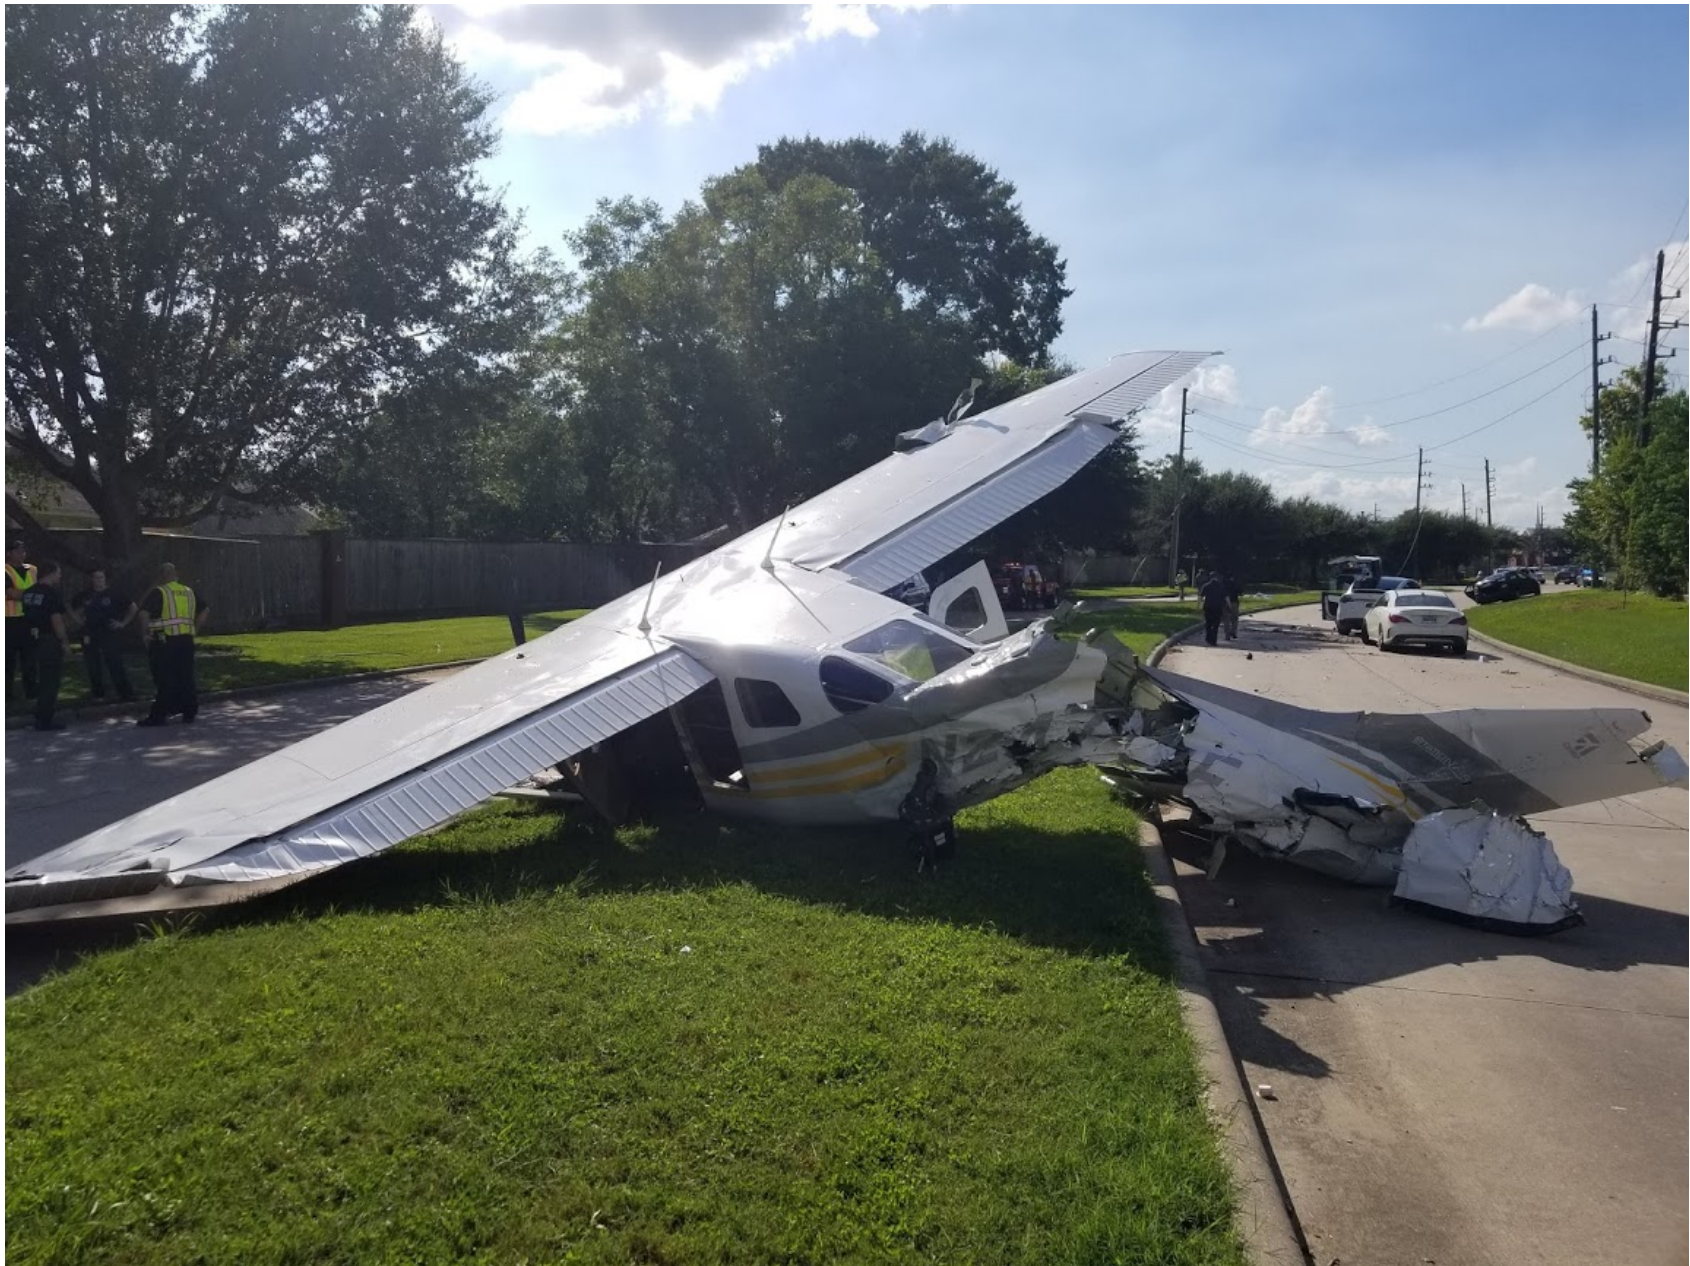
**Photo 3 – Severed empennage.**

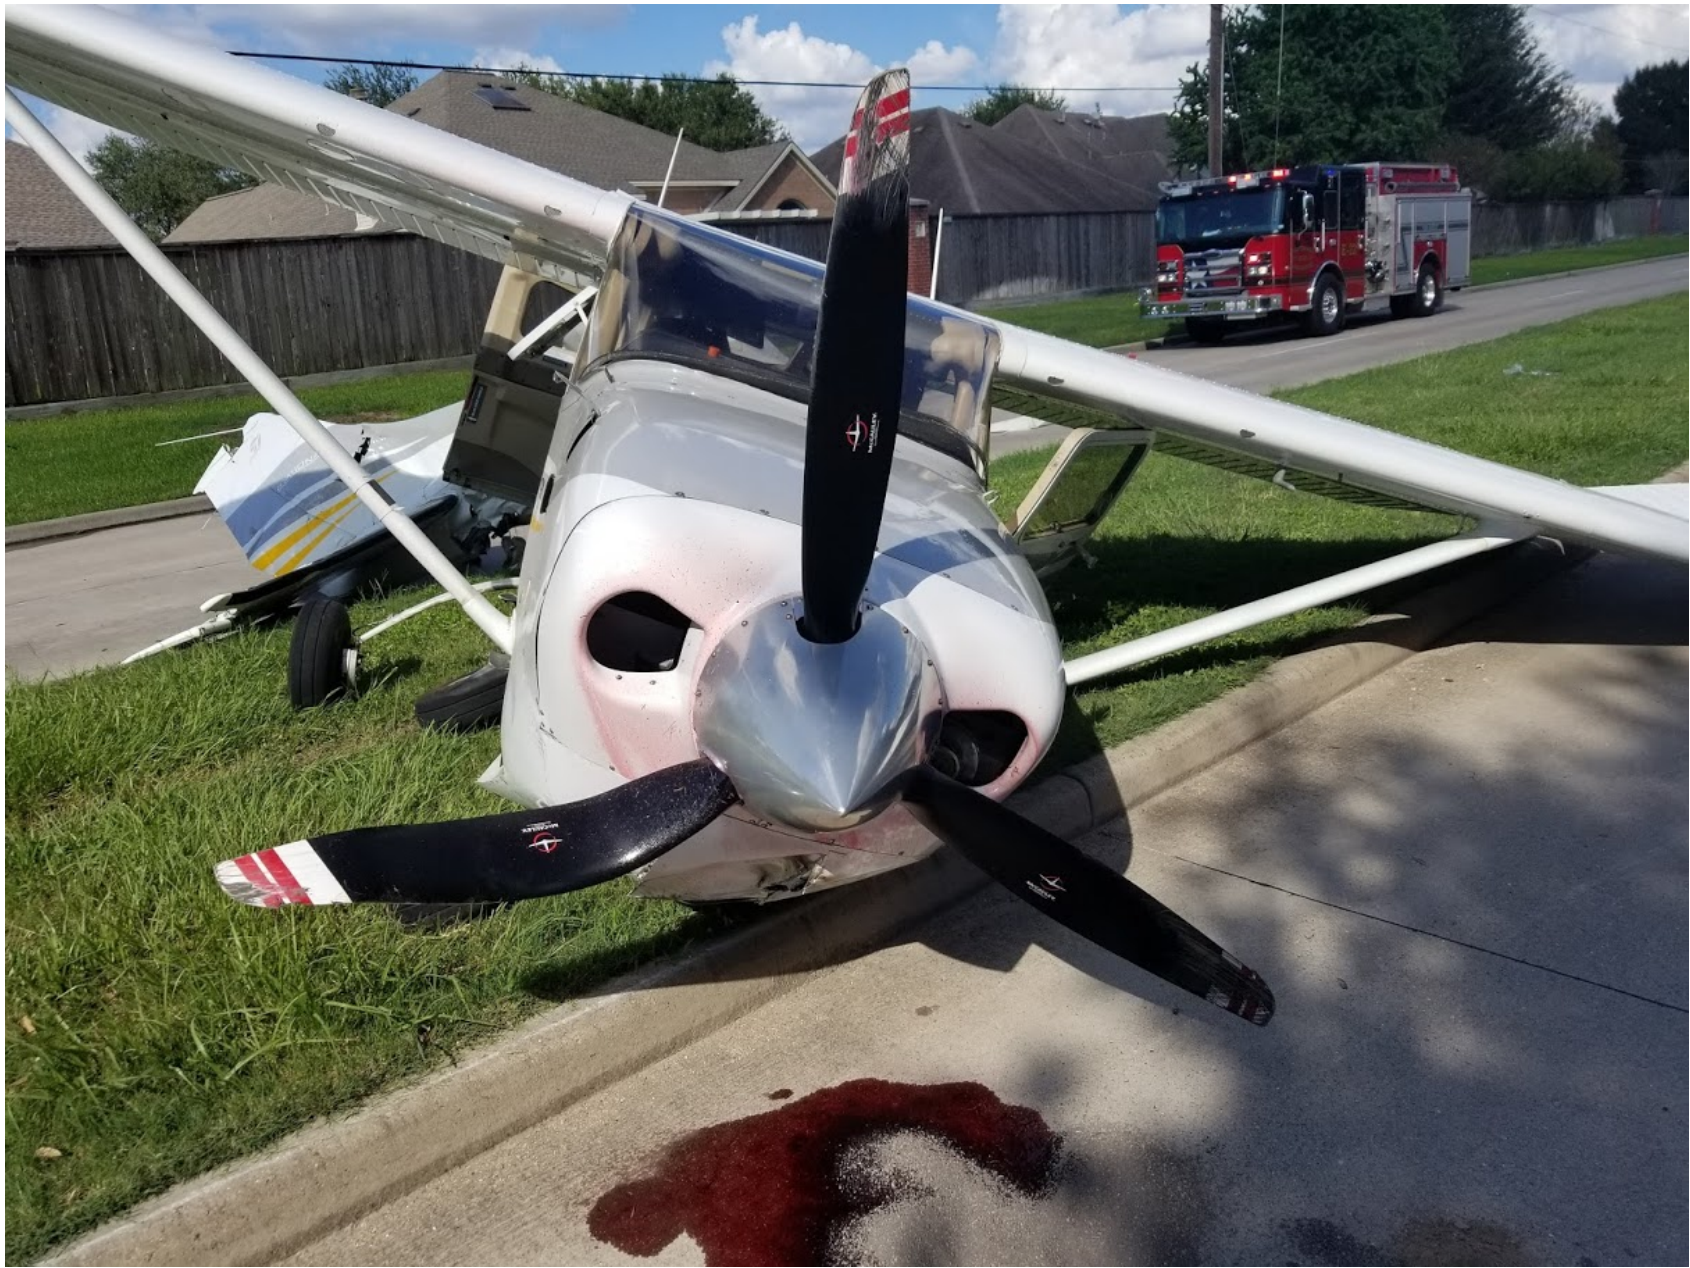
**Photo 4 – The nose of the airplane and spilled hydraulic fluid.**

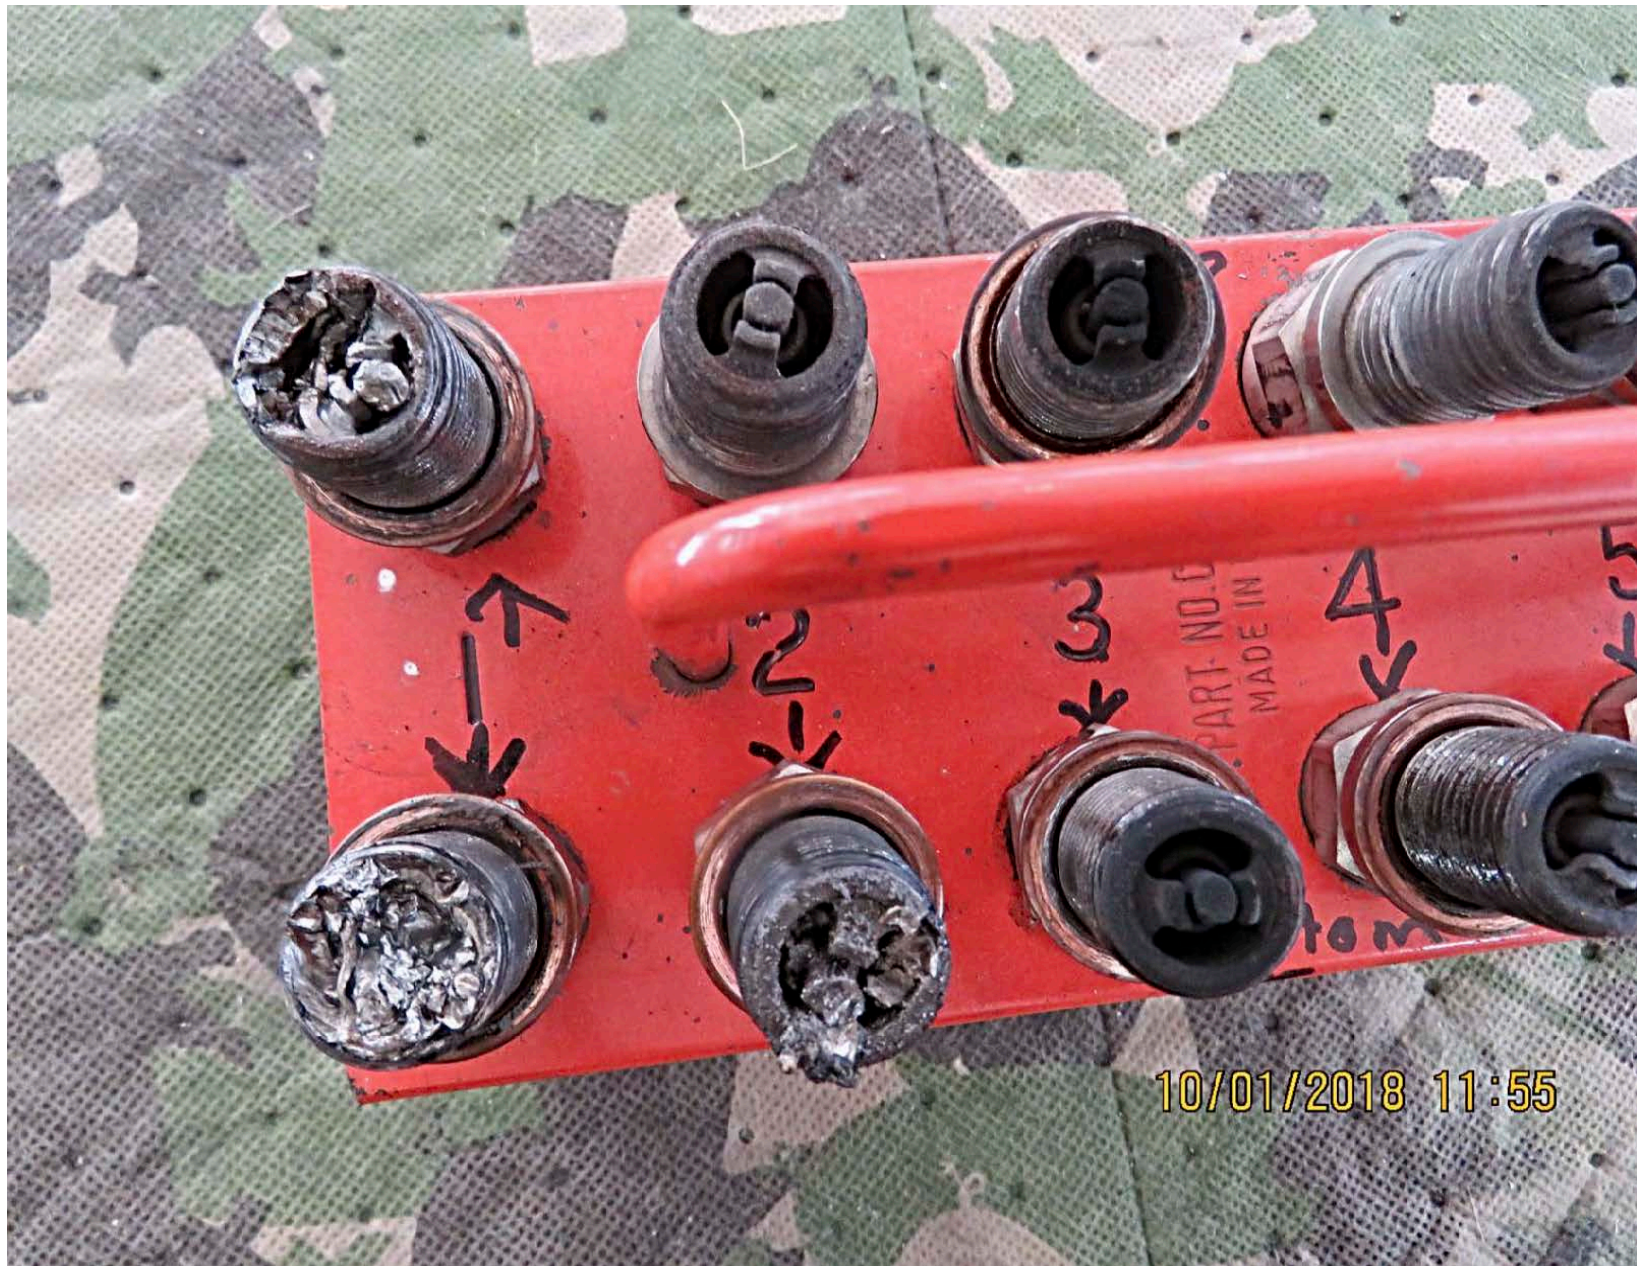
**Photo 5 – The spark plugs after removal from the engine. Note the damage to plugs 1 and 2.**

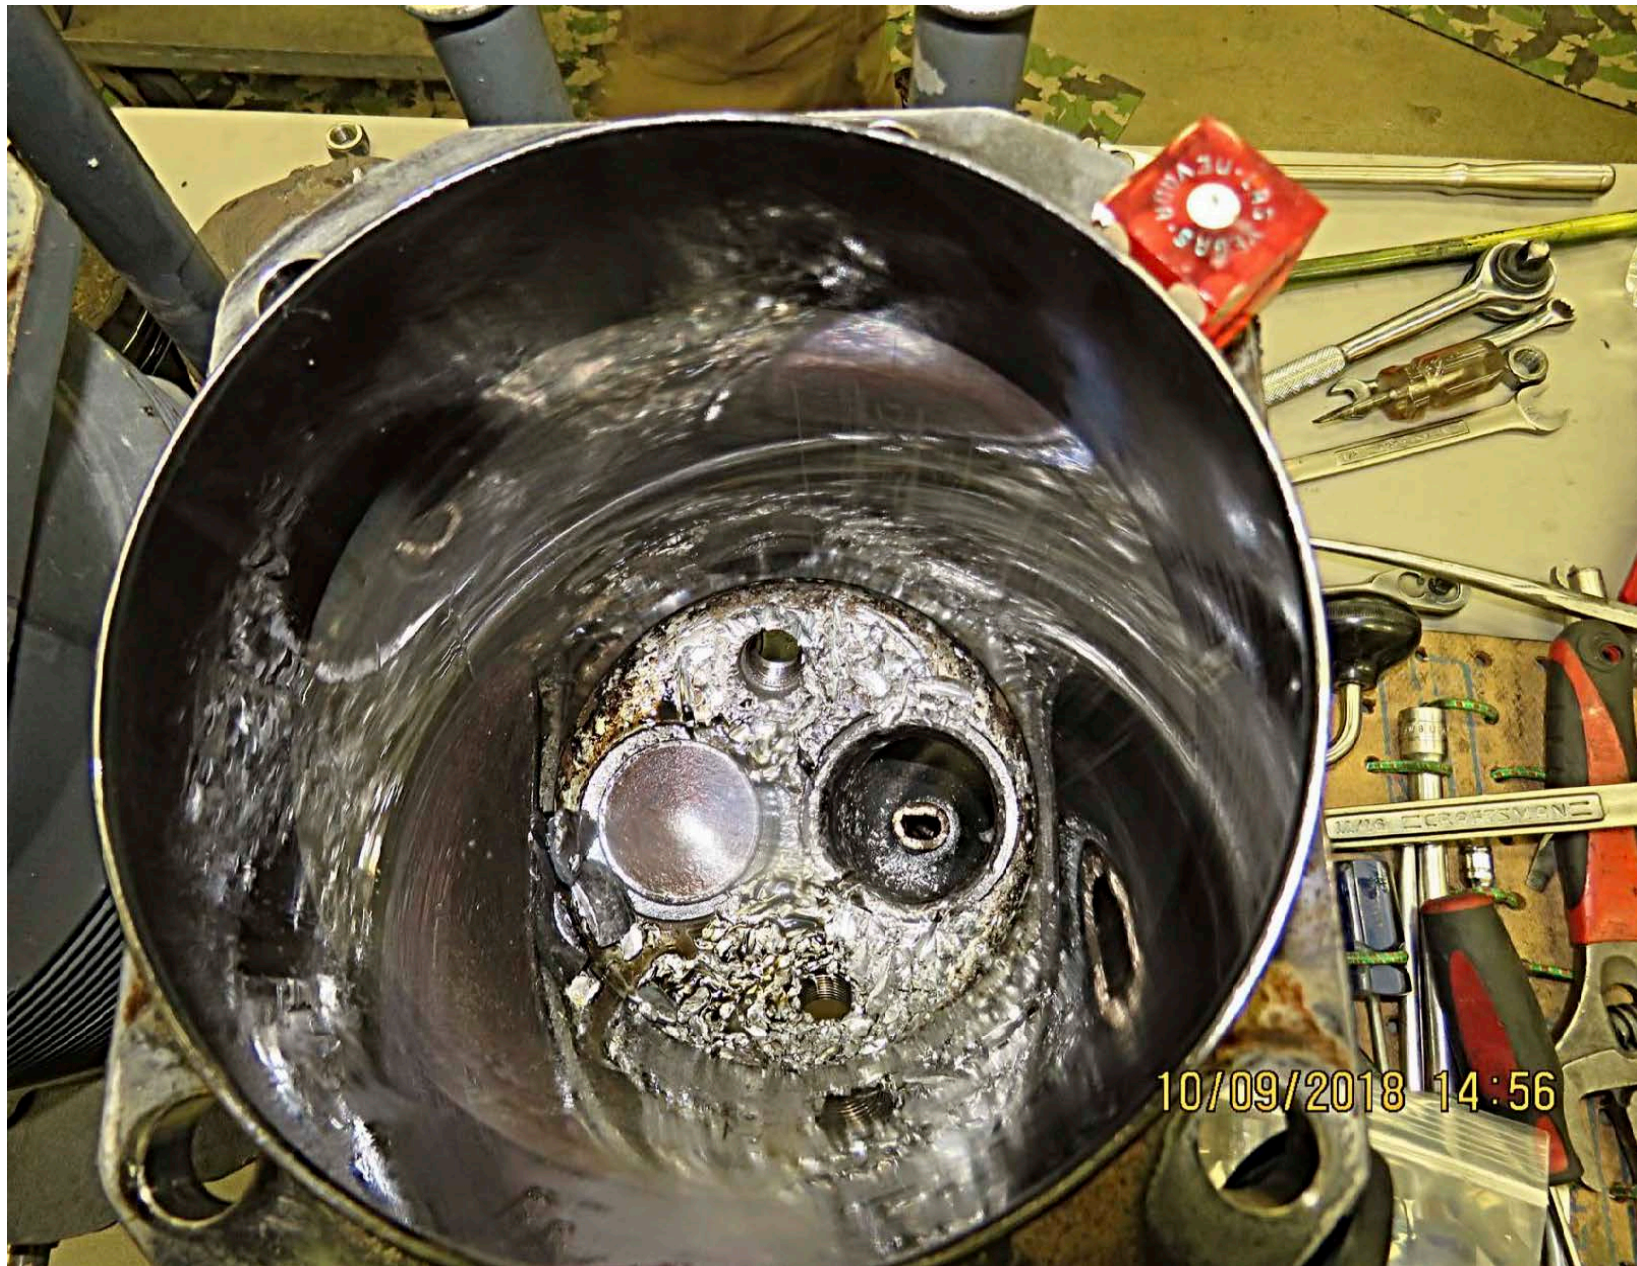
**Photo 6 – Damage to cylinder 1.**

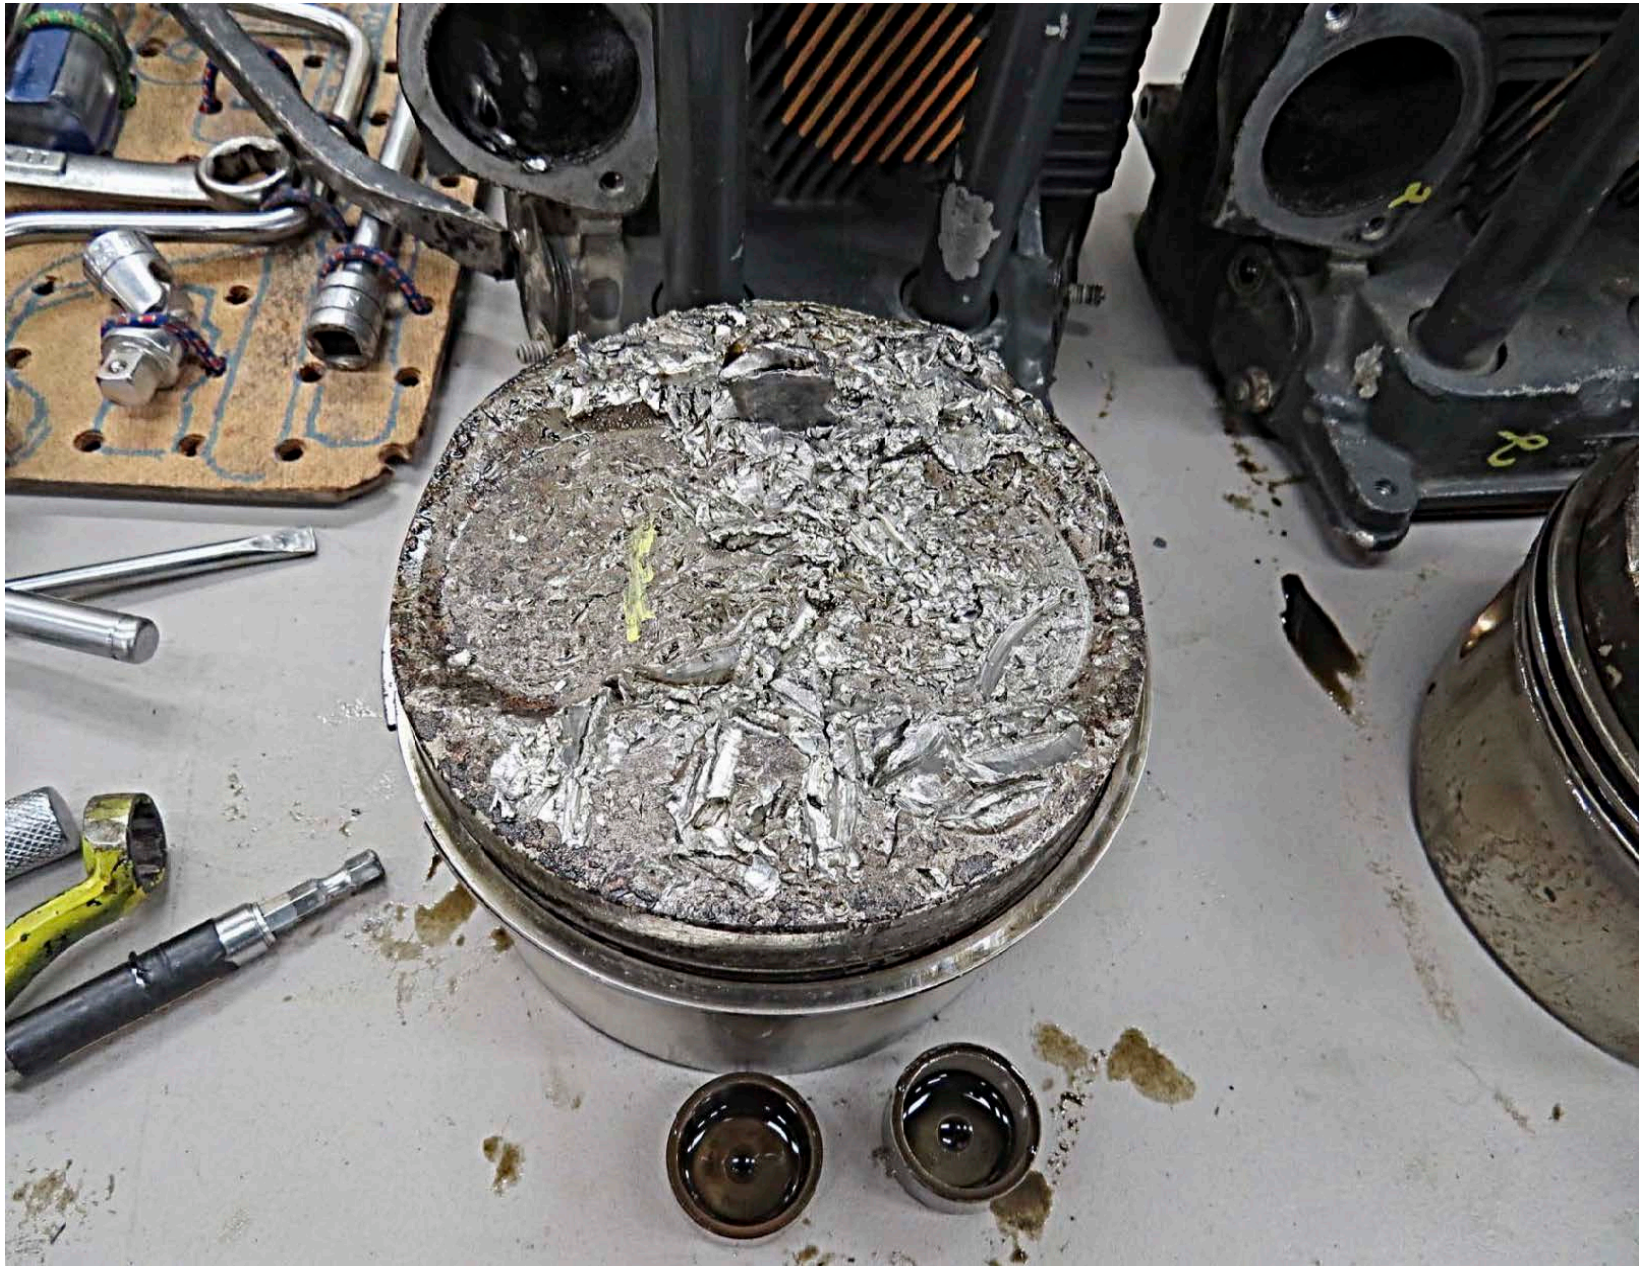
**Photo 7 – Damage to piston 1. Note embedded valve fragment.**

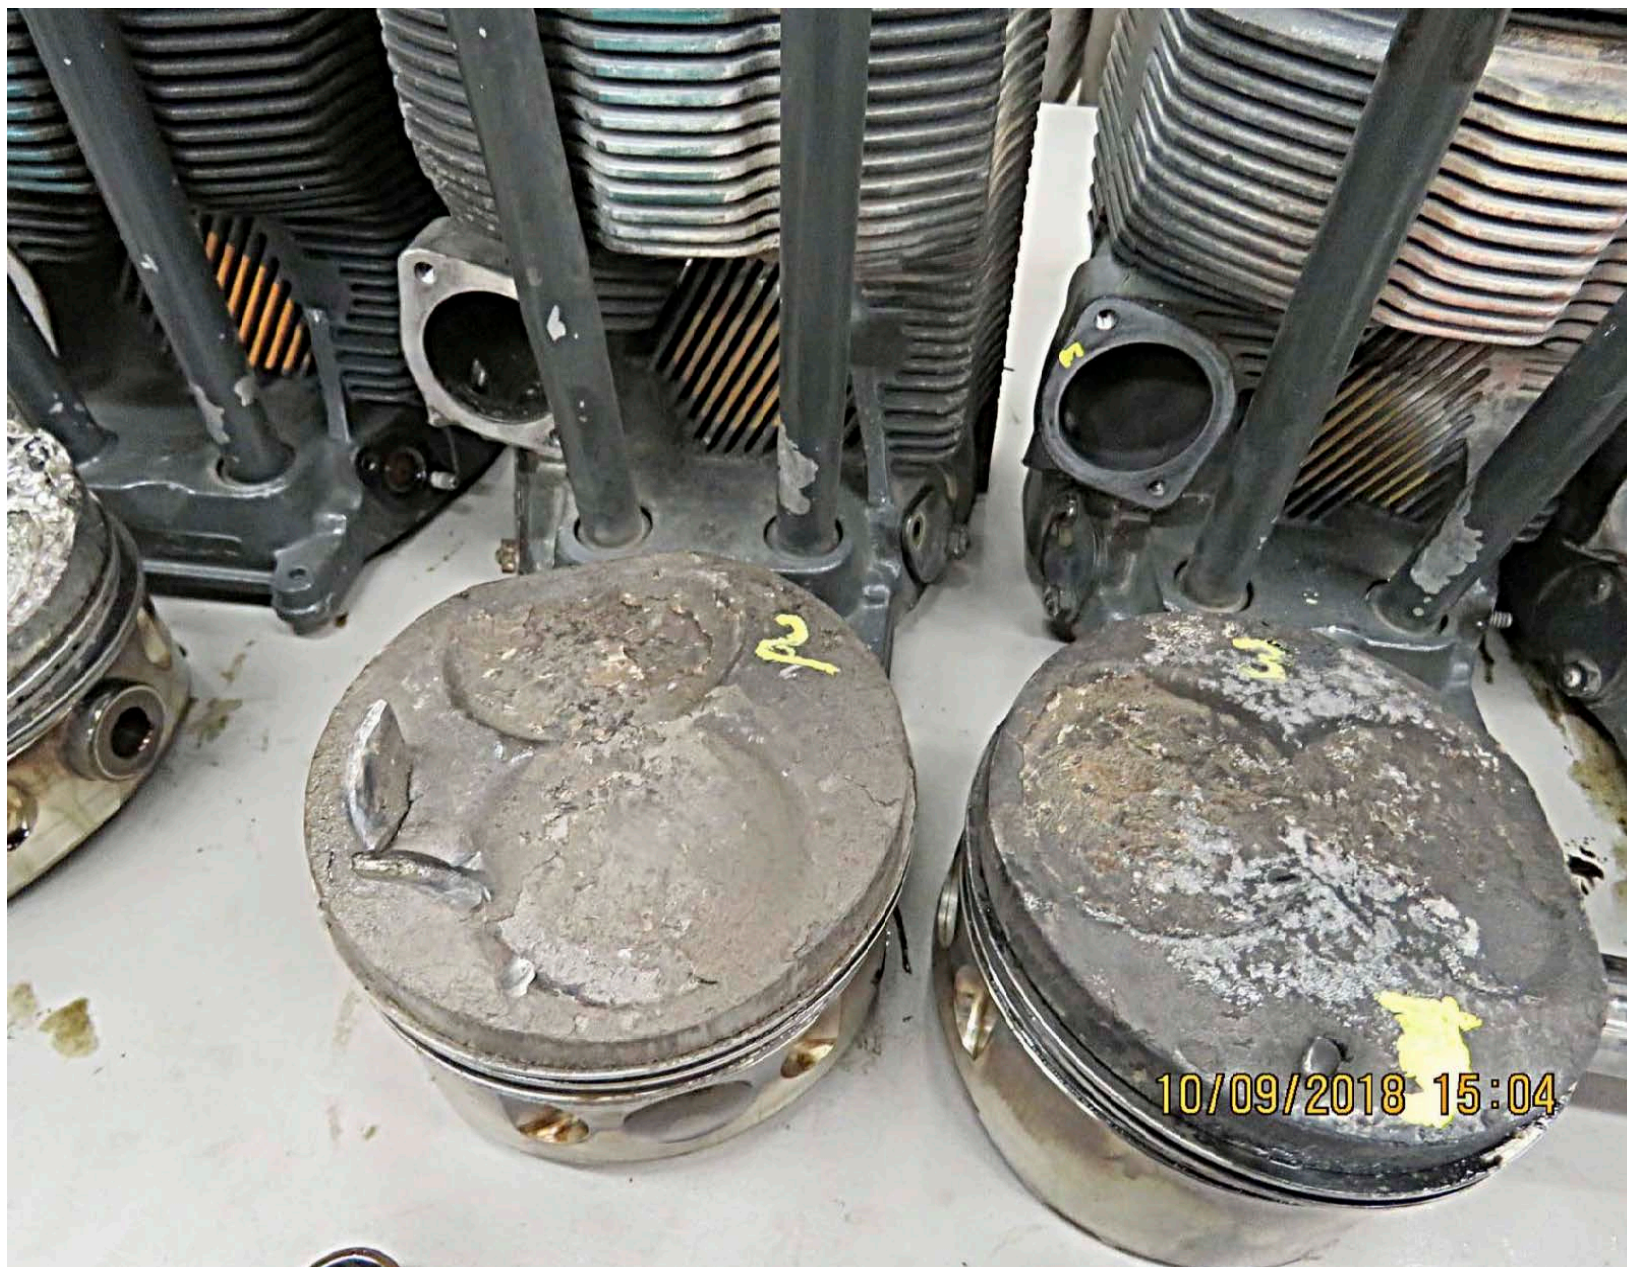
**Photo 8 – Damage to pistons 2 and 3. Note embedded valve fragments.**

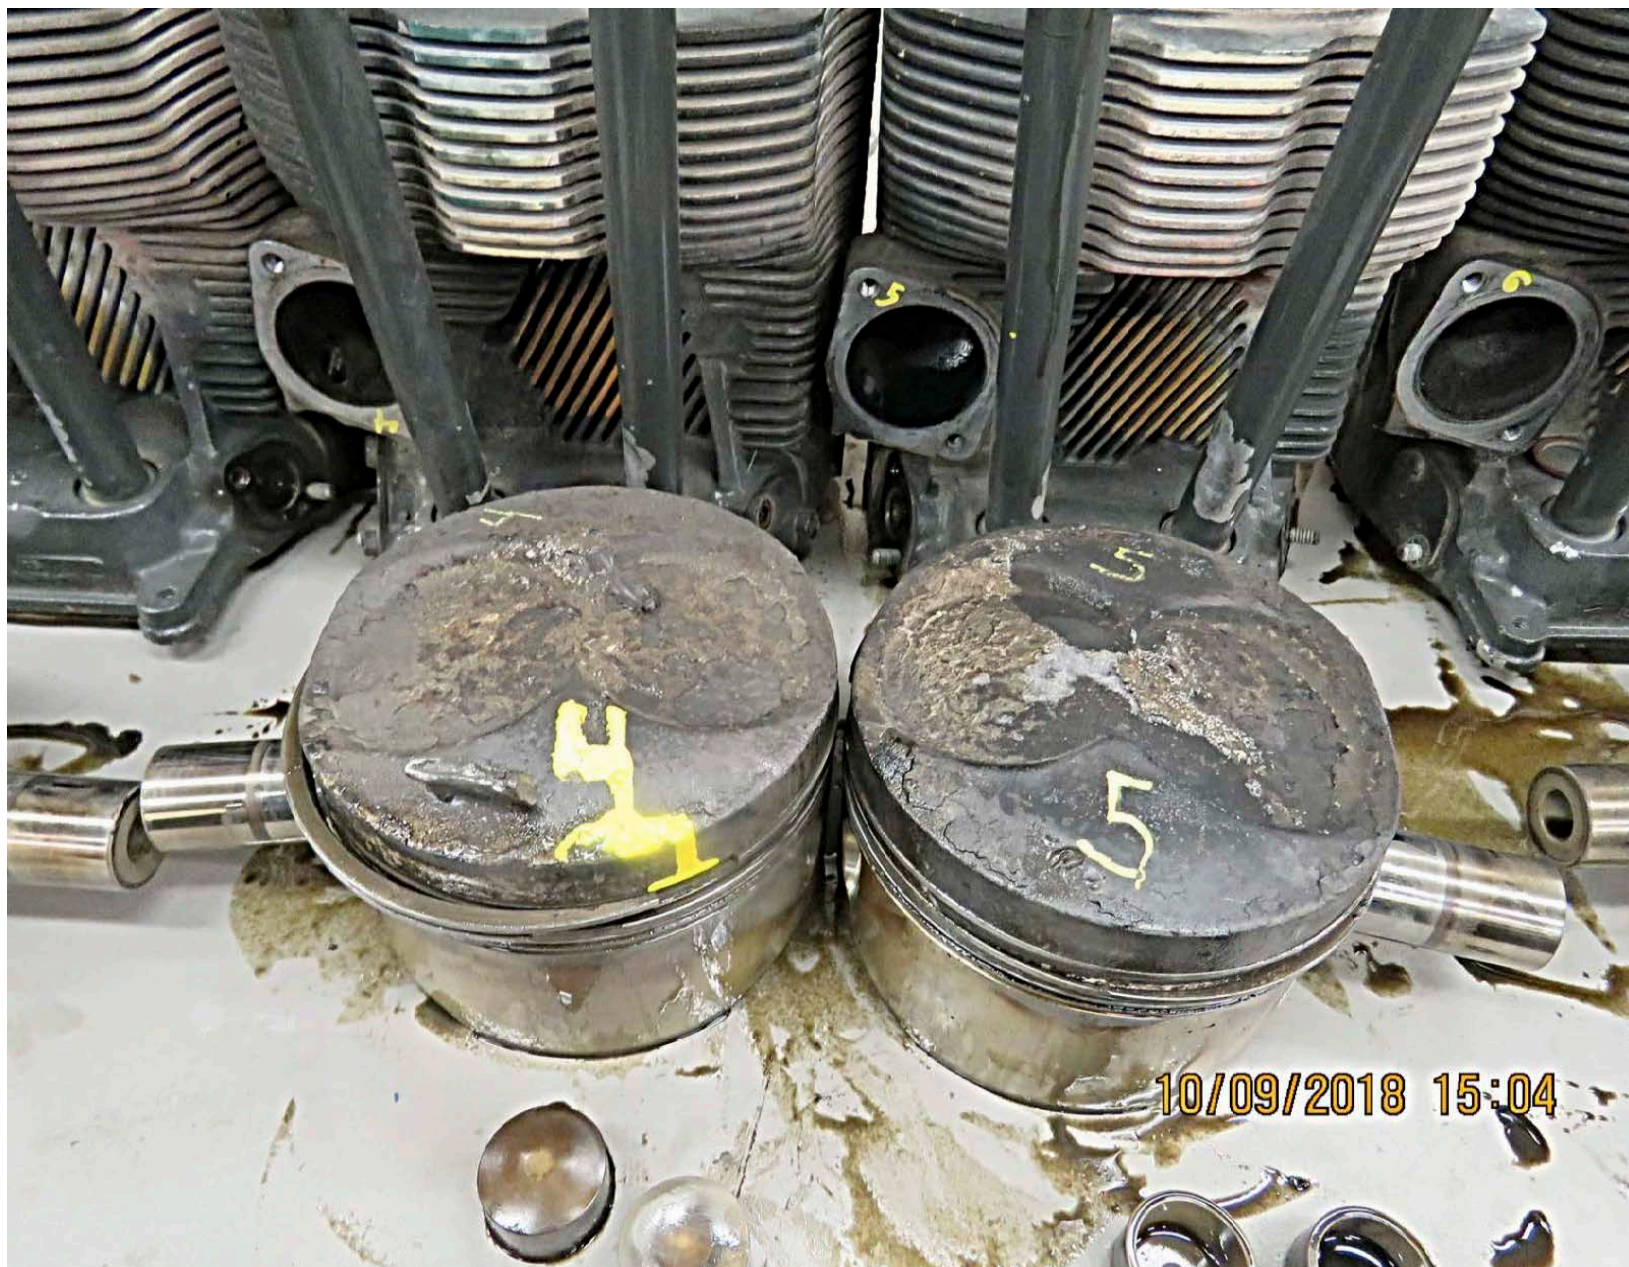
**Photo 9 – Damage to pistons 4 and 5. Note embedded valve fragments.**

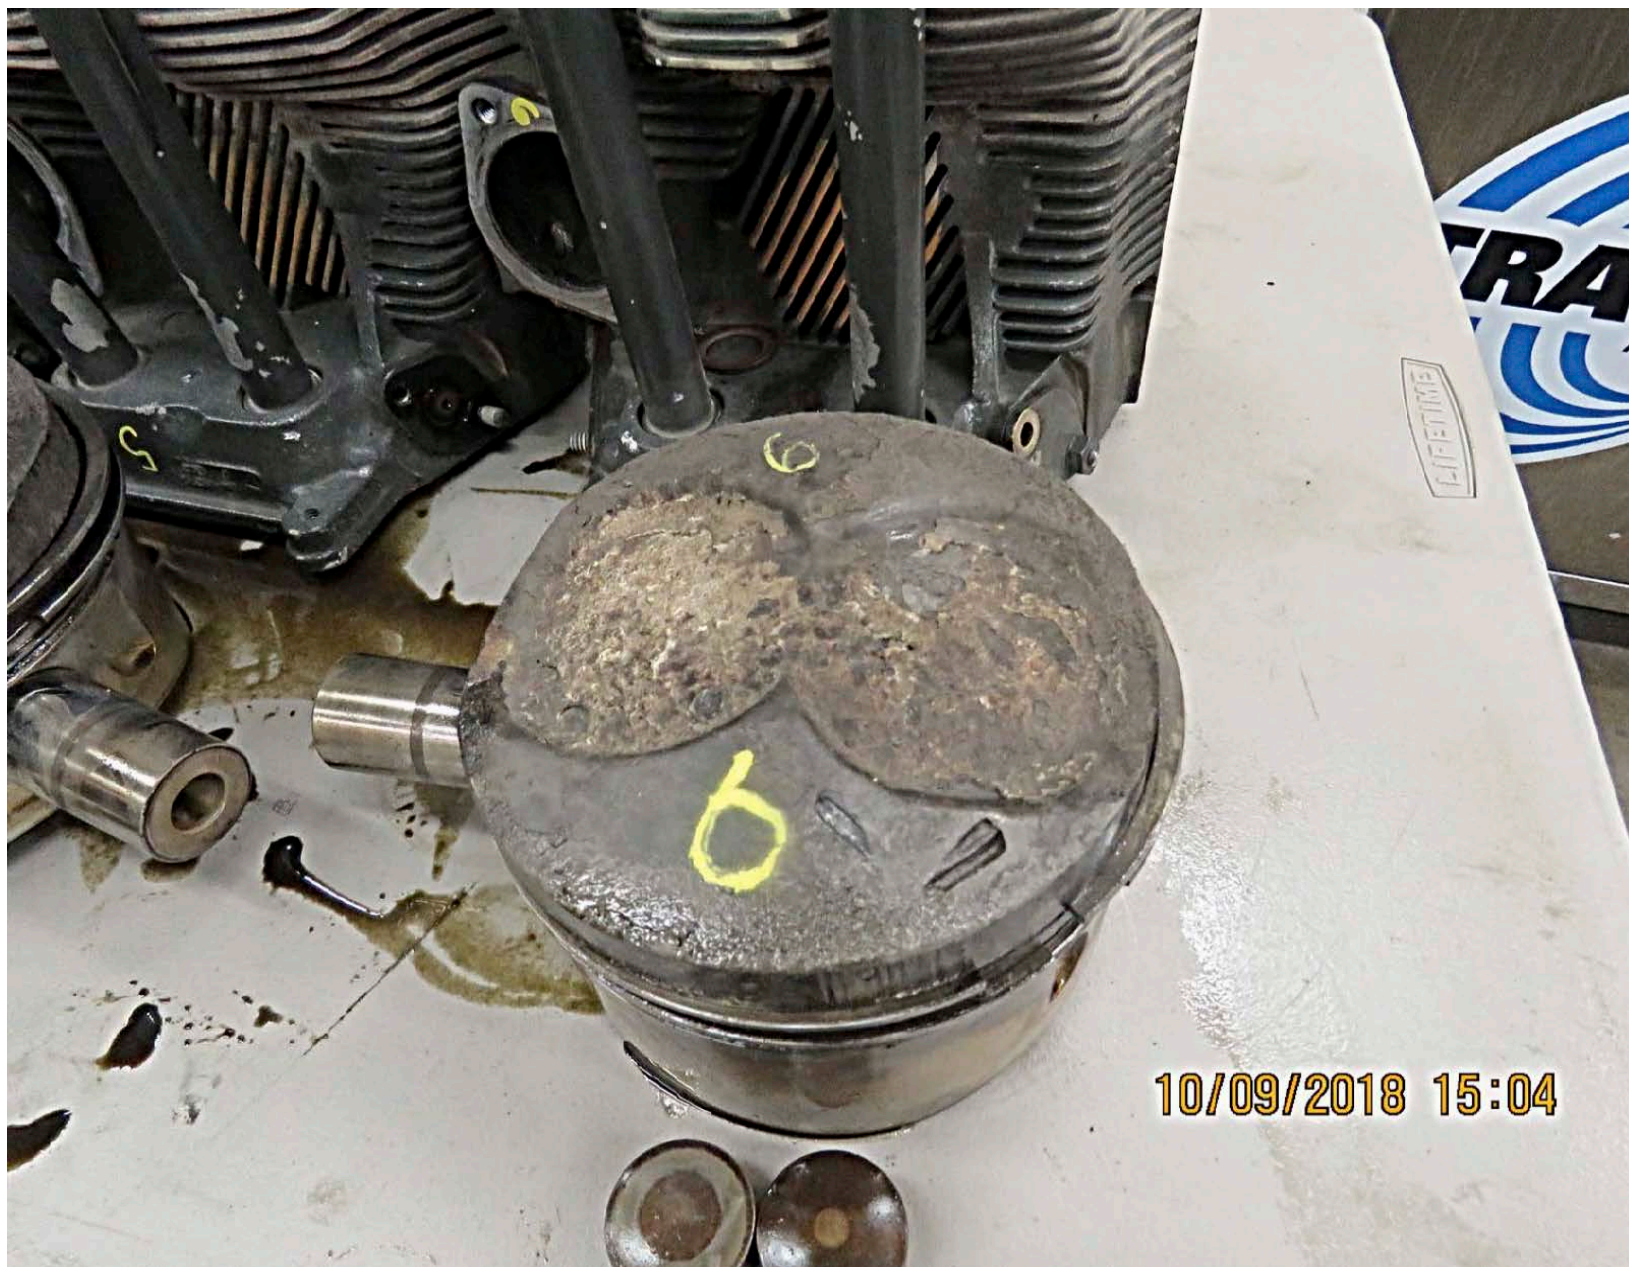
Photo 10 – Damage to piston 6. Note embedded valve fragment.

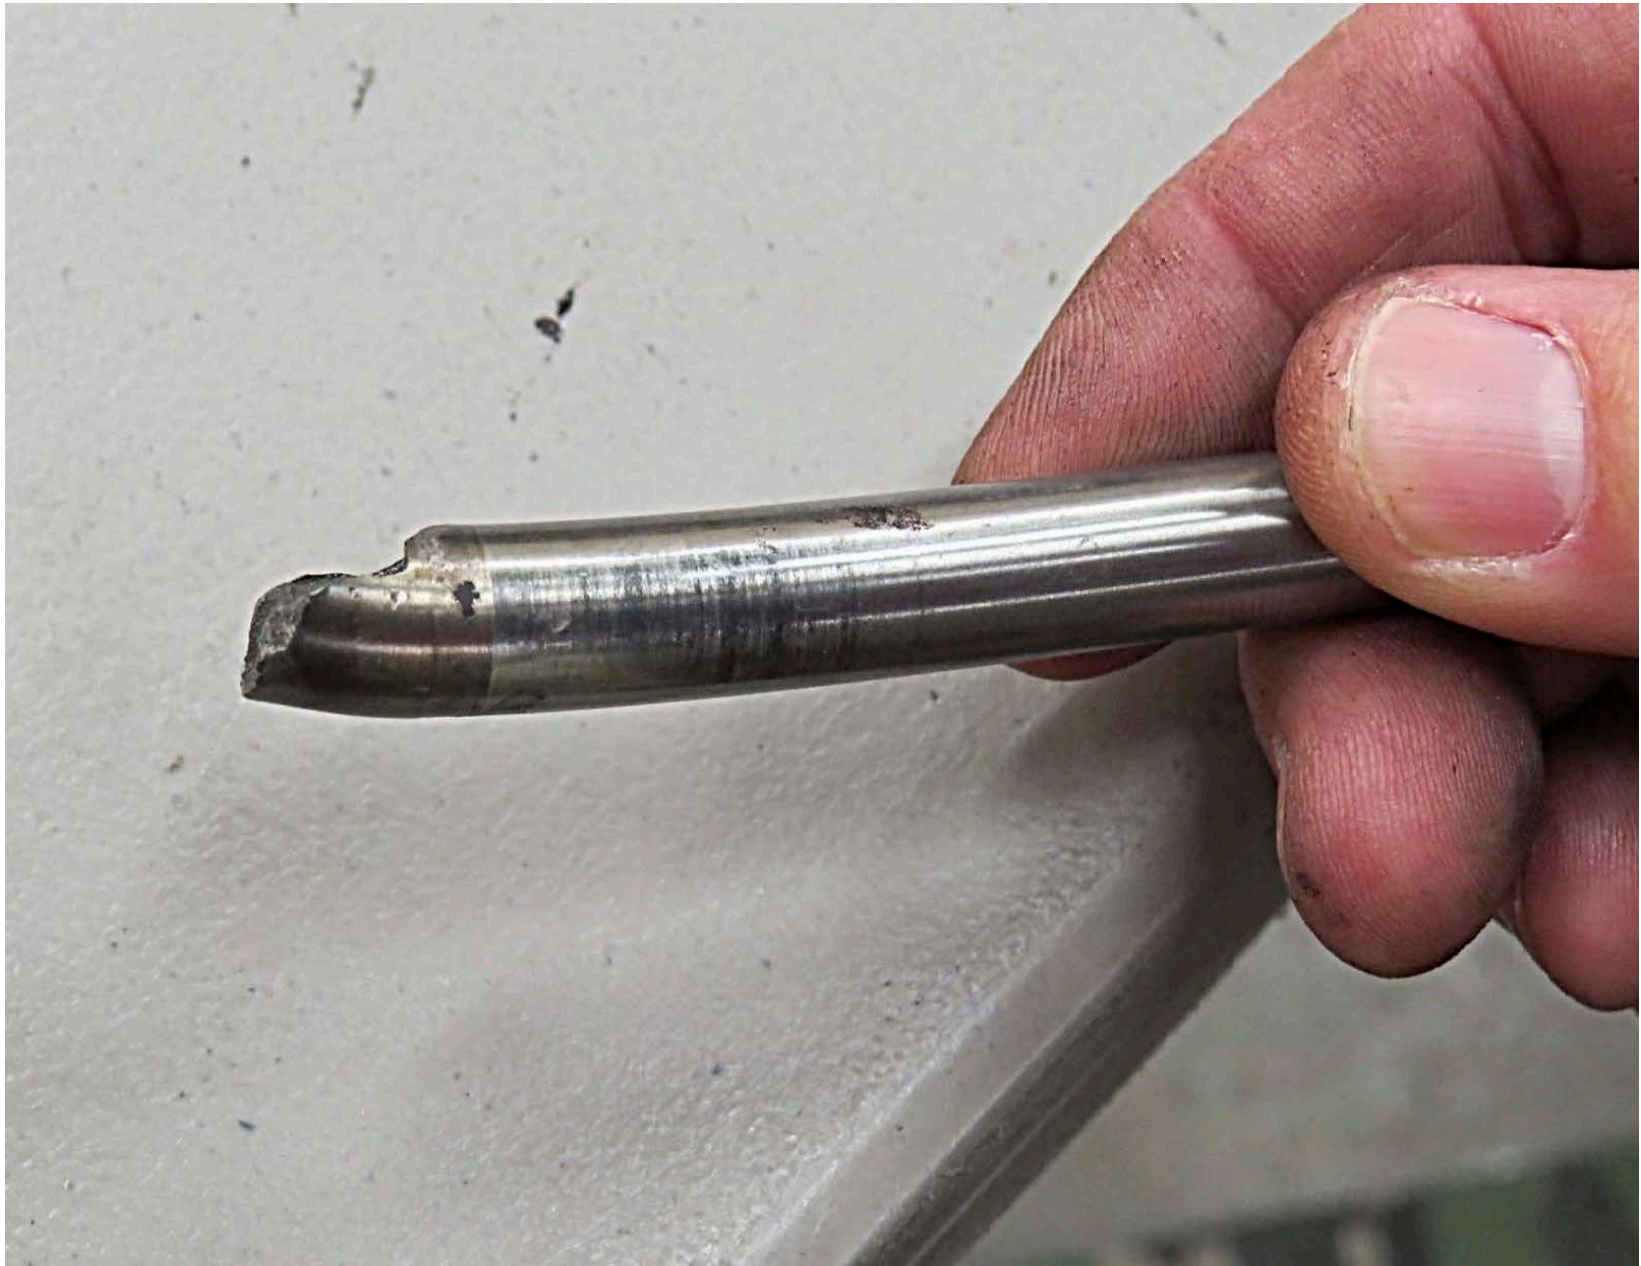
**Photo 11 – Bent no. 1 valve stem tip caused by piston and combustion chamber contact, and most probably contributed to no. 1 intake valve failure.**
