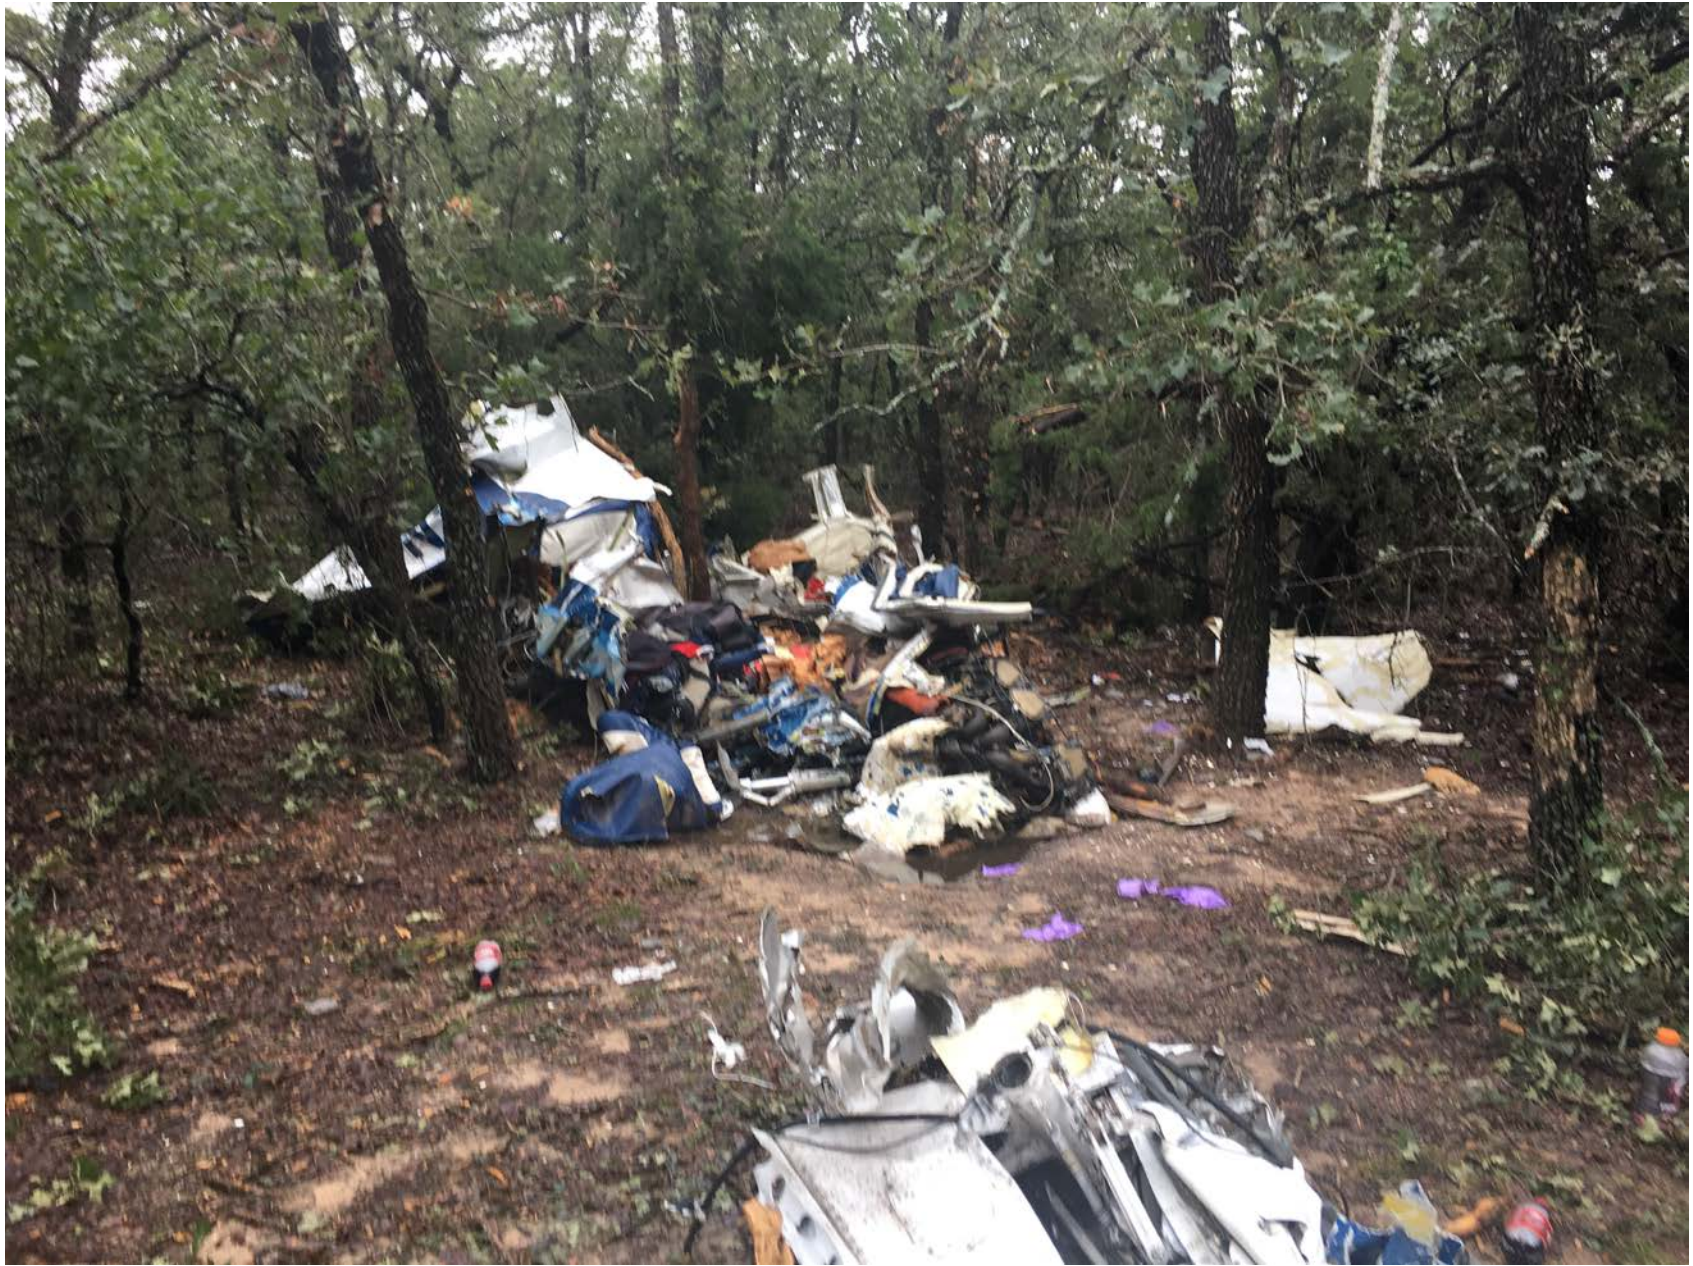
**Photo 1 – Main wreckage at accident site**

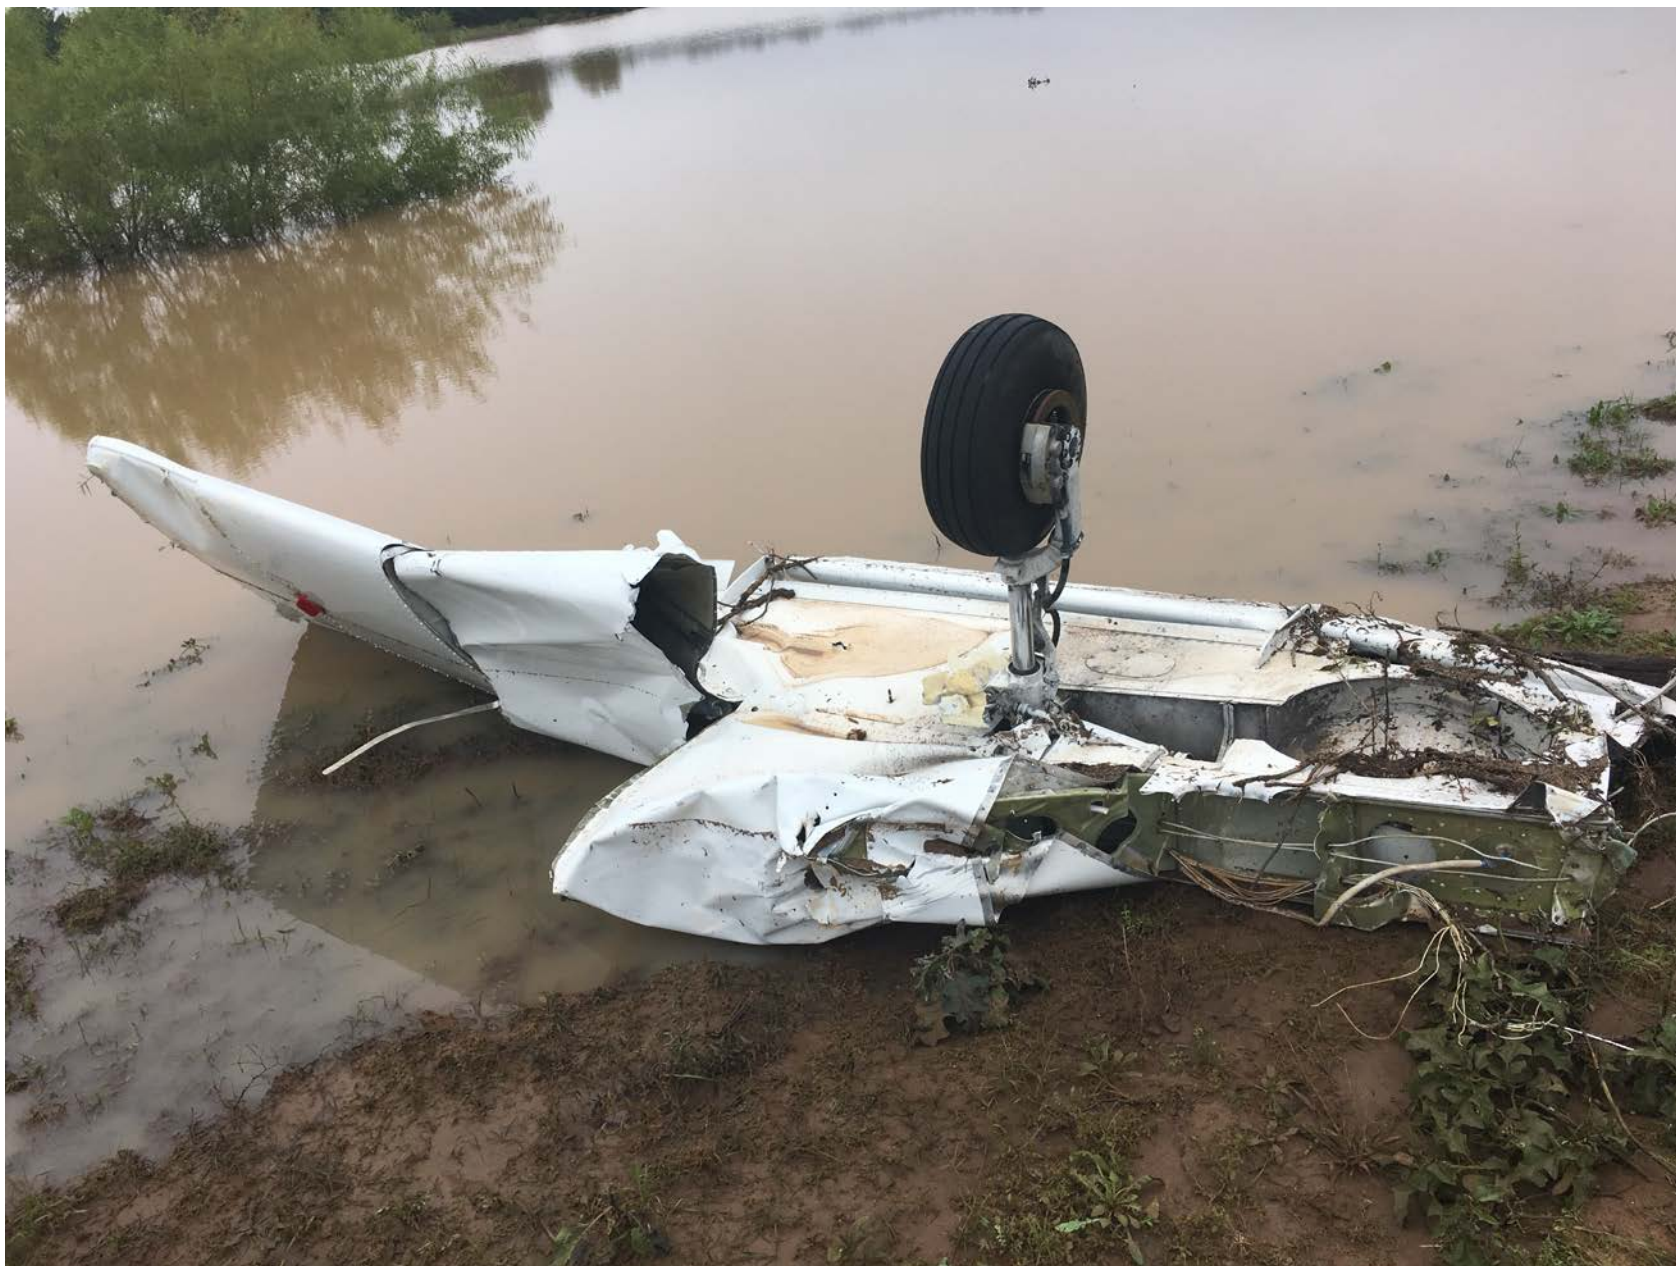
**Photo 2 – Left wing at accident site**

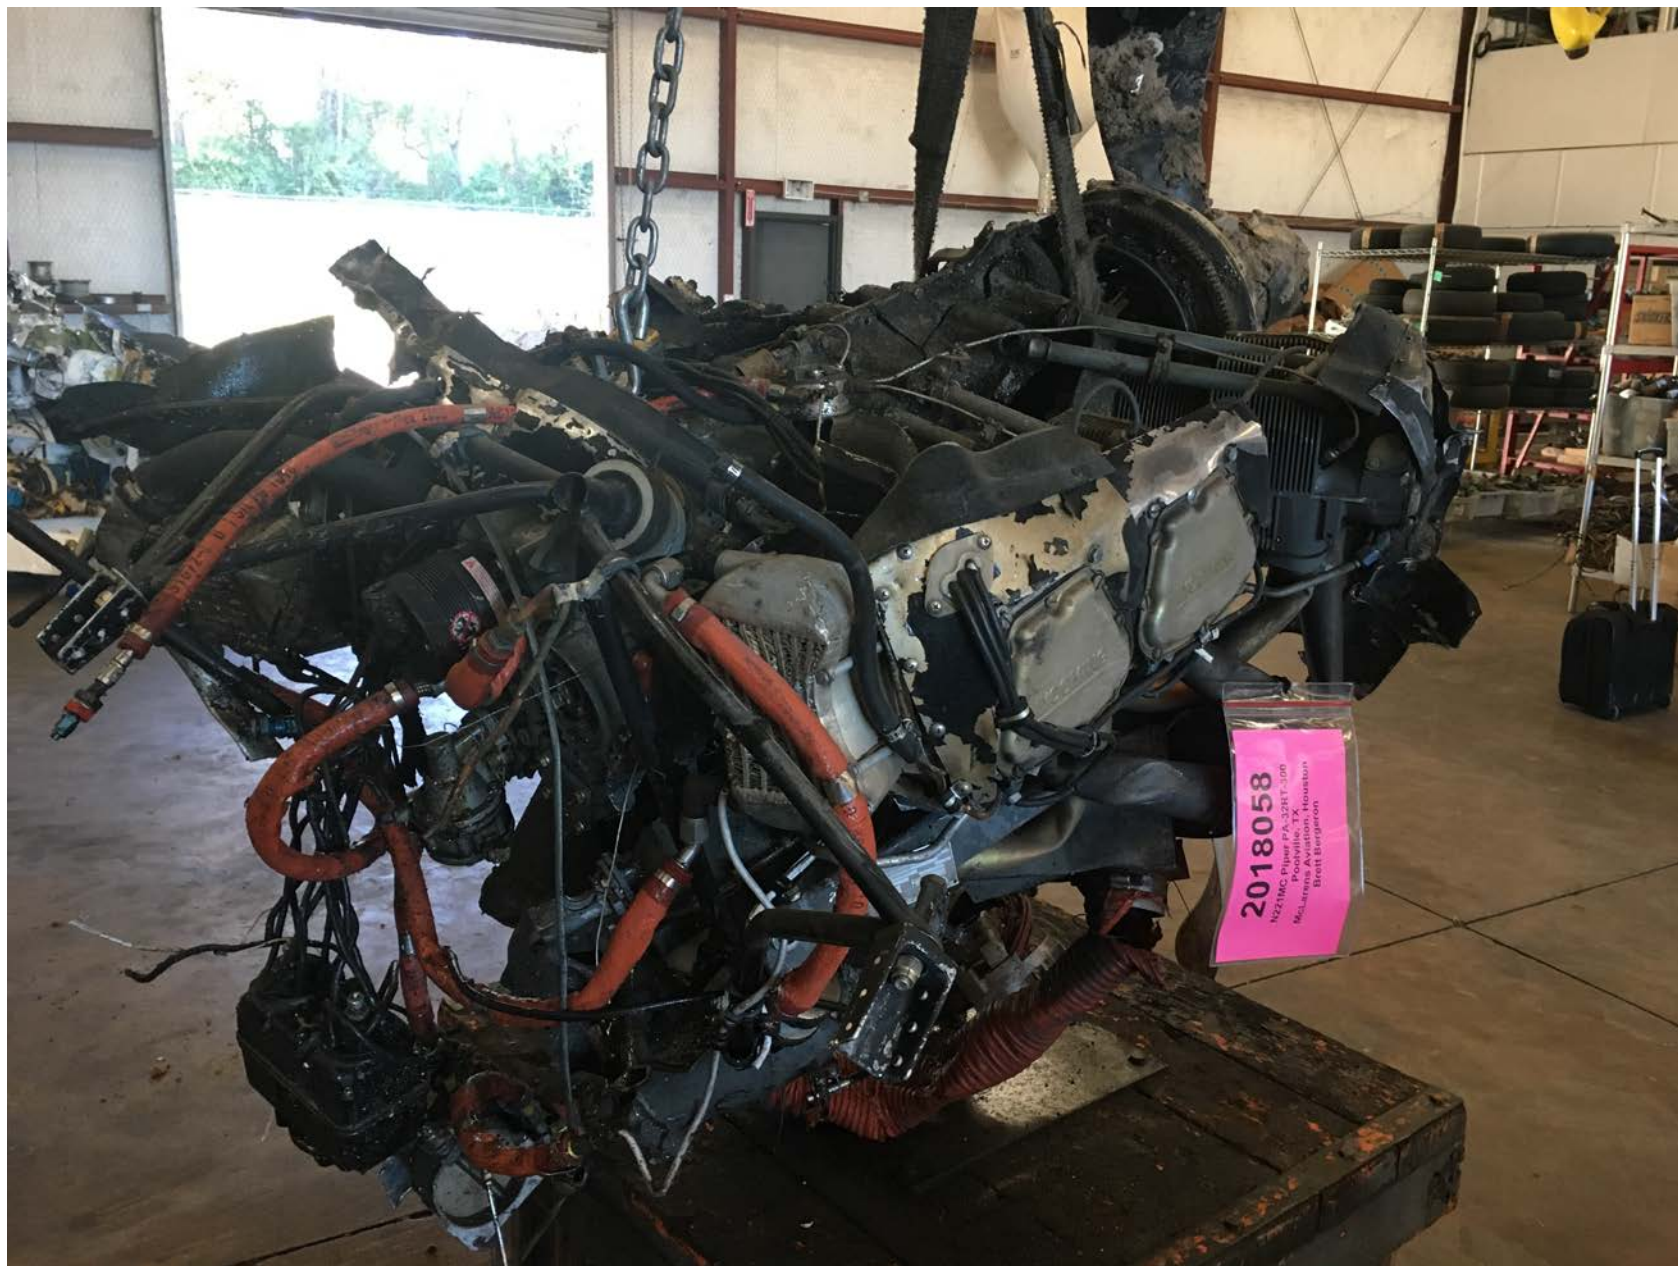
**Photo 3 – Engine during layout examination**

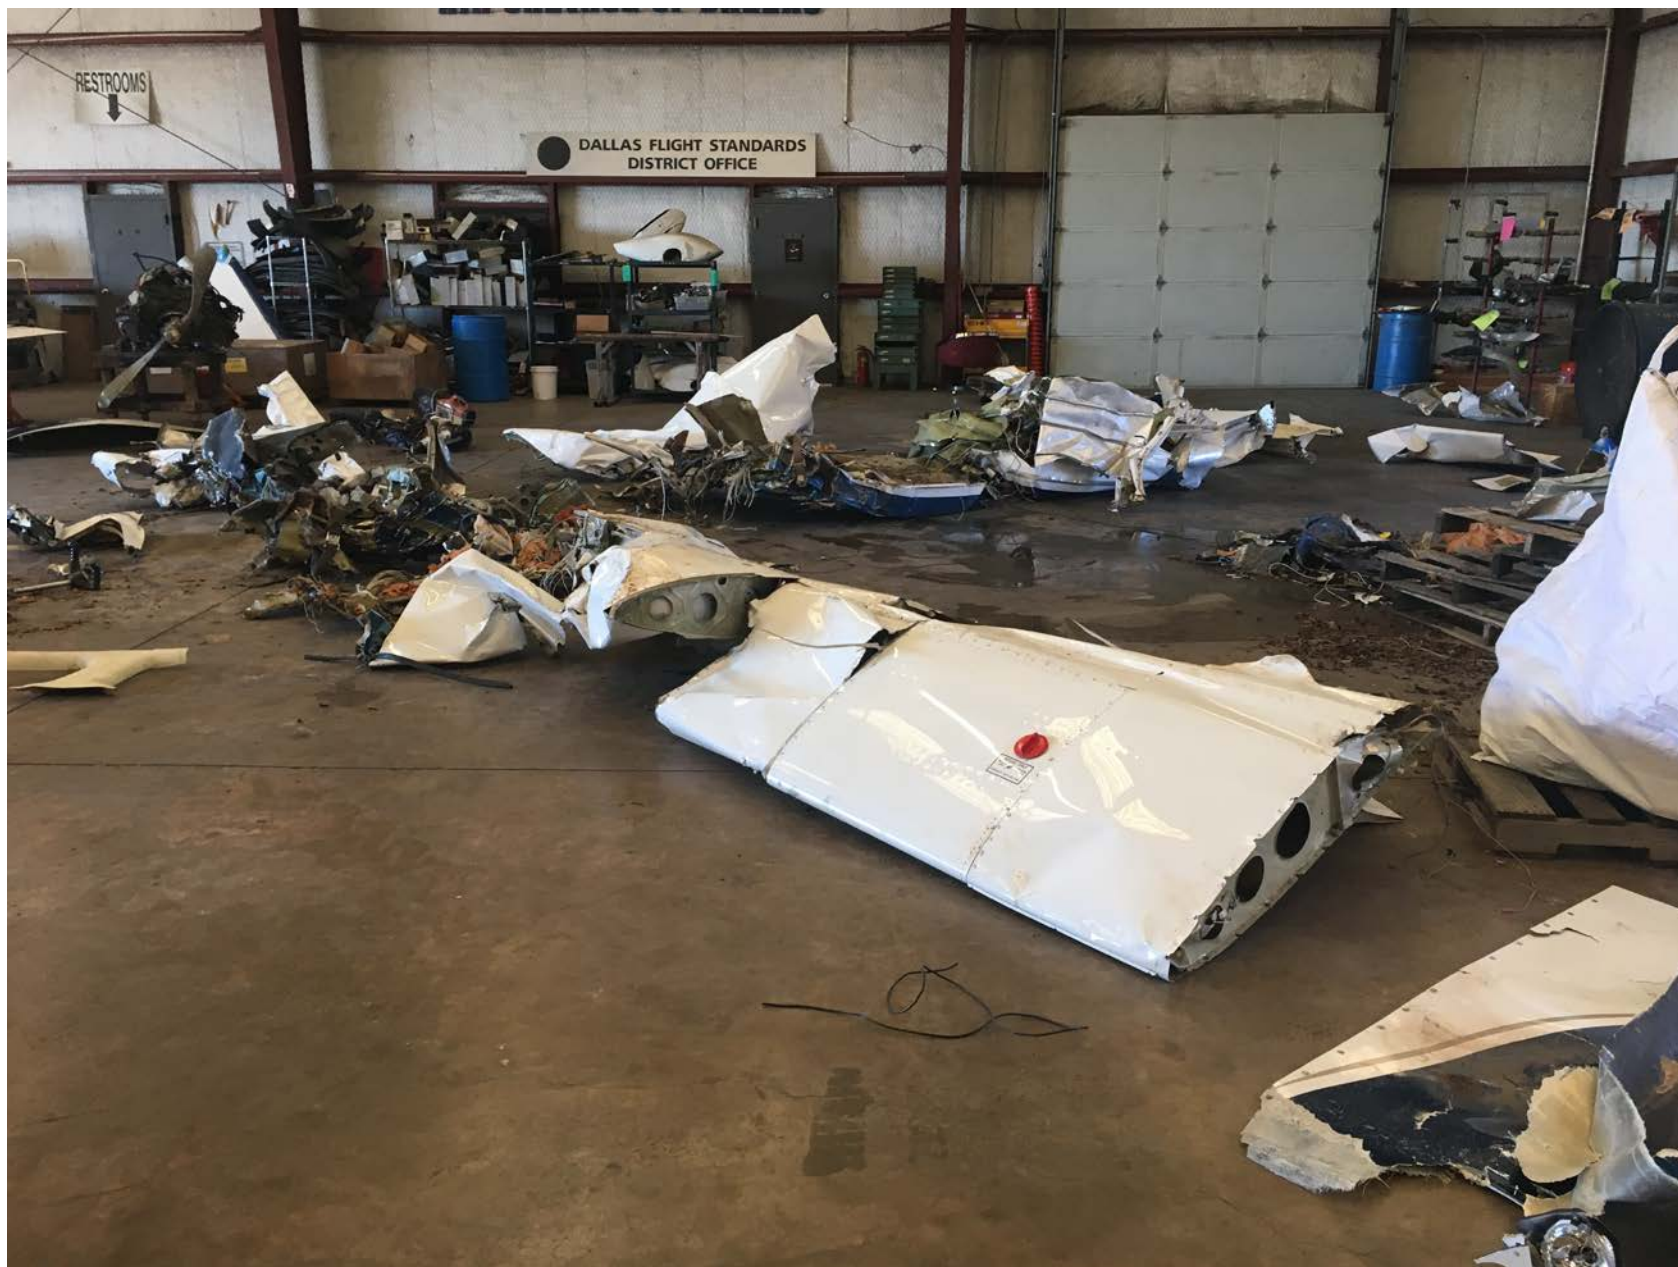
**Photo 4 – Airframe during layout examination**

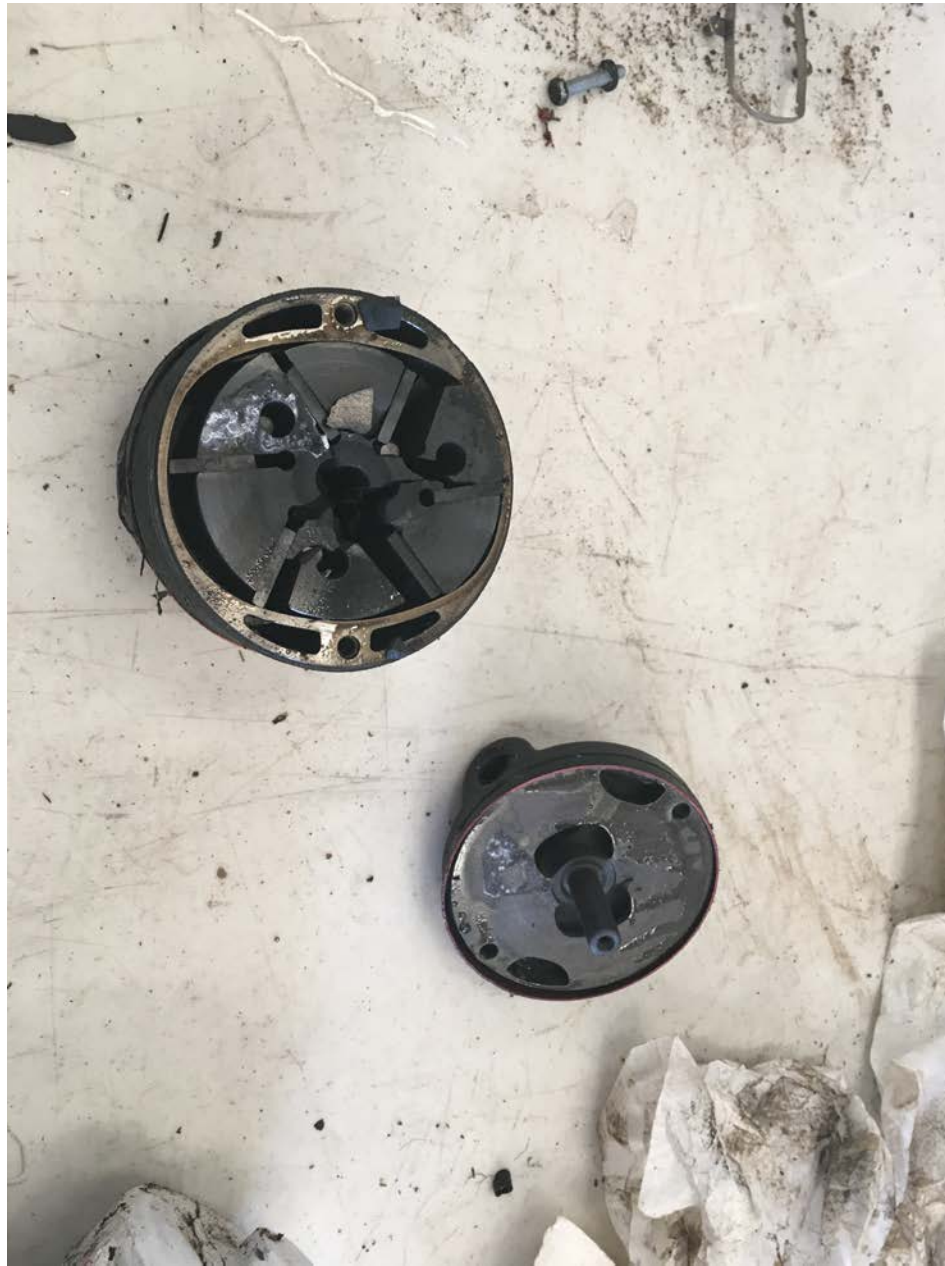
**Photo 5 – Vacuum pump during layout examination**

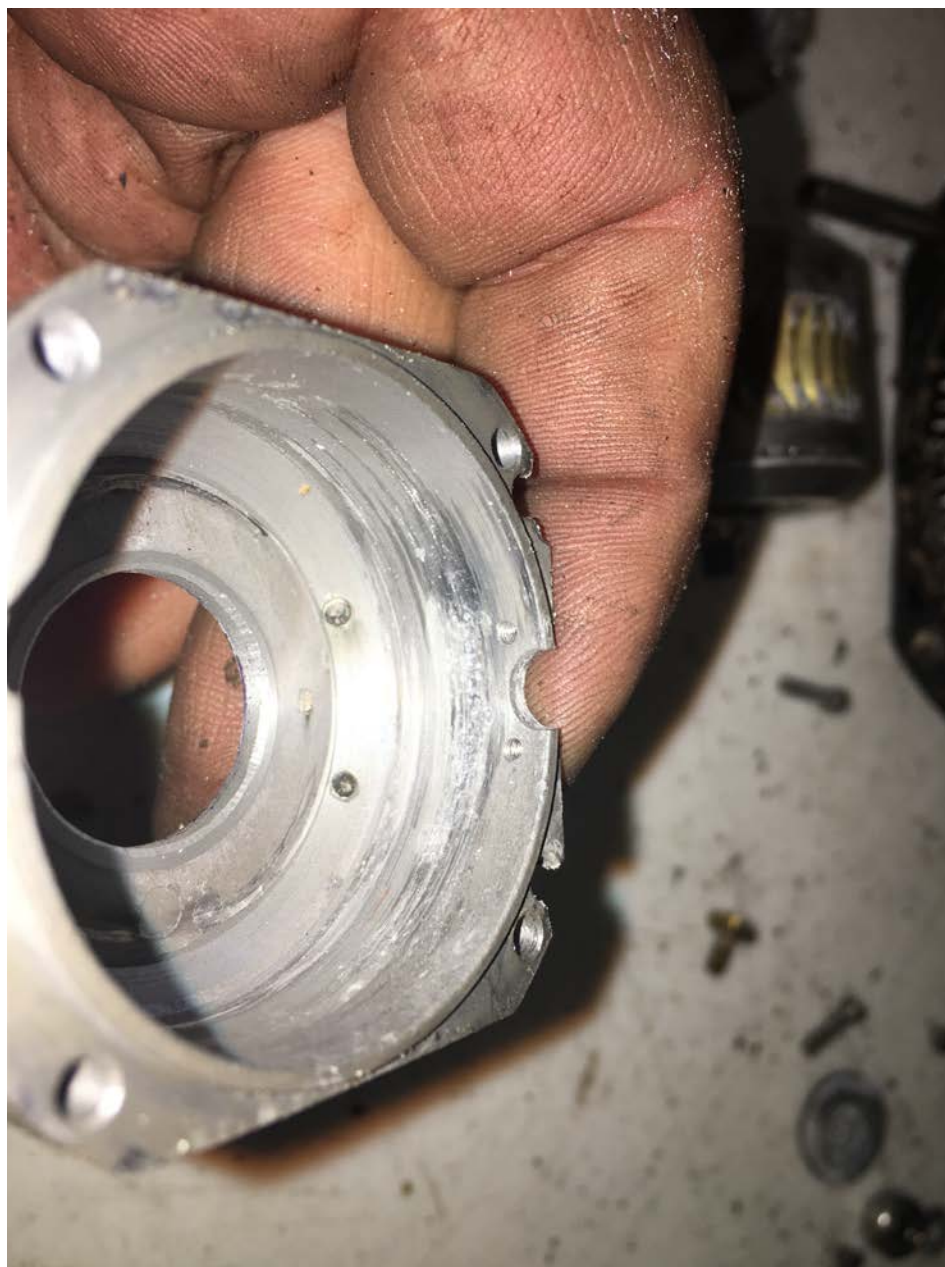
**Photo 6 – Gyroscope housing showing rotational scoring**

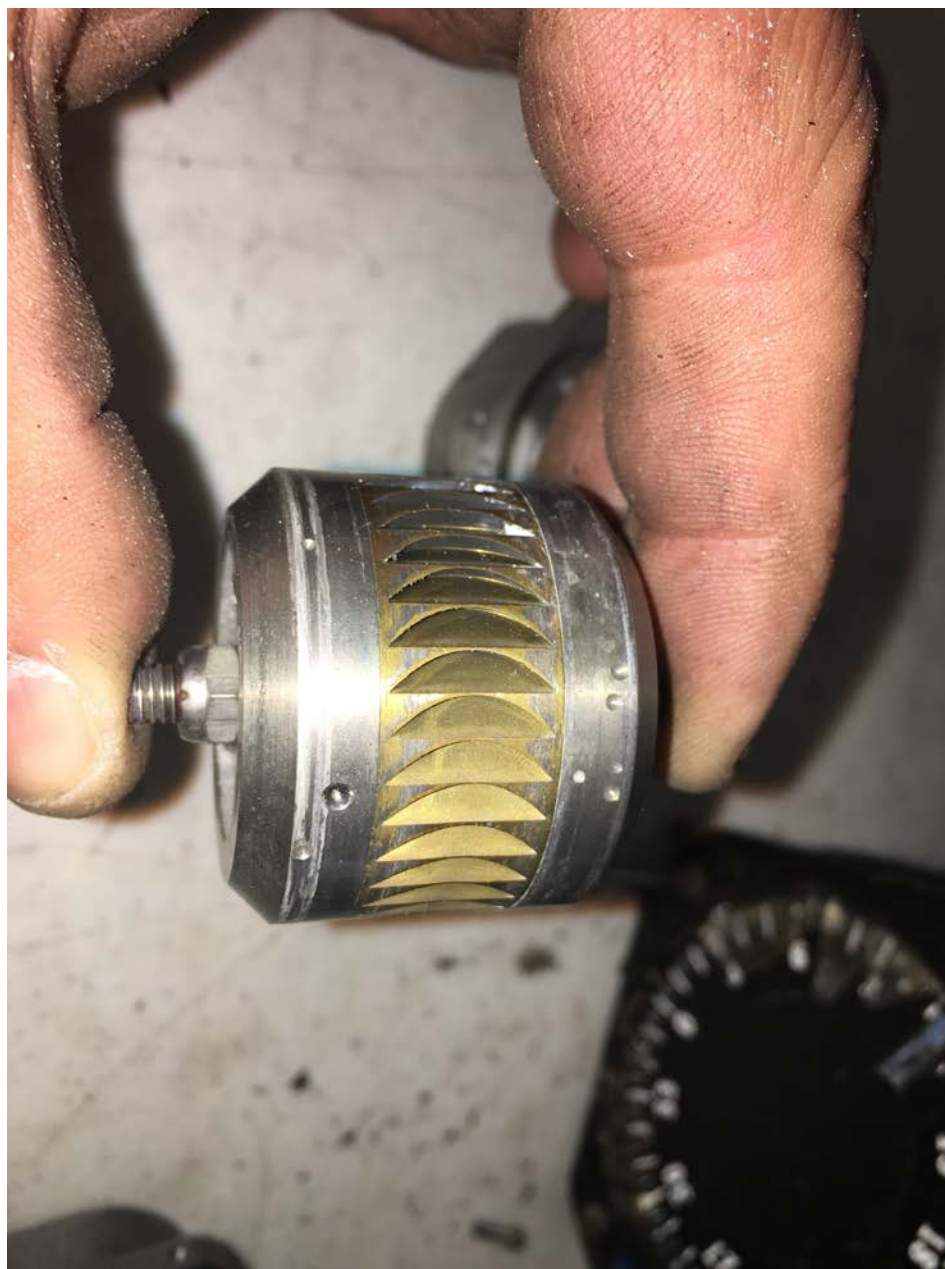
**Photo 7 – Gyroscope core showing rotational scoring**
