# NATIONAL TRANSPORTATION SAFETY BOARD

## MATERIALS LABORATORY FACTUAL REPORT

Report No. 19-024

Place : Canoncito, New Mexico  
Date : 10/16/2018  
Vehicle : Cessna 182P N9326G  
NTSB No. : CEN19FA008  
Investigator : Andrew Todd Fox

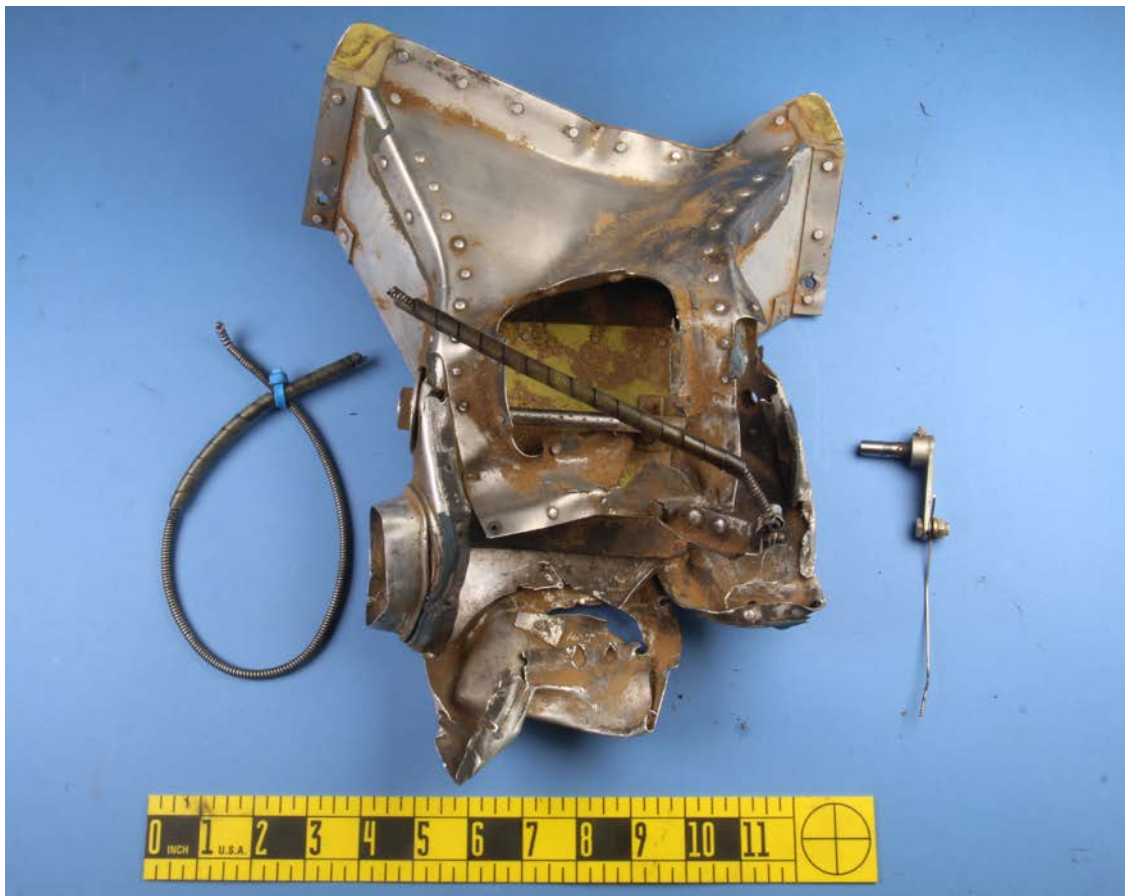
The carburetor heat box had been deformed from impact forces. The heat valve vane inside the carburetor heat box conformed to the deformation of the heat box body. No evidence was observed to reveal the vane's pre deformation position.

Figure 1: Carburetor heat box, portion of heat valve shaft and cable sheathing as received.

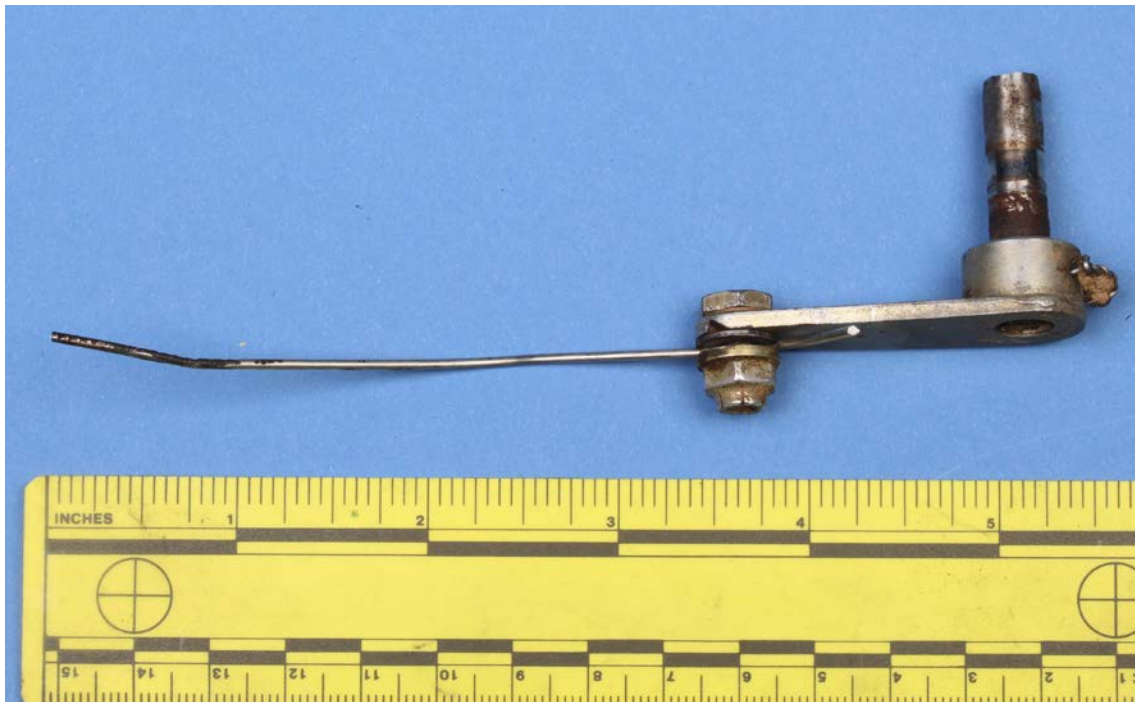
Figure 2: Portion of heat valve shaft, control arm and portion of control cable.

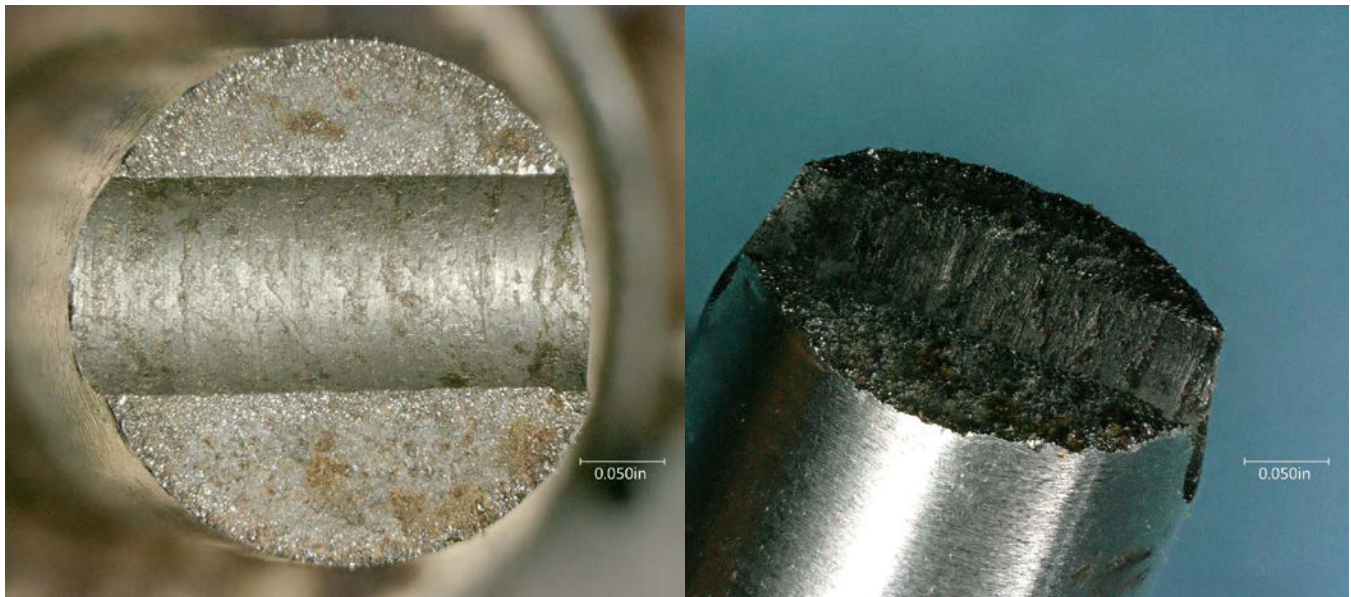
The heat valve shaft that carried the carburetor heat box vane was fractured. The fracture occurred in a part of the shaft that was cross drilled for the vane attachment. A portion of the heat valve shaft remained attached in the deformed carburetor heat box. The separated portion of the heat valve shaft included a control arm with a portion of control cable attached (figure 2). Examination of the heat valve shaft's fracture surface revealed fracture features consistent with a brittle overstress fracture (figure 3).

Figure 3: Heat valve shaft fracture surface.

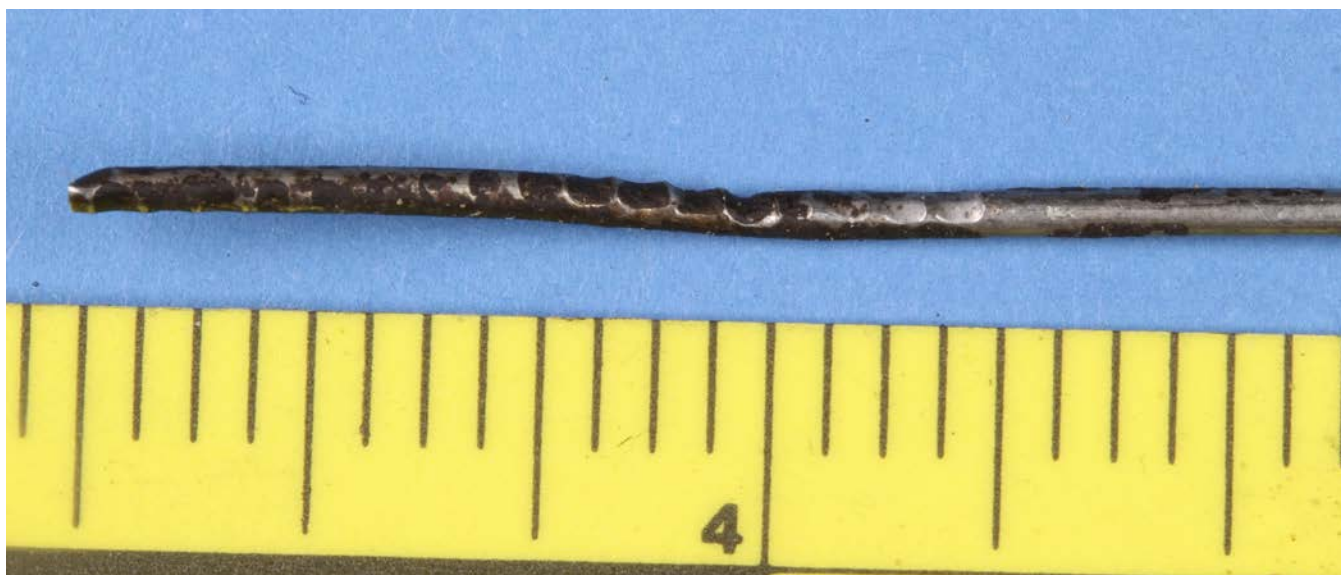
The portion of control cable attached to the heat valve shaft control arm was approximately 3.5 inch long. The last inch of the control cable on the end opposite the control arm exhibited a scalloped wear pattern and a tar like substance adhering to the cable surface (figures 4, 5). The fracture surface on this end of the control cable also exhibited a tar like substance adhering to the fractured end (figure 6). After ultrasonic cleaning in Acetone the fractured end of the control cable was examined using a scanning electron microscope (SEM). SEM micrographs (figure 7) revealed a fracture surface characterized by microvoid coalescence consistent with an overstress fracture. A portion of the fracture surface exhibited polishing wear and another portion exhibited microvoids that had been smeared.

Figure 4: Heat valve shaft control cable end.

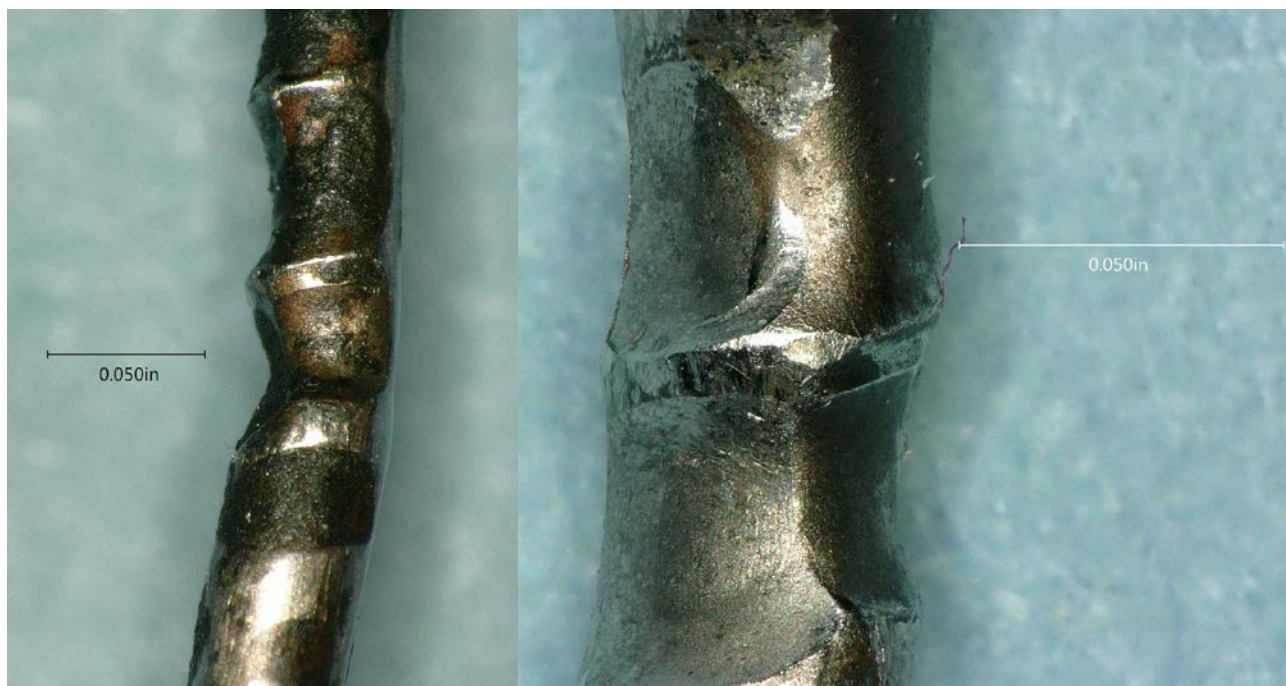
Figure 5: Close-up of scalloped wear pattern on control cable end (right image taken after cleaning).

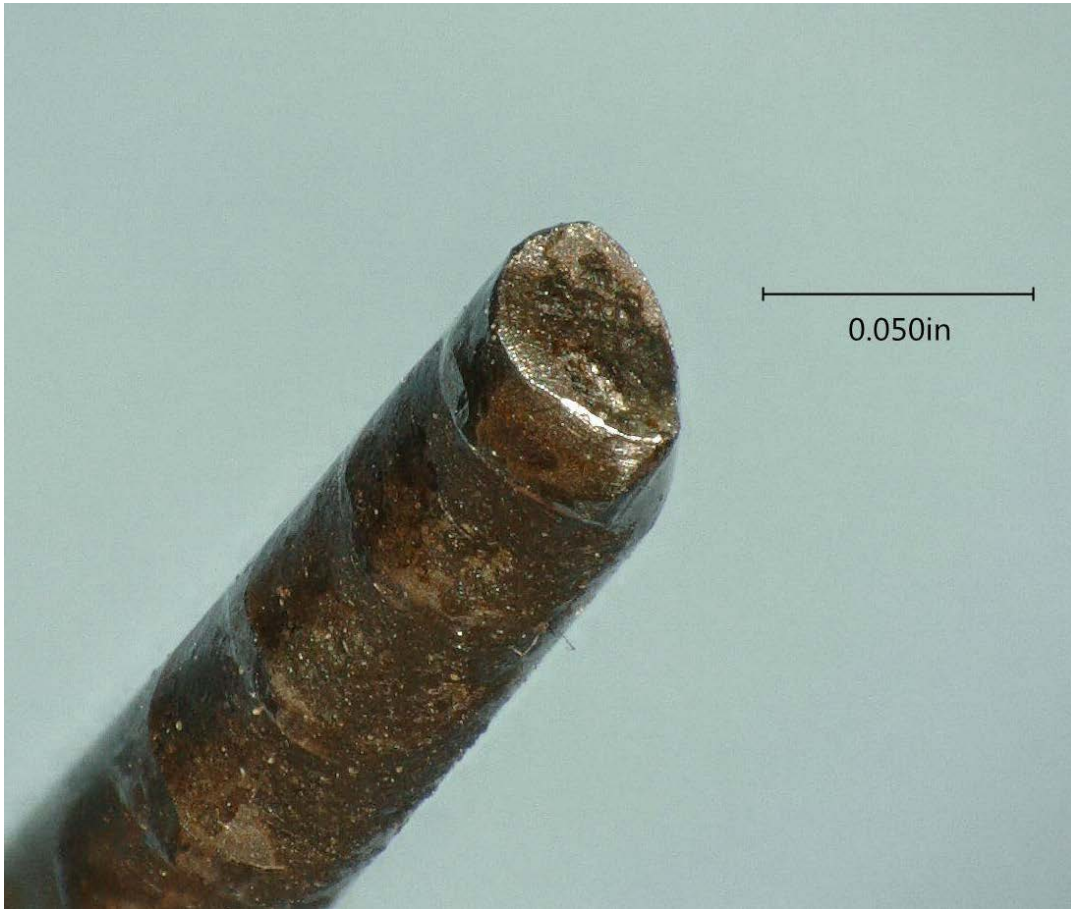
Figure 6: Control cable end fracture surface.

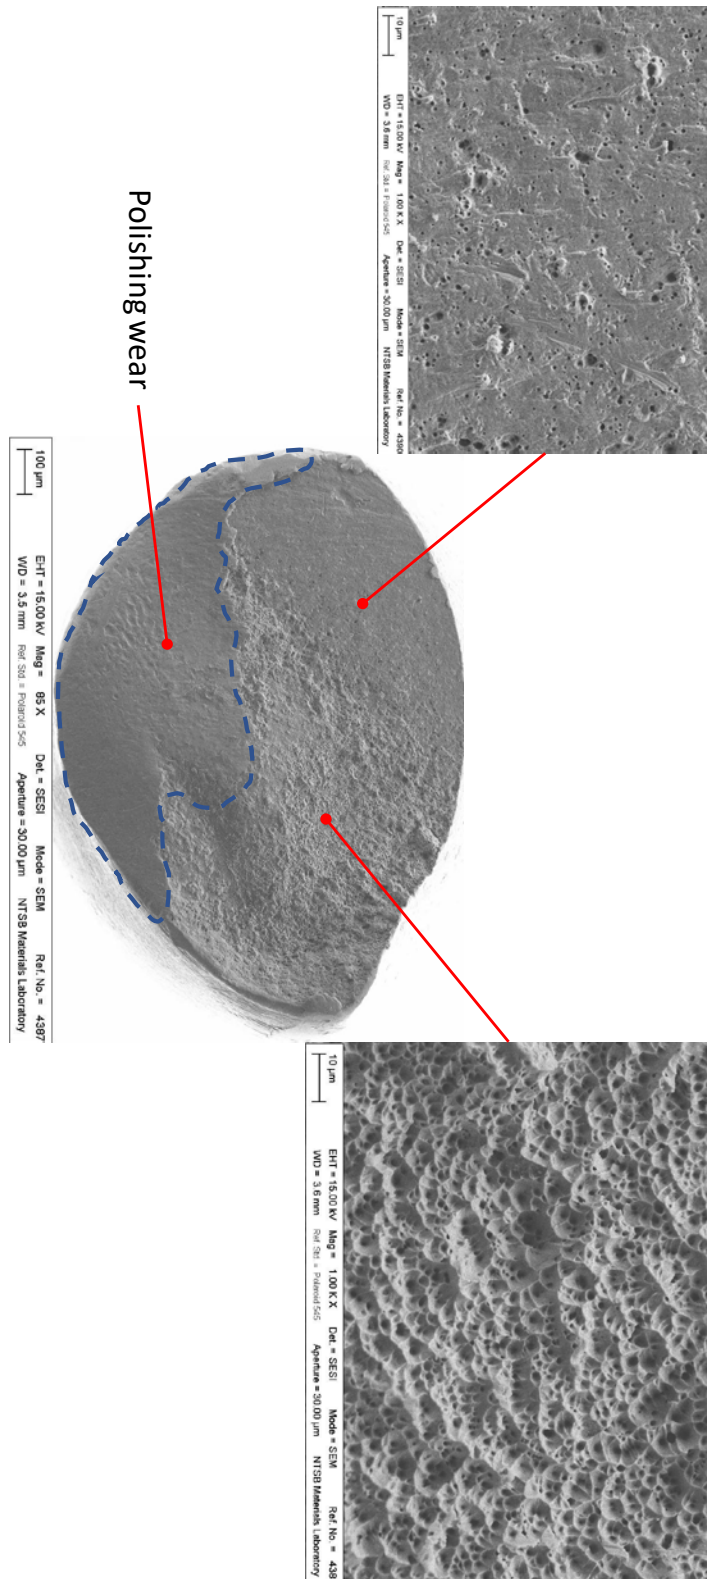
Figure 7: SEM micrographs of control cable end fracture surface.
