# Physical Analysis Report on CEN19FA018

Prepared by Binghamton University for the  
National Transportation Safety Board

December 10, 2018

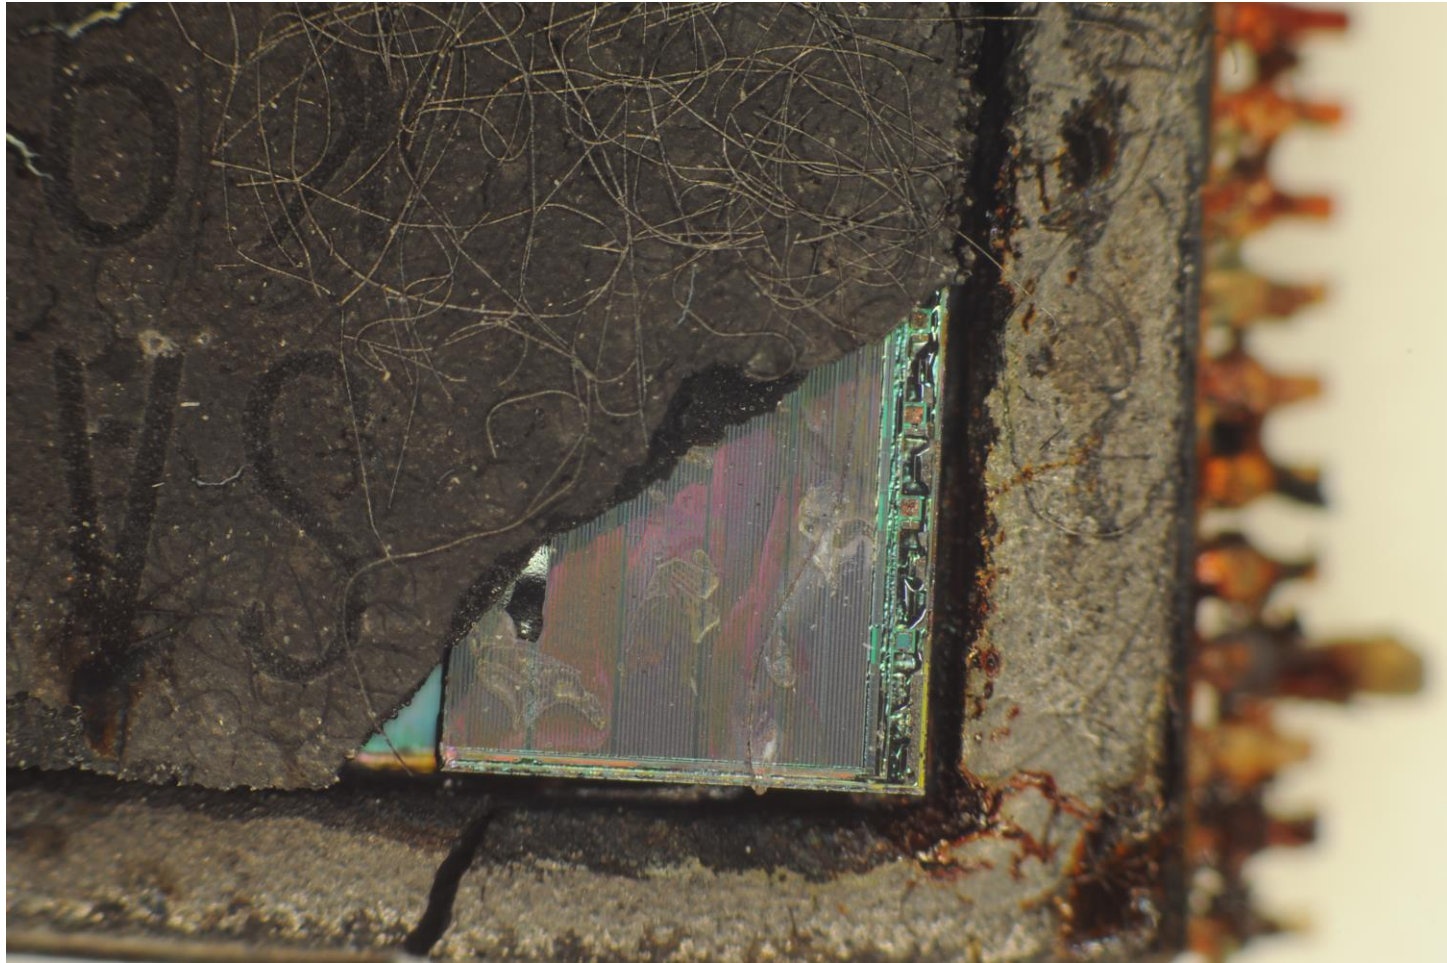
# Top of Module 1: Note the Exposed Chip

Large crack in the overmold

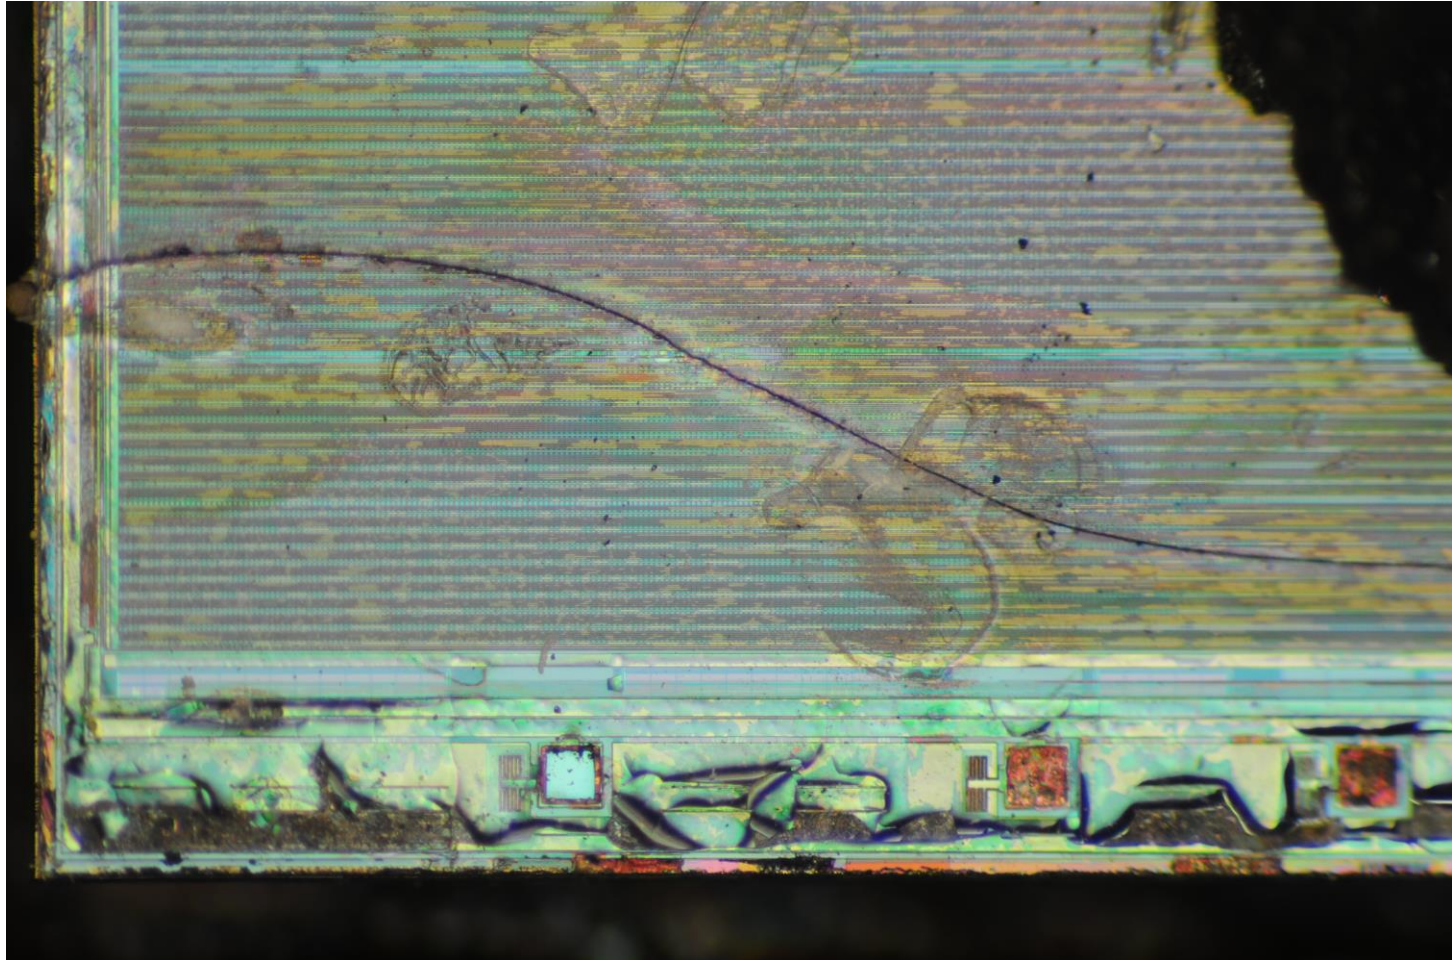
# Surface Crack in the Chip in Module 1

- Integrated circuit was exposed in one corner of module 1
    - Integrated circuit was almost completely exposed in module 2
    - Confirmed chip crack in the exposed corner (module 1)

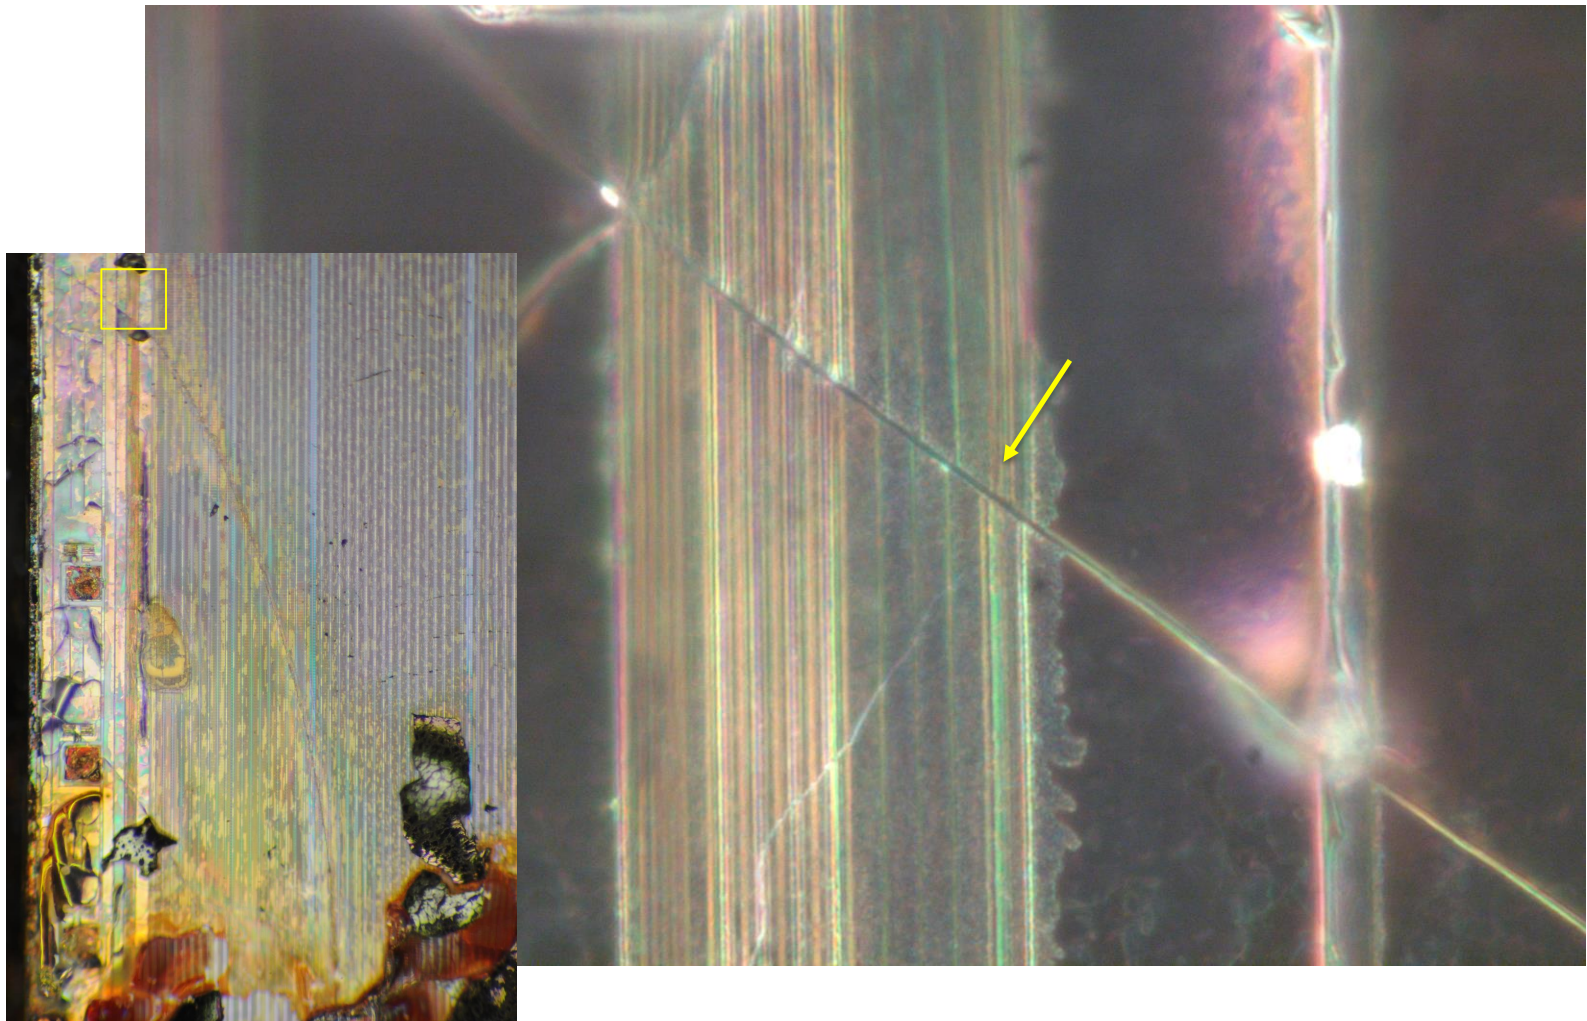
# Module2: Confirmation of Crack – Note the Dislocation

Dark field image at 1000x, showing dislocation of lines at the crack

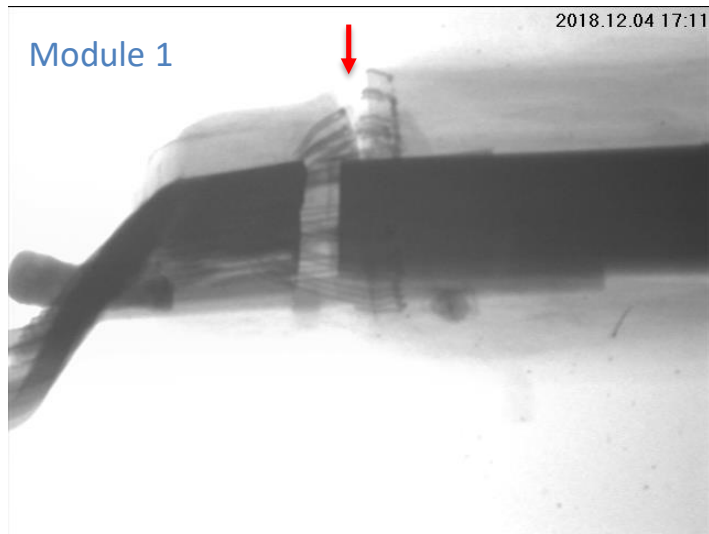
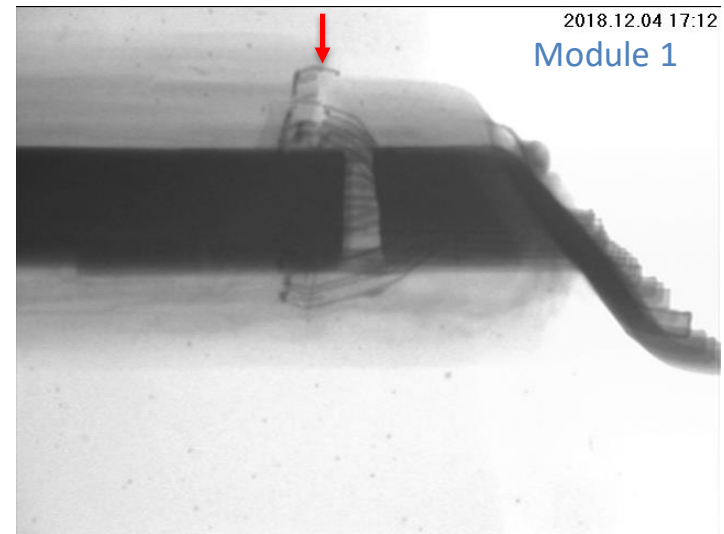
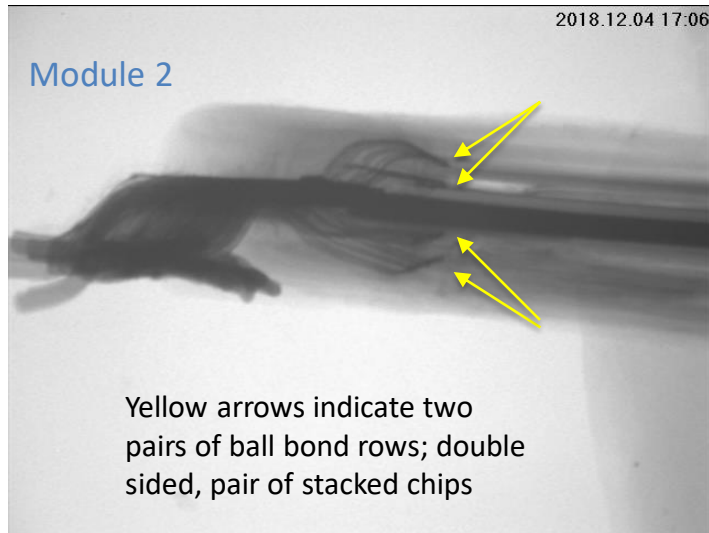
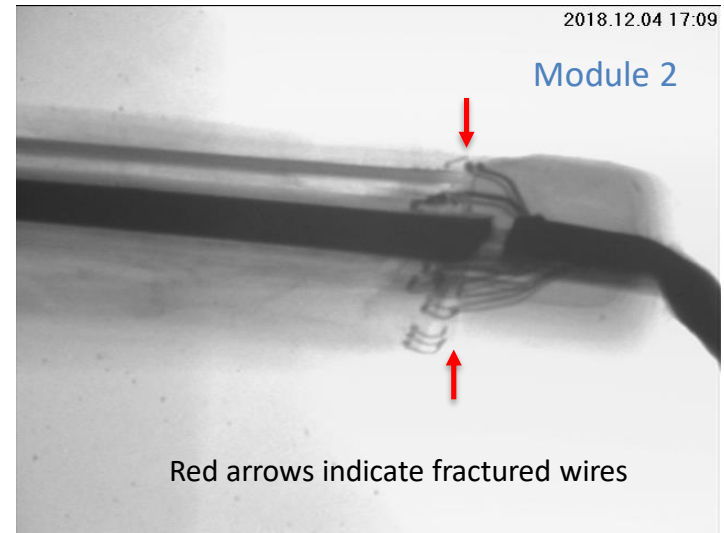
# Side View of Modules 1 and 2 at Each End

Yellow arrows indicate two pairs of ball bond rows; double sided, pair of stacked chips

Red arrows indicate fractured wires

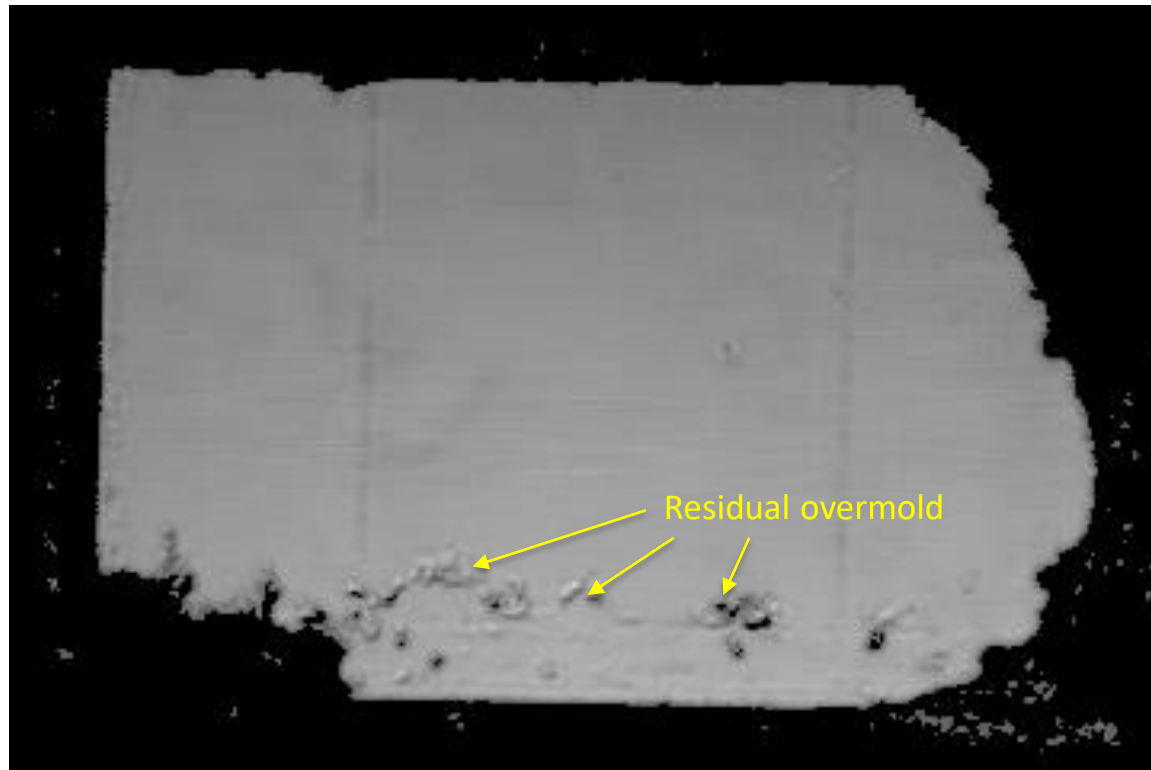
# Surface of the Exposed Chip in Module 2

- Black area is the overmold remaining on the outer lead frame
- Spots in the chip area are residual overmold that did not completely burn or flake off

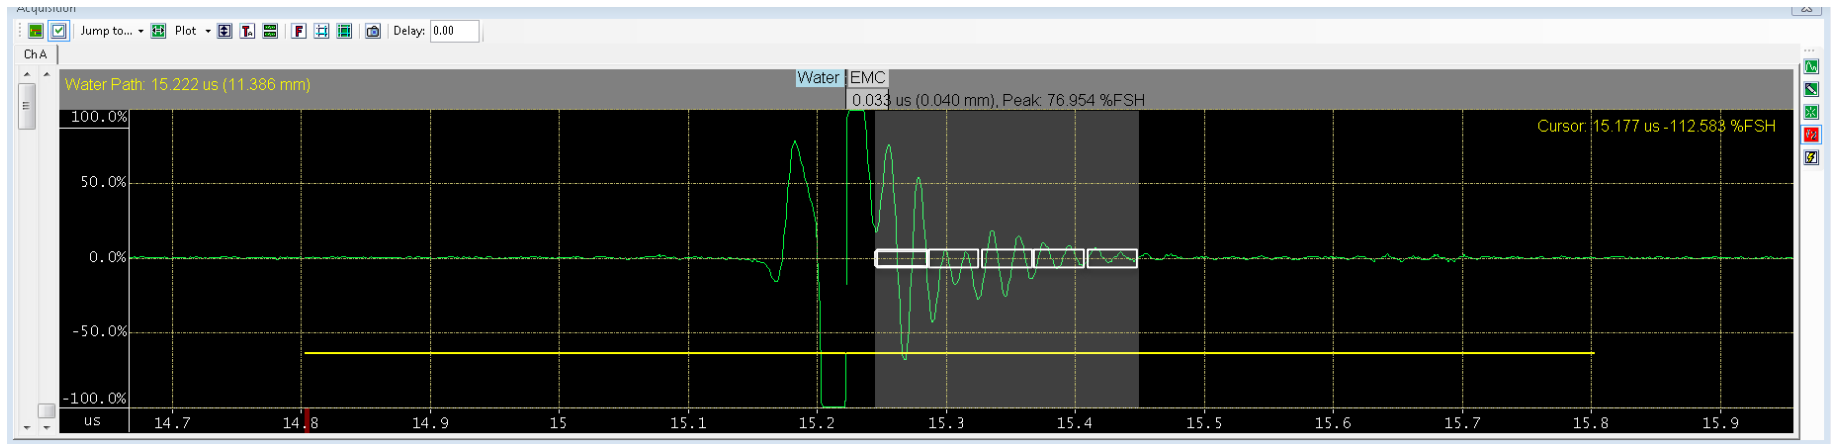
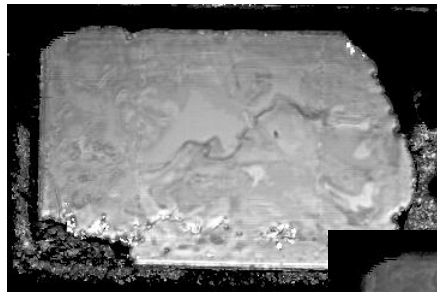
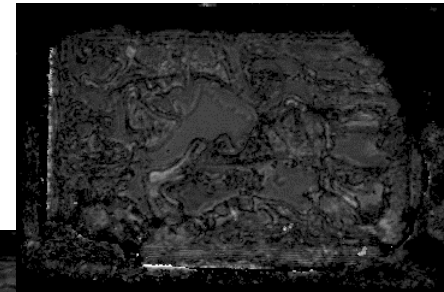
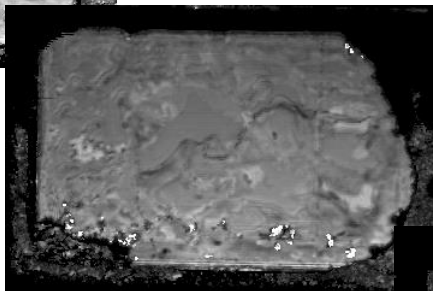
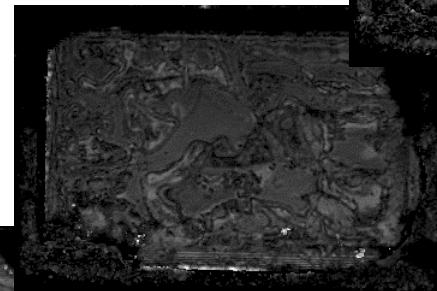
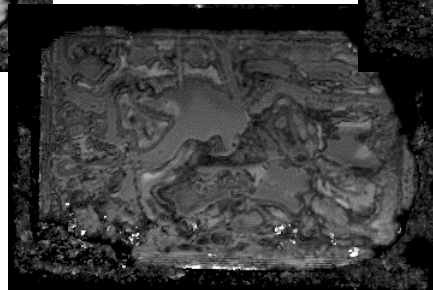
# C-SAM Setup – Five Gate Settings for Pulse Echo

All images are essentially the same, and spaced at equal time delay intervals

- Likely echoes of the first image
- Cannot image below the 1<sup>st</sup> interface below the surface

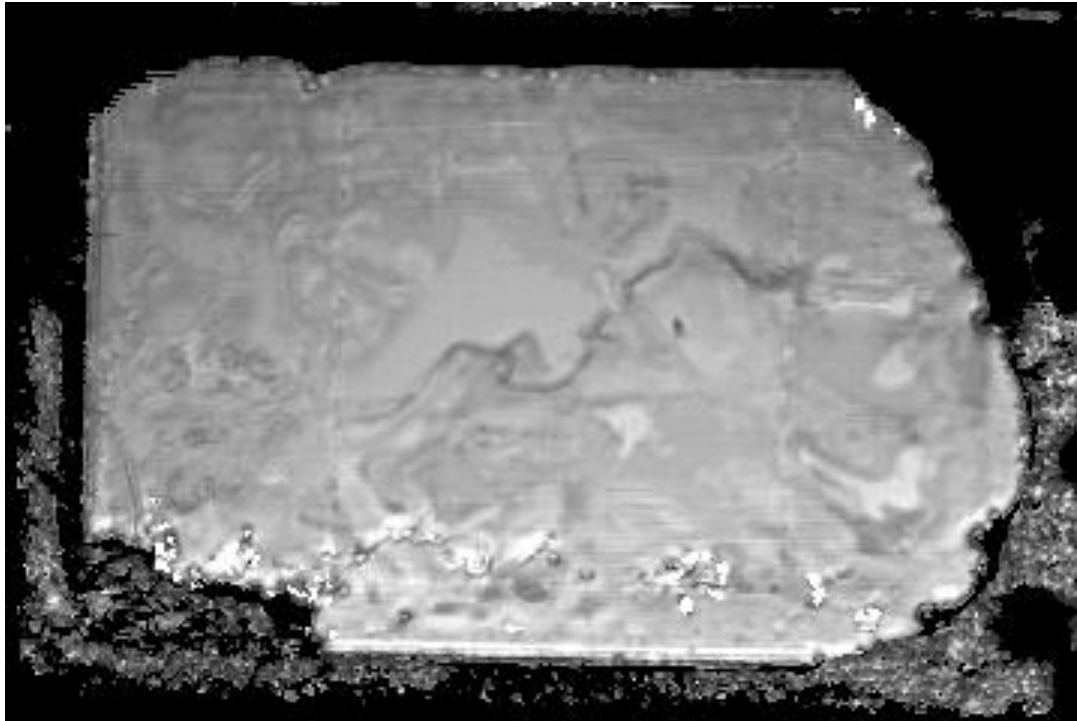
# Larger View of the First Subsurface Interface

- Only the top chip in module 2 could be sonically imaged; the layer between stacked chips showed a pattern that is consistent with severely interfacial damage, and likely damage to the bottom chip as well

- Odd pattern – suggests deformation of material between the chips
- Deformation would lend the chip integrity to be suspect
