# NATIONAL TRANSPORTATION SAFETY BOARD

## MATERIALS LABORATORY FACTUAL REPORT

Report No. 19-006

Place : McDougal, Arkansas  
Date : November 2, 2018  
Vehicle : Hughes 369D, N5187S  
NTSB No. : CEN19FA020  
Investigator : Courtney Liedler, AS-CEN

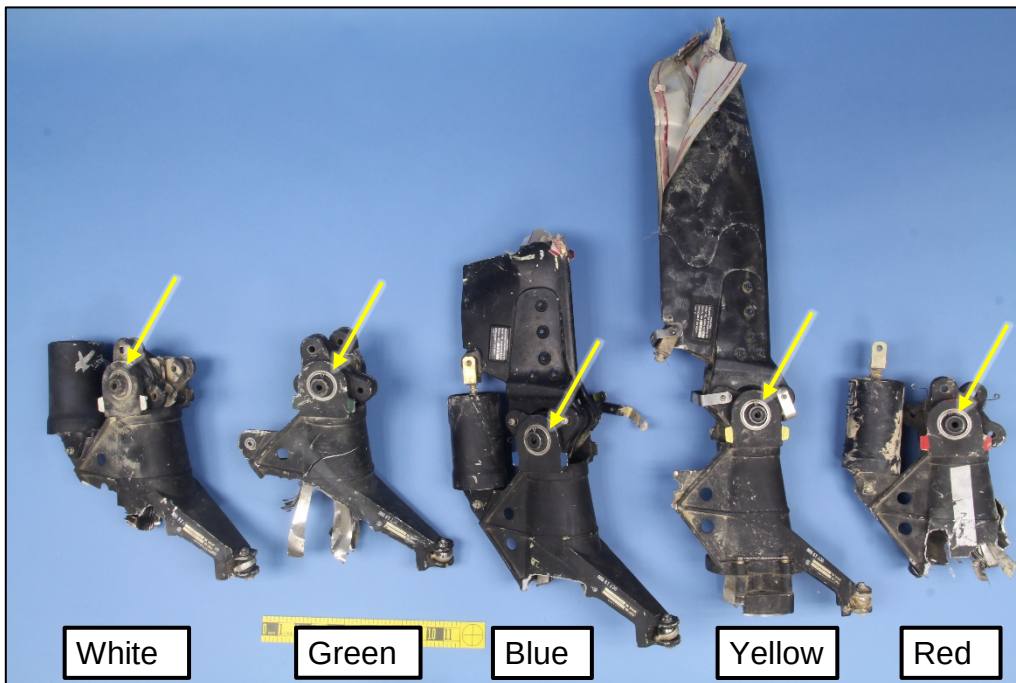
An overall view of the submitted main rotor assembly pieces is shown in figure 1. As installed, the blades and corresponding hub attachment locations were referenced by color, and the color associated with each piece is shown labeled in figure 1. The blade pieces were attached to the hub pieces by a lead-lag bolt fastened with a nut. The lead-lag bolts in the submitted components appeared intact, and the nuts were attached with lock pins in place.

Figure 1. Overall view of the submitted main rotor assembly pieces. Unlabeled arrows indicate the lead-lag bolt attachment locations.

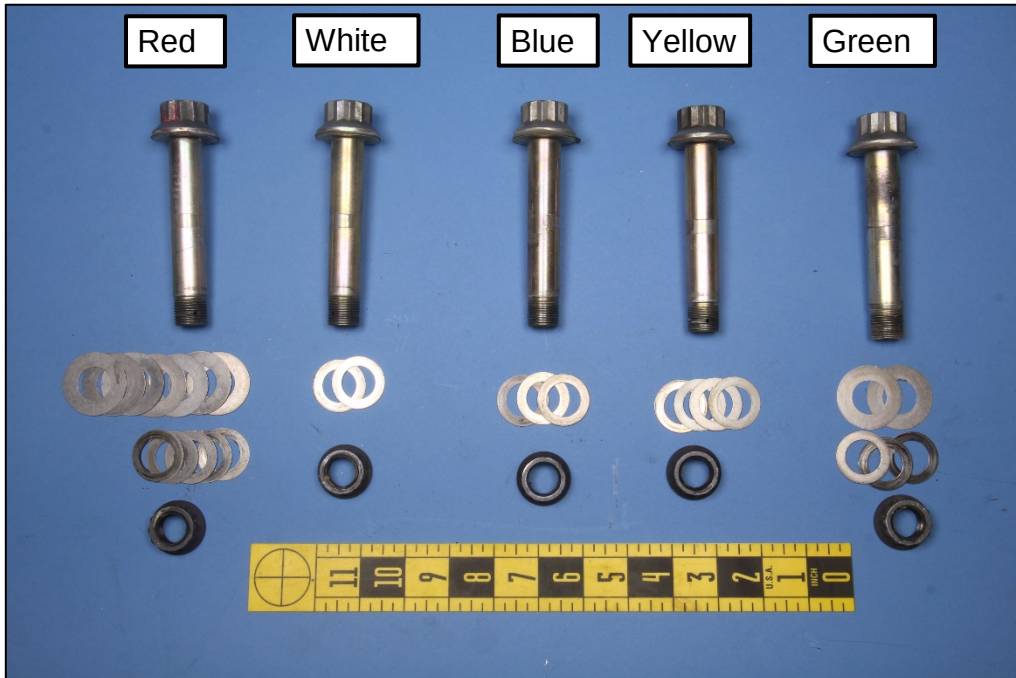
An overall view of the lead-lag bolts after cleaning is shown in figure 2. The nuts and washers that were removed from each lead-lag bolt attachment are also shown in figure 2. Varying numbers of washers with 2 different outer diameters had been installed at the attachment location. Nine washers with the larger diameter were installed on two lead-lag bolts with 7 installed on the red lead-lag bolt and 2 installed on the green lead-lag bolt. Washers with the smaller outer diameter were installed on all 5 bolts with 5, 2, 3, 4, and 3 installed on the red, white, blue, yellow, and green lead-lag bolts, respectively.

Each of the lead-lag bolts was examined closely using an optical stereomicroscope at magnifications up to 100 times. Particular attention was focused on the intersection between the head and the shank, edges of contact areas on the shank surface, and thread roots for the first 2 full threads adjacent to the shank. No evidence of cracks were detected on any of the lead-lag bolts.

Figure 2. View of the intact lead-lag bolts, washers, and nuts after removal and after the bolts were cleaned for optical examination.
