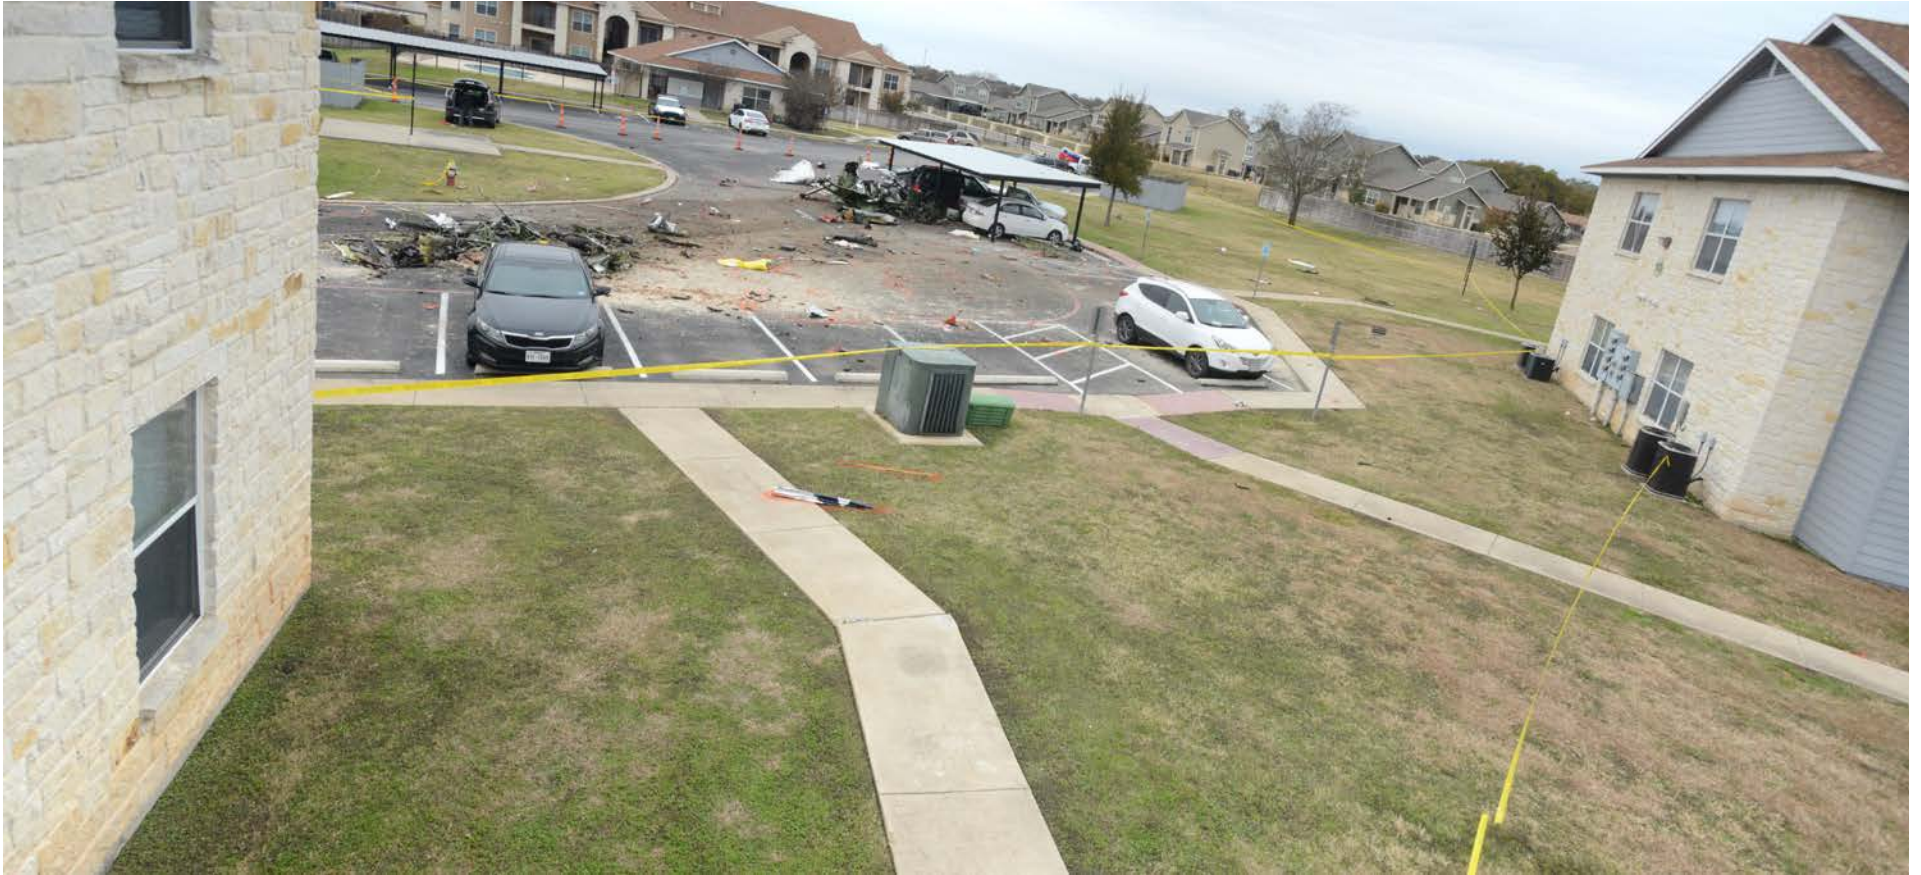
**Photo 1 – View of the accident site looking down from a balcony.**

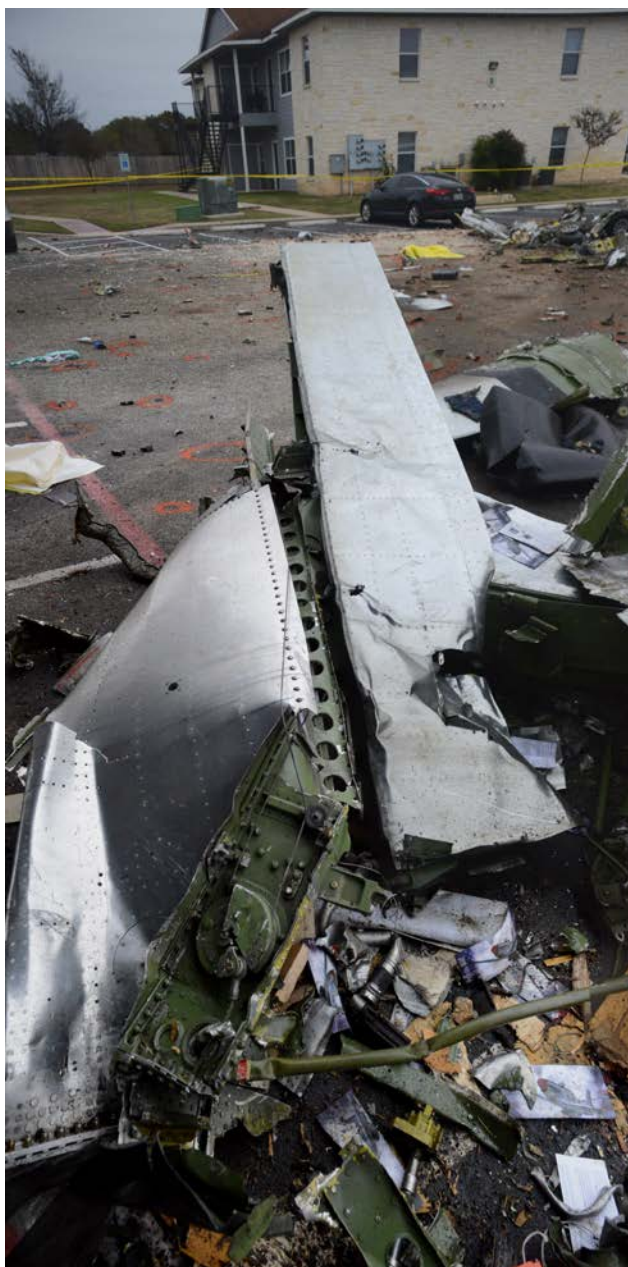
**Photo 2 - View of a separated section of a wing.**

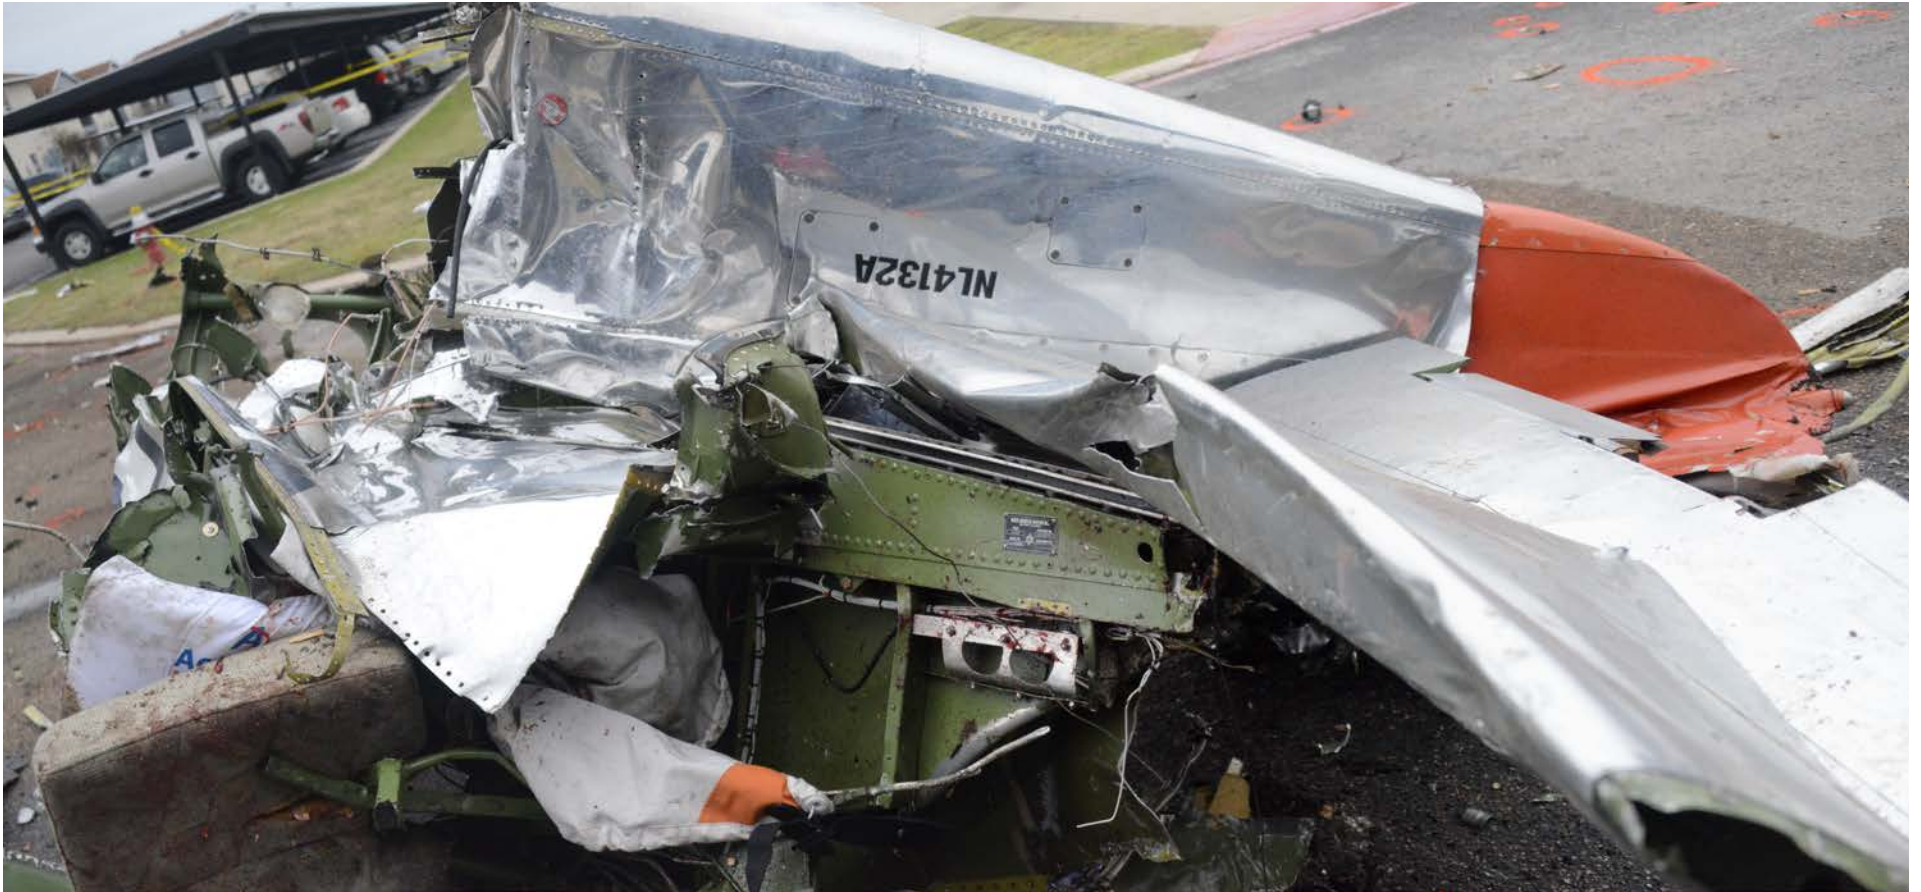
**Photo 3 - View of the right side of the inverted, separated empennage.**

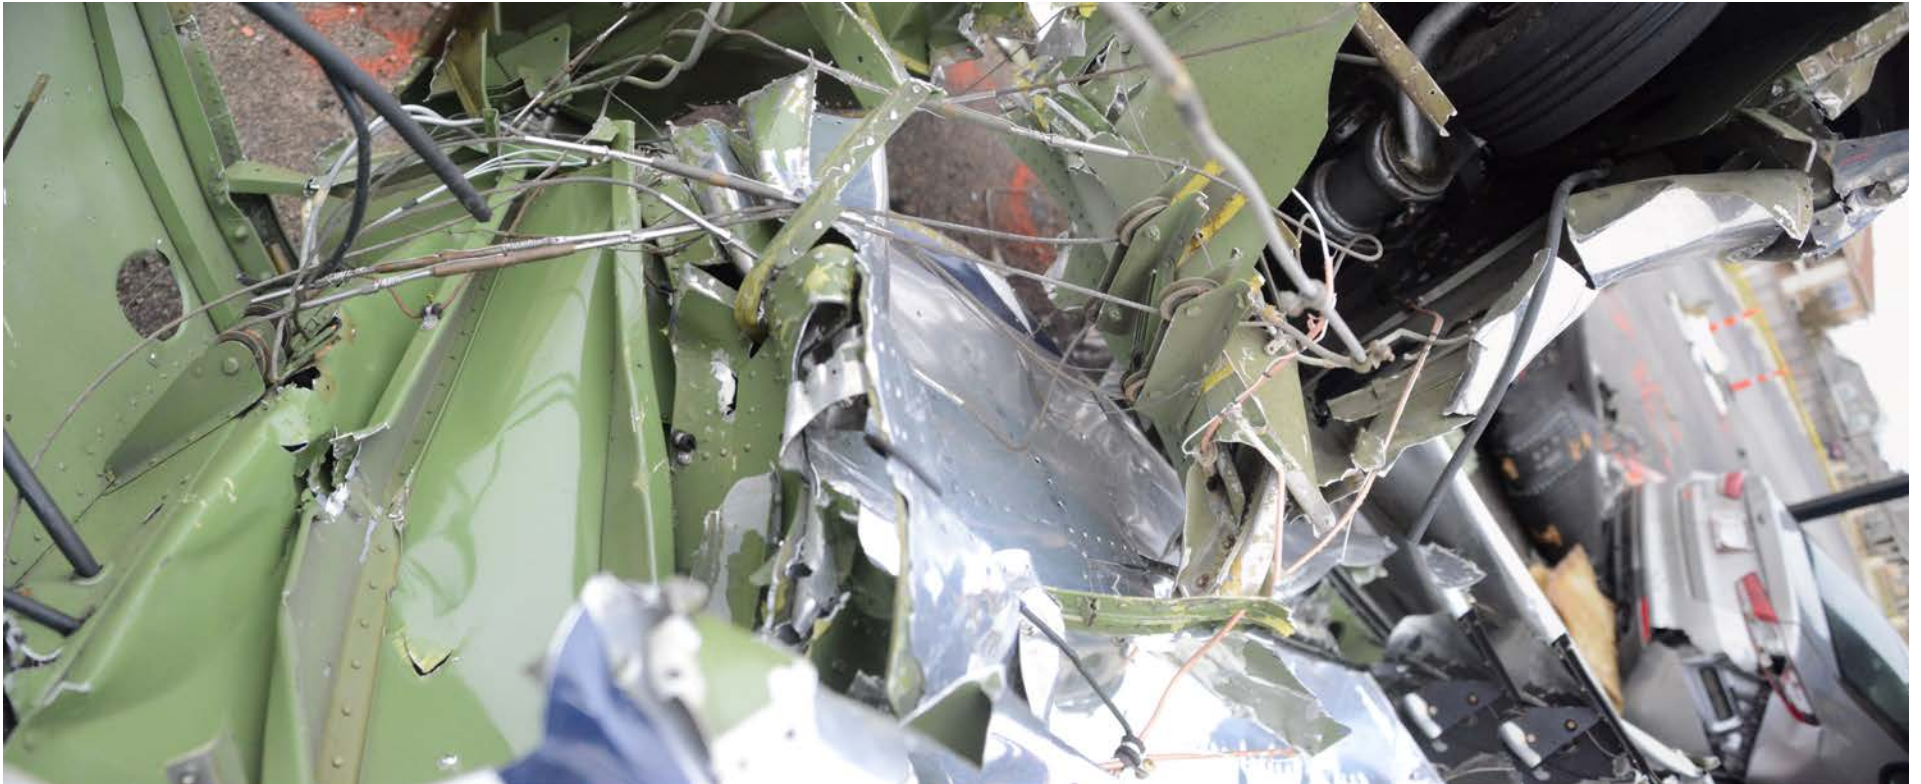
**Photo 4 - View of control cables forward of the empennage.**

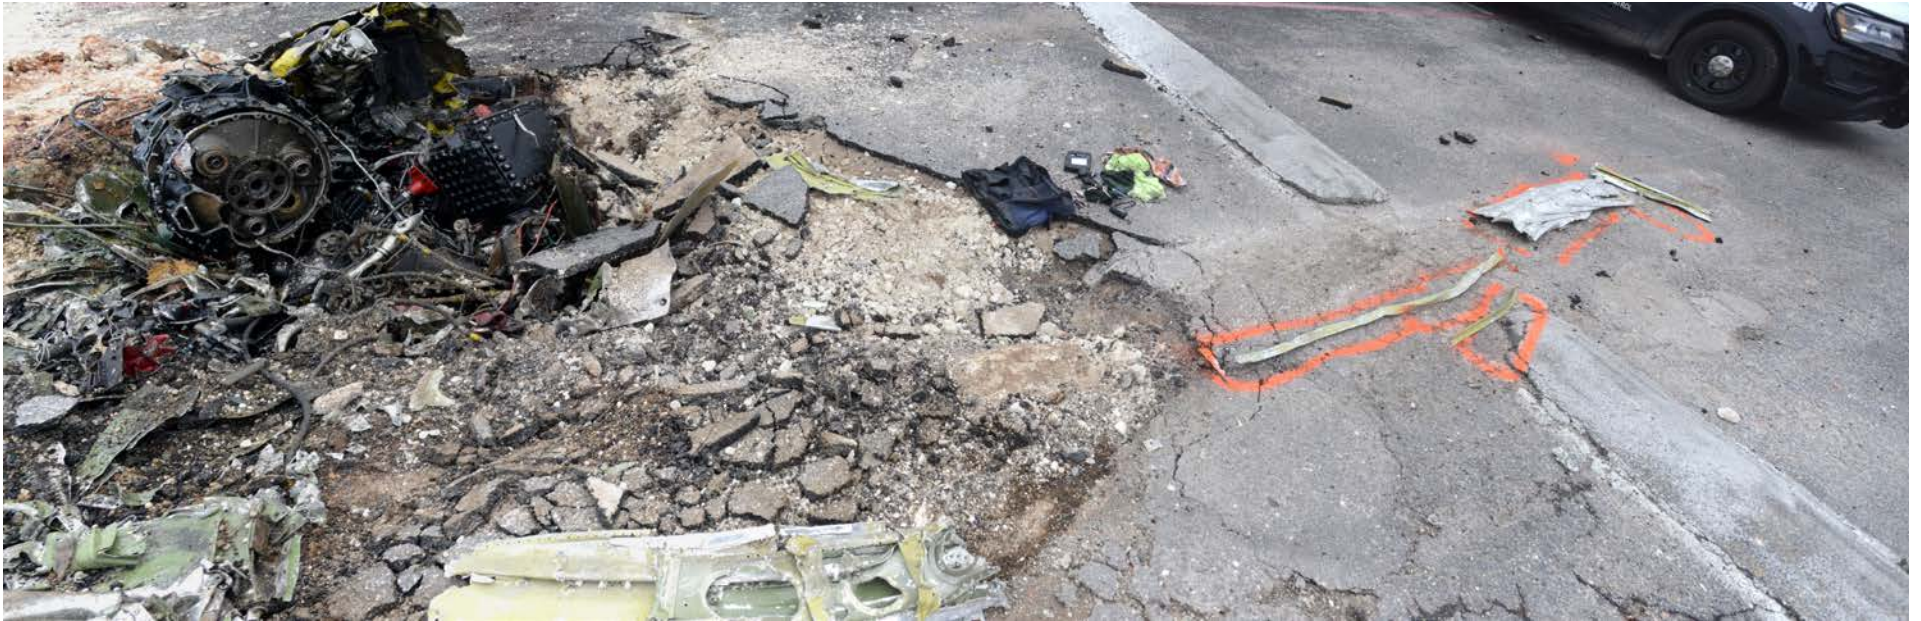
**Photo 5 - View of the engine embedded in terrain and a linear ground scar.**

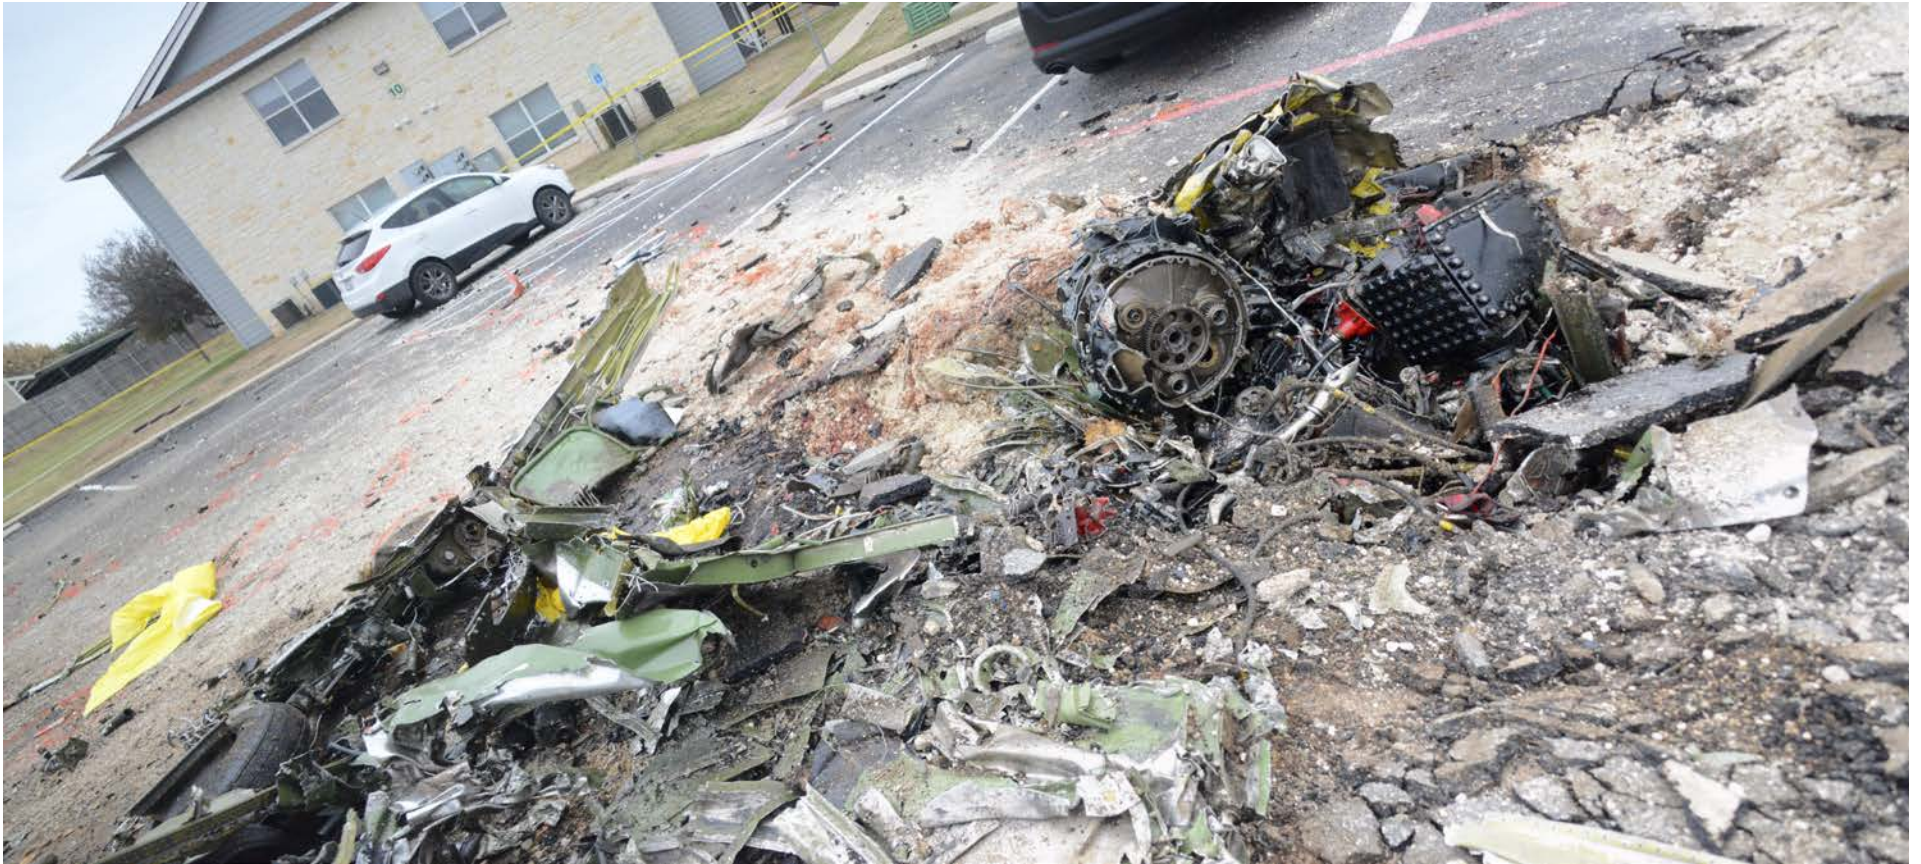
**Photo 6 - View of the engine embedded in terrain and a linear ground scar.**

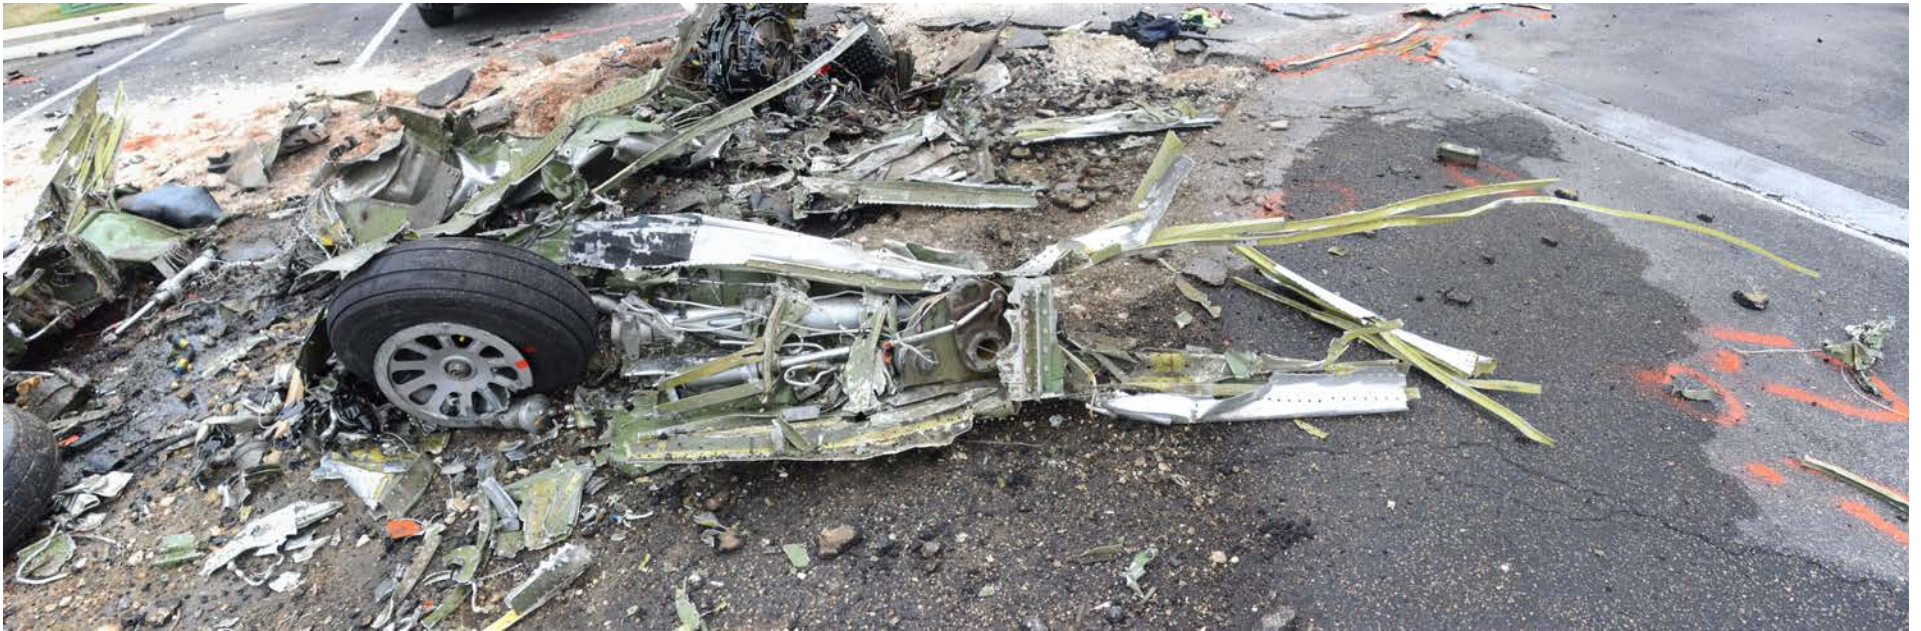
**Photo 7 - View of a separated main landing gear.**

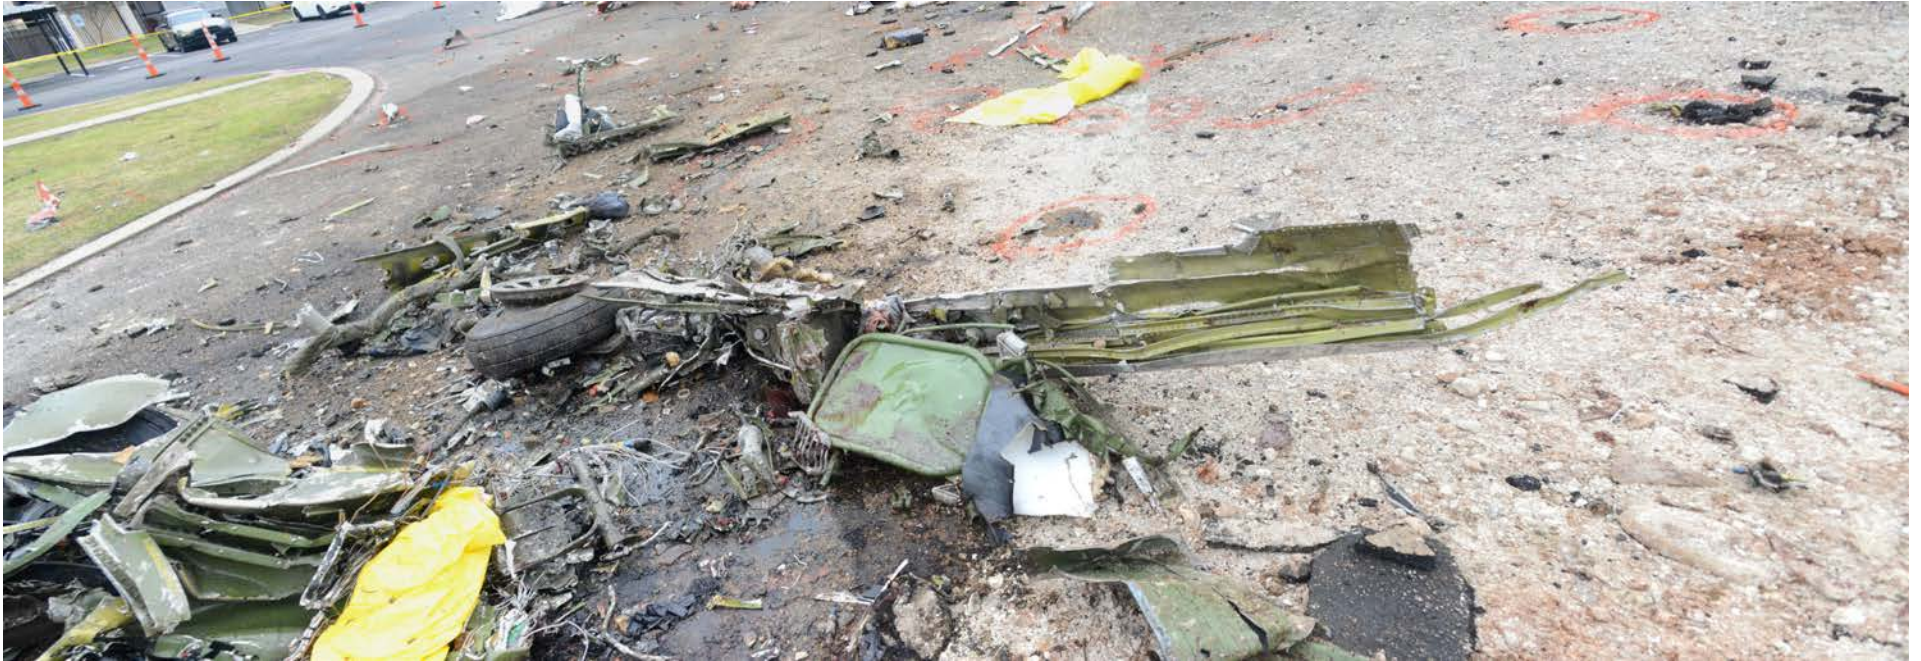
**Photo 8 - View of a separated main landing gear.**

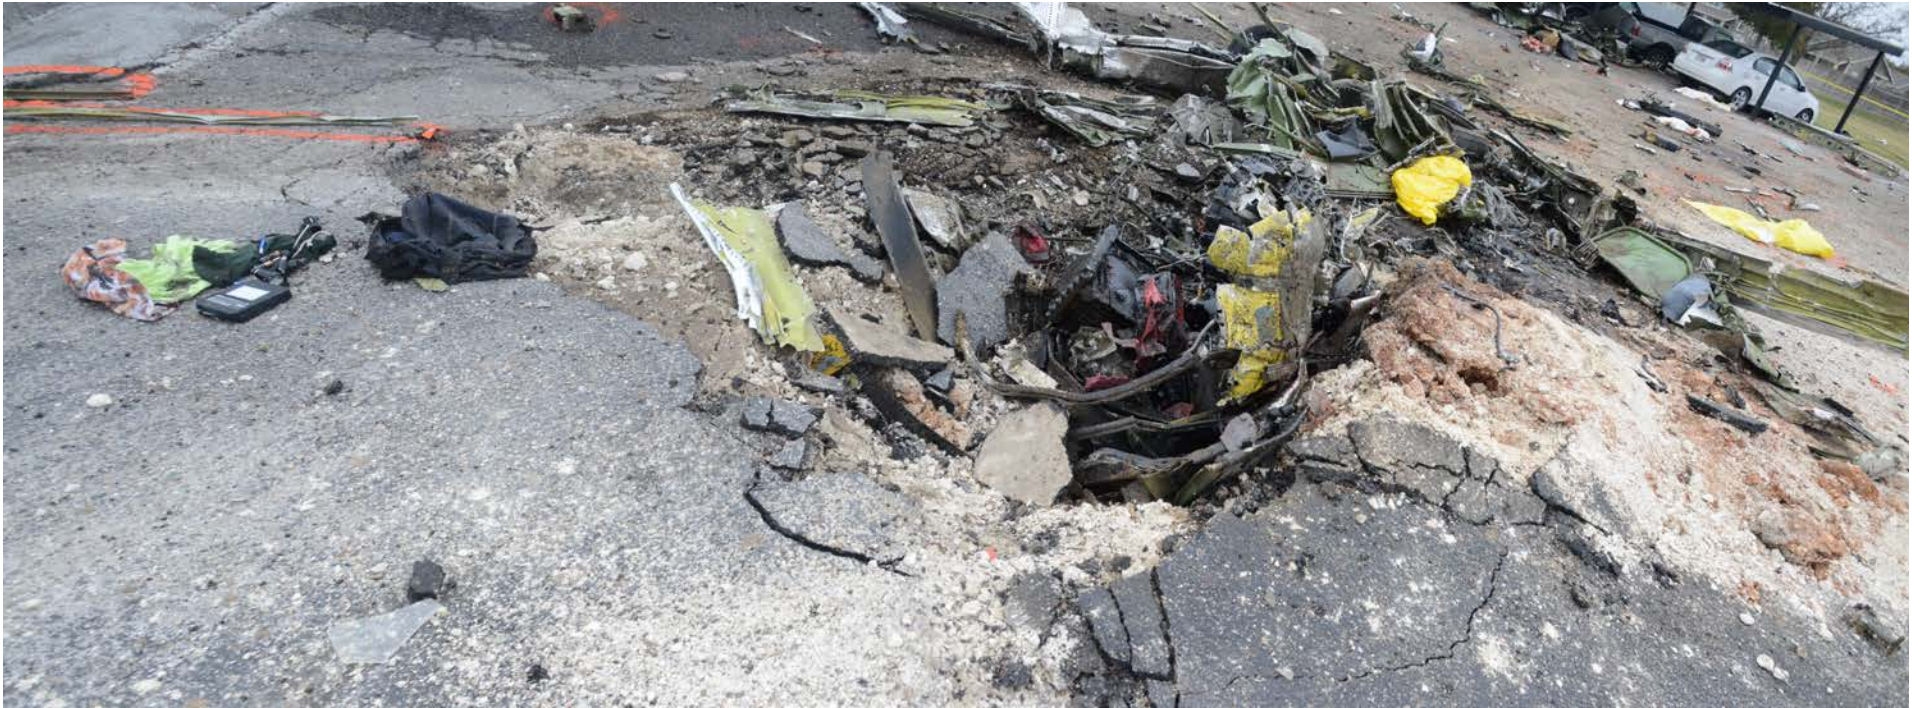
**Photo 9 - Close up view of the embedded engine.**

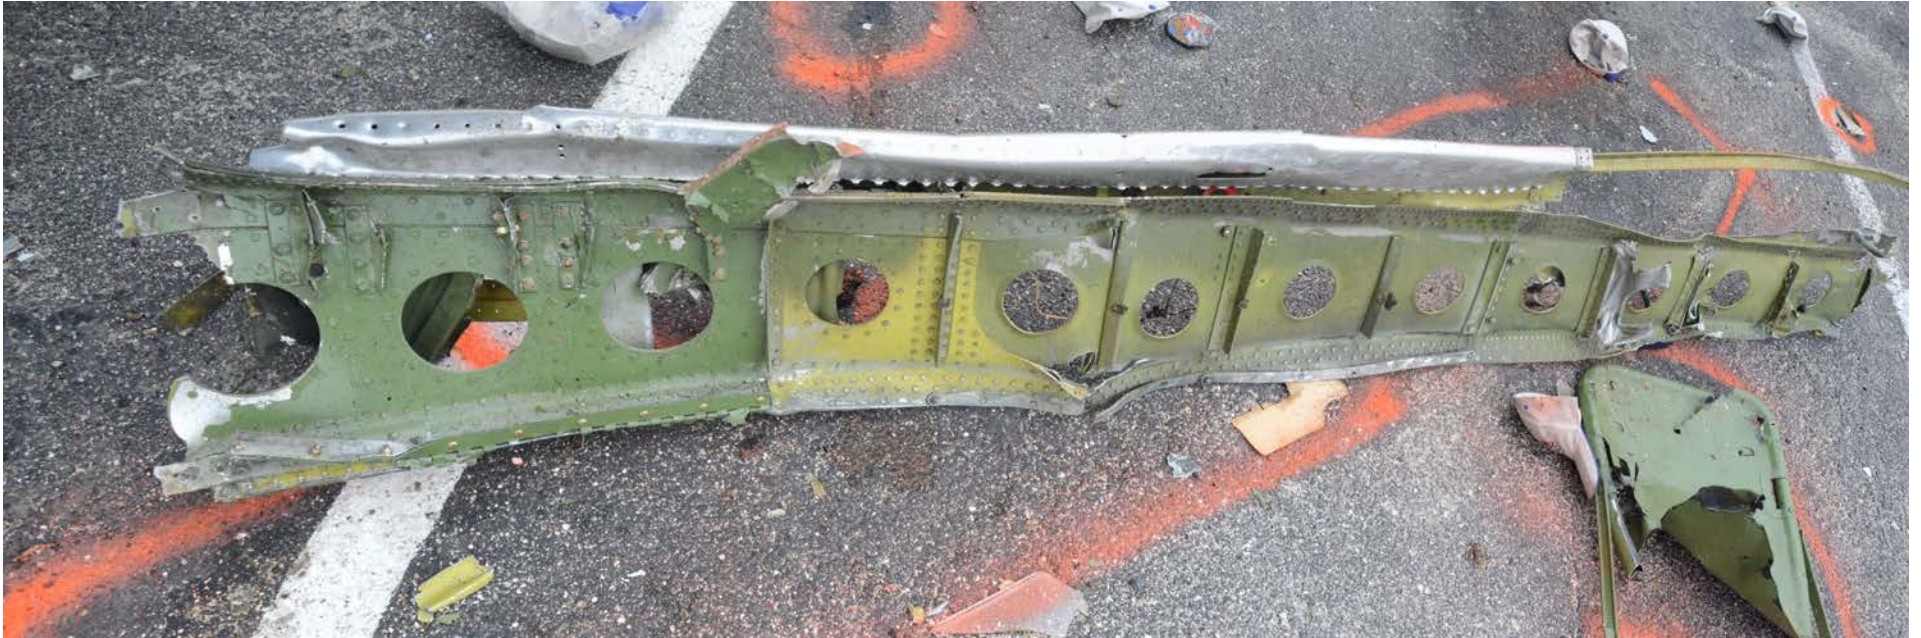
**Photo 10 - View of a separated section of a wing spar.**

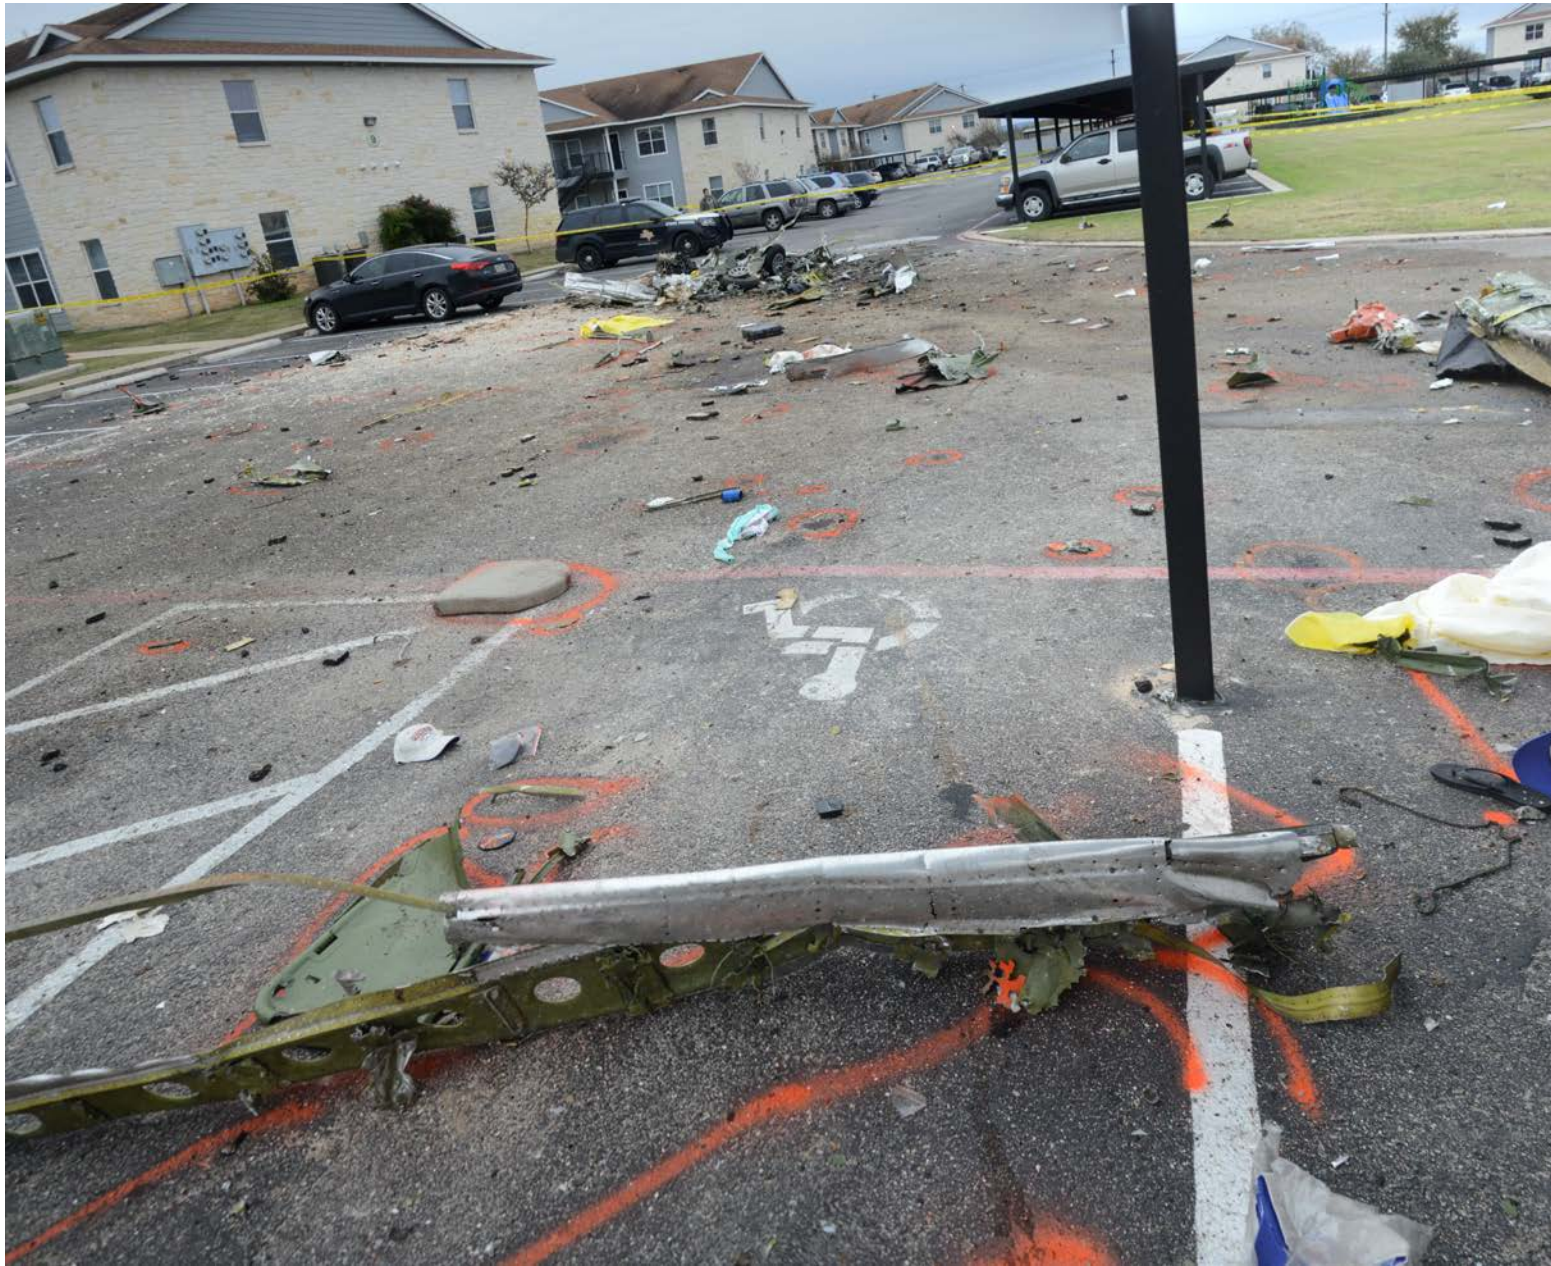
**Photo 11 - View of a separated section of a wing spar with the embedded engine in the background.**

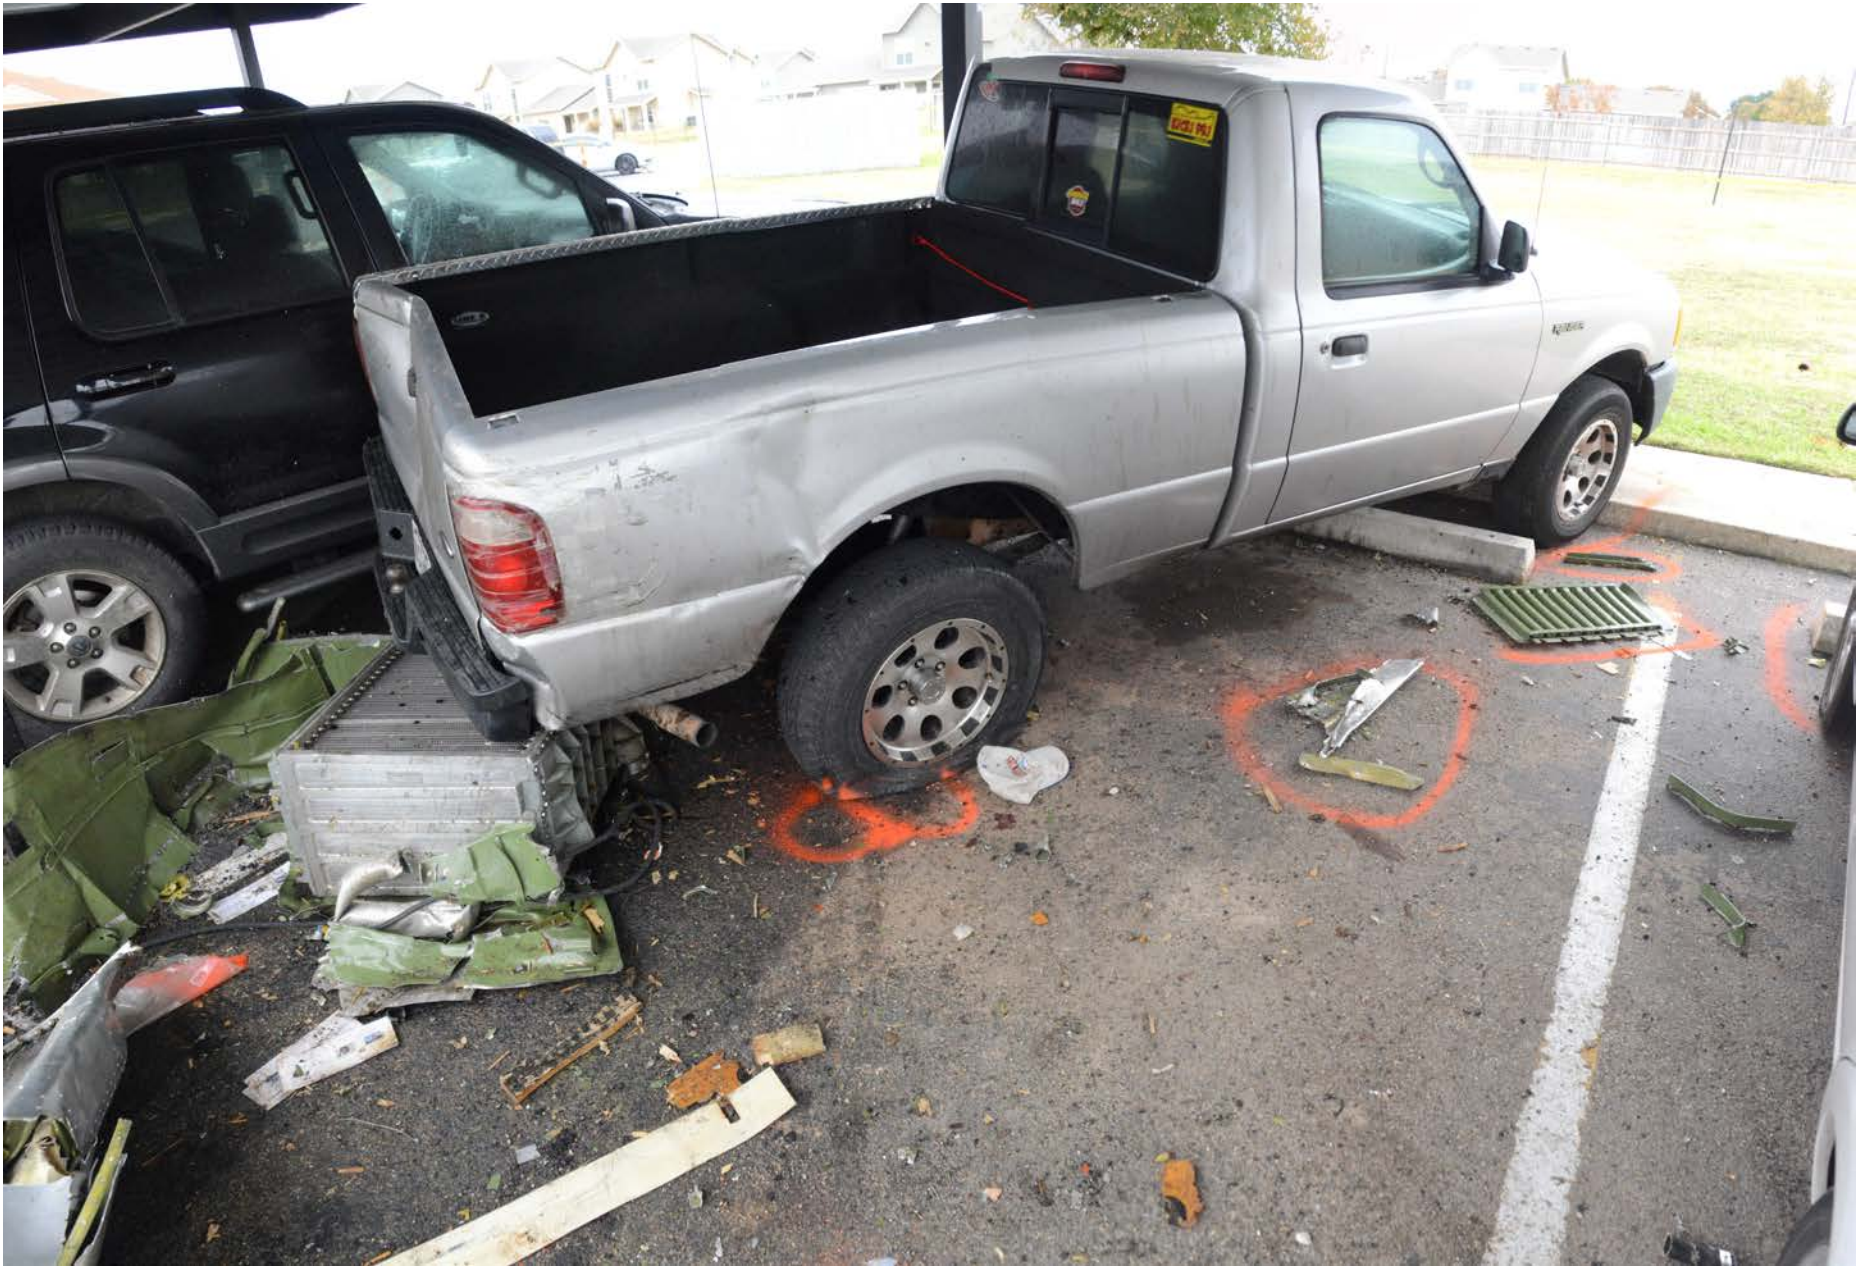
**Photo 12 - View of impacted ground vehicles.**

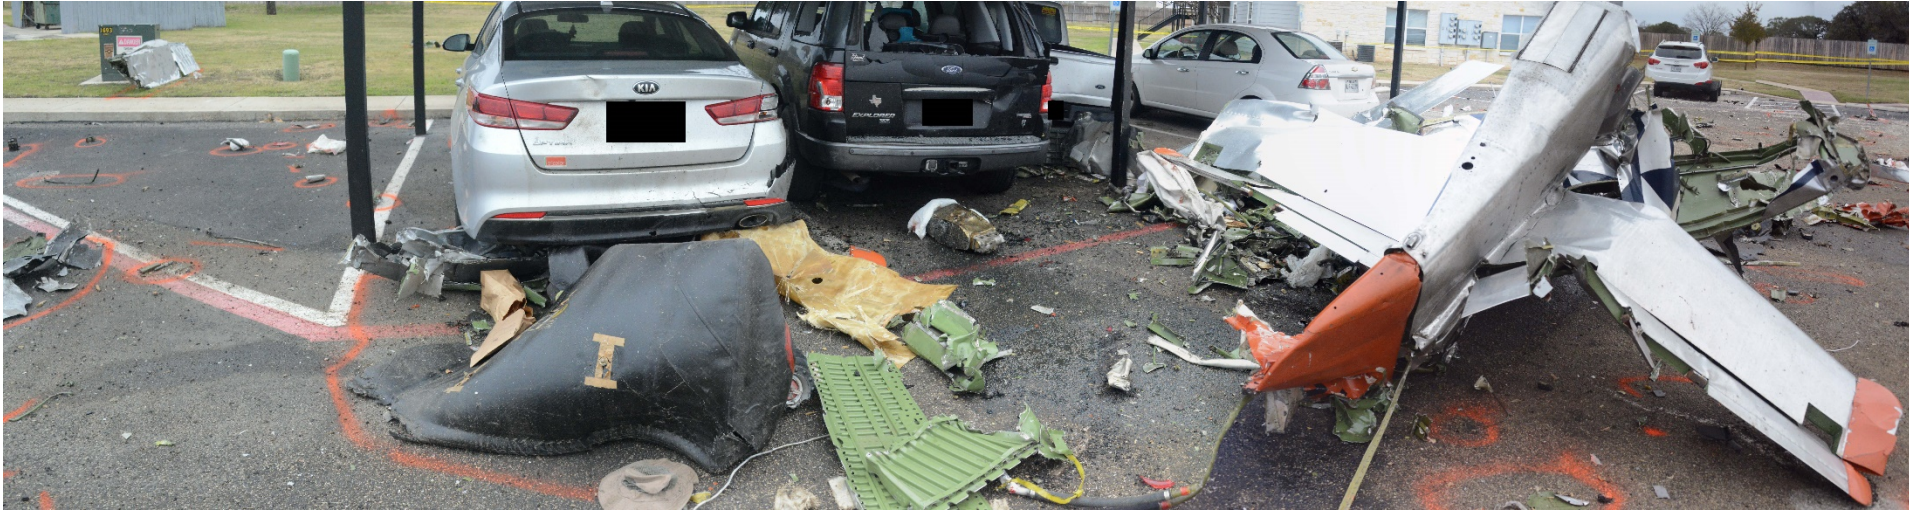
**Photo 13 - View of the separated empennage near impacted ground vehicles.**

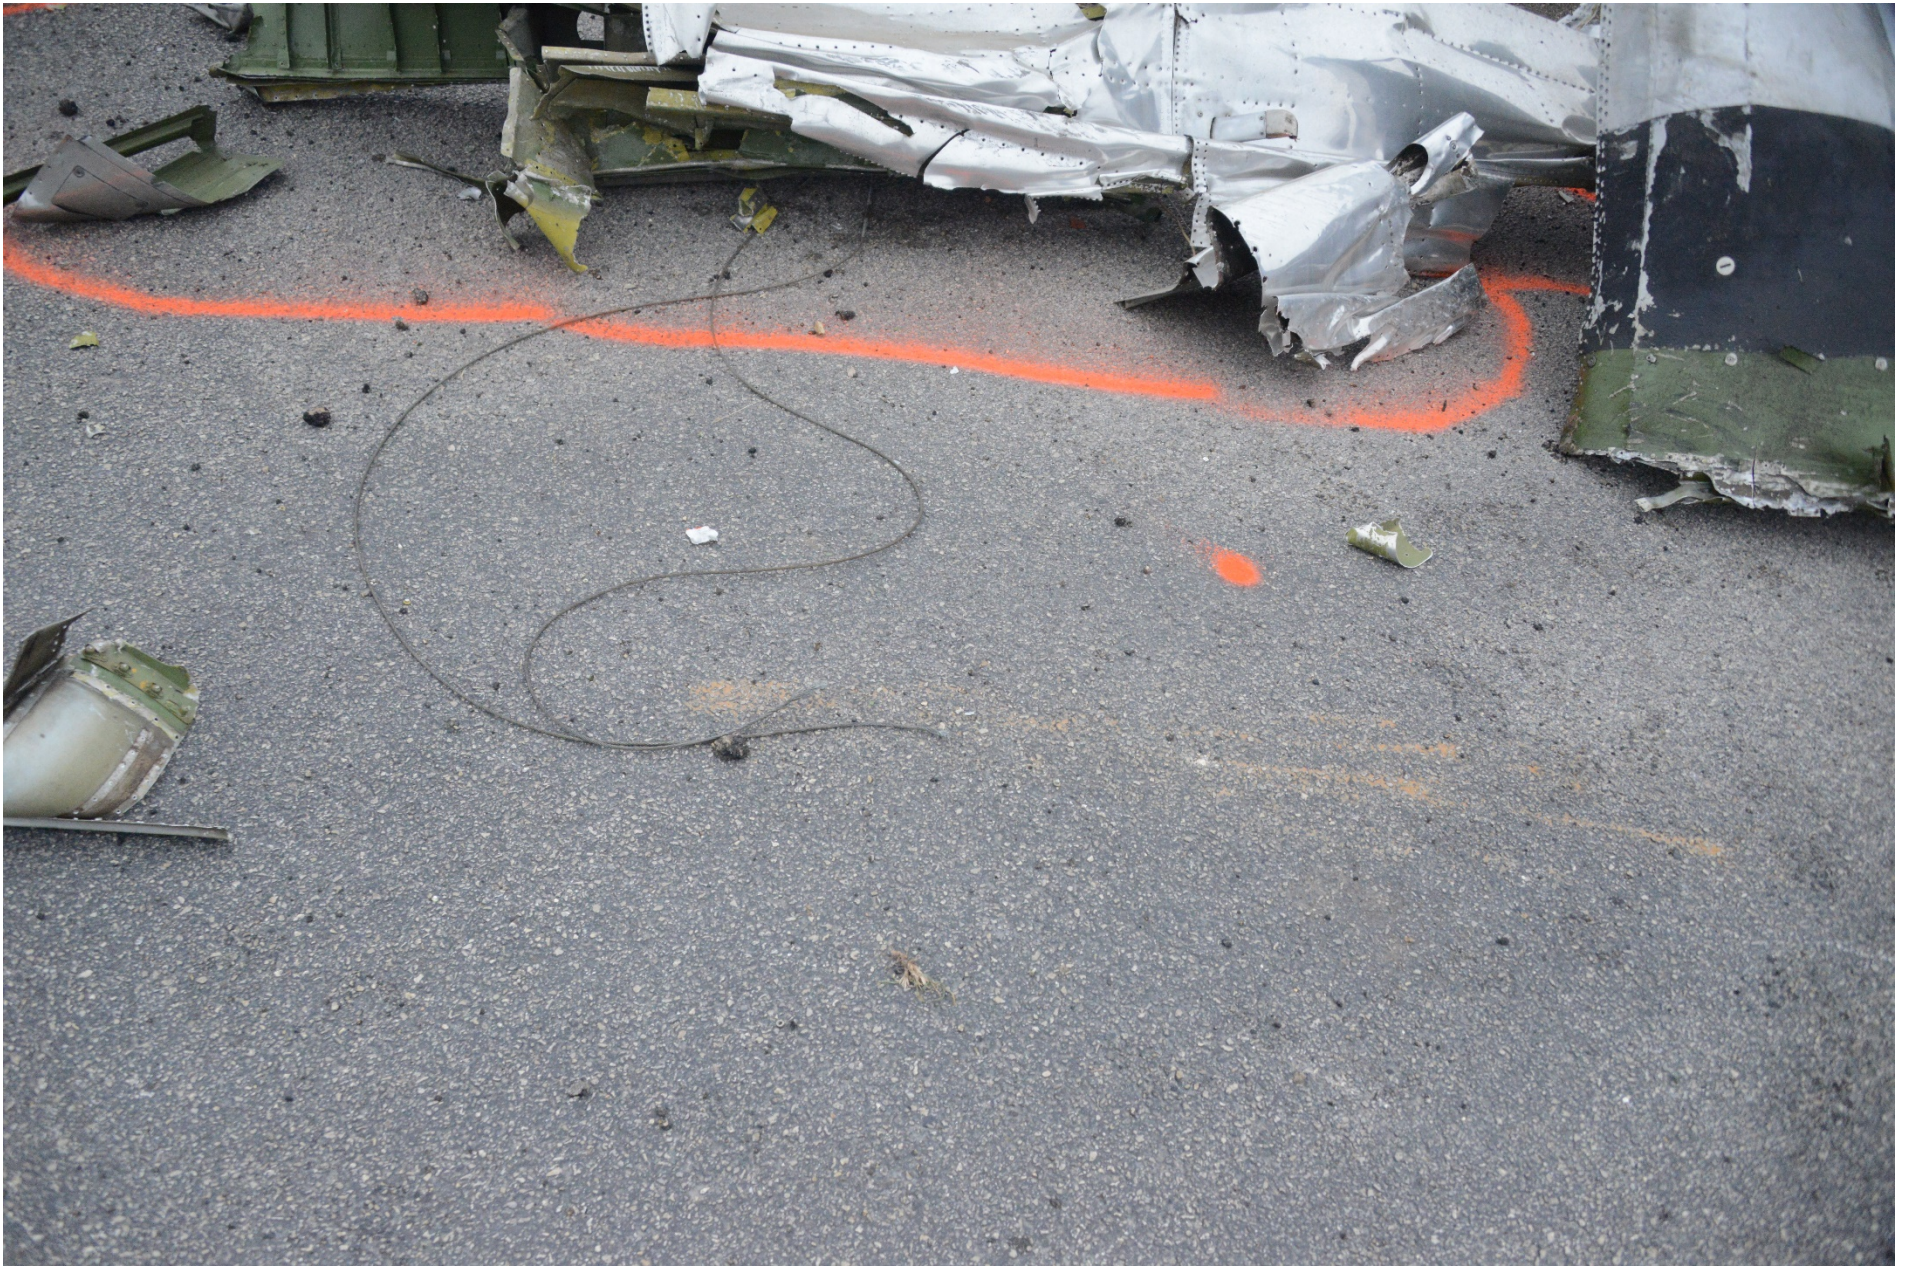
**Photo 14 - View of the separated flight control cables.**
