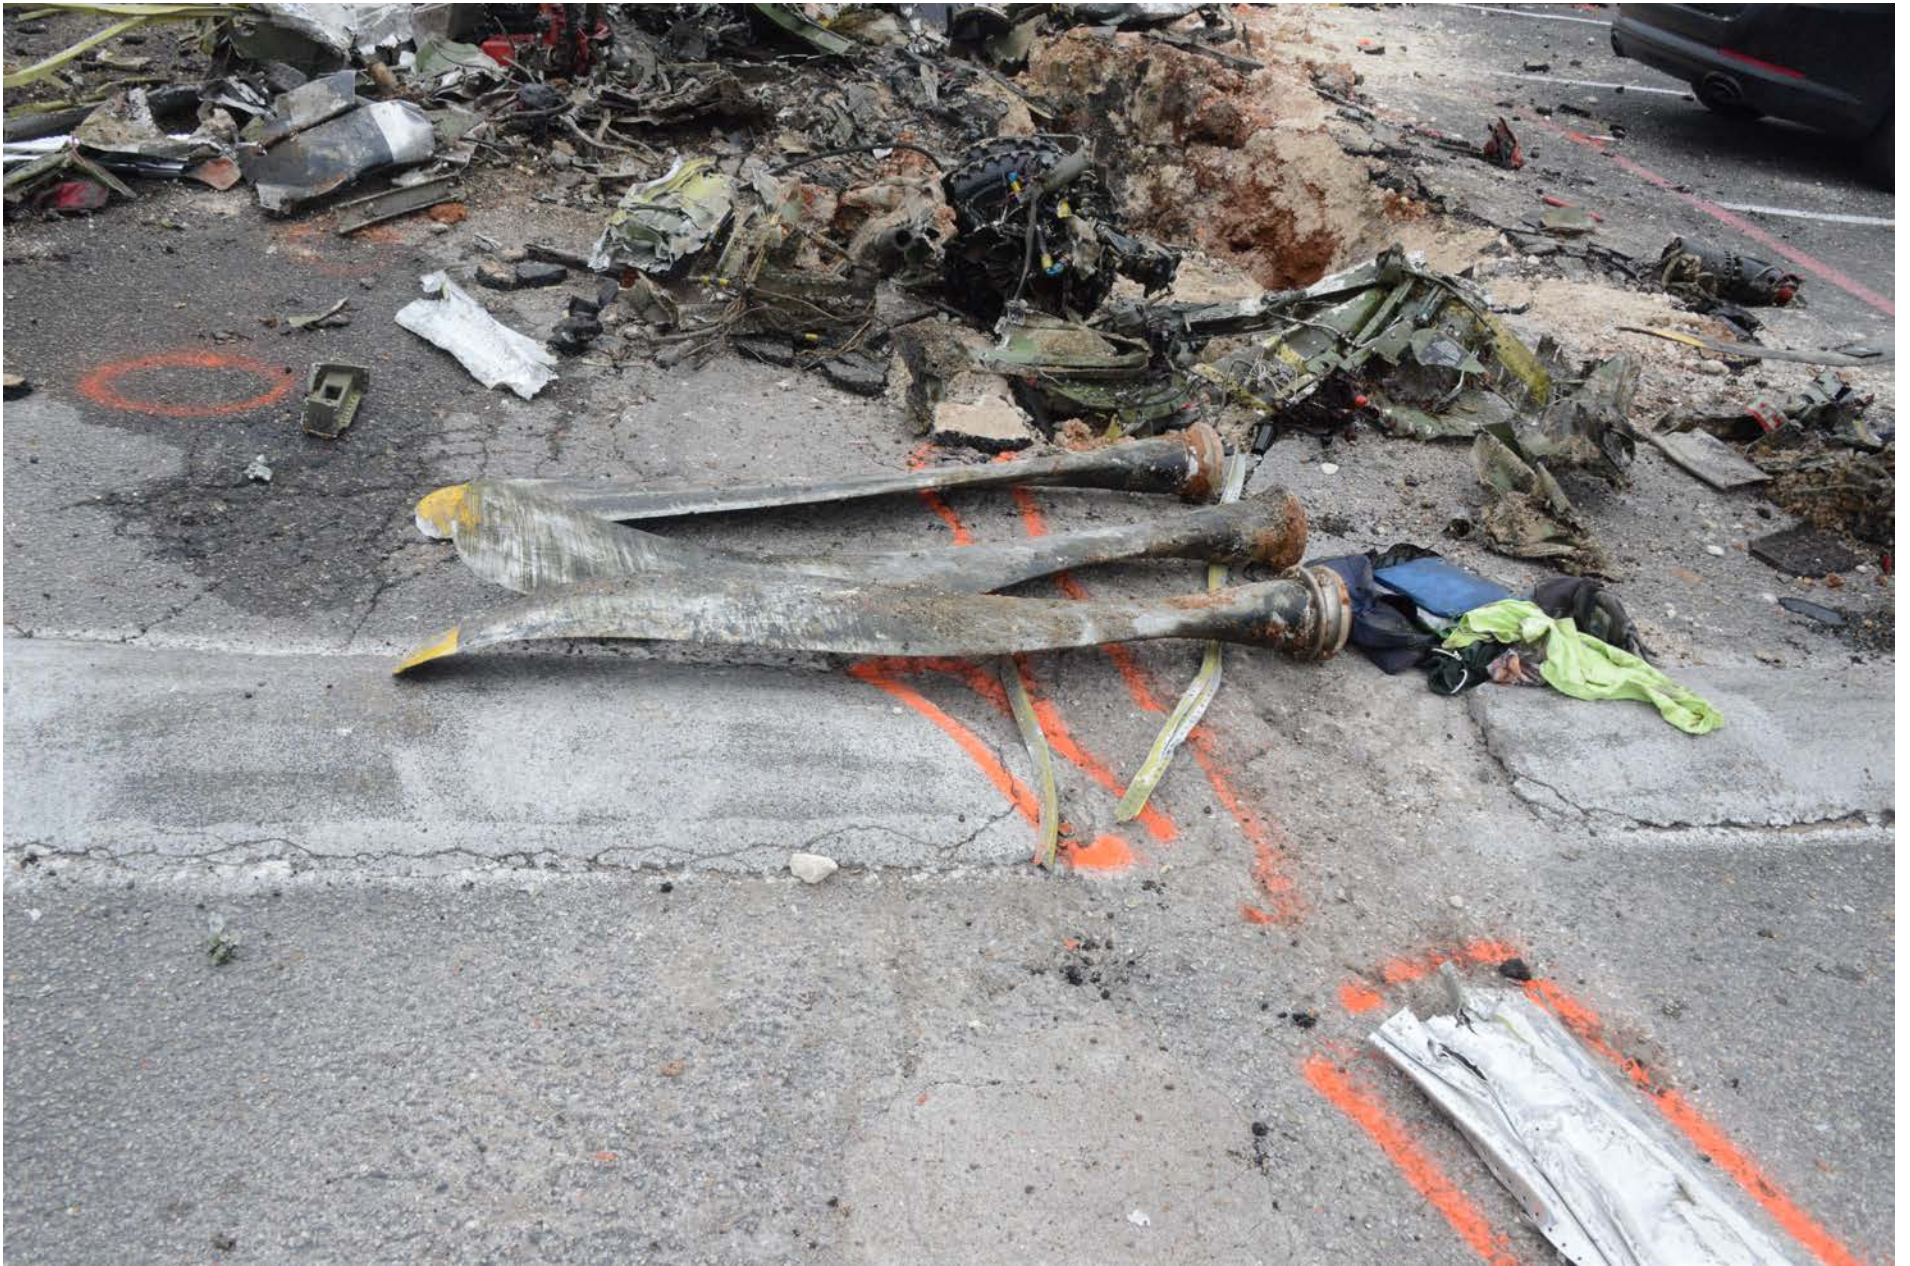
**Photo 15 - View of the recovered, separated propeller blades.**

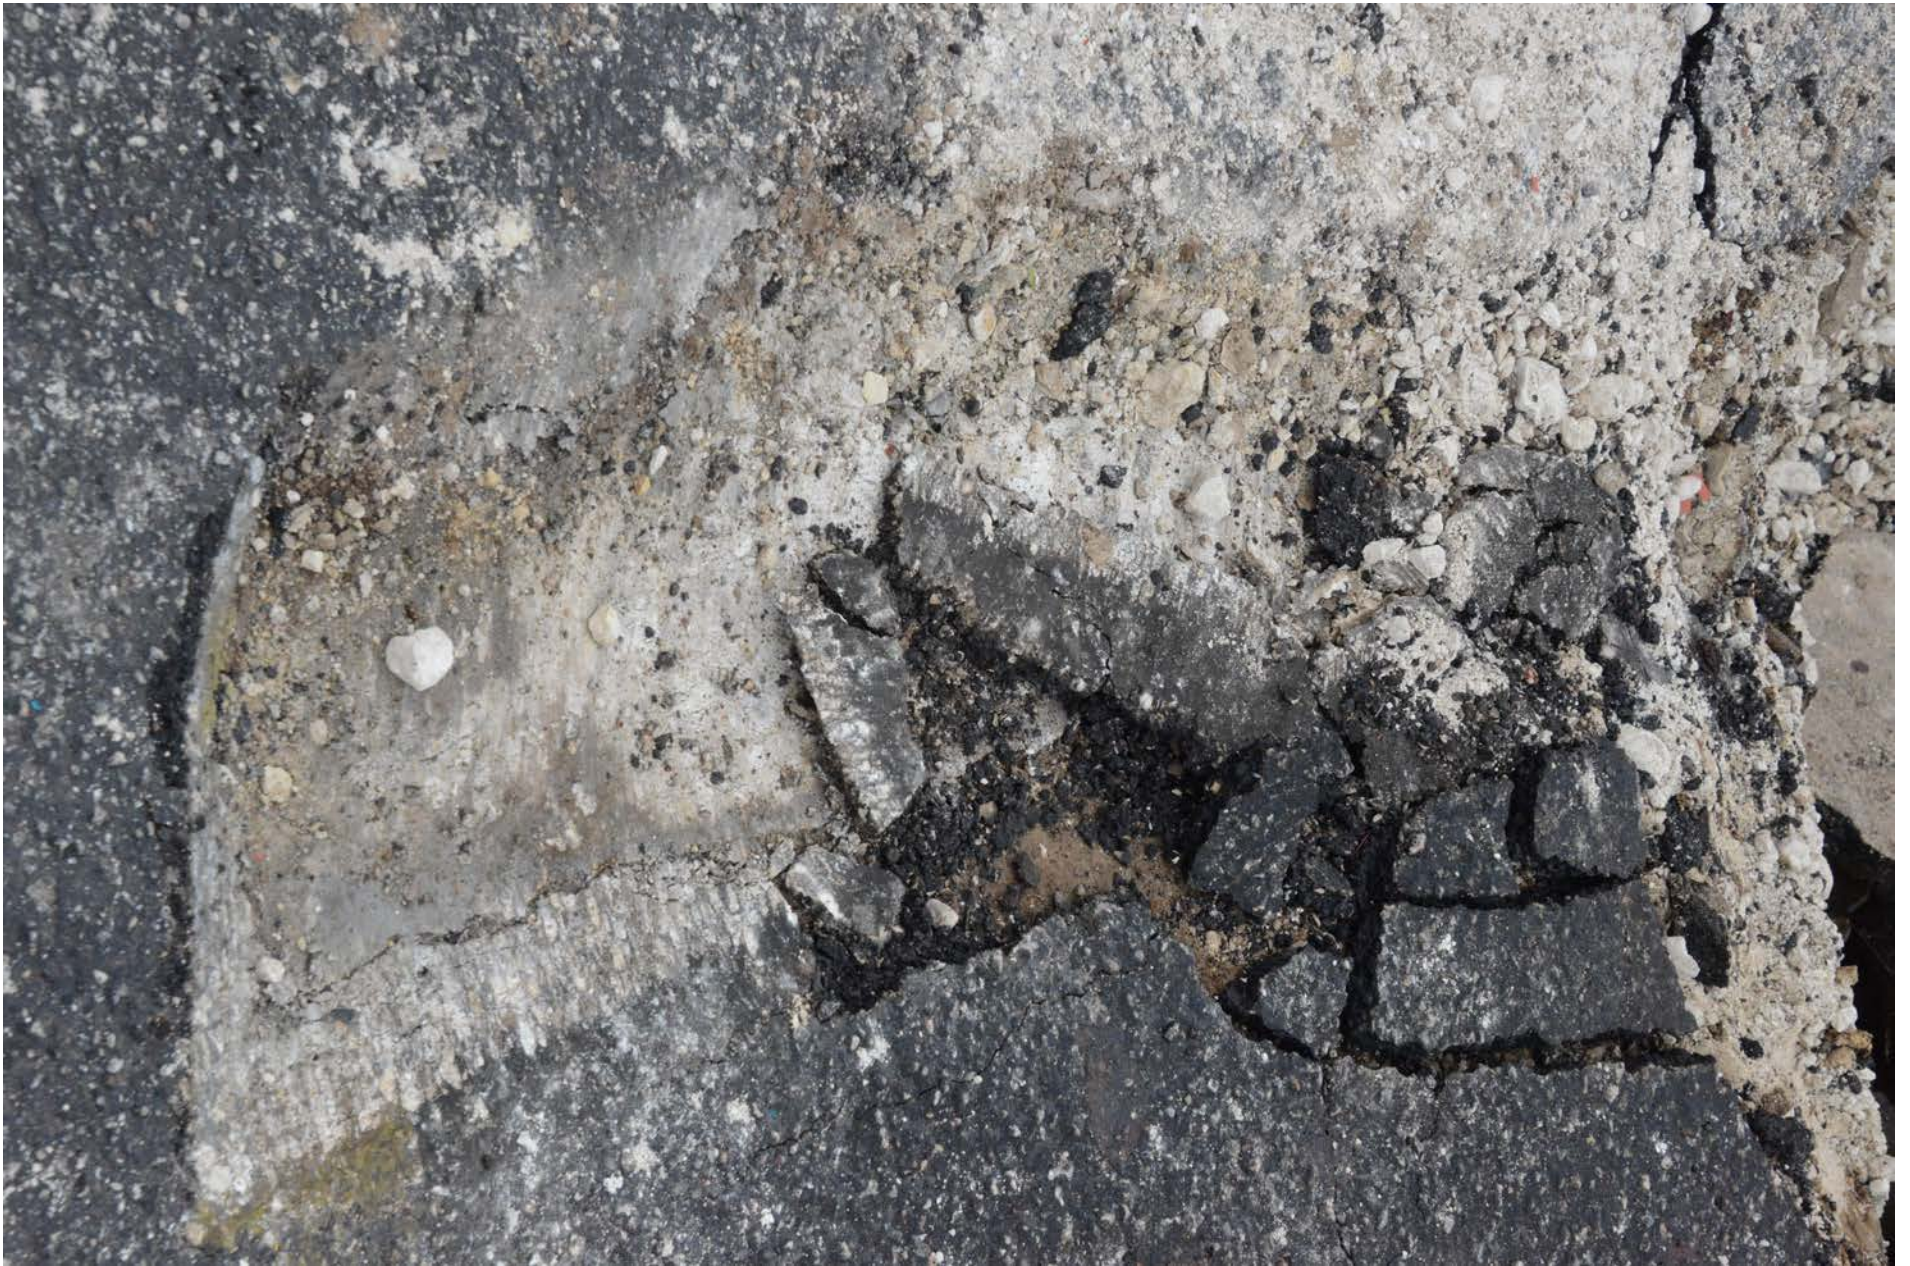
**Photo 16 - View of a ground scar near the location of a propeller blade.**

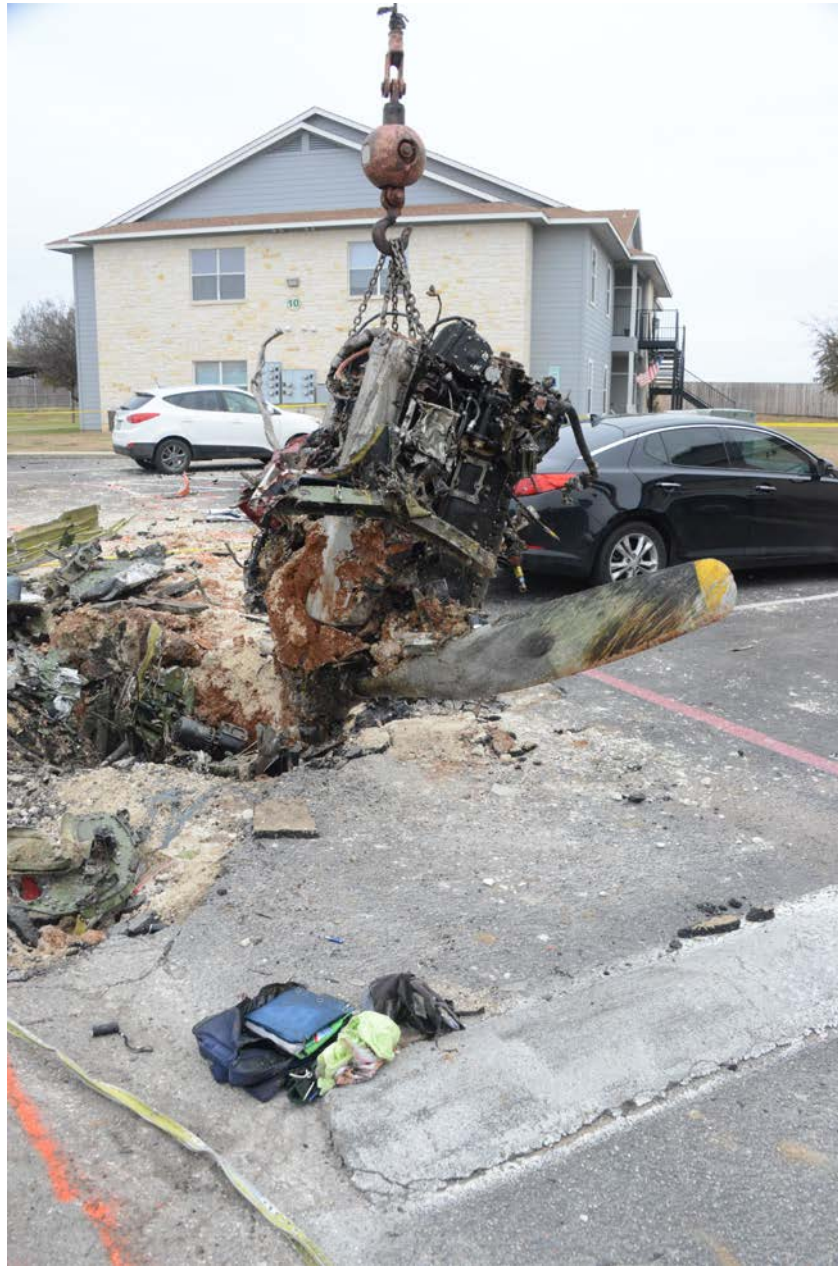
**Photo 17 - View of the recovered engine and an attached propeller blade.**

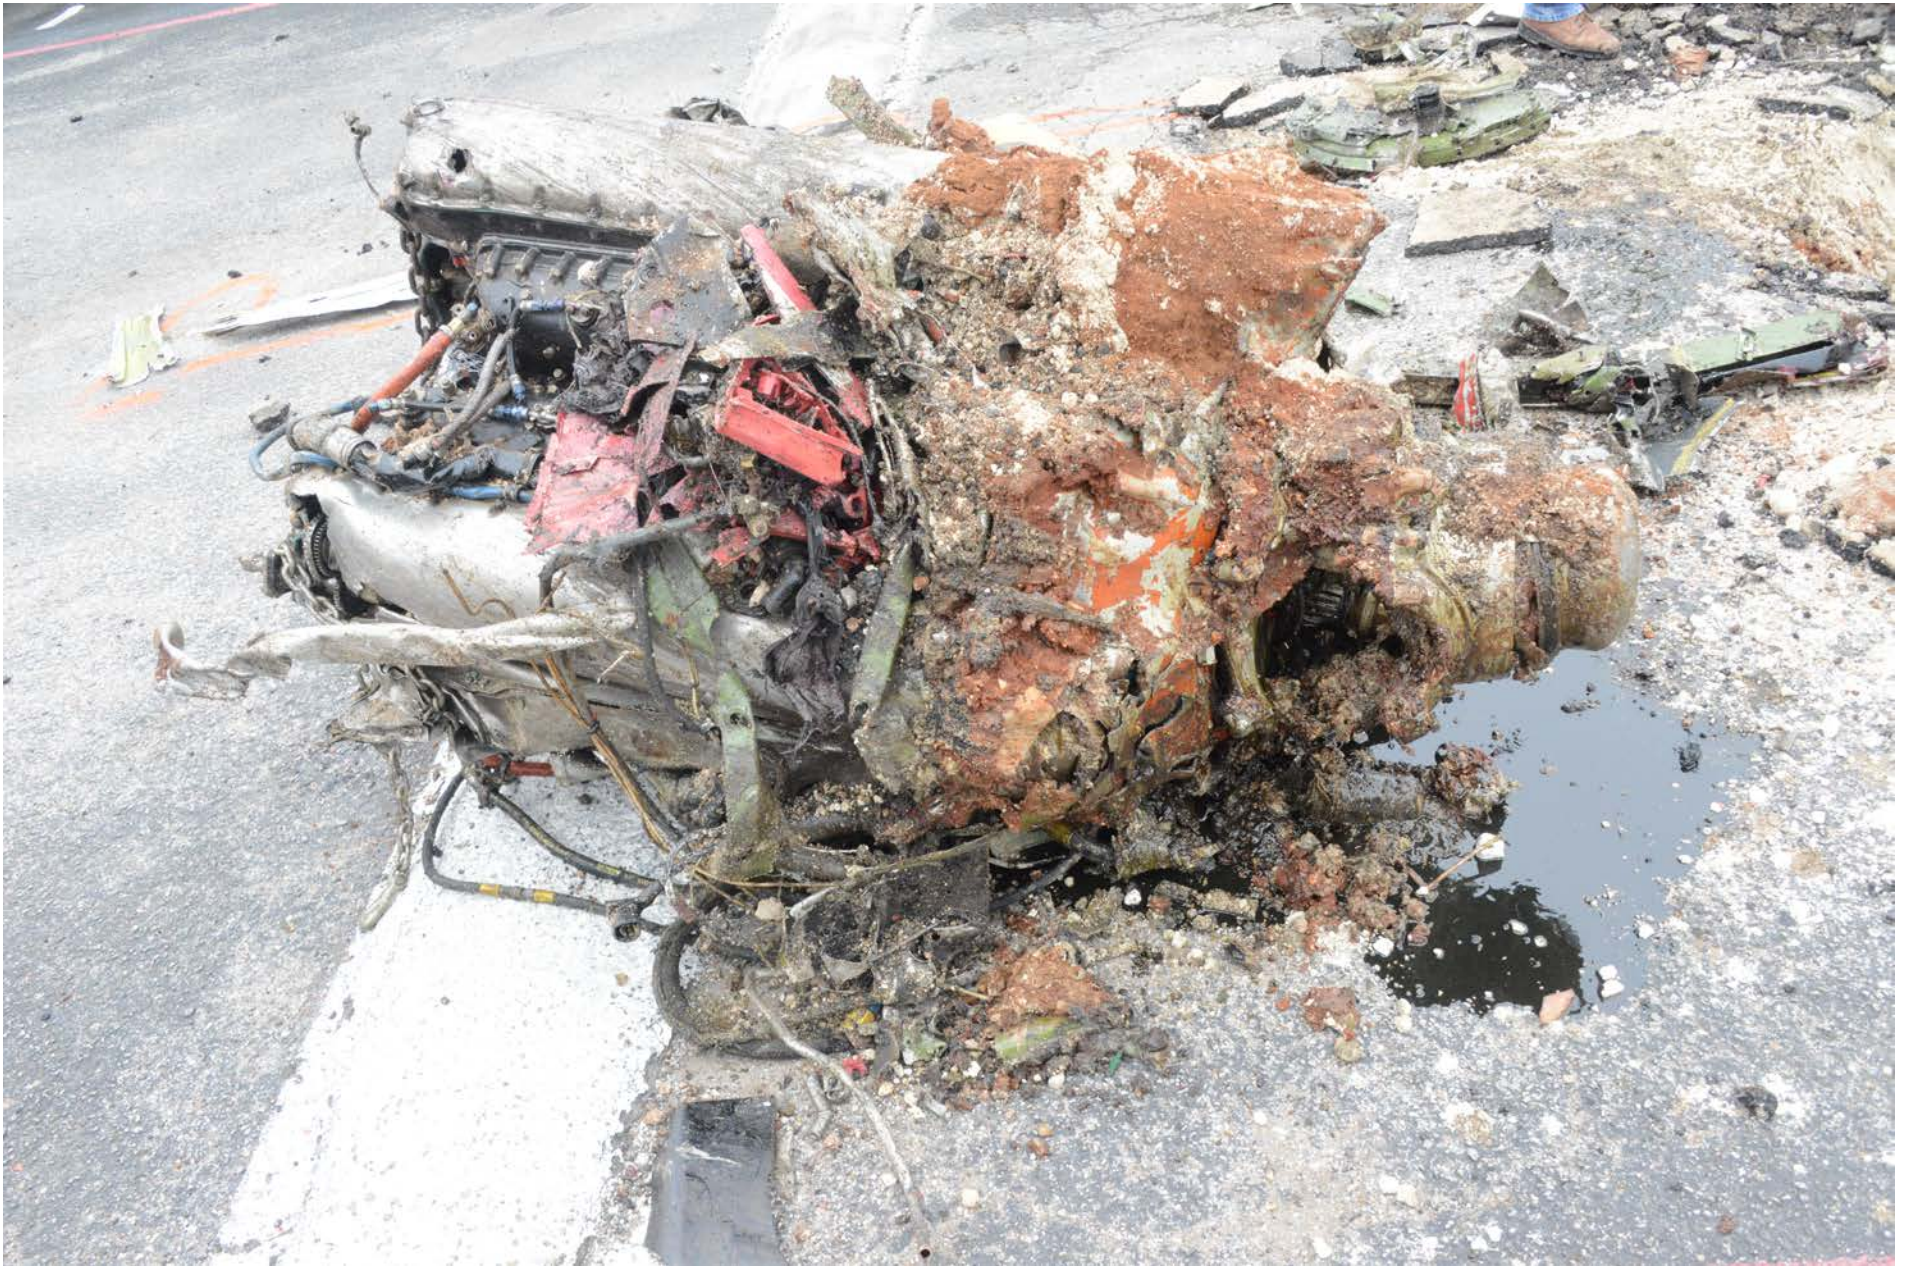
**Photo 18 - Side view of the recovered engine.**

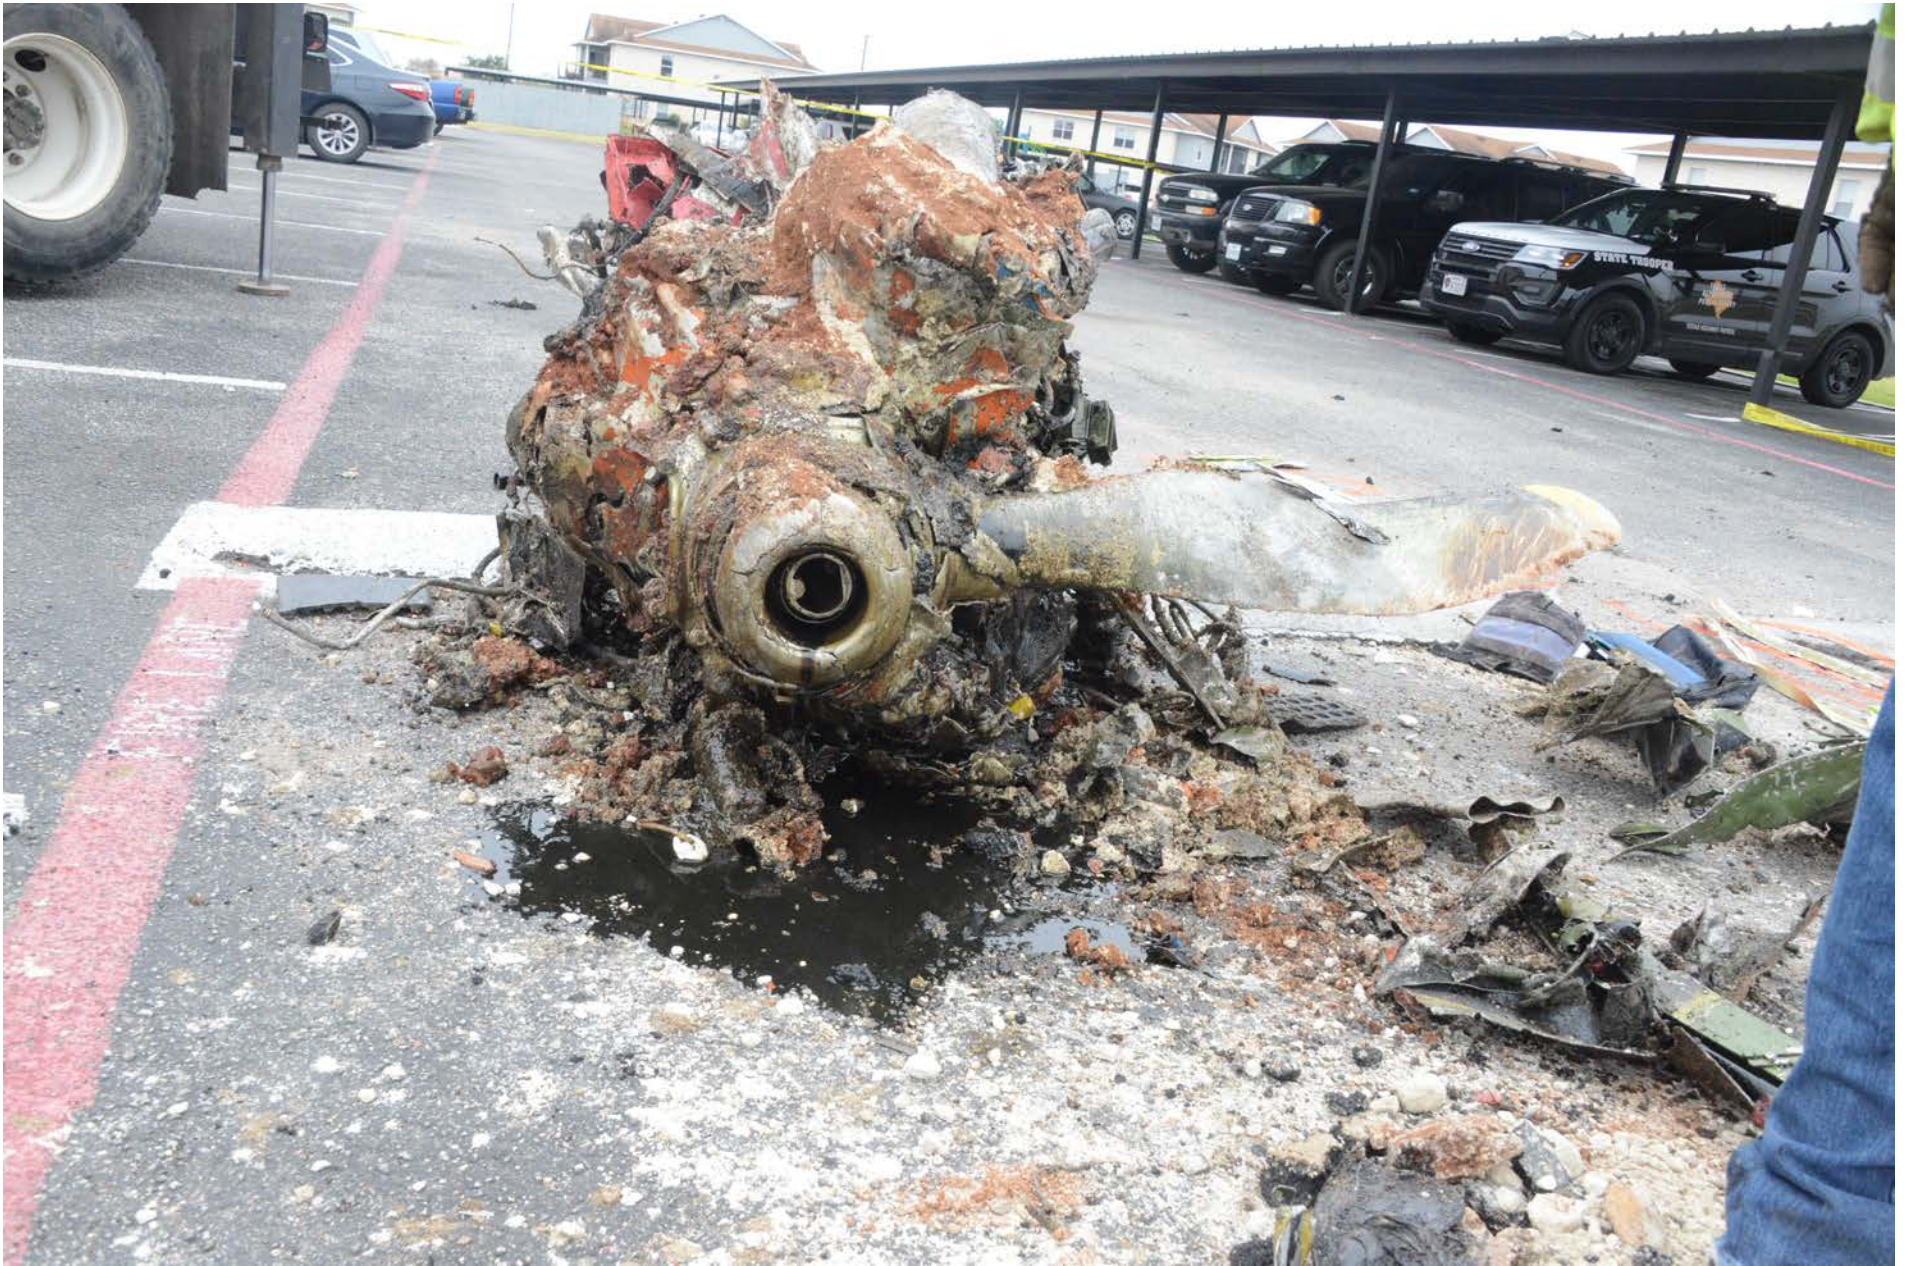
**Photo 19 - Front view of the recovered engine and an attached propeller blade.**

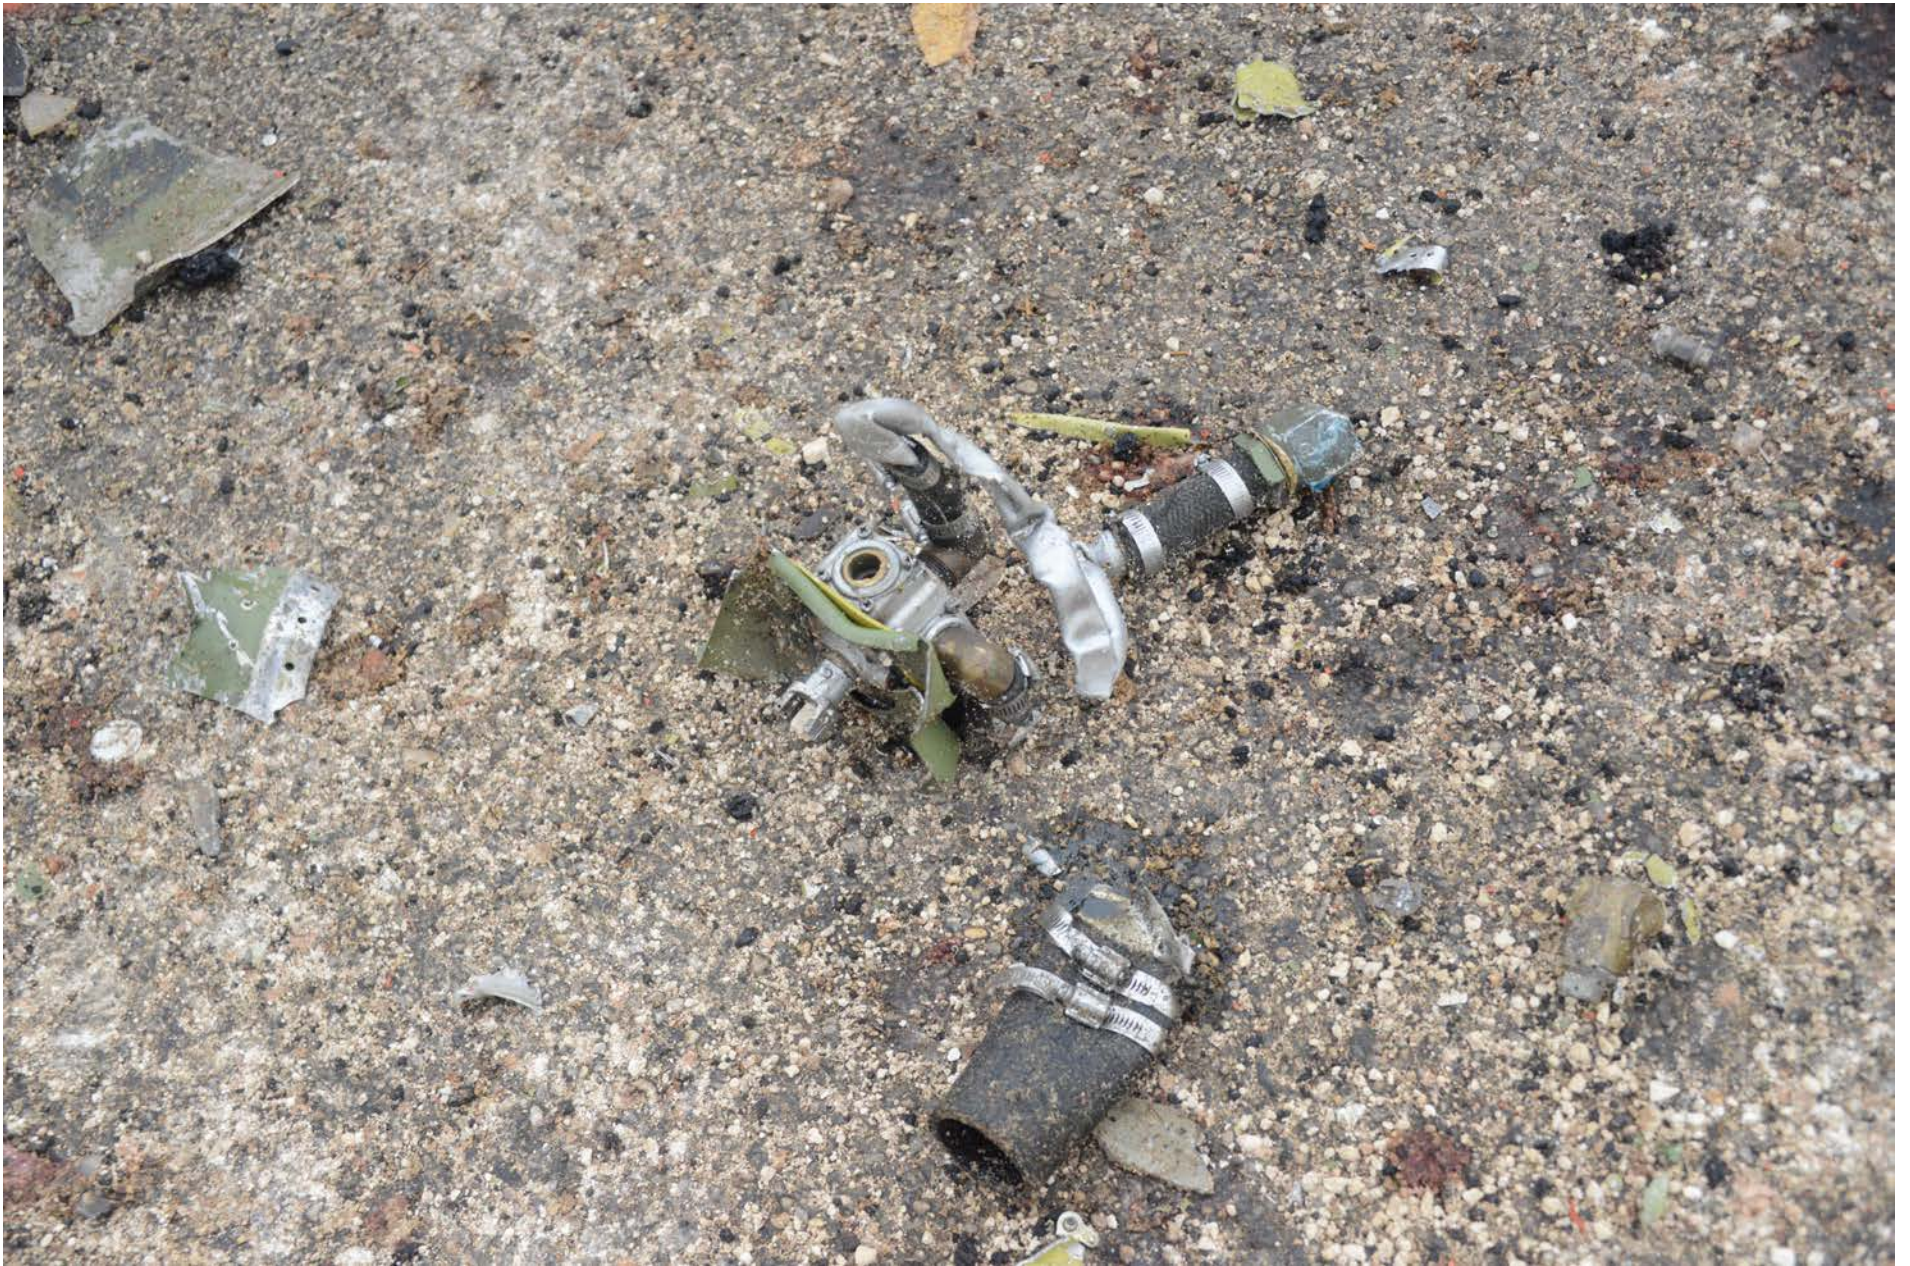
**Photo 20 - View of the separated fuel selector valve.**
