**NATIONAL TRANSPORTATION SAFETY BOARD**

**UAS Aerial Imagery Factual Report**

**A. ACCIDENT CEN19FA030**

Location: Harmon, ND  
Date: November 18, 2018  
Time: 1040 Local Time (CST)  
Event: Inflight breakup, N441CX, C441

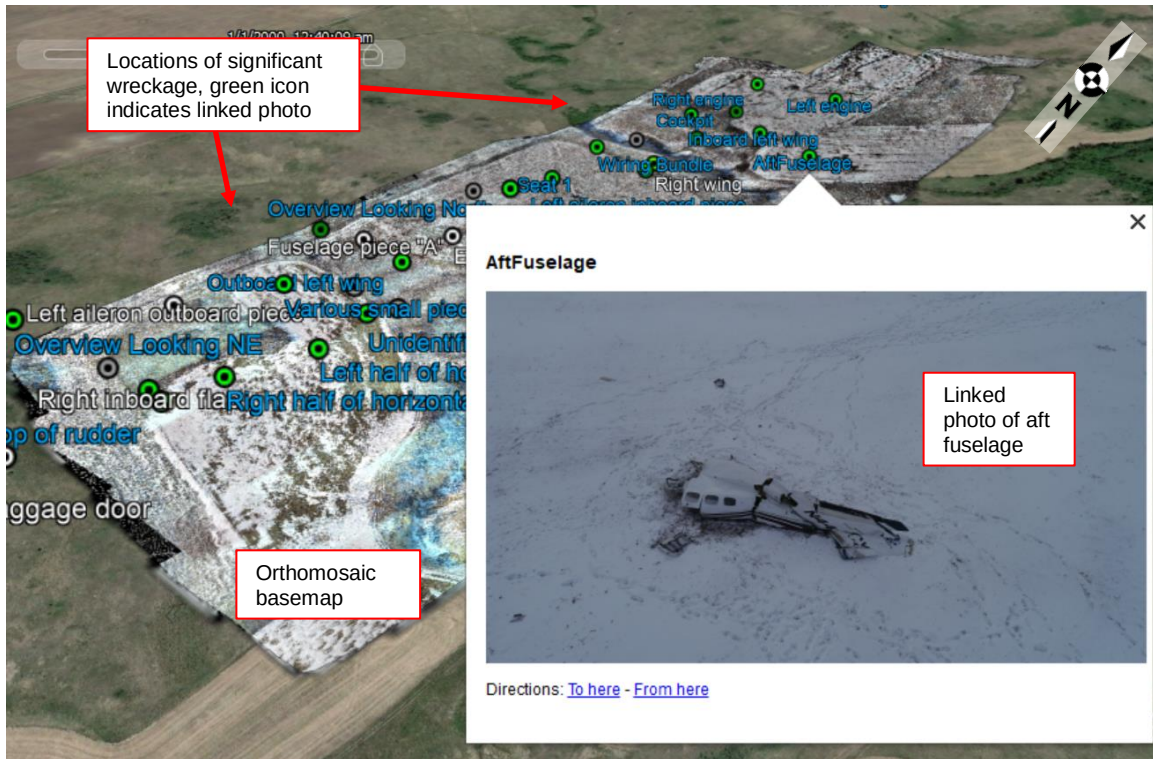
Figure 1 – Overview of Google Earth orthomosaic with sample linked photo

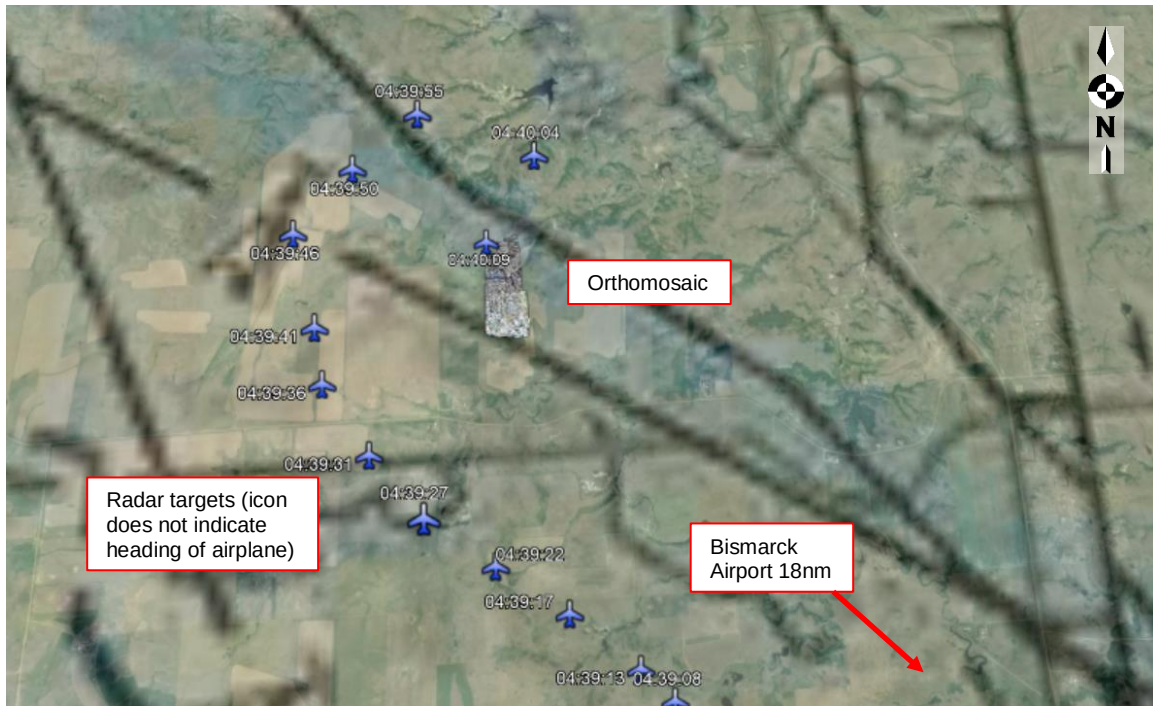
Figure 2 – Orthomosaic with radar and sectional overlay (sectional is semi-transparent)

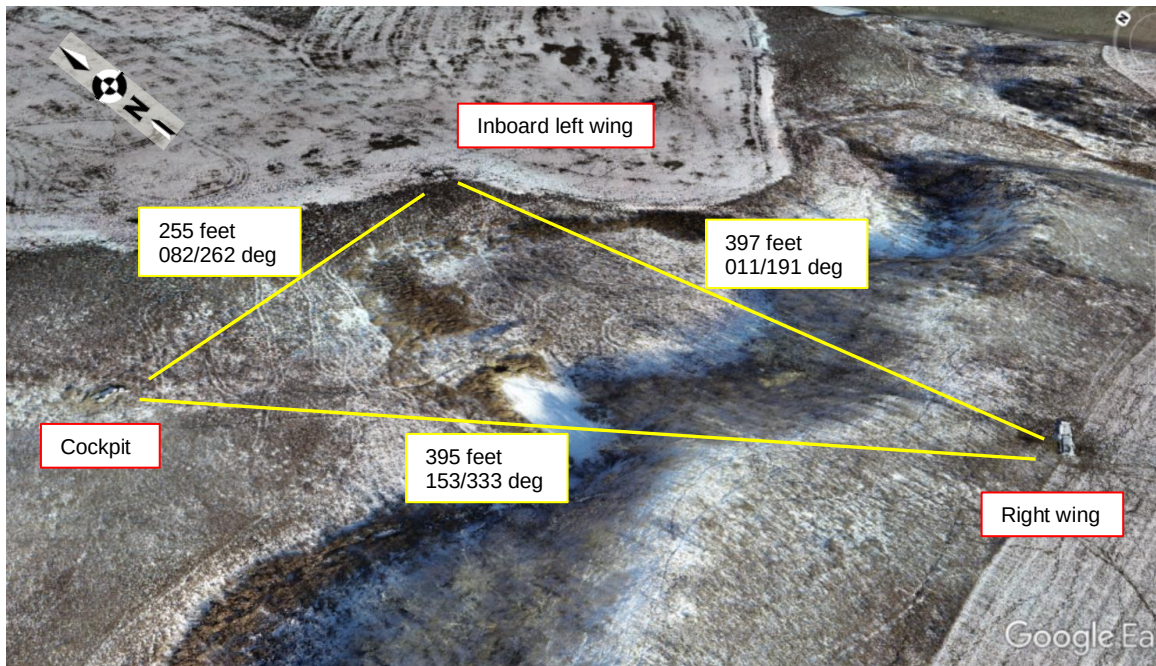
Inboard left wing

Figure 3 – Oblique view of orthomosaic, looking northeast along gully, with select measurements

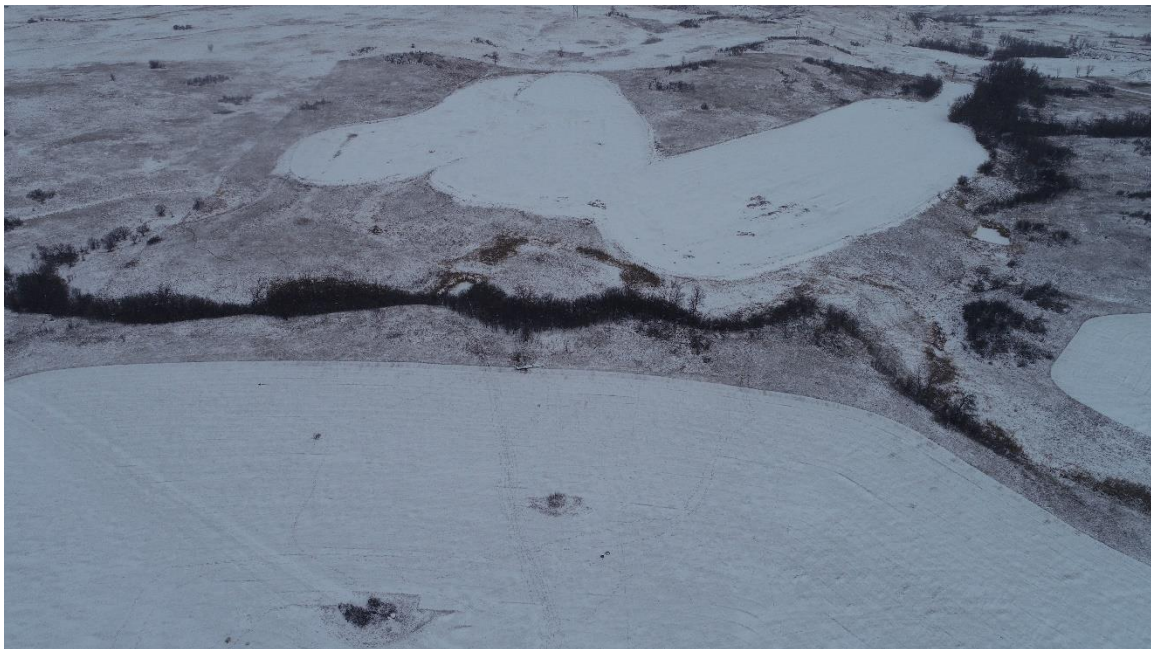
Figure 4 – Aerial overview photo, looking north. Right wing is in center of photo.
