# National Transportation Safety Board

## Performance Study

### Specialist Report

Location: Memphis, Indiana  
Date: November 30, 2018  
Time: 10:28 eastern standard time (EST)  
Airplane: Cessna 525, N525EG  
NTSB Number: CEN19FA036

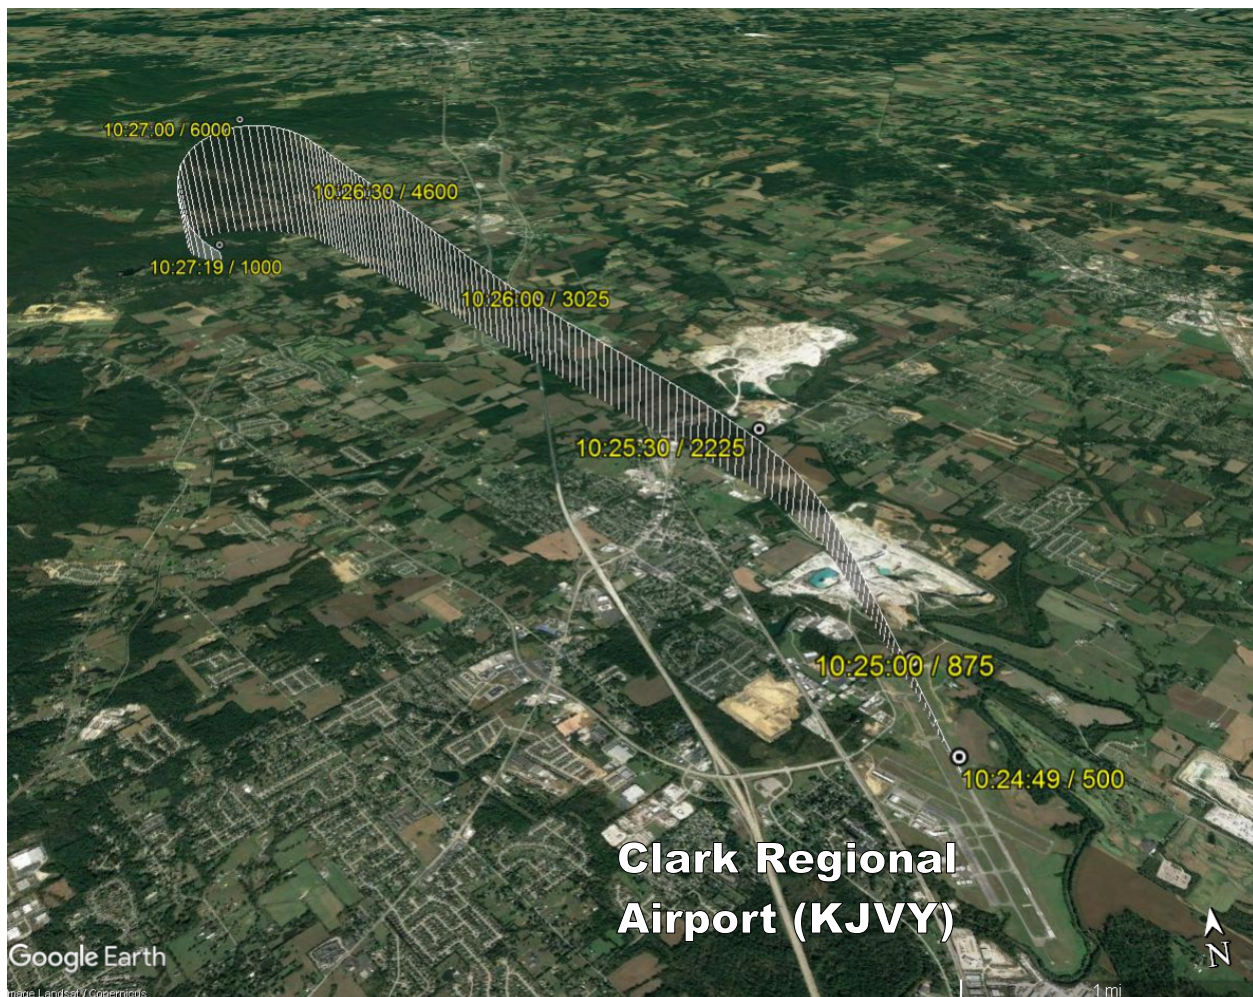
Figure 1 shows the accident flight path. The flight path was approximately 7.5 NM long and the flight lasted about 2 minutes and 30 seconds. Figure 2 shows the altitude profile, calculated groundspeed, airspeed, roll, and roll rate of the flight. The airplane took off from runway 36 (elevation 476 ft) and climbed to about 1,400 ft MSL<sup>1</sup> before turning left onto a track of 330° and continuing to climb. The airplane likely entered the clouds between about 1,000 and 1,500 ft MSL, per the cloud ceiling information in the Weather Observations section. The airplane's autopilot was turned on at approximately 10:25:26. Selected altitude, initially set to 3,000 ft, was changed to 10,000 ft at 10:25:50, consistent with ATC instructions [3]. Once passing 3,000 ft at 10:26, the airplane's airspeed leveled out between 230 and 240 kts and the airplane continued to climb steadily.

**Figure 1.** Accident flight with select times and altitudes annotated in yellow.

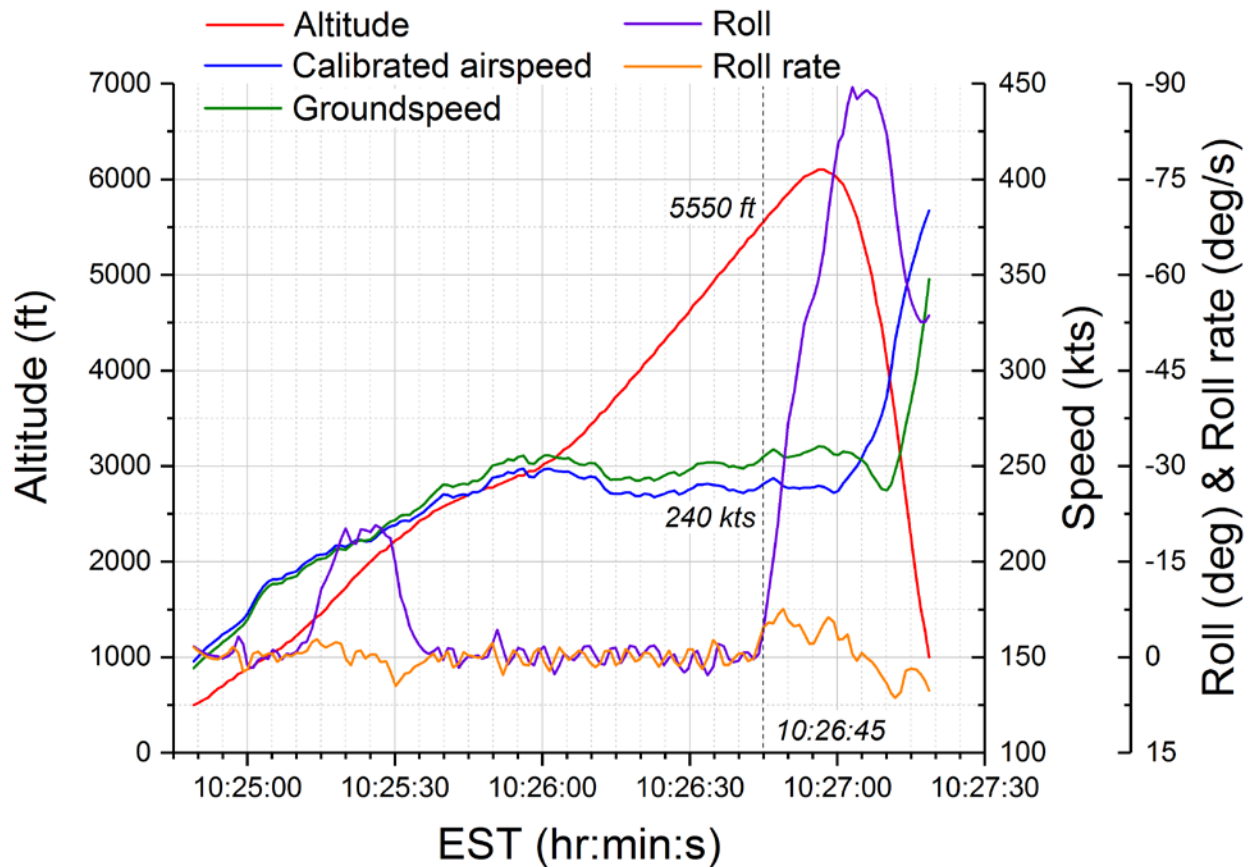
**Figure 2.** Accident flight altitude, calculated ground and airspeeds, and roll and roll rate.

Then, at 10:26:45 the airplane began to bank to the left at a rate of about  $5^\circ/\text{s}$  so that by 10:27:05 the airplane was near  $90^\circ$  left wing down. After the onset of the roll, the airplane maintained airspeed while continuing to climb for 12 seconds, indicating that engine power was not reduced in response to the roll onset. At 10:26:57, the airplane reached its maximum altitude of 6,100 ft and began to descend rapidly, reaching a final recorded altitude of 1,000 ft by 10:27:18.7.

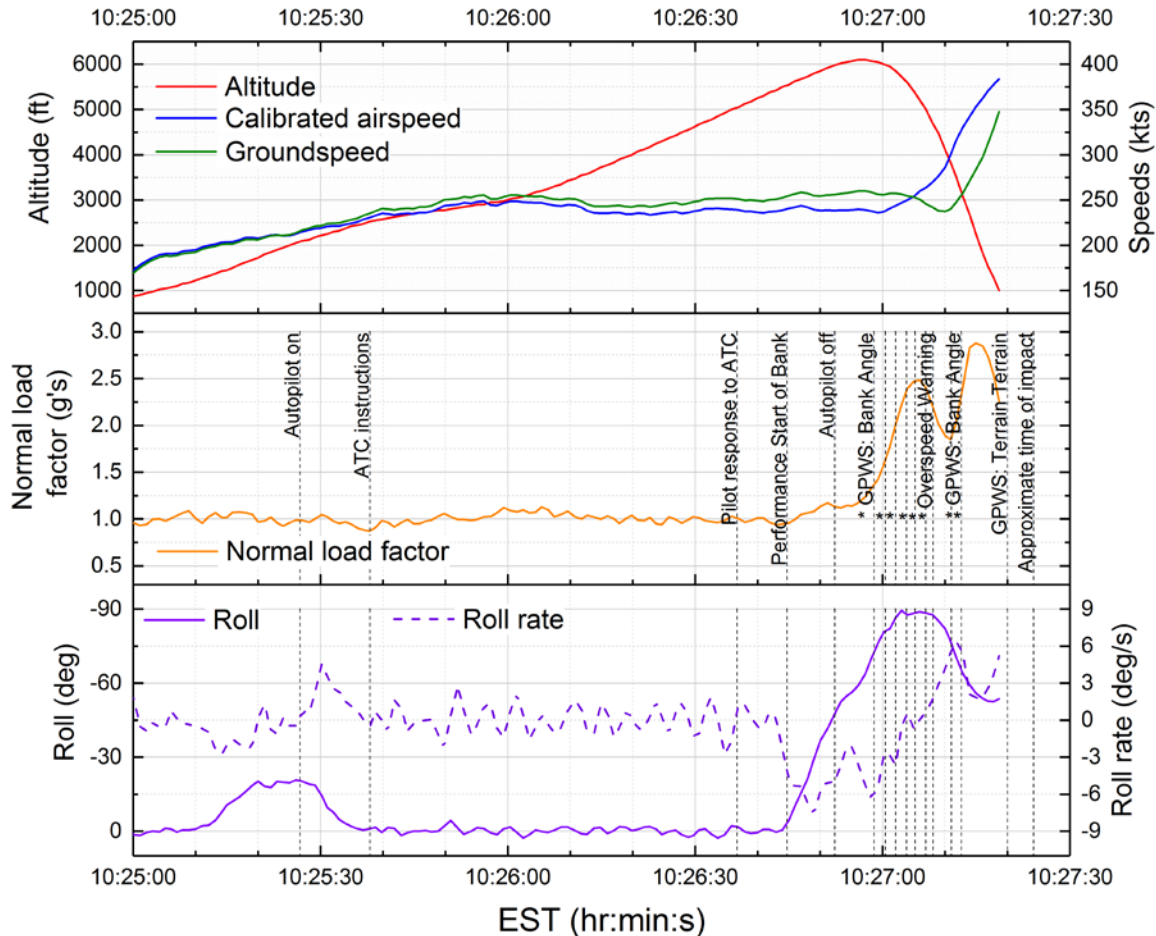
Figure 3 shows the flight altitude, speeds, cockpit annunciations, ATC communications, calculated normal load factor, roll, and roll rates. About six seconds after the start of the left bank, as the bank angle reached about  $-45^\circ$  left wing down, the autopilot disconnected. At 10:26:58, when the bank angle was calculated to be about  $-70^\circ$  left wing down and the airplane was beginning to descend, the GPWS began to annunciate “Bank Angle”. The GPWS annunciated “Bank Angle” six times until at 10:27:08 it said “Overspeed Warning” as the airplane passed 270 kts of calibrated airspeed and an altitude of 4,700 ft. The GPWS annunciated “Bank Angle” two more times. The final “Bank Angle” warning was at 10:27:12, after which the airplane’s bank angle was less than  $-60^\circ$ . ADS-B data ended at 10:27:18. The final recorded altitude was 1,000 ft and the airplane’s calculated airspeed was 380 kts and final bank angle was  $-53^\circ$  left wing down. At 10:27:20, the CVR recorded the GPWS annunciating “Terrain Terrain” and the approximate time of impact was 10:27:24. The impact point was 800 ft of ground distance from the last ADS-B point and at an

elevation of about 550 ft. Total time from beginning of left roll to the sound of impact was about 39 seconds.

**Figure 3.** Accident flight including annunciations and ATC conversation. The multiple GPWS Bank Angle annunciations are indicated by the asterisks.
