**NATIONAL TRANSPORTATION SAFETY BOARD  
Office of Research and Engineering  
Vehicle Recorder Division  
Washington, D.C. 20594**

**GROUP CHAIRMAN'S FACTUAL REPORT OF INVESTIGATION**

**CEN19FA036**

## **Cockpit Voice Recorder**

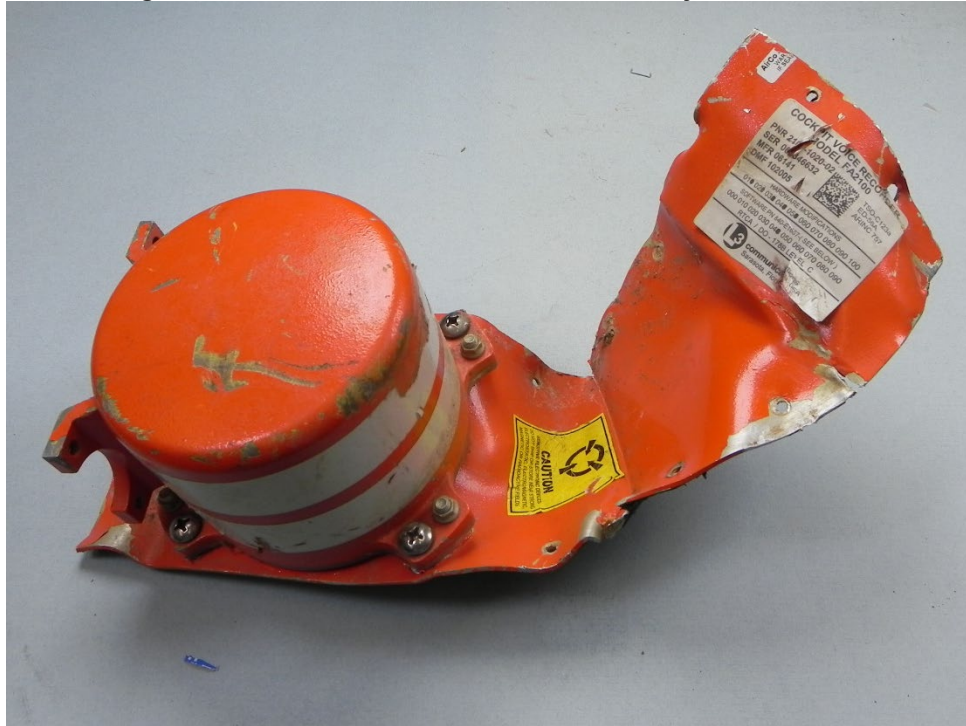
Upon arrival at the laboratory, it was evident that the CVR had sustained significant structural damage. The outer case was removed and the interior crash-protected case did not appear to have any heat or structural damage (see Figures 1 and 2). The memory board within the crash-protected case was checked for heat or structural damage and none was found. A new ribbon cable was attached to the module and the digital audio was successfully downloaded from the crash-survivable memory unit.

**Figure 1. Exterior of crash-survivable memory, as received.**

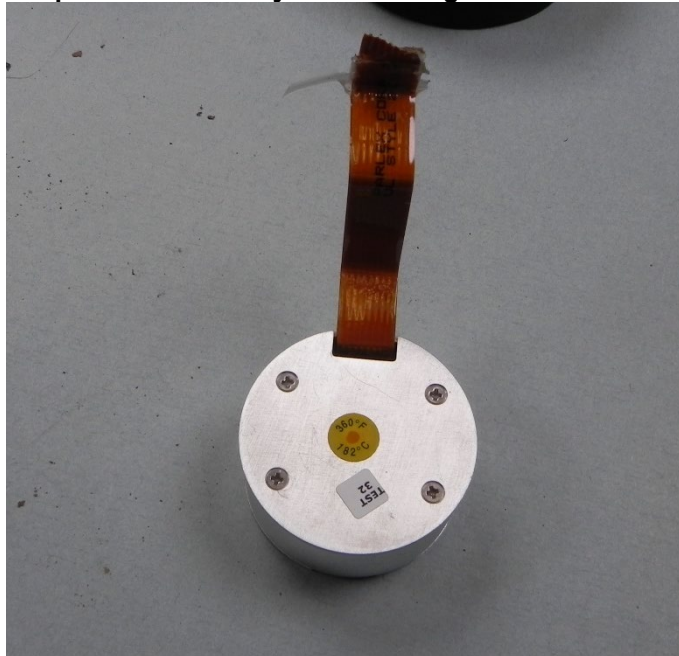
**Figure 2. Crash protected memory unit showing no heat or structural damage.**
