**APPENDIX A**  
**MATERIAL LAB SEM IMAGERY OF LH TCU**

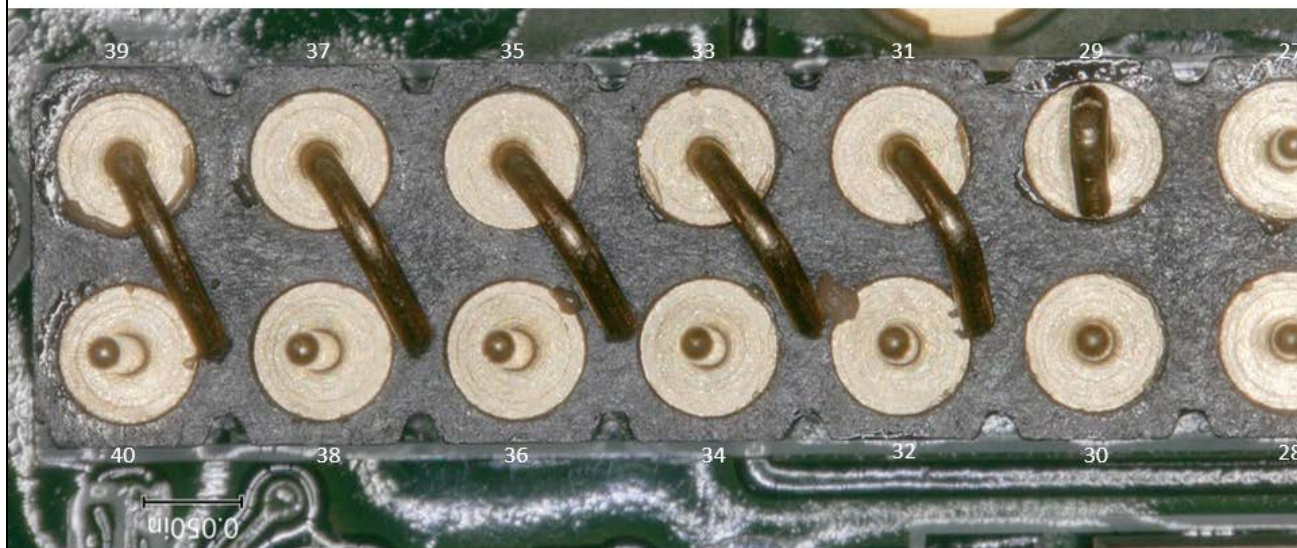
Digital microscope image of the bent pins

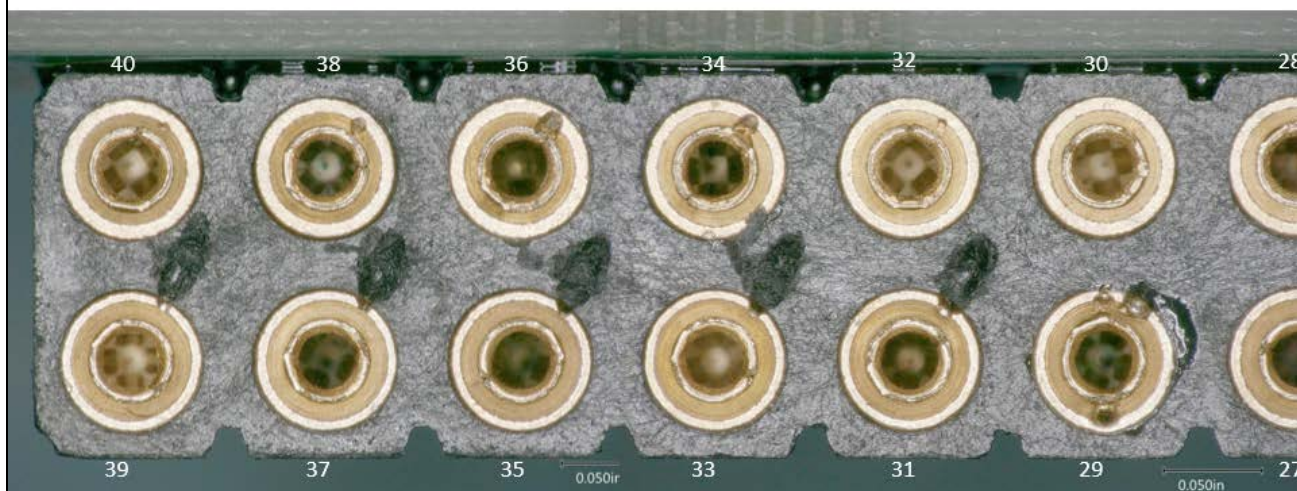
Digital microscope view of the sockets that mate with the bent pins

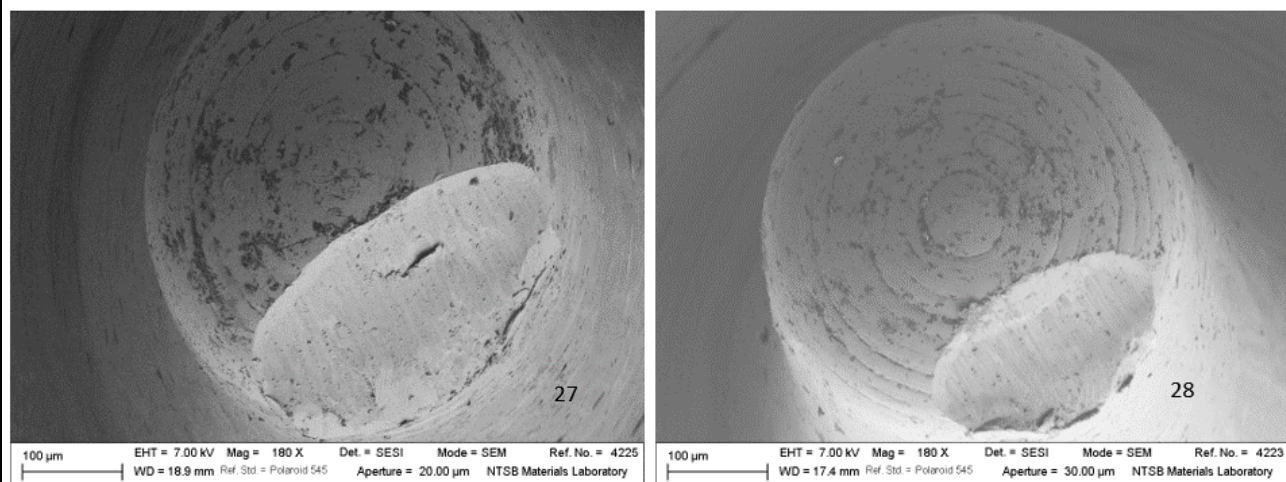
Closer SEM images of pins 27 and 28 showing nick artifacts at the tips

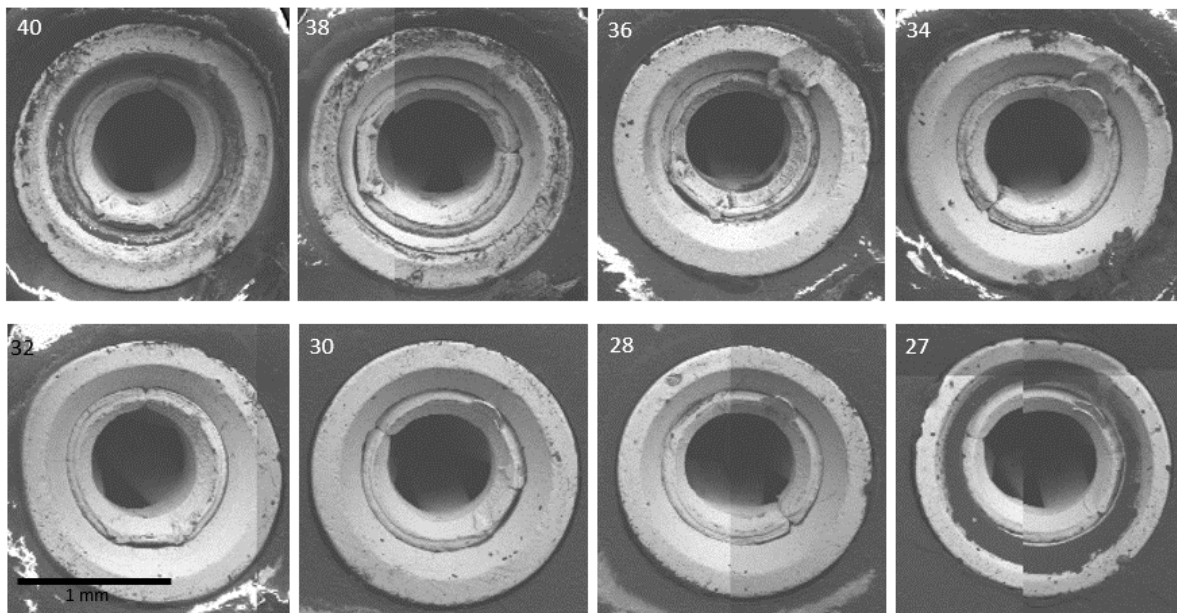
SEM Images of sockets with a nick or deposit at the ~1:00 position
