# **NTSB File No. CEN19LA002**

## **Alternator Exam Notes**

Accident Date: January 31, 2019  
Location: Katy, TX  
Aircraft: Mooney M20K, N56359  
Engine: Continental TSIO-360

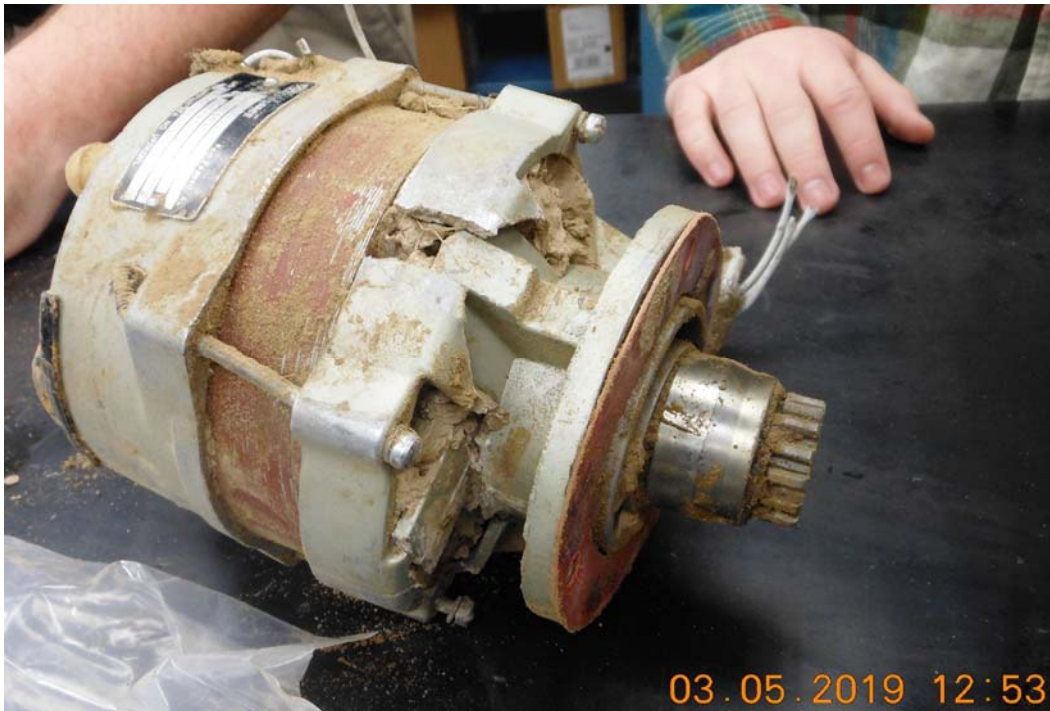
The alternator was presented for examination as shown in Photos #1 and #2. Functional testing on a test bench was not possible due to impact damage. The alternator case (both slip ring end and drive end) was fractured and stator/armature ring was bent and distorted. The case thru-bolts were bent and the threaded sections were fracture-separated. The alternator was packed with dried mud/dirt. The mounting gasket appeared intact and undamaged. The slip ring end case assembly where the terminals are located was dented with some corrosion. The terminals did not display

Photo #1 – Alternator as-received

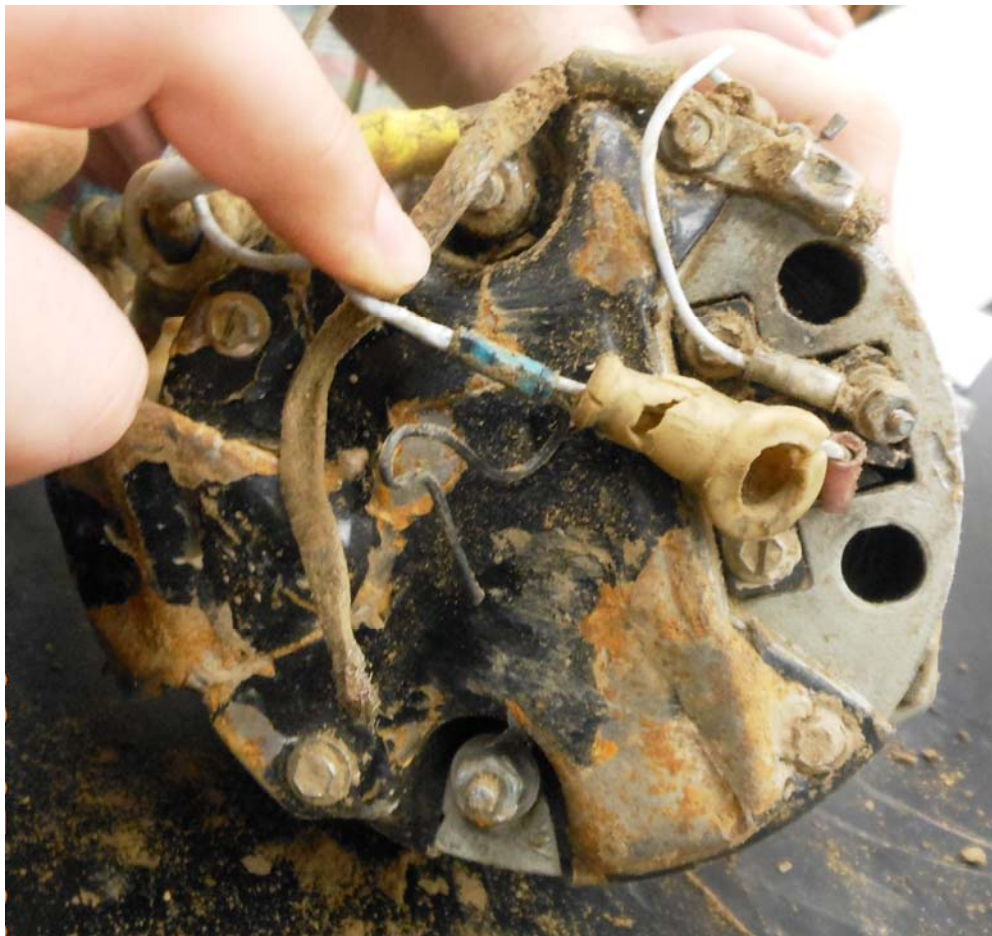
any thermal distress. The drive coupling was intact with nut and cotter pin in place. The rotor could not be rotated by hand force.

Photo #2 – Alternator terminal end as-received

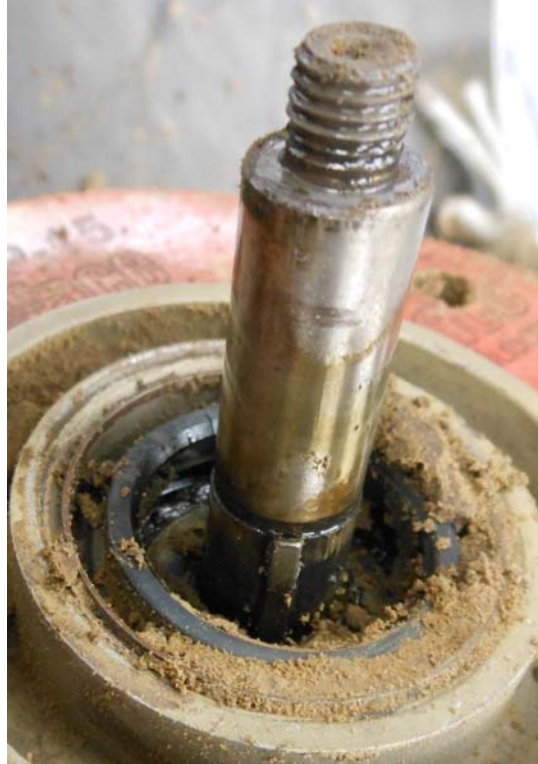
1. The alternator coupling was intact on the shaft with the nut secure and cotter pin present (Photo #4). The coupling nut breakaway torque was measured to be 20 in-lbs. vs. an installation torque specification of 175-200 in-lbs. The rotor shaft appeared bent but intact (Photo #5) with the Woodruff key intact and undamaged. The coupling bore and key slot was clean and undamaged (Photo #6).

Photo #5 – Alternator drive shaft and Woodruff key

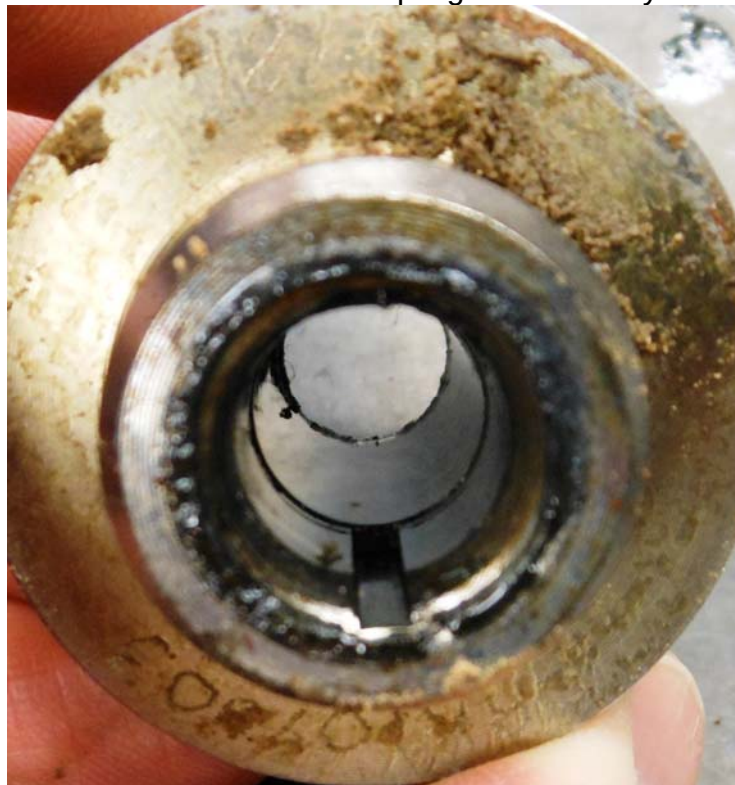
Photo #6 – Alternator coupling bore and key slot

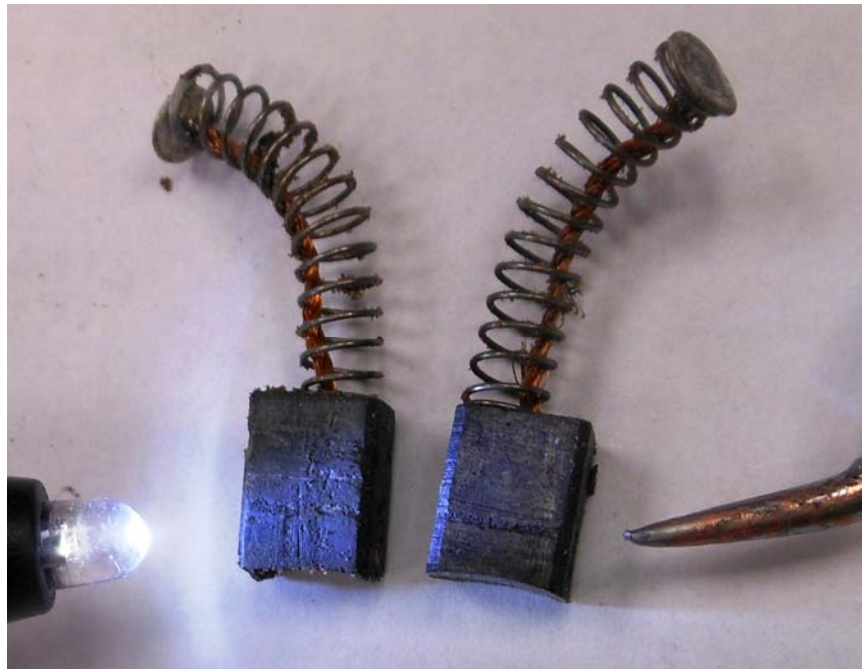
2. The brush holder was displaced and fractured (Photo #10). The brushes were intact but had some impact damage (Photo #7). The brush wear limit line was visible and the wear pattern was smooth indicating proper seating on the slip ring for both brushes.

Photo #7 – Alternator brushes

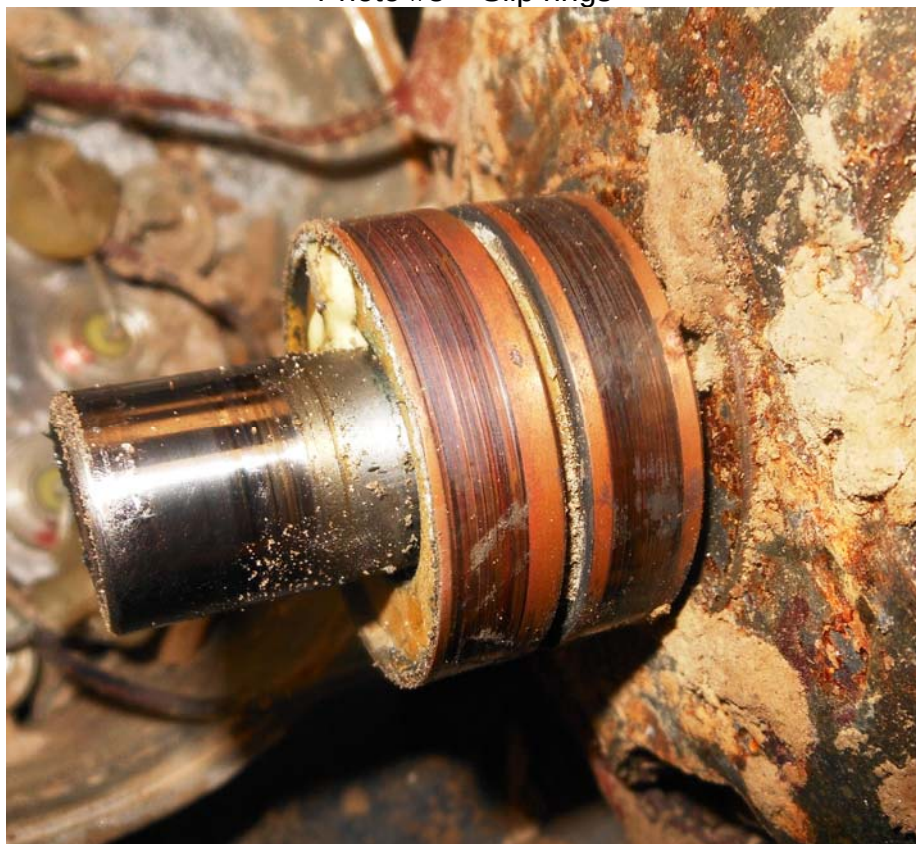
3. The slip rings appeared intact and undamaged with normal wear patterns (Photo #8).
4. Gaps between the stator assembly and rotor assembly were packed with dry mud/dirt, and the two were jammed together by impact forces (Photo #9) and had to be forcibly pressed apart in an arbor press.

Photo #8 – Slip rings

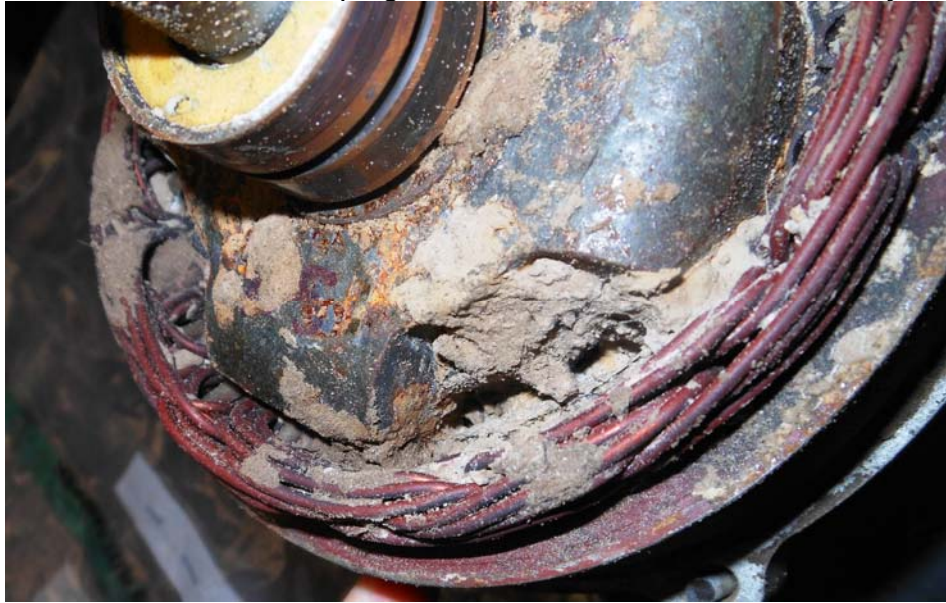
Photo #9 – Rotor impingement on stator/armature assembly

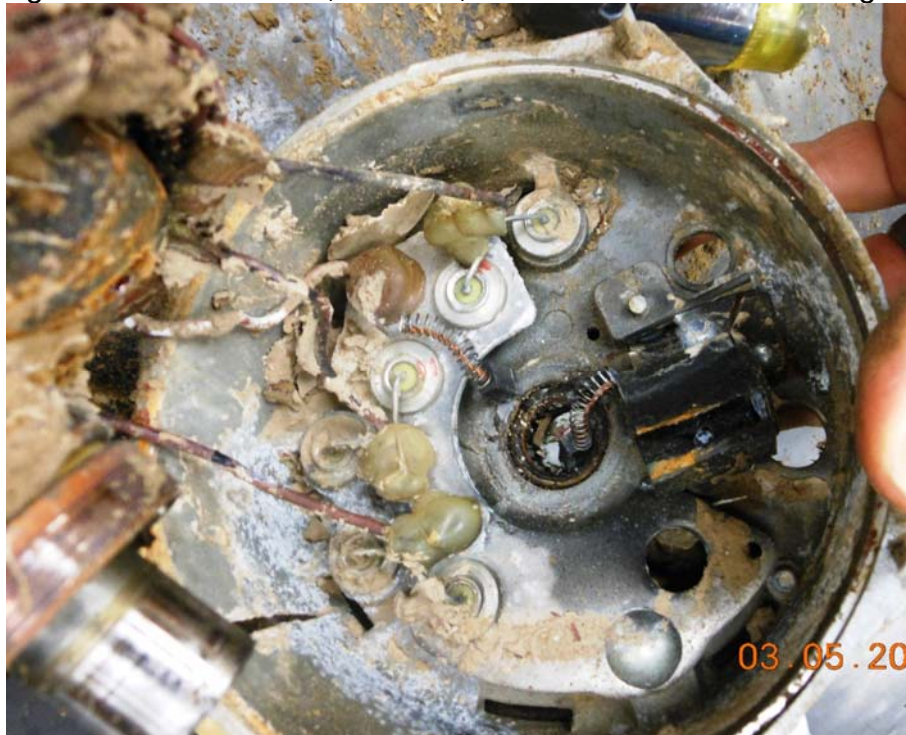
Photo #10

5. Rectifier diode continuity and polarity checked Ok and the diode potting showed no signs of thermal distress (Photo #10).

Aft housing with rectifier diodes, brushes, brush holder and aft bearing as-opened

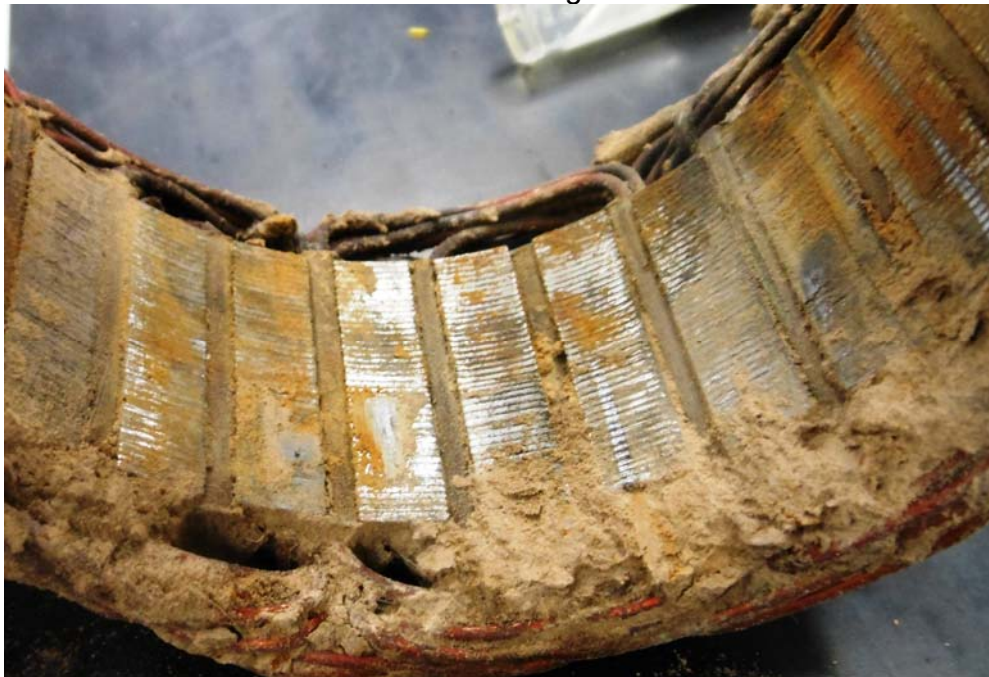
8. The stator/armature coils were tested using the Baker Tester (Photo #13). The stator/armature coil insulation resistance test detected some leakage between two stator coils but there was no evidence of high temperatures indicative of leakage/arcing/short during operation. It was concluded the impact damage to the stator (Photo #11) pressed some stator wires together enough to compromise the insulating varnish.

Photo #11 – Stator/armature damage from contact with rotor

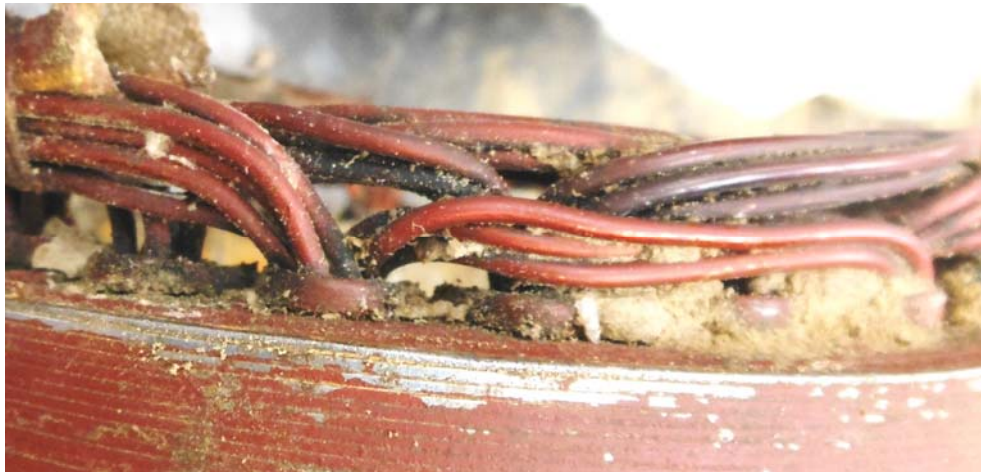
9. Some stator wires showed slight black discoloration (Photo #12). This discoloration was at the slip ring end and attributed to brush dust. There was no evidence of thermal distress on any other part of the stator coils.

Photo #12 – Some discoloration on stator/armature wires

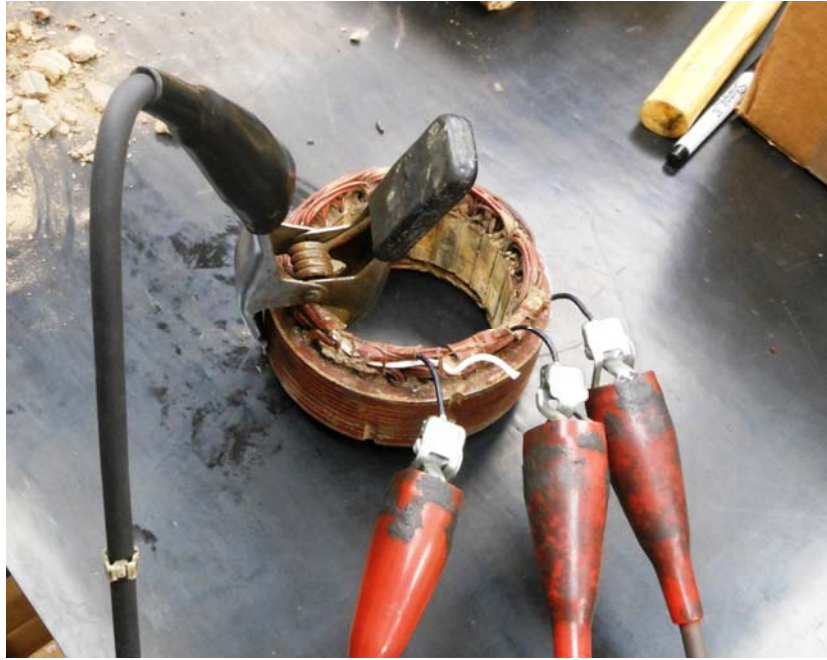
Photo #13 – Stator/armature coil test

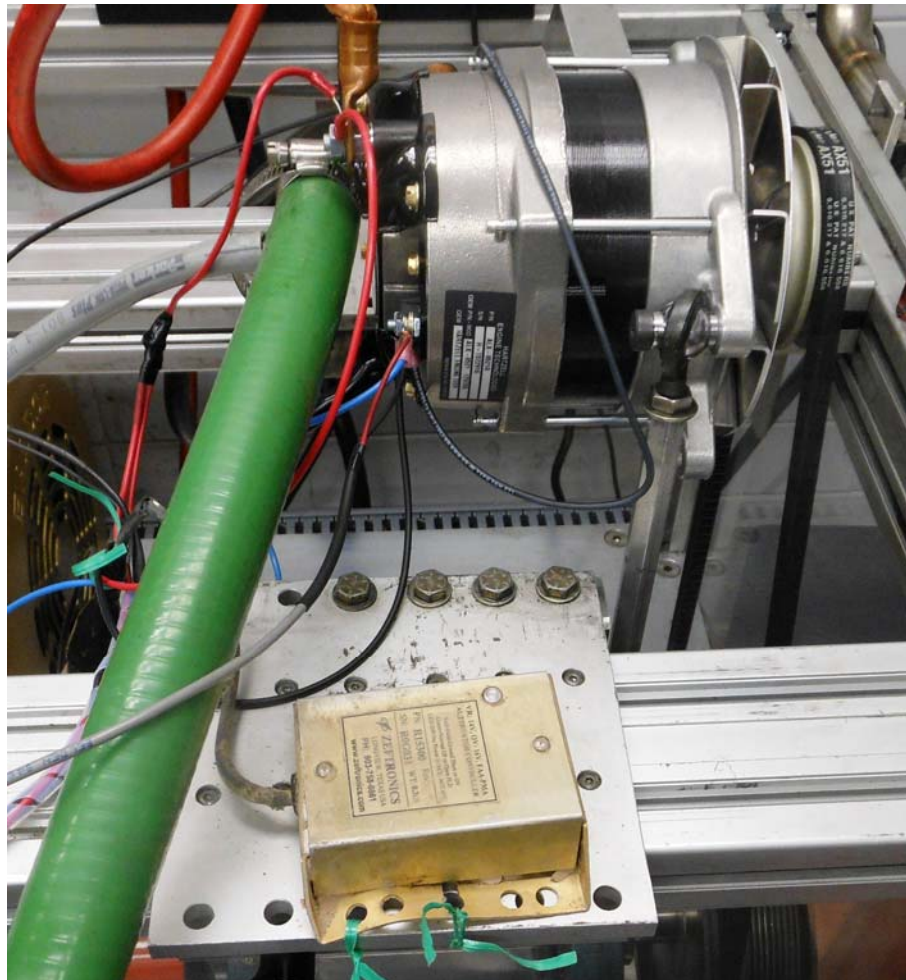
10. The Alternator Controller was mounted to a test bench and wired into a mule alternator for functional testing (Photo #14). Initial tests indicated the controller was not functioning properly so the cover was removed for examination of the internal components (Photo #15). Although the dented/bent case appeared to be

Photo #14 – Alternator Controller on test bench

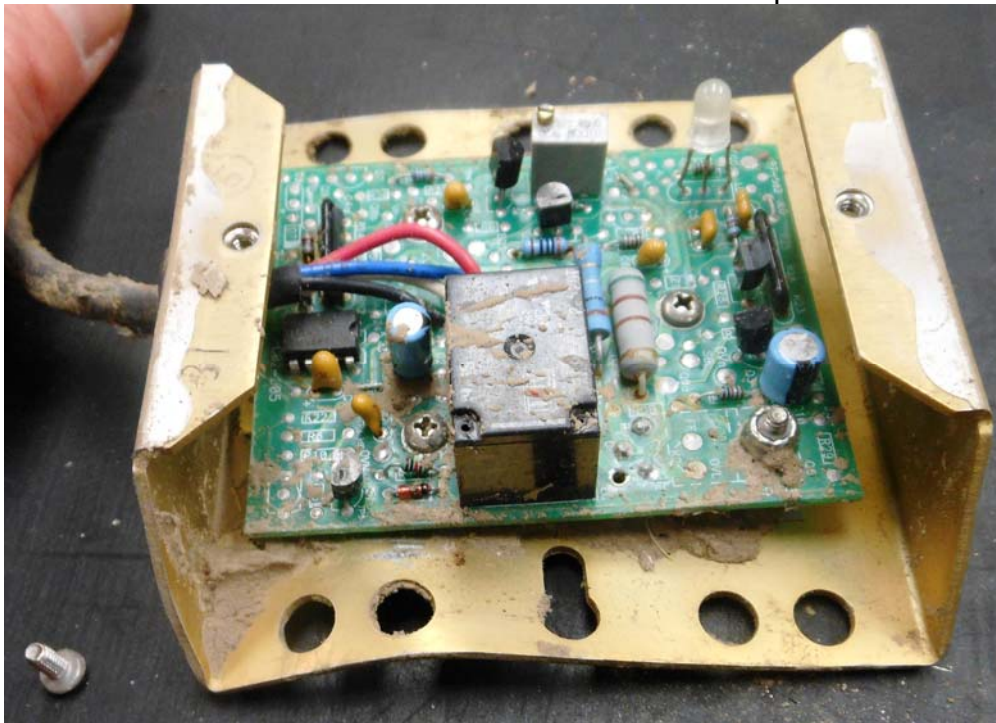
impinging on the back of the circuit board, opening the cover indicated the controller chassis needed to be grounded to function properly. The controller was remounted to the test bench with an additional ground wire to the chassis and run again. The controller functioned properly with the additional ground wire. Voltage output was approximately 13.6V at 45 amp current draw (Photo #16).

Photo #15 – Alternator Controller internal components

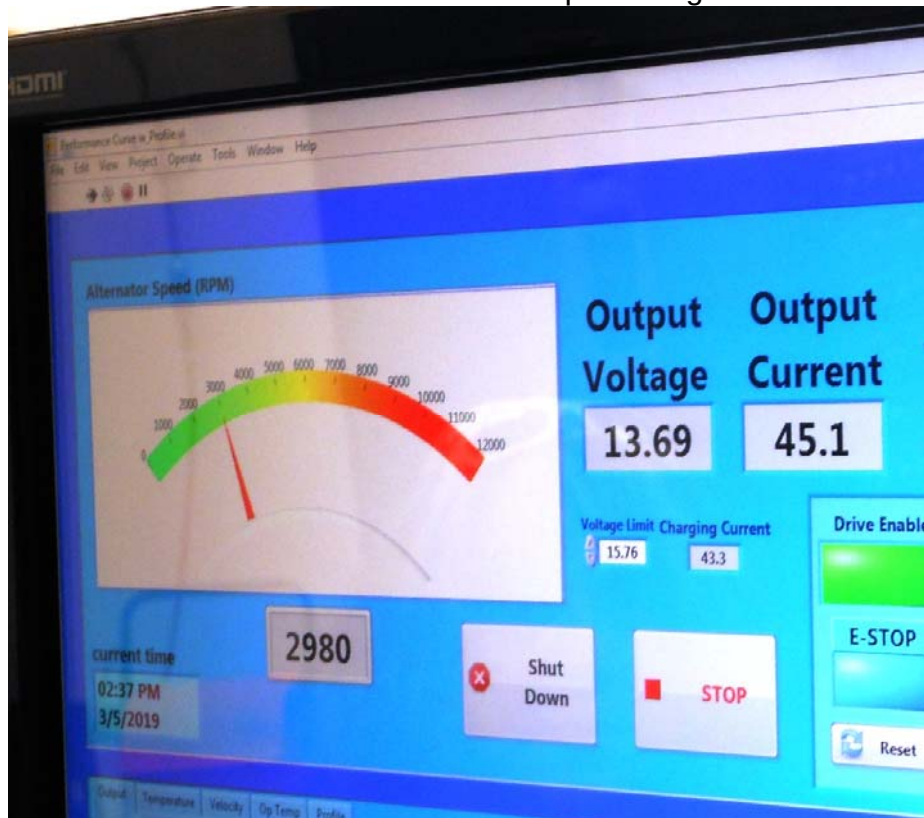
The alternator examination found no discrepancies that would prevent or degrade normal operation prior to impact. All damage was due to high impact forces. The alternator controller functioned properly with slightly low (<14v) output voltage at current levels above approximately 40 amps.

Photo #16 – Alternator Controller output voltage and current
