## NTSB Accident Number CEN19FA082

### **ATC SUMMARY**

Location: Canadian, Texas  
Date: February 15, 2019  
Time: 0957 CST  
Registration: N421NS  
Aircraft: Cessna 421C

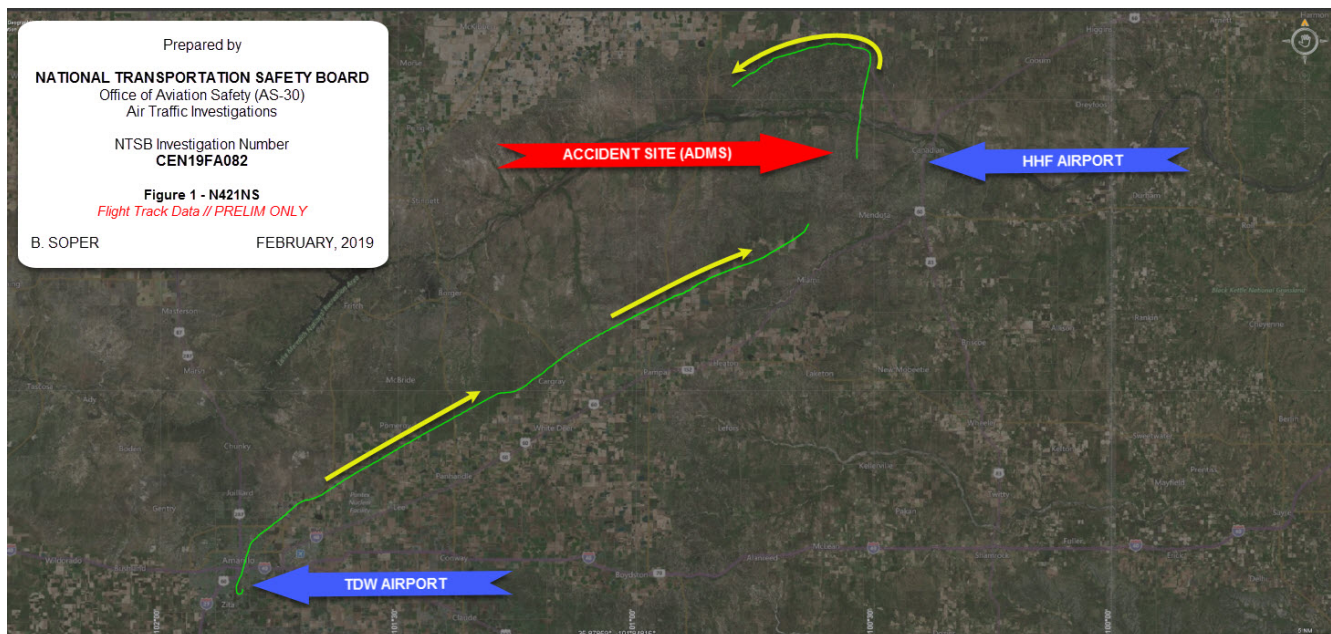
Track data indicates N421NS likely departed RWY 17 at Tradewinds Airport (TDW) at about 0900 CST making a climbing right turn out to a NNE bound heading until passing through about 5,500' msl, then turning further right to a NE bound heading. The aircraft continued to climb to a cruise altitude of about 7,500' msl and tracked NE bound toward Hemphill Airport (HHF). About 26 nm SW of HHF, the aircraft began to descend until about 13.5 nm SW of HHF when track data was lost at 0921:20 CST, and indicated an altitude of 4,775' msl. At 0925:02 about 6 nm NE of where track data was previously lost, and about 6.5 nm W of HHF, track data resumed and indicated the aircraft was climbing through about 4,650' msl on a NNE heading. The flight track continued NNE bound for about 11 nm then began turning left to a SW bound heading reaching about 6,500' msl, then descending again until track data was lost at 0935:31 CST indicating an altitude of about 4,950' msl and about 20.5 nm NW of HHF, and about 12 nm NW of the accident site as documented in ADMS.

First Track Data: 0900:11 CST // 4,075' msl ---- Last Track Data: 0935:31 CST // 4,950' msl
