## **NATIONAL TRANSPORTATION SAFETY BOARD**

### **Weather Study**

CEN19FA082

Location: Canadian, Texas  
Date: February 15, 2019  
Time: 0957 central standard time (1557 UTC<sup>1</sup>)  
Airplane: Cessna 421C; N421NS

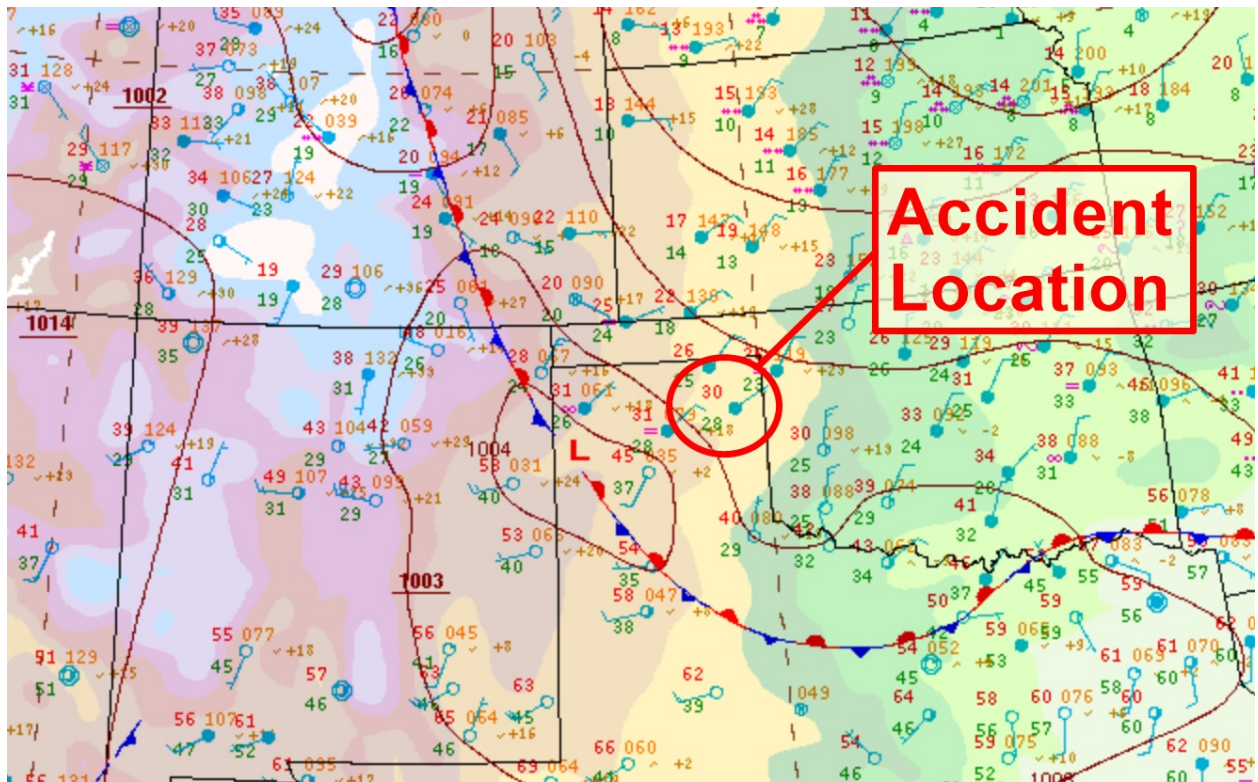
A southcentral section of the National Weather Service (NWS) Surface Analysis Chart for 0900 CST is presented in figure 1. The surface analysis chart showed a low pressure center west of the accident location along the Texas/New Mexico border. Stationary fronts extended north-northwest and southwest from this low pressure center. The accident site was located on the cold air side and north of the front. Station models near the accident location depicted overcast skies and an east-northeast to northeast wind of 10 knots. Temperatures were below freezing and dew point depressions were about 3° Fahrenheit or less. Fog and haze were reported at several stations west of the accident location.

**Figure 1 - NWS Surface Analysis Chart for 0900 CST.**

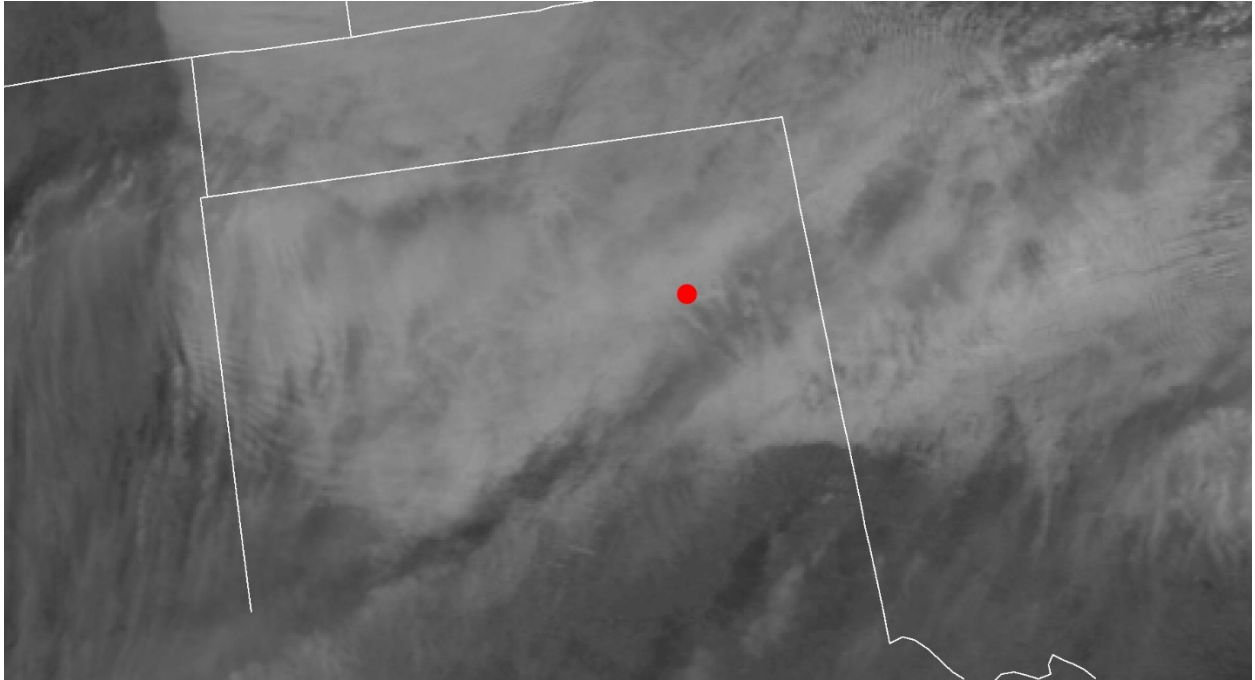
Advanced Very-High-Resolution Radiometer (AVHRR) visible (0.63μm) and infrared (10.8μm) data from the METOP-A platform were obtained from the NOAA. Imagery from near the time of the accident are presented in figures 3 and 4. The visible AVHRR imagery depicted cloudy skies over the accident region. The infrared data retrieved brightness temperatures over the accident location of about -15°C, which, considering the HRRR sounding, corresponded to cloud top heights of about 18,500 feet. However, the HRRR sounding retrieved a very dry atmosphere at this level, which would not support clouds. Further, minimum temperatures below the temperature inversion do not go below about -4°C. It is possible the model did not resolve upper level moisture or the tropospheric temperature profile very well. Additional information for this atmosphere from models, balloons and aircraft did not add any value. Therefore, confident determination of cloud top heights from the satellite data are not possible.

**Figure 3** – METOP-A visible imagery from about 0956 CST. Accident location denoted by red dot.

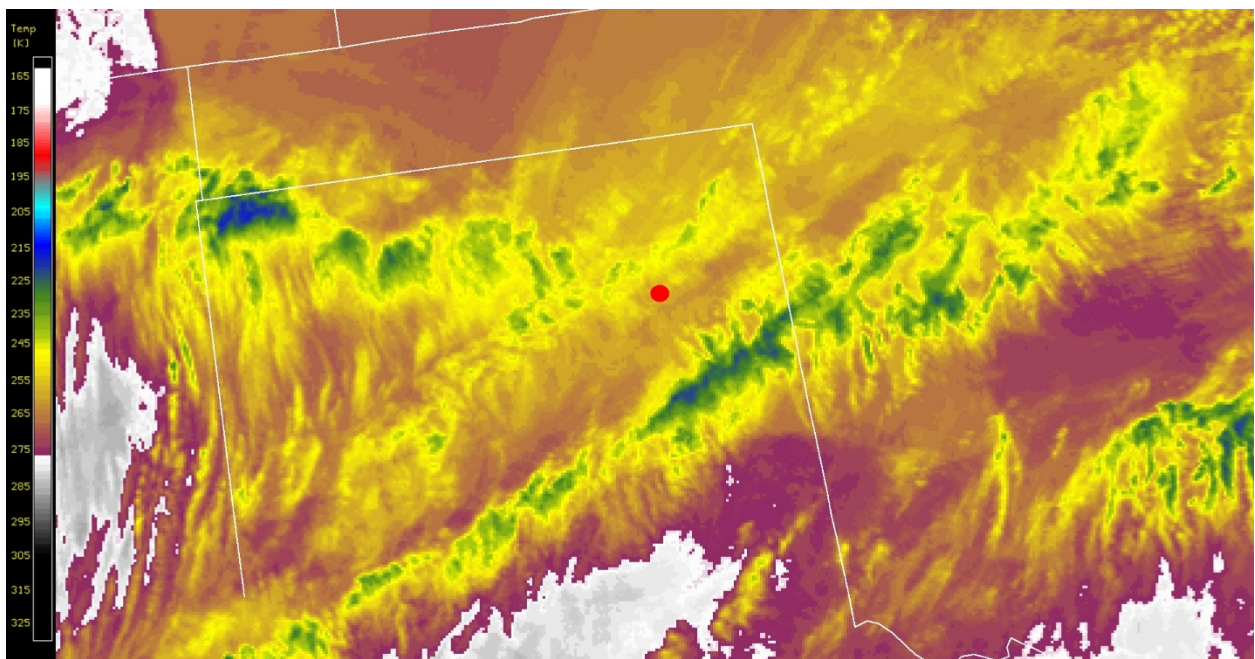
**Figure 4** – METOP-A infrared imagery (brightness temperature in degrees Kelvin) from about 0956 CST. Accident location denoted by red dot.
