## Air Safety Investigations Aircraft Incident/Accident Technical Report

| <b>Aircraft Incident/<br/>Accident Information</b> | Year: 1980 | Make: Cessna | Model: 421C |
| Location: Canadian, TX | | Date: 02-15-19 | Time: 0957 CST |
| Senior Air Safety Investigator: Andrew L. Hall | | Report #: ASI-19-AF-T | Report date: 11-11-19 |

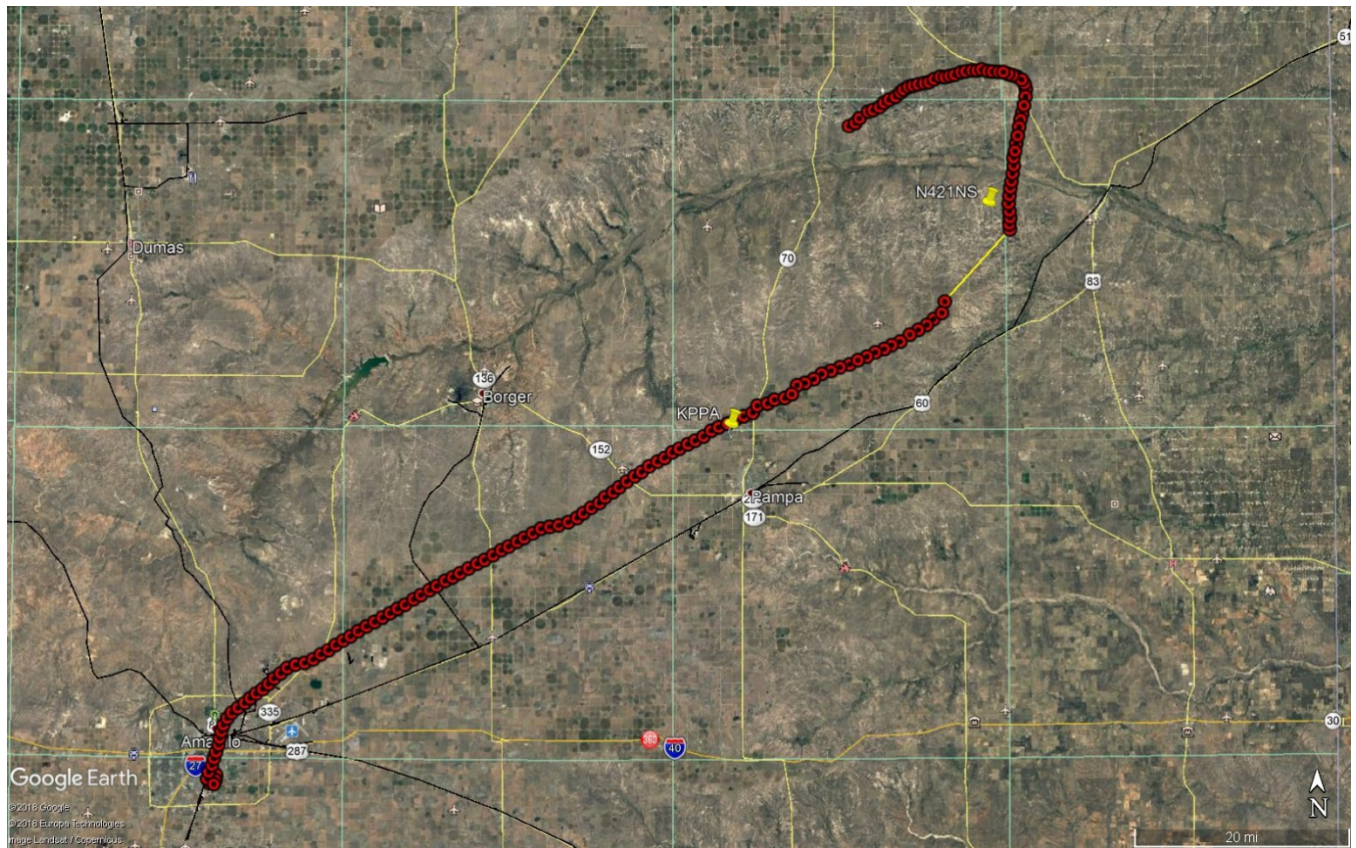
Radar track.
