# Continental Motors

## ENGINE EXAMINATION REPORT

| ENGINE MODEL | GTSIO-520-L |
| AIRCRAFT REGISTRATION | N421NS |

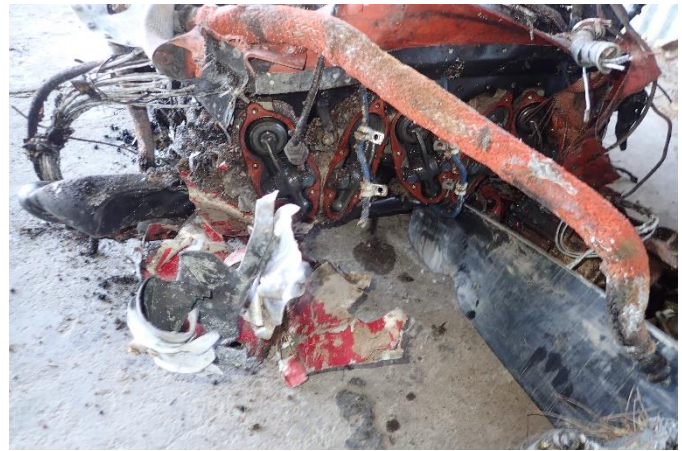
The exhaust system remained attached to the engine and displayed a significant amount of impact damage. The exhaust risers displayed the most impact damage and were crushed upwards against the engine; several of the risers were crushed almost completely flat. There were no signs of exhaust leaks noted.

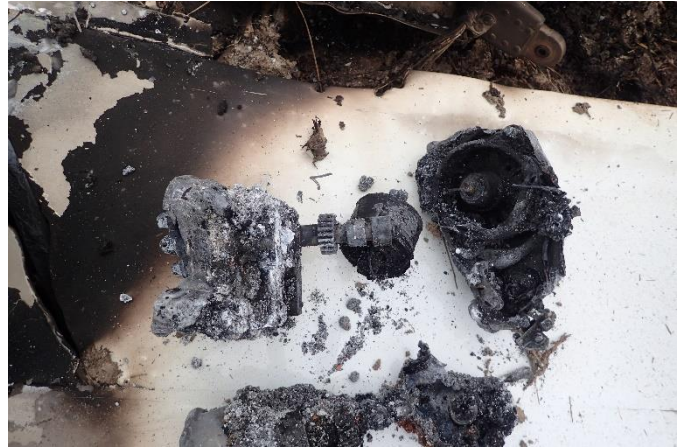
The magneto had broken free from its installation point and was almost destroyed by thermal forces; the housing had almost completely melted and all of the internal components displayed significant thermal damage.

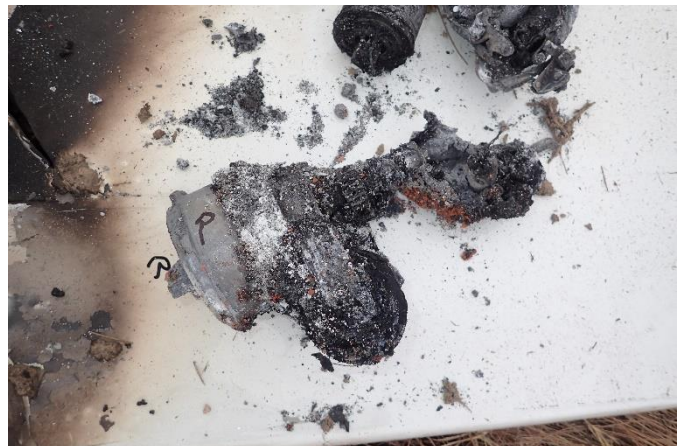
The magneto had broken free from its installation point and was almost destroyed by thermal forces; the housing had almost completely melted and all of the internal components displayed significant thermal damage.

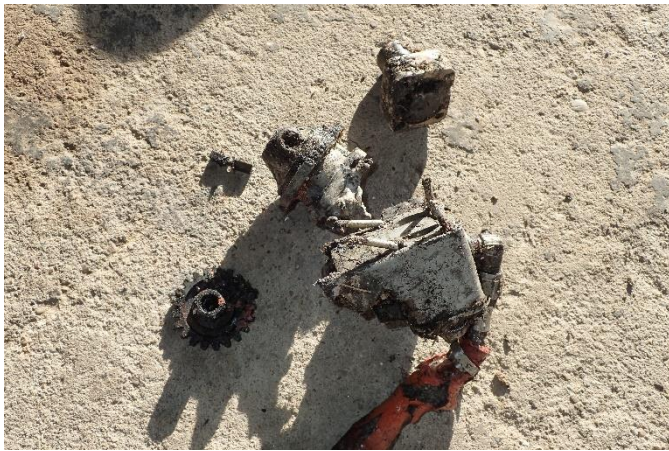
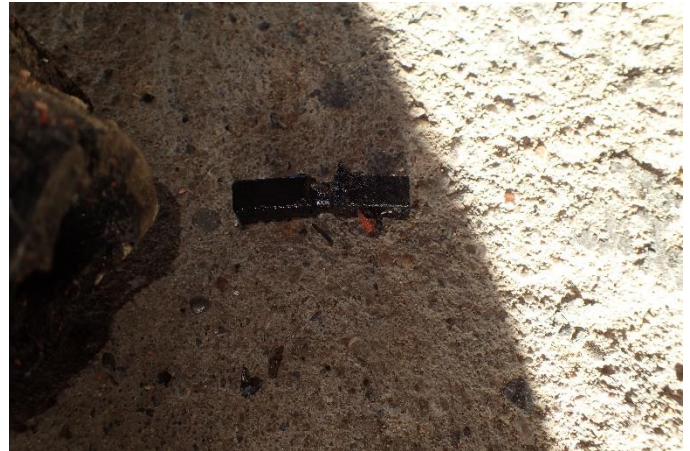
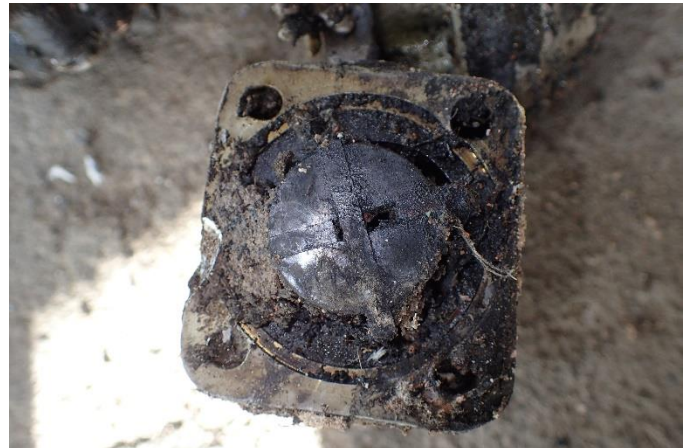
The fuel pump had broken free from its installation point and displayed a significant amount of impact damage signatures; several portions of the fuel pump were not located at the time of the examination. The fuel pump drive shaft and drive gear were located and were found to be intact. The fuel pump drive shaft and vanes were noted to have remained intact and displayed some impact damage signatures. There were no anomalies noted with the recovered portions of the fuel pump.

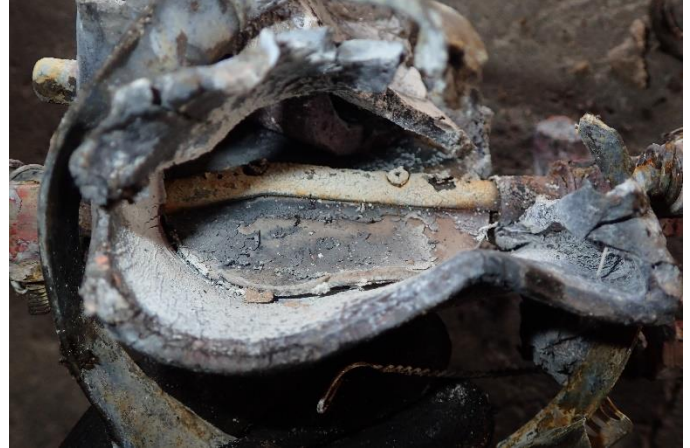
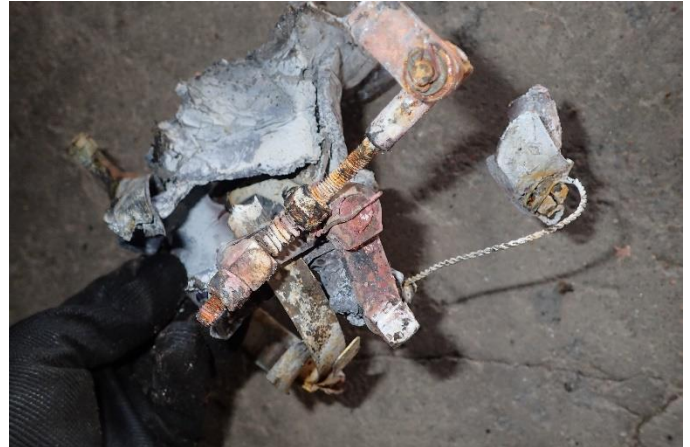
The throttle body and metering unit had broken free from its installation point and displayed a significant amount of impact and thermal damage signatures; the metering assembly had broken free from the throttle body and was not located at the time of the examination. There were no anomalies noted with the recovered portion of the throttle and metering assembly.

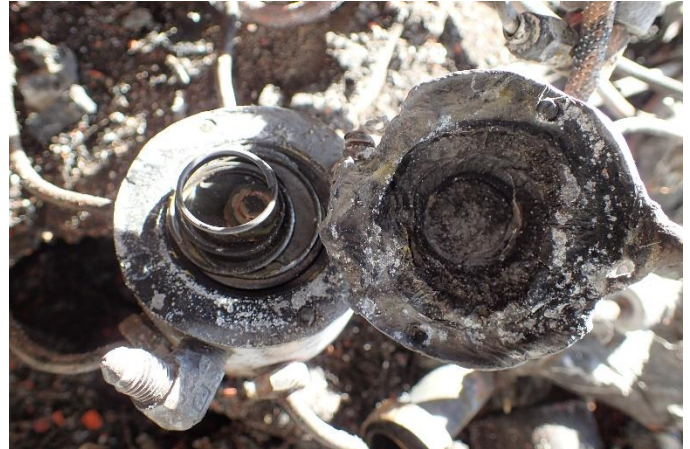
The fuel manifold valve remained partially attached to the engine and displayed some impact and a significant amount of thermal damage; the manifold valve cap had almost completely melted. The internal components displayed thermal damage signatures. There were no anomalies noted.

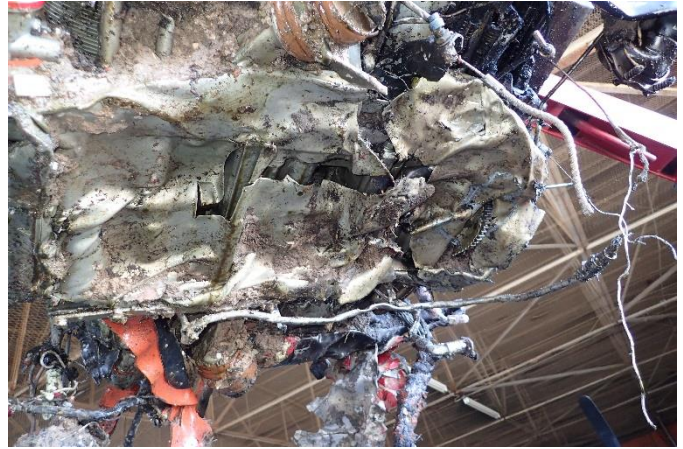
The oil sump displayed a significant amount of impact damage and was crushed upwards and was breached. There were no anomalies noted.

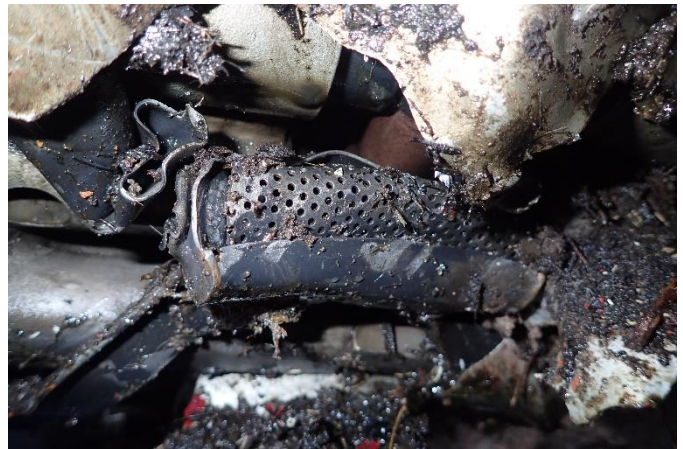
The oil pick-up tube and screen were visible through the broken oil sump. The pick-up tube and screen displayed significant impact damage signatures and the screen had material consistent with dirt/mud in the screen. There was no metallic material found in the oil pick-up screen. There were no anomalies noted.

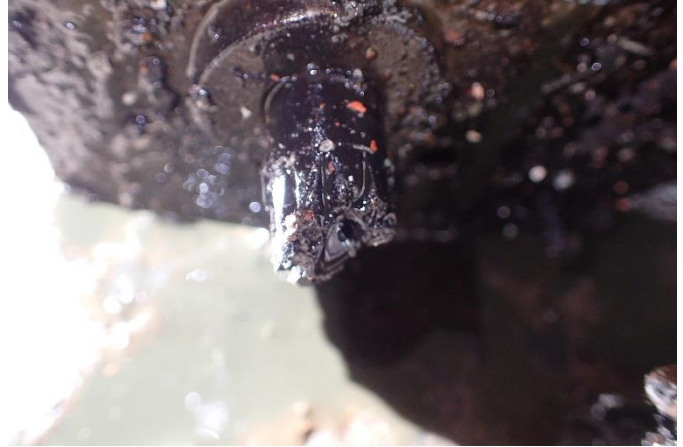
The oil pump had broken free from the engine and displayed a significant amount of impact damage signatures. It was noted that the oil pump drive shaft had broken, and a portion of the shaft remained within the camshaft gear; the damage was consistent with impact damage. There were no anomalies noted with the oil pump.

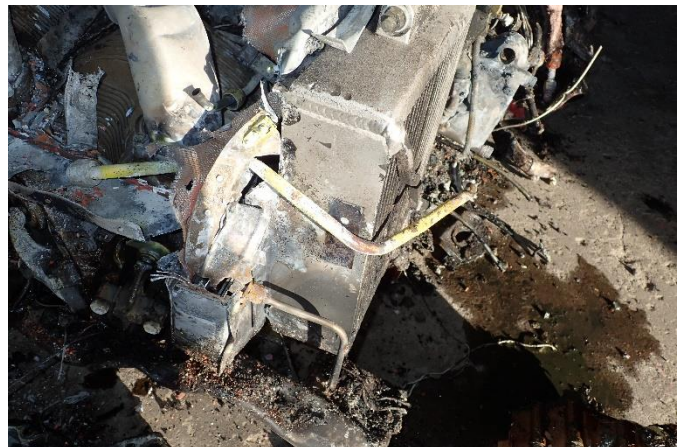
The oil cooler remained attached to the engine and displayed impact damage signatures. There were no anomalies noted with the oil cooler.

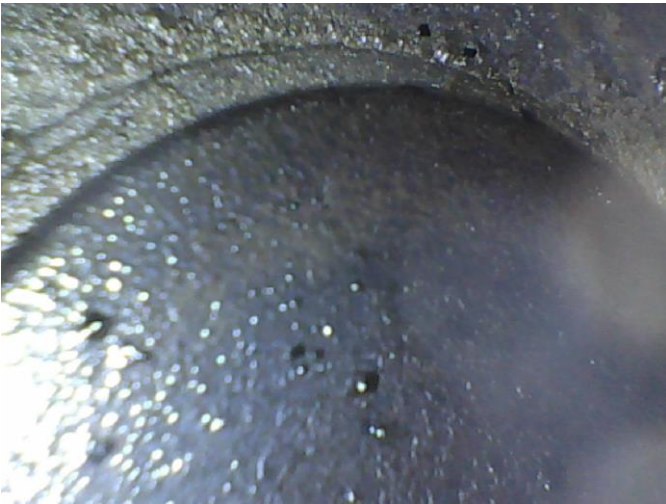
The valve heads were inspected using a lighted borescope; the valve heads displayed normal operating and combustion signatures. All of the valves were capable of movement when actuating the rocker arms manually; there were no anomalies noted.

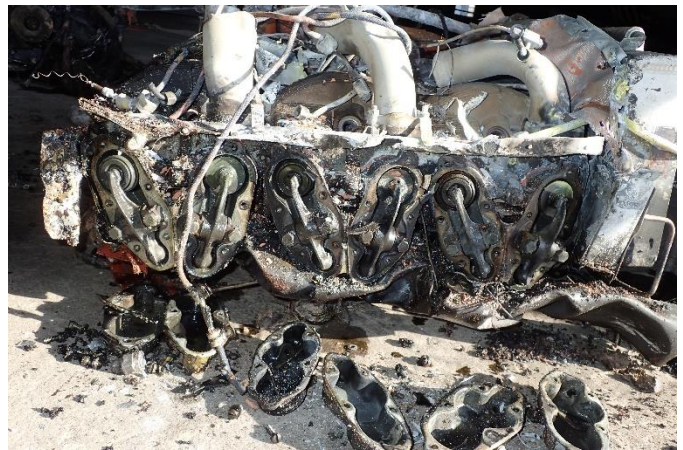
All of the rocker arms remained attached to their cylinders and displayed varying amounts of thermal damage signatures with the left side rocker arms showing the most thermal damage. The rocker arms also displayed normal operating signatures and were capable of movement when actuating the rocker arms manually.

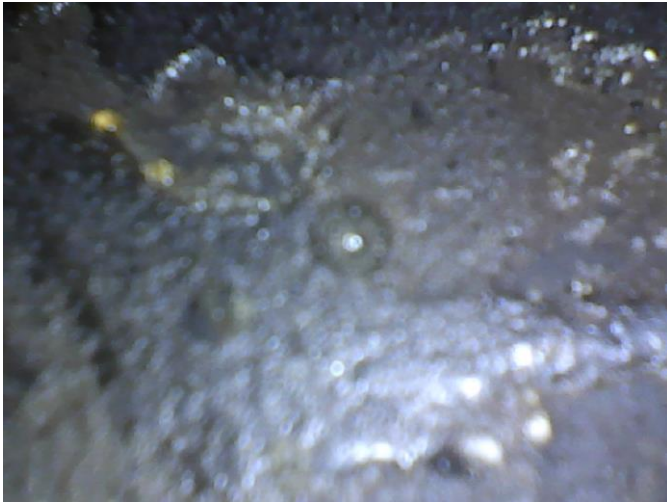
All of the piston faces were inspected using a lighted borescope. The piston faces displayed normal operating and combustion signatures. There were no anomalies noted with the pistons.

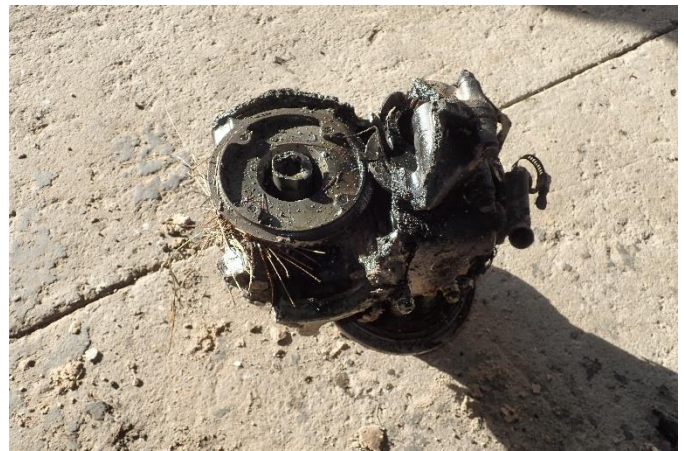
| CRANKCASE | Casting Number: | 1-3-5: Not observed | 2-4-6: Not observed | S/N: Not observed |
|---|---|---|---|---|
| Condition: | <p>The crankcase displayed a significant amount of impact damage with most of the damage occurring to the forward portion of the crankcase; the portion of the crankcase that houses the propeller shaft and reduction gear had broken free from the rest of the crankcase. There were no breaches in the crankcase that would indicate a catastrophic internal engine failure. Holes were drilled into the top of the crankcase to facilitate inserting a lighted borescope to inspect portions of the internal components; there were no anomalies noted with the visible internal portions of the crankcase.</p> | | | |

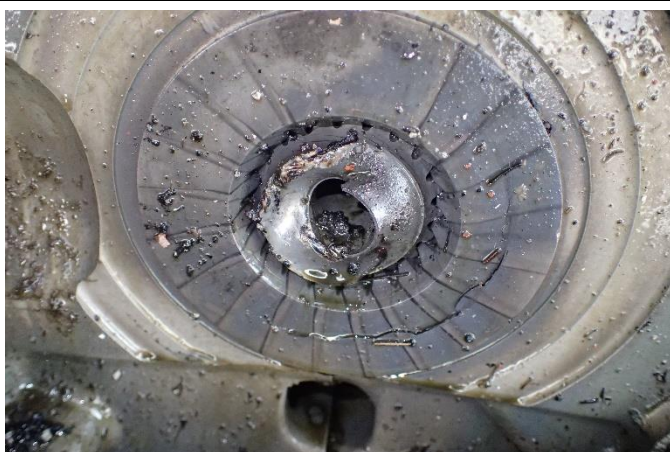
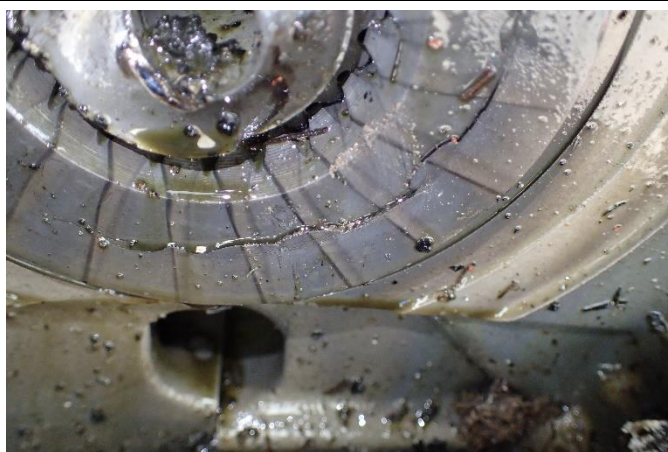
The forward portion of the crankshaft was visible through the broken crankcase and displayed impact damage signatures. The crankshaft was unable to be rotated which was consistent with the extensive impact damage to the engine. The crankshaft gear was noted to be intact and properly secured. Small portions of the crankshaft were visible by drilling holes in the crankcase and using a lighted borescope; the visible portions of the crankshaft displayed normal operating signatures and there were no anomalies noted with the visible portions of the crankshaft.

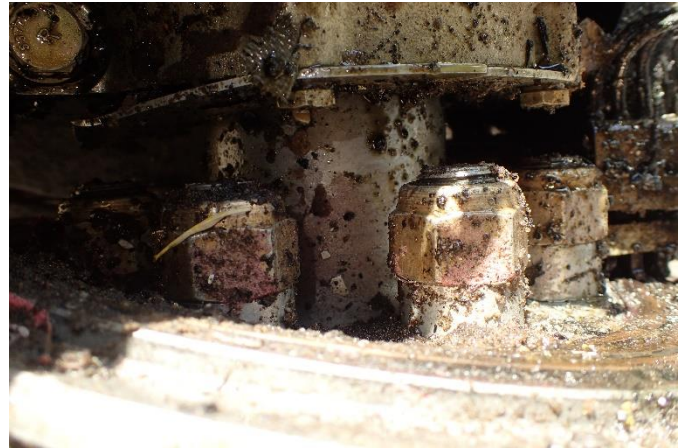
The propeller flange remained attached to the propeller shaft and displayed impact damage signatures. A portion of the rear part of the propeller shaft was visible and displayed impact damage and normal operating signatures.

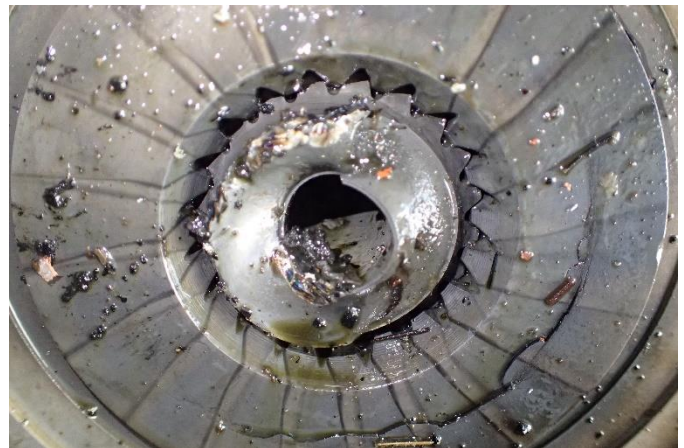
The quill shaft displayed impact damage signatures and was broken into two pieces. The fracture surface displayed some 45° cracks and ratcheting marks.

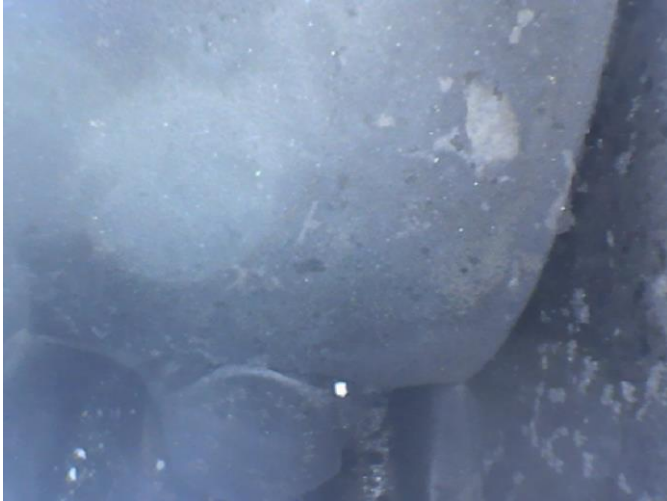
The connecting rods were able to be partially inspected by drilling holes in the crankcase and inserting a lighted borescope. It was noted that all six connecting rods remained on their journal and there were no signs of lubrication distress to any of the rods.

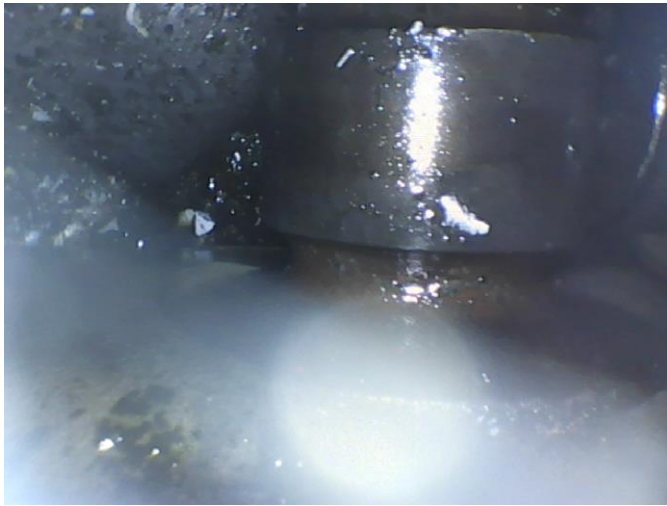
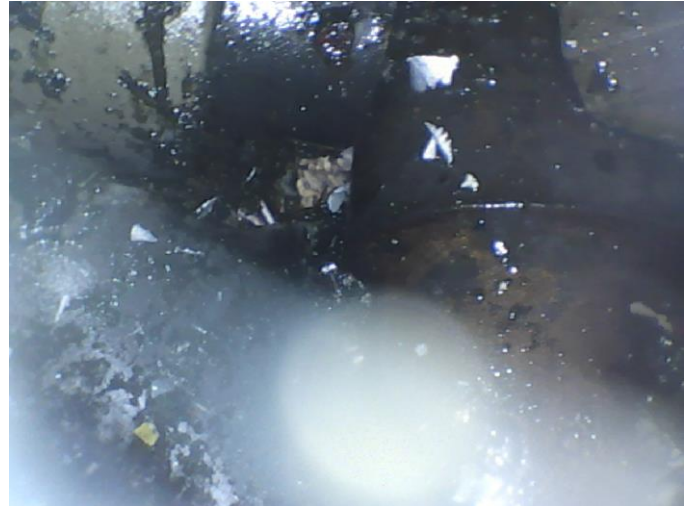
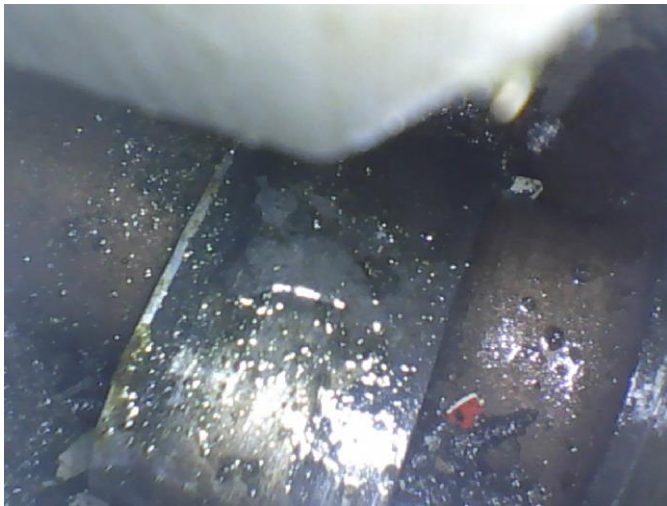
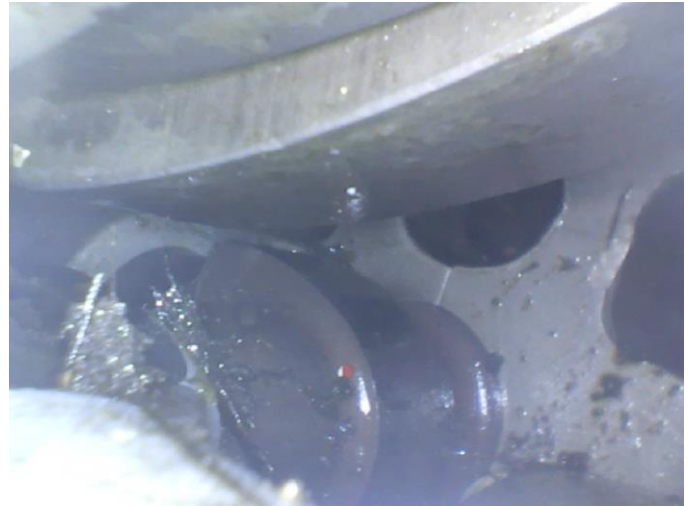
The forward portion of the camshaft was visible through the broken crankcase; the camshaft displayed impact damage signatures and a portion of the camshaft had broken free from the rest of the camshaft. The rest of the camshaft was partially visible by inserting a lighted borescope into drilled holes in the crankcase. The visible portions of the camshaft displayed normal operating and lubrication signatures.

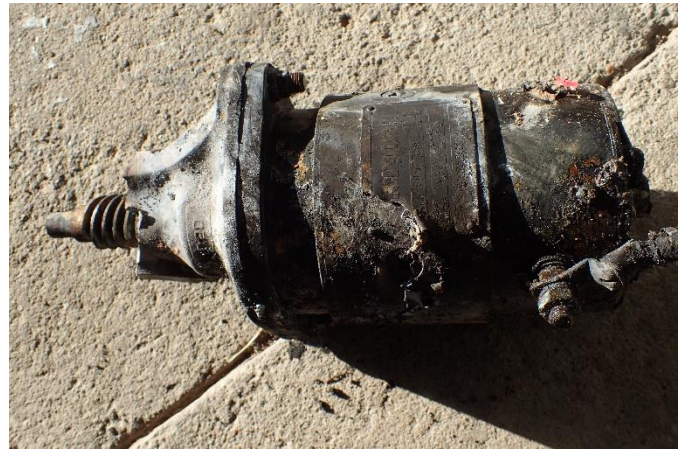
The starter remained attached to its mounting flange; however, the mounting flange had broken free from the rest of the starter adapter. The starter displayed impact and significant thermal damage signatures. There were no anomalies noted.

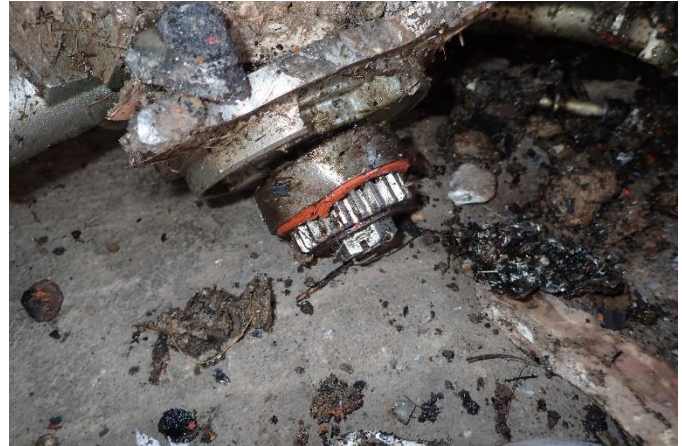
The alternator had broken free from its installation point and displayed significant impact damage signatures and the drive shaft was unable to be rotated. There were no anomalies noted.

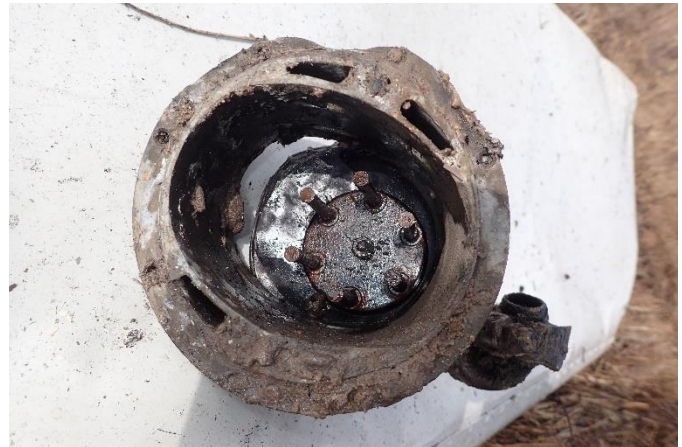
The vacuum pump had broken free from the engine and only the vacuum pump housing was located at the time of the examination. There were no anomalies noted with the recovered portion of the vacuum pump.

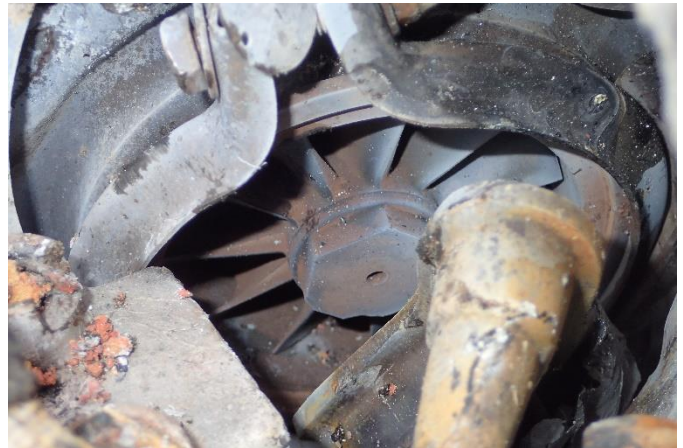
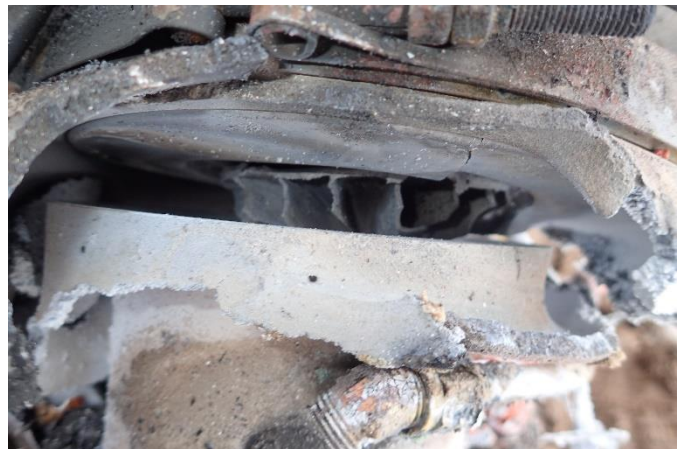
The turbocharger remained attached to its installation point and displayed impact and thermal damage signatures. It was noted that the V-band clamp remained attached to the turbocharger exhaust; however, the tailpipe had broken free from the turbocharger exhaust which was consistent with impact damage. It was noted that the turbine and compressor were unable to be rotated which was consistent with the impact and thermal damage. The compressor blades and turbine blades displayed normal operating signatures.

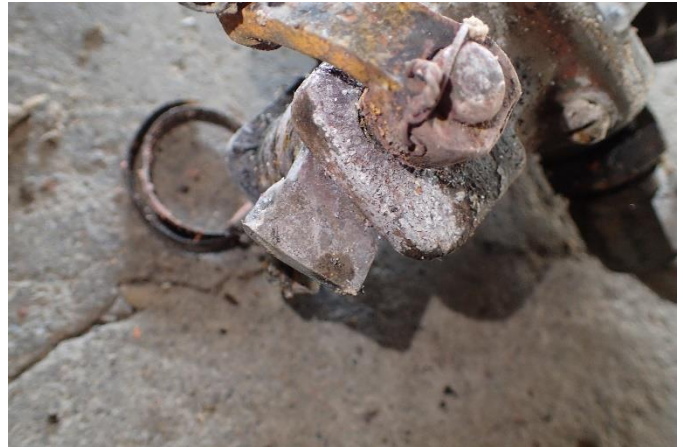
The turbocharger controller had broken free from its installation point and displayed a significant amount of impact damage signatures. There were no anomalies noted with the recovered portions of the controller.

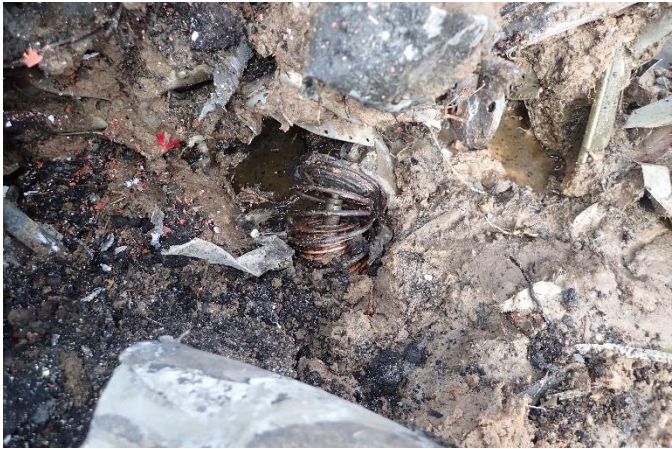
| Condition: | The overboost valve had broken free from its installation point and displayed a significant amount of impact damage signatures. There were no anomalies noted with the overboost valve. | | |

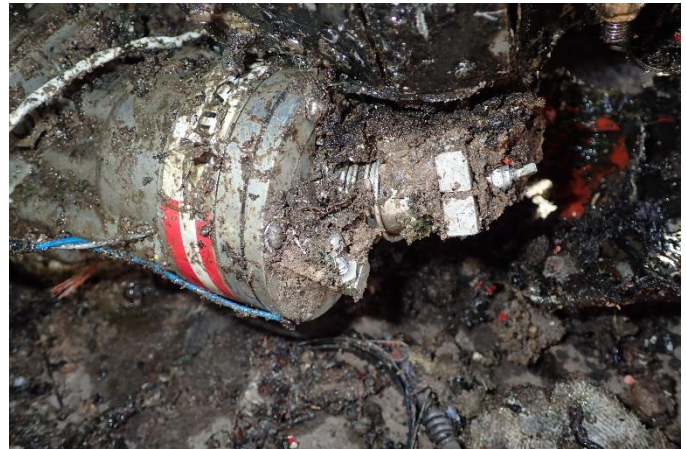
The propeller governor remained attached to its installation point and displayed impact damage signatures. There were no anomalies noted.

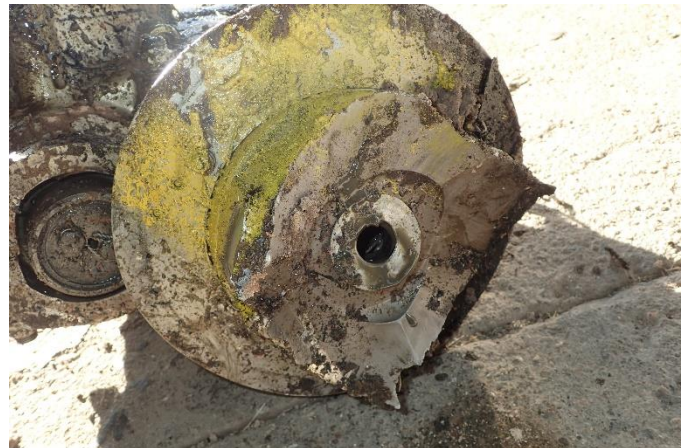
The three blade, constant speed propeller had broken free from the propeller shaft and the propeller hub was found to be fractured into multiple pieces. Two of the three propeller blades remained attached to portions of the propeller hub; the third propeller blade had completely separated from the propeller hub. The propeller blade marked "A" displayed a large gouge in the trailing edge, twisting deformation, leading edge polishing and chordwise scratches. The propeller blade marked "B" displayed S-bending deformation, significant polishing of the cambered side, and chordwise scratches. The propeller blade marked "C" displayed chordwise scratches and minor forward bending deformation.

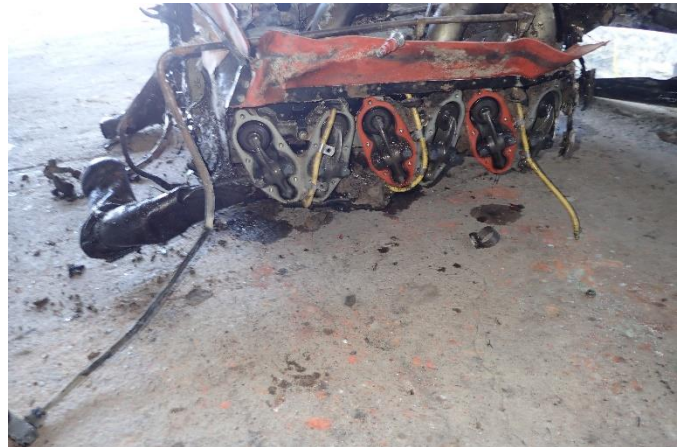
The exhaust system displayed a significant amount of impact damage signatures; the risers had crushed upwards and several of the risers were crushed almost completely flat in areas. The turbocharger V-band clamp was noted to have remained attached to the tailpipe; however, it had broken free from the turbocharger which was consistent with impact damage.

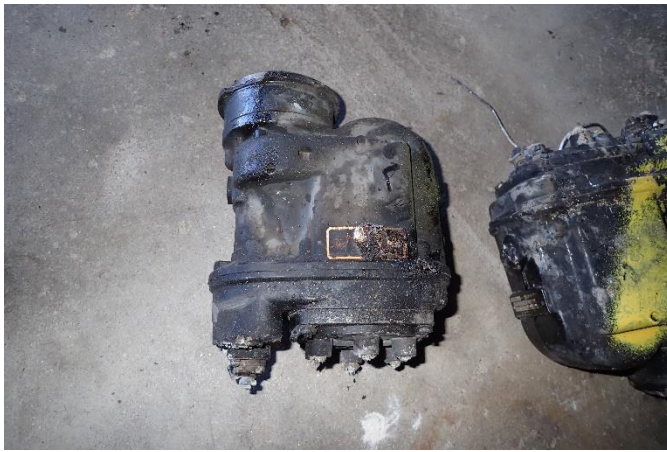
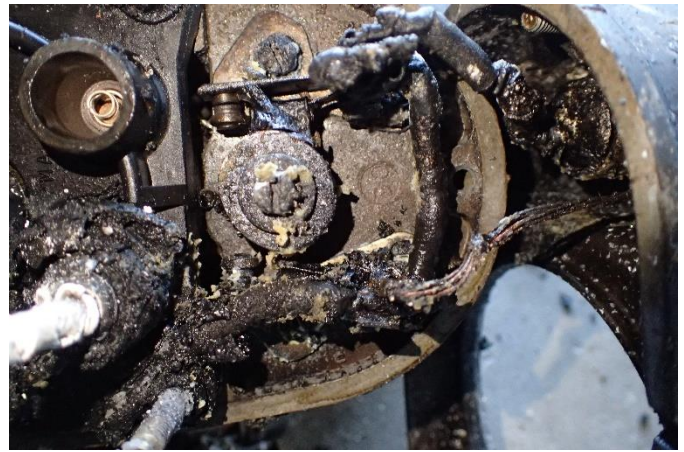
The magneto had broken free from its installation point and displayed impact and thermal damage signatures. The drive shaft was noted to be capable of rotation; however, it was noted that magneto was unable to produce a spark. The magneto was partially disassembled, and it was noted that all of the internal components displayed significant thermal damage signatures.

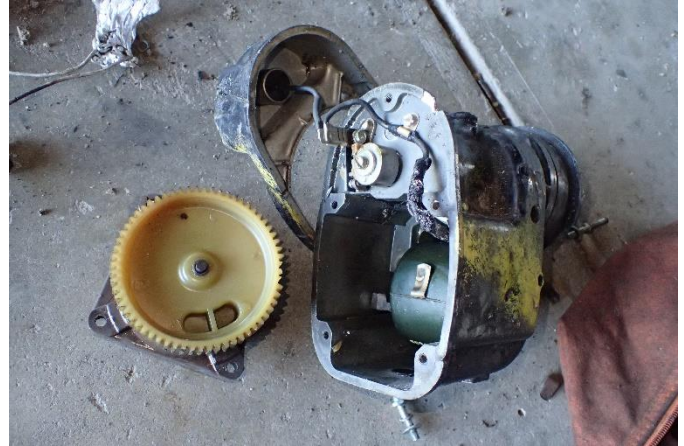
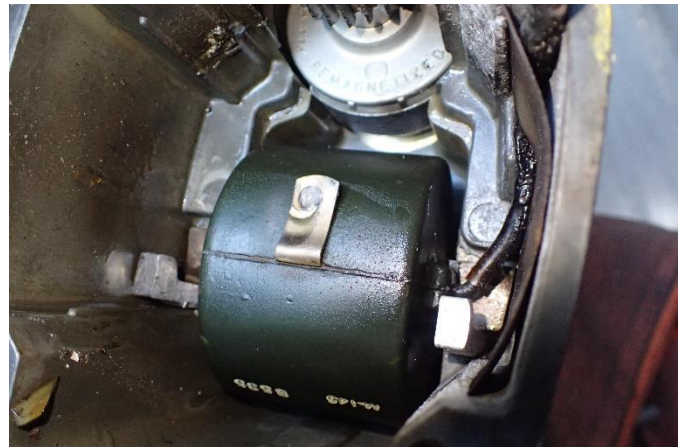
The magneto had broken free from its installation point and displayed impact and thermal damage signatures. The magneto drive was rotated, and it was noted that the driven gear was not rotating, and the magneto was unable to produce a spark. The magneto was disassembled, and it was noted that several gear teeth were broken that were in contact with the drive gear; there were no signs that the engine operated with the broken gear teeth and the damage was consistent with impact damage. The rest of the internal components displayed impact and thermal damage signatures.

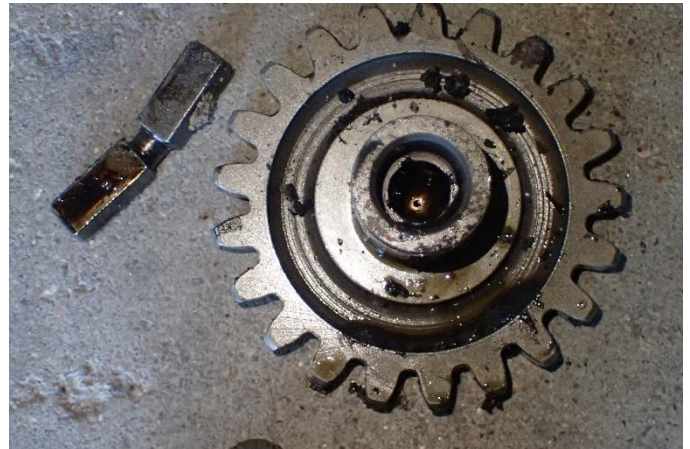
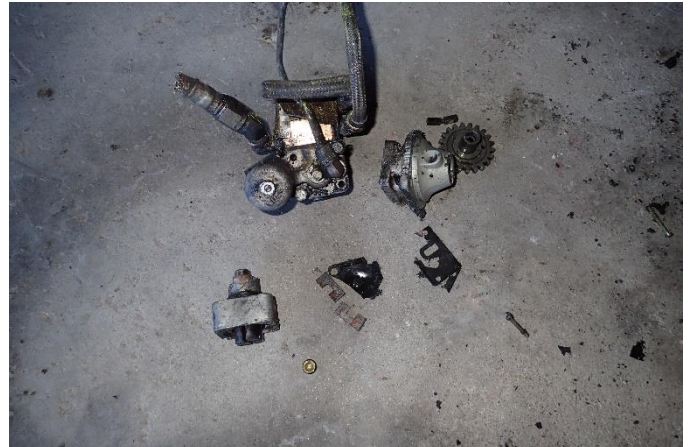
The fuel pump had broken free from its installation point and displayed impact and thermal damage signatures. It was noted that the fuel pump drive coupling remained with the drive gear and was bent; the damage was consistent with impact damage. It was noted that the fuel pump drive shaft was capable of rotation. The fuel pump was disassembled, and the internal components were visually inspected; the components displayed impact damage, some thermal damage, and normal operating signatures. There were no anomalies noted.

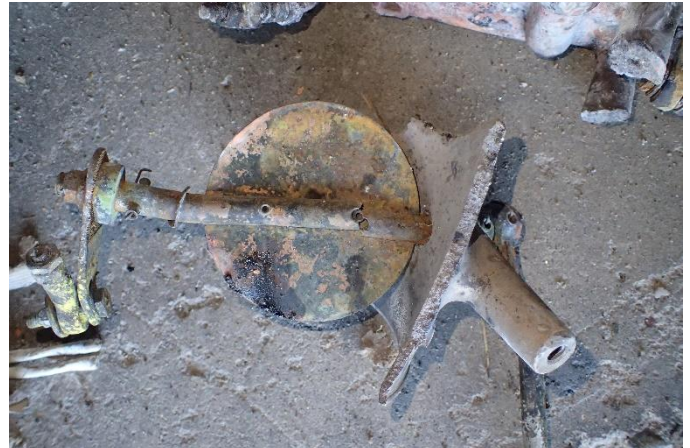
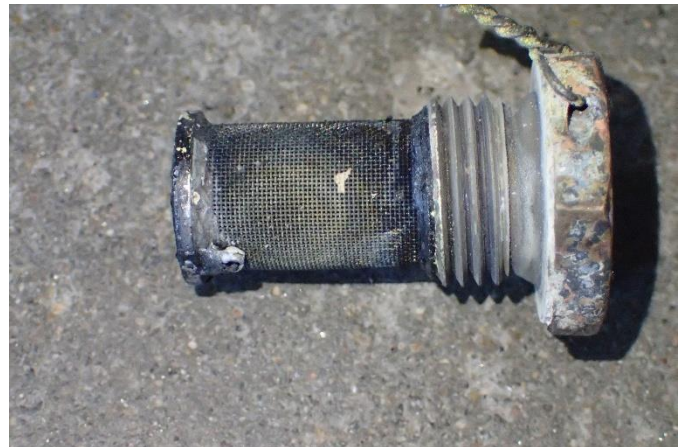
The throttle and fuel metering assembly had broken free from its installation point and displayed significant impact and thermal damage signatures. The metering assembly had broken free from the throttle body and most of the throttle body had broken free from the throttle valve. It was noted that the mixture and throttle control cable rod ends remained secured to their control arms. The fuel inlet screen was removed and was noted to contain a small amount of burnt debris but was not blocked. There were no anomalies noted.

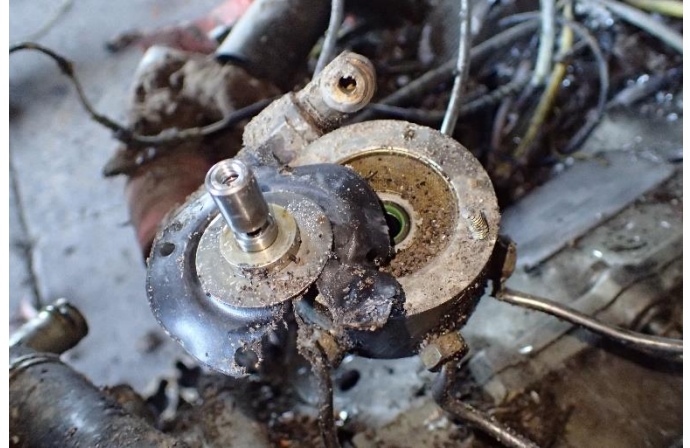
The fuel manifold valve remained partially attached to the engine through the fuel lines. The valve displayed a significant amount of impact damage; the fuel manifold valve cap had broken free from the rest of the valve and the diaphragm was torn. The internal components displayed impact damage and were covered in material consistent with dirt. There were no anomalies noted.

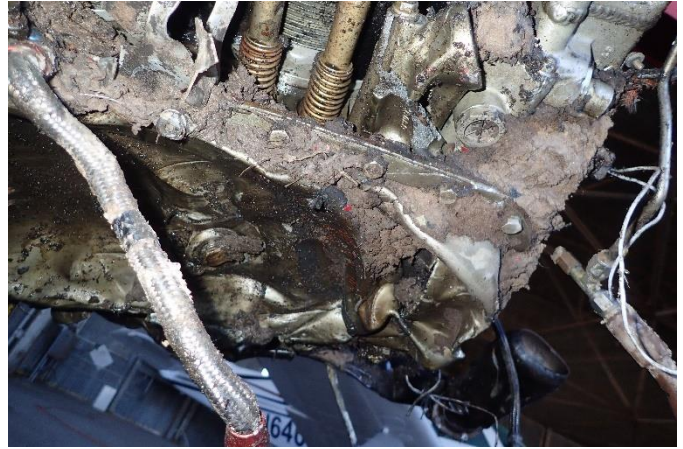
The oil sump displayed a significant amount of impact damage and was crushed upwards and breached. There were no anomalies noted.

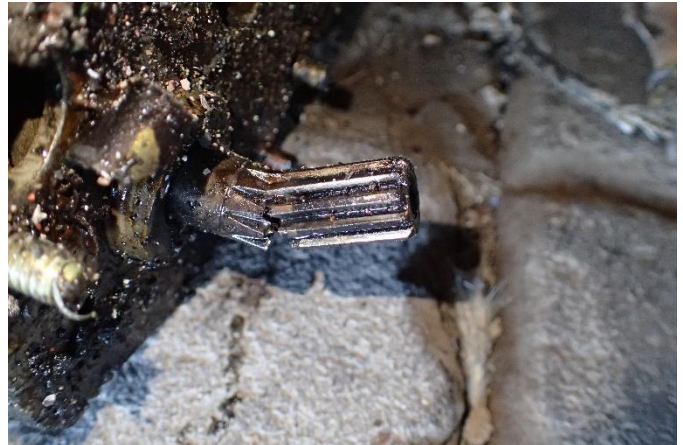
The oil pump had broken free from its installation point and displayed a significant amount of impact damage and some thermal damage signatures. The oil pump drive shaft was noted to be partially broken which was consistent with impact damage.

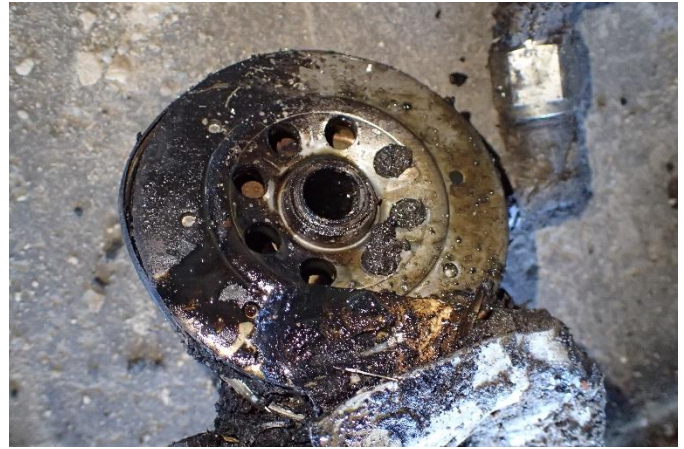
The oil filter had broken free from the oil filter adapter and was not located at the time of the examination.

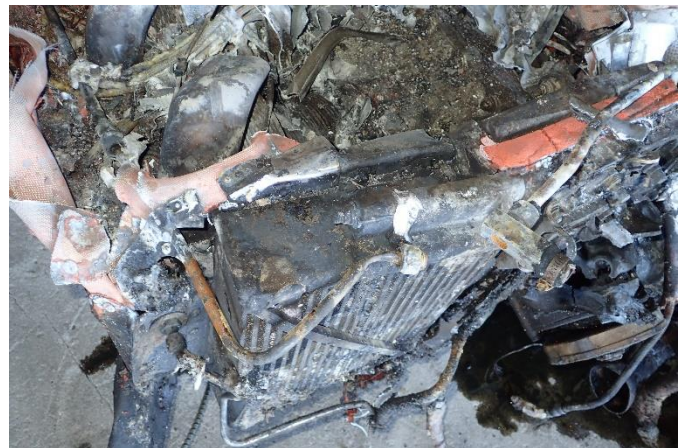
The oil cooler remained attached to the engine and displayed a significant amount of impact damage and some thermal damage signatures. There were no anomalies noted with the oil cooler.

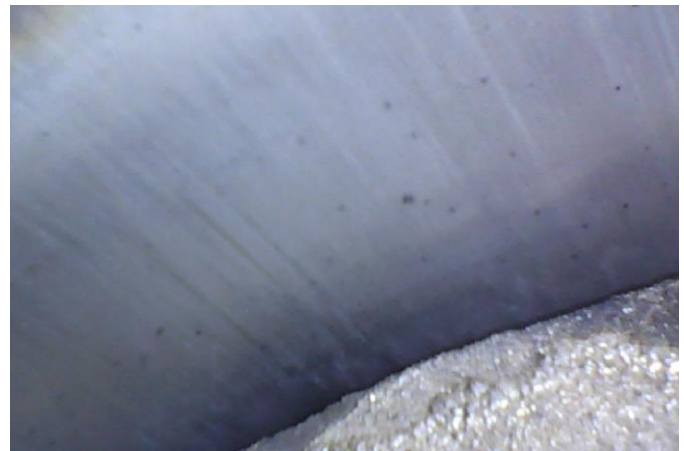
All six cylinders remained attached to their cylinder bays and displayed impact damage signatures with the bottoms of the cylinders showing the most damage. All of the cylinders were inspected using a lighted borescope; the valve heads, cylinder bores, and piston faces displayed normal operating and combustion signatures. The overhead components (valves, springs, and rocker arms) displayed normal operating and lubrication signatures. All of the rocker arms and valves were capable of movement when actuating the rocker arms manually.

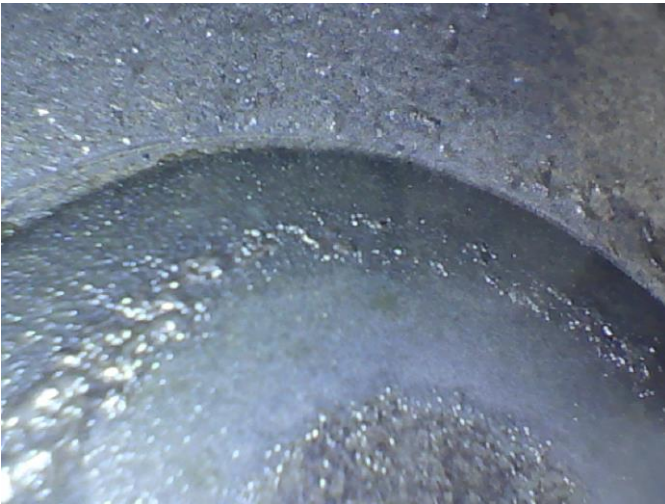
The valve heads were inspected using a lighted borescope. The valve heads displayed normal operating and combustion signatures. It was noted that the valves were capable of movement when the rocker arms were actuated manually.

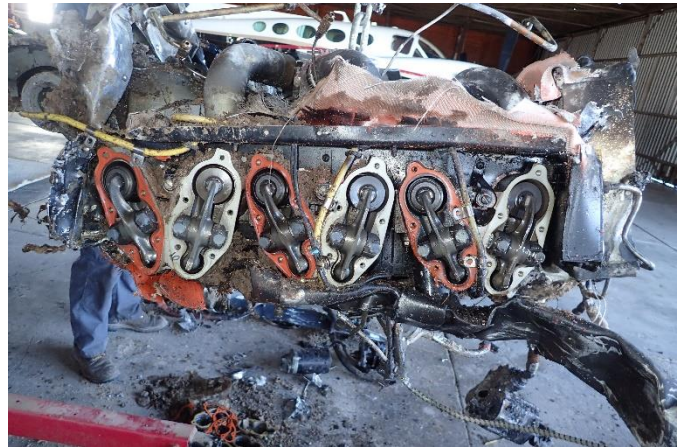
The rocker arms remained attached to their installation points and displayed normal operating and lubrication signatures. The rocker arms were operated manually, and it was noted that all of the rocker arms were capable of movement.

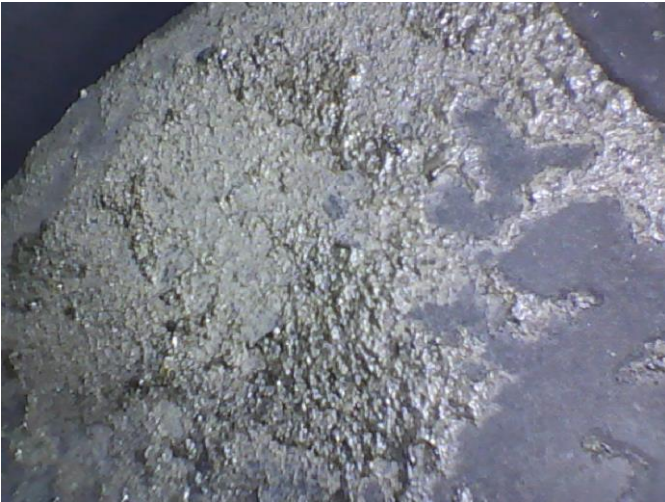
The piston faces were inspected using a lighted borescope. The piston faces displayed normal operating and combustion signatures. There were no anomalies noted with the pistons.

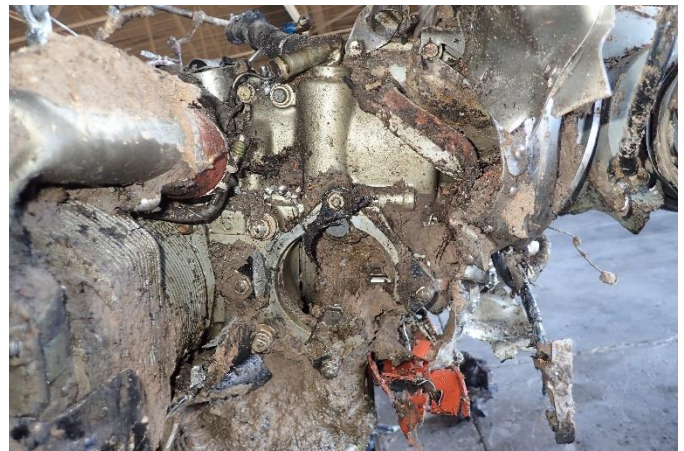
| CRANKCASE | Casting Number: | 1-3-5: Not observed | 2-4-6: Not observed | S/N: Not observed |
|---|---|---|---|---|
| Condition: | The crankcase displayed impact damage signatures with the most damage occurring to the bottom and front of the crankcase; the portion of the crankcase that houses the propeller shaft and reduction gear assembly was cracked and had partially separated. There were no breaches in the crankcase that would indicate a catastrophic internal engine failure. Holes were drilled in the top of the crankcase to facilitate inspection of the internal components; there were no anomalies noted with any of the internal portions of the crankcase. | | | |

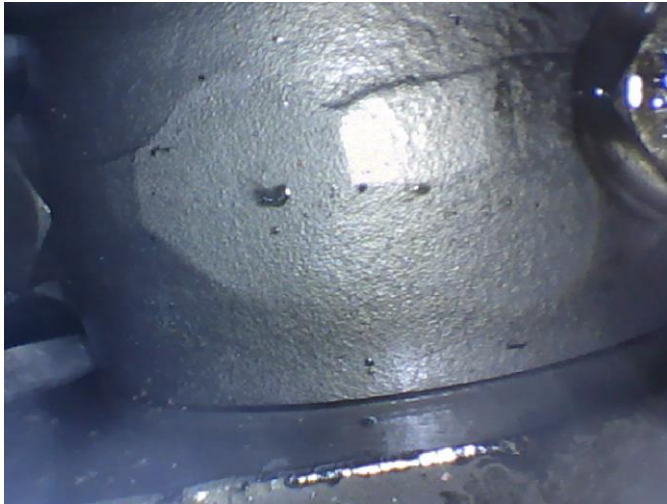
The connecting rods were inspected using a lighted borescope that was inserted into holes that were drilled into the crankcase. All of the connecting rods remained attached to their journals and displayed normal operating and lubrication signatures. There were no anomalies noted.

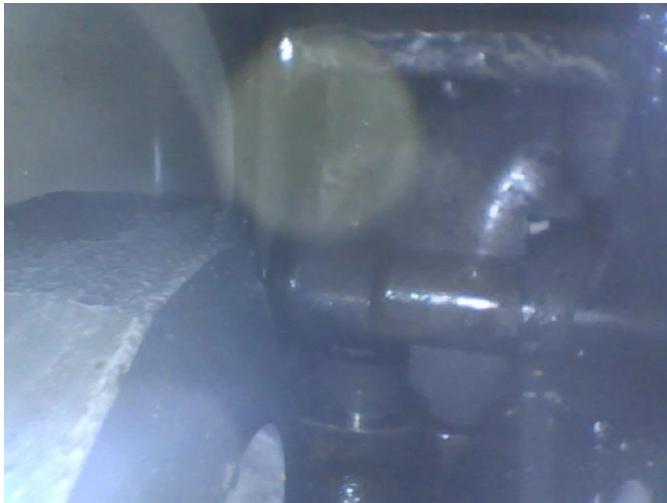
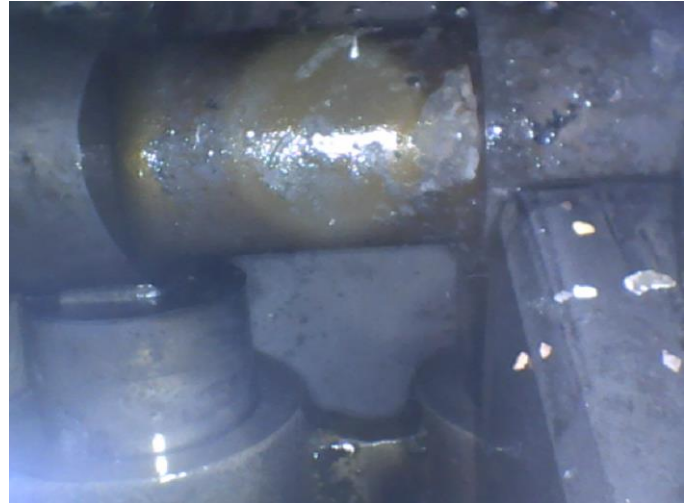
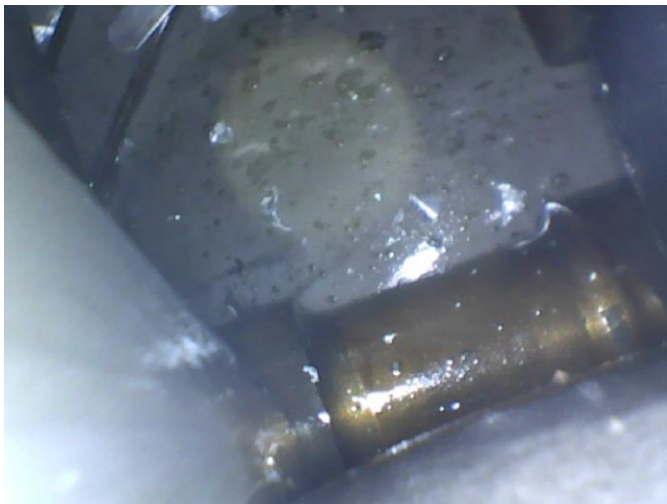
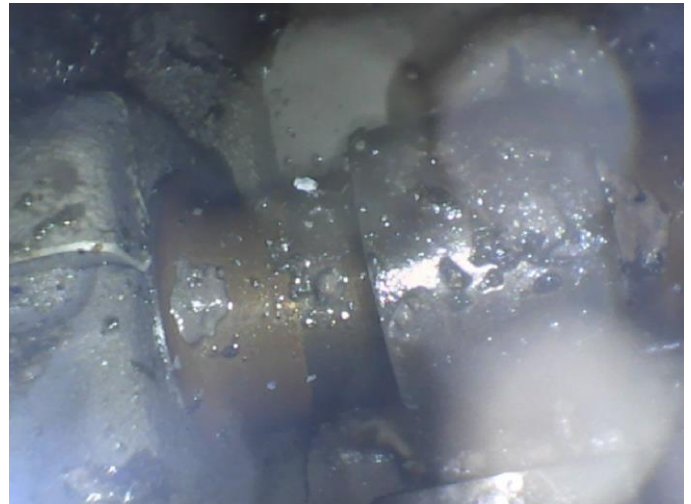
The camshaft gear remained intact and displayed normal operating signatures. Portions of the camshaft were visible by inserting a lighted borescope into drilled holes in the crankcase. The visible portions of the camshaft displayed normal operating signatures.

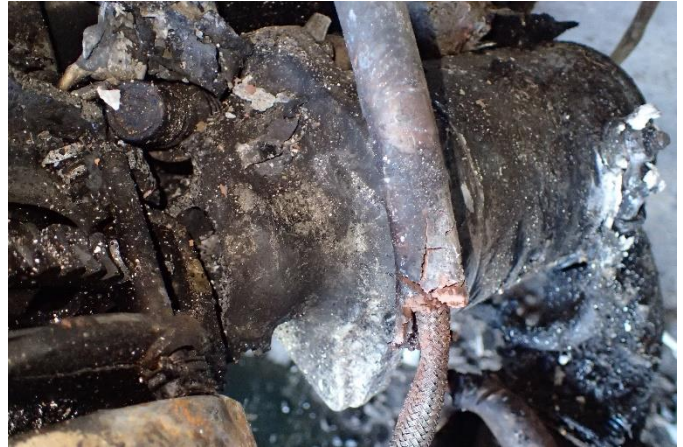
The starter remained attached to the starter adapter attach flange; however, the attach flange had broken free from the rest of the adapter. The starter displayed impact and thermal damage signatures. There were no anomalies noted.
